May 2018

# **Construction noise and vibration Monthly Report – January 2018**

**Three Rivers District**

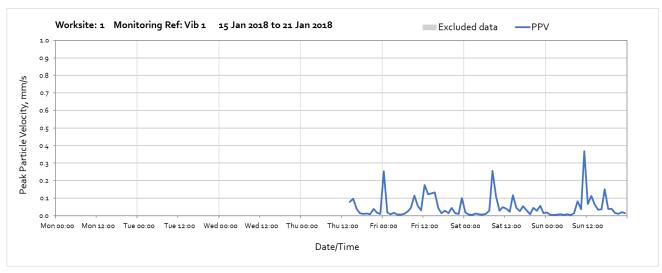
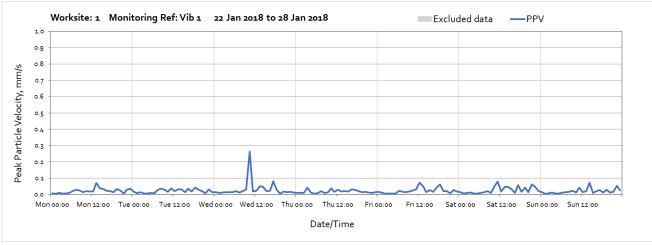
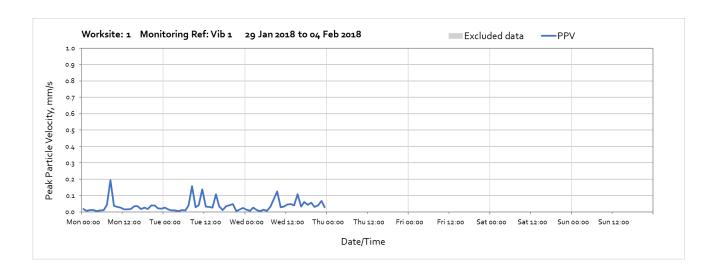
### Worksite: M25 J16/17 Slip Road – Monitoring Ref: V1

Worksite Reference	Measurement Reference	Site Address	Highest PPV measured in any axis, mm/s
M25 J16/17 Slip Road	V1	Inside Gellibrands, Shire Lane	0.32 (Z axis)

The following graphs show the hourly measured peak particle velocity PPV recorded during the monitoring period. The graphs show the resultant PPV due to vibration components on three orthogonal axis x, y and z.
