## **Construction noise and vibration Monthly Report – August 2018**

**London Borough of Camden**

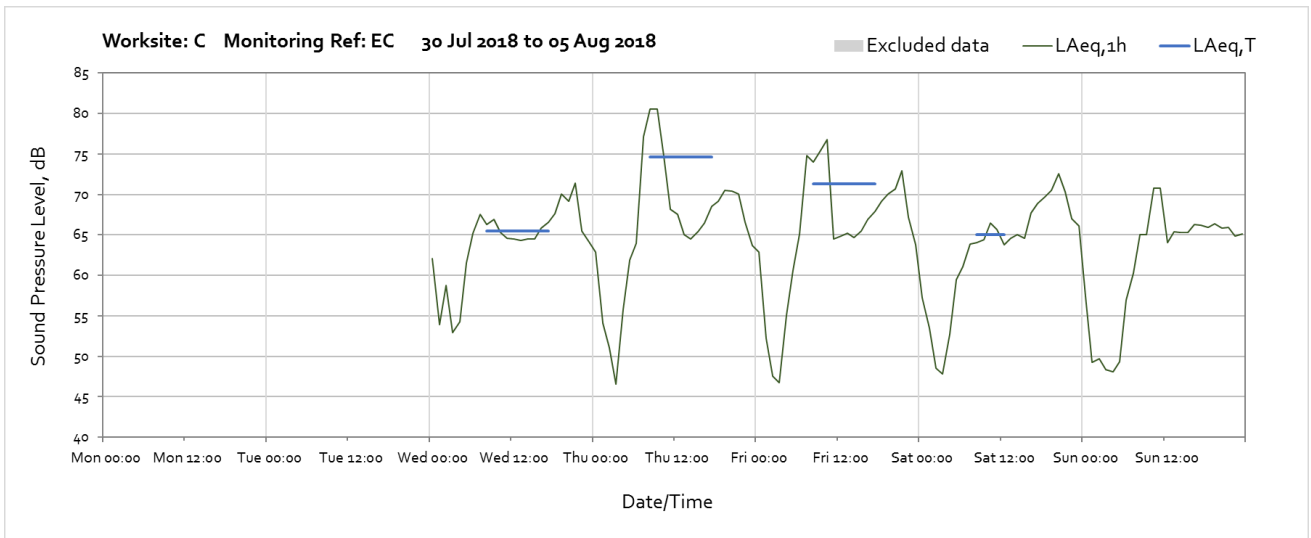
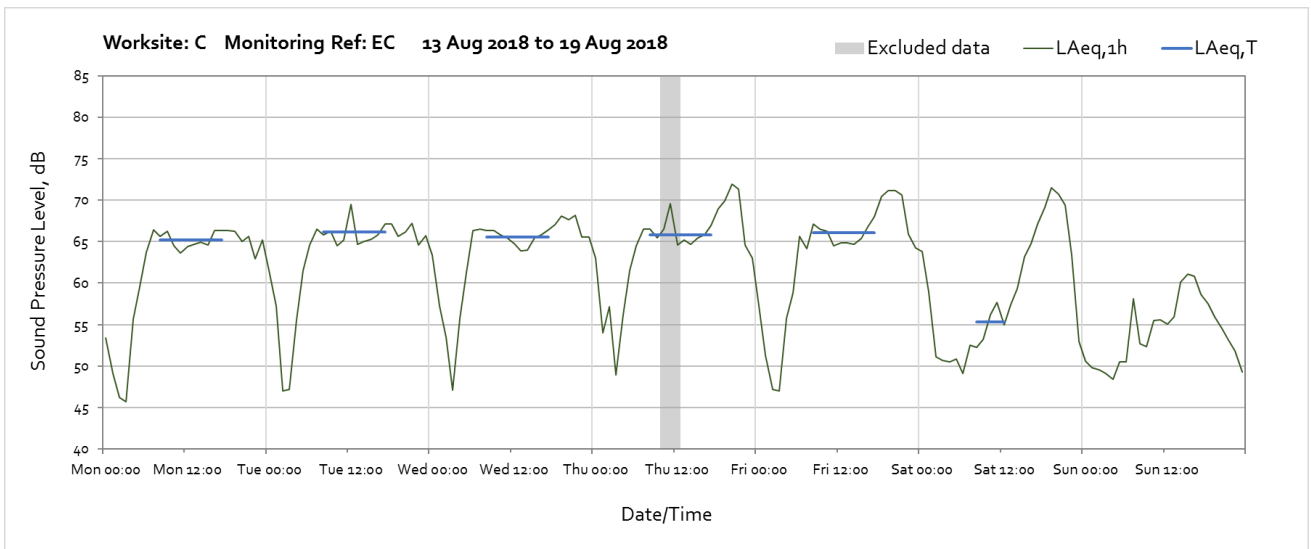
## Worksite: C – Monitoring Ref: EC

Note – Missing data between 22:00 on Tuesday 07 and 16:00 on Wednesday 08 due to a loss of power at the noise monitor.

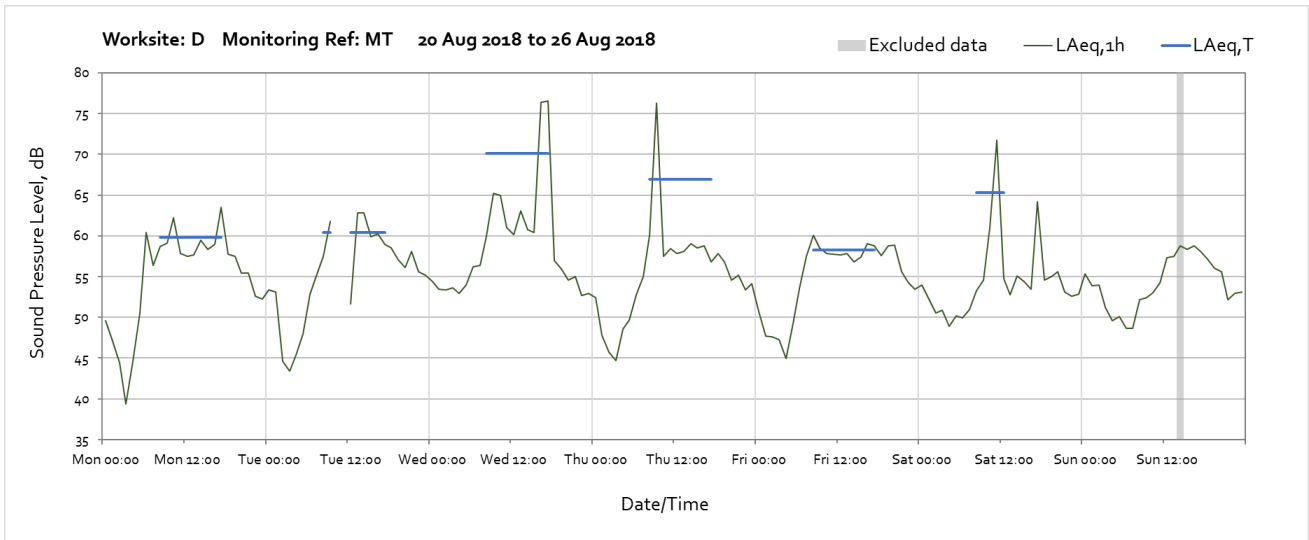
## Worksite: D – Monitoring Ref: MT

Note – Missing data between 10:00 and 12:00 on Tuesday 21 due to a loss of power at the noise monitor.
