## **Air Quality and Dust Monitoring Monthly Report – October 2018**

**London Borough of Ealing**

- 1.1.1 This Summary Report is published in fulfilment of commitments detailed in the High-Speed Rail (London-West Midlands) Environmental Minimum Requirements, Annex 1: Code of Construction Practice, for the nominated undertaker to present the results of air quality and dust monitoring undertaken in the London Borough of Ealing (LBE) during September and October 2018 respectively.

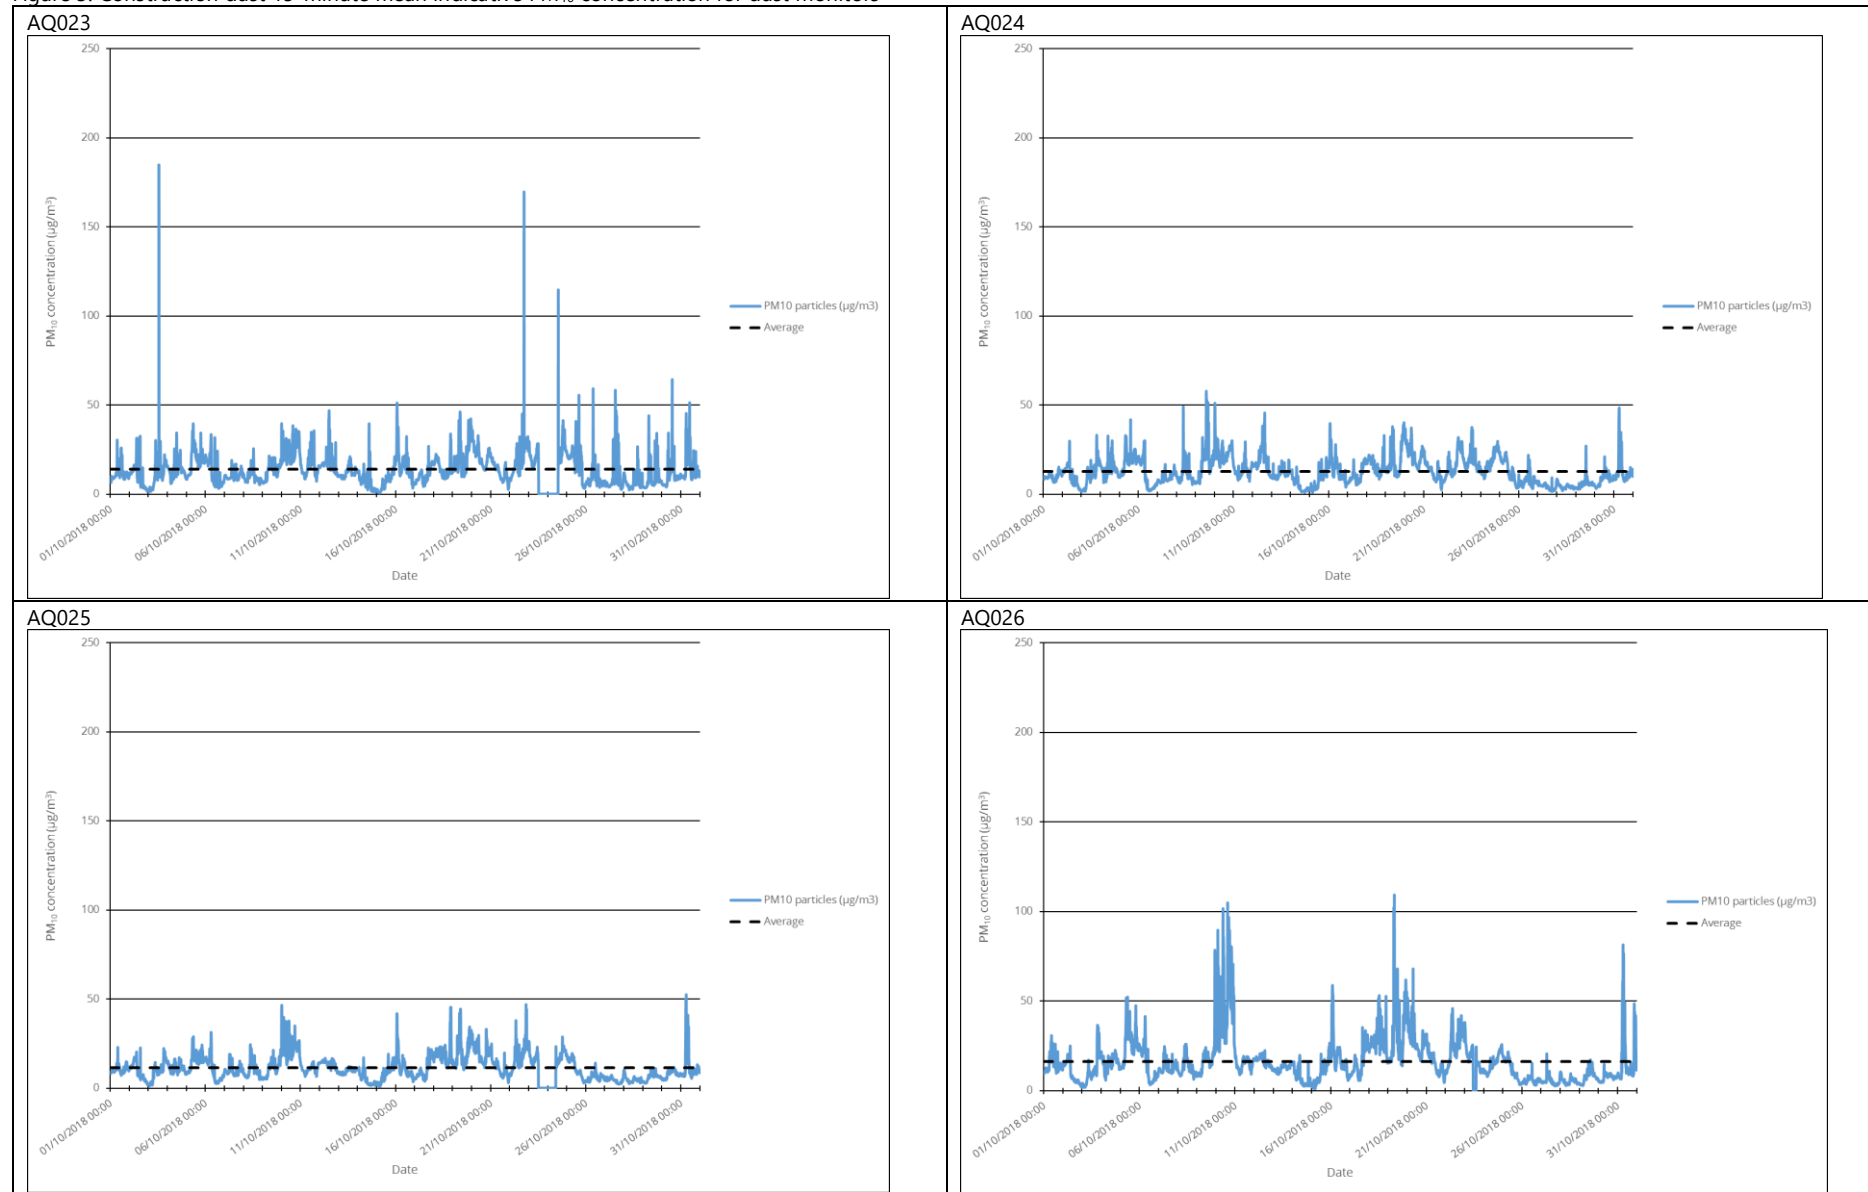
Figure 3: Construction dust 15-minute mean indicative PM<sub>10</sub> concentration for dust monitors

- 1.1.6 Dust monitoring locations and results are presented in Appendix B, Table 1, together with line charts of monthly data from each dust monitor.
- 1.1.7 There were no exceedances of the dust trigger level recorded during the month of October 2018.
