Air Quality and Dust Monitoring Monthly Report – November 2018

London Borough of Hillingdon

A report prepared by Costain Skanska on behalf of HS2 Ltd.

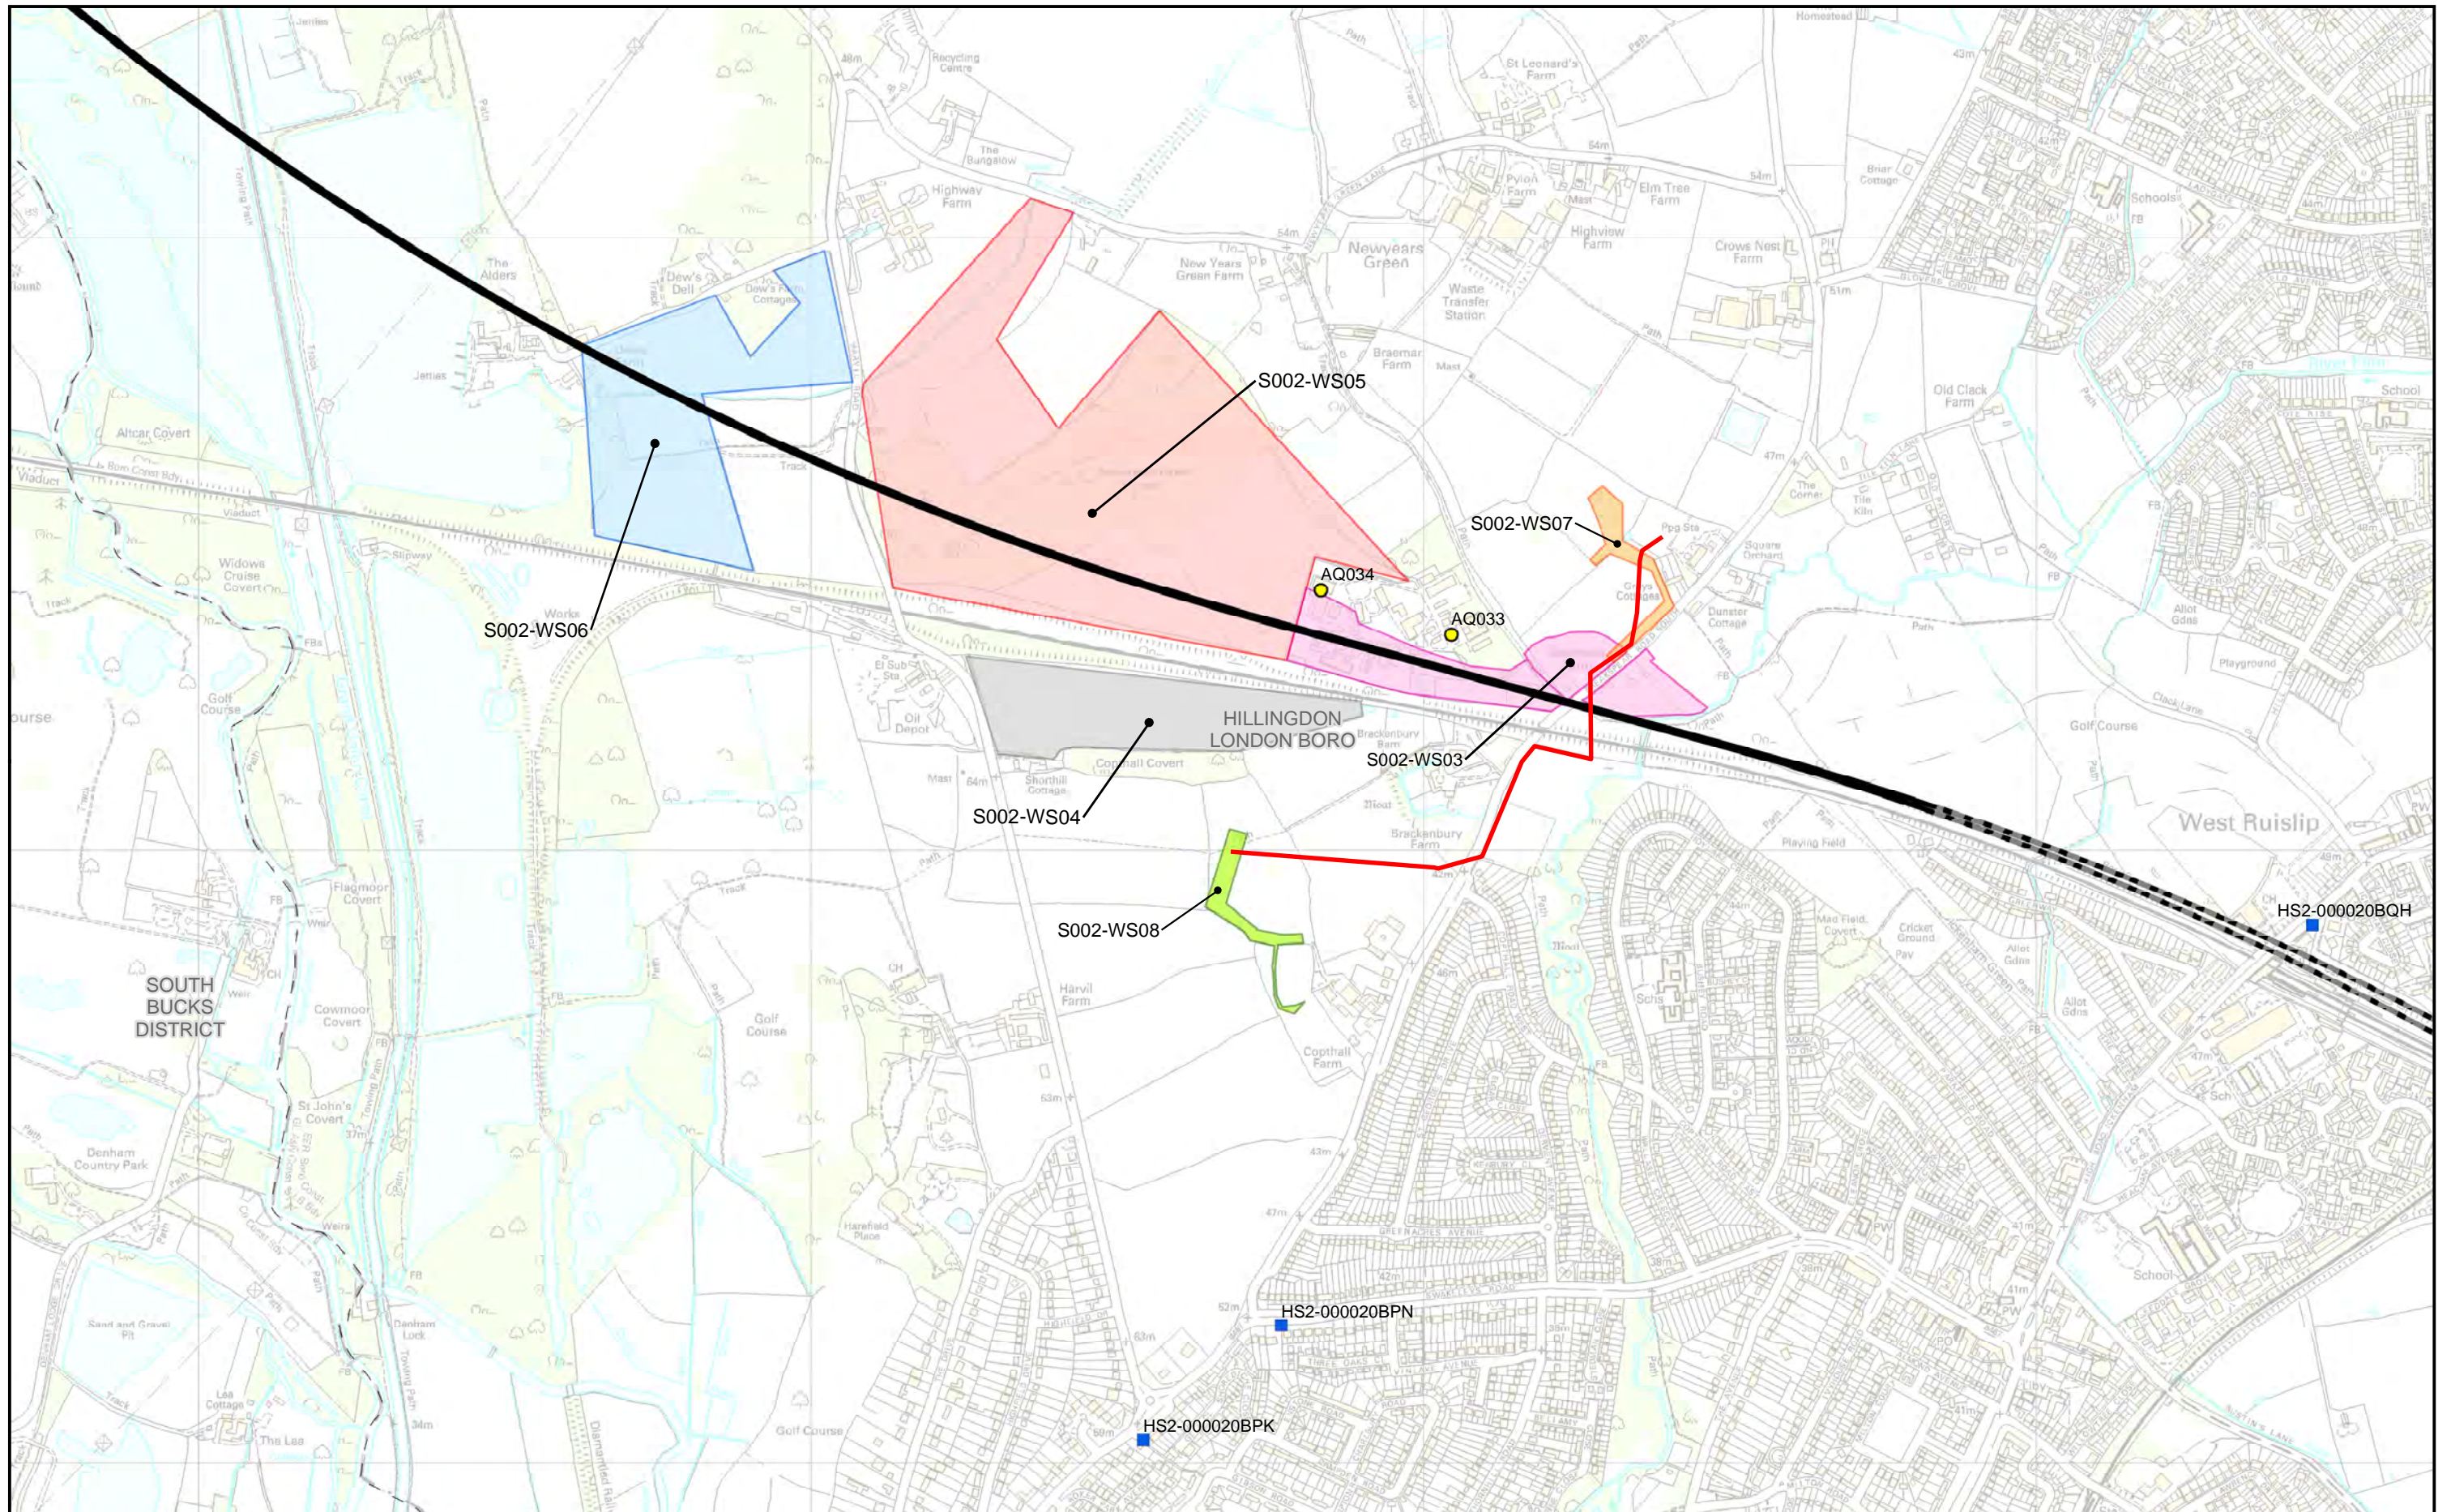
Figure Number
Figure Name
Worksites and Monitoring locations in LBH (sheet 1)
London Borough of Hillingdon

- 1.1.2 Figure 1 to Figure 4 in Appendix A indicate the current work sites, together with air quality and dust monitoring locations.
- 1.1.3 This summary should be read in conjunction with the overview monitoring report available from www.gov.uk/government/collections/monitoring-the-environmental-effects-of-hs2, which highlights: the applicable standards and guidance, as well as the air quality and dust monitoring methodologies to be implemented by nominated undertakers throughout construction.

- 1.1.4 The current phase of works commenced within the LBH during May 2018 and are expected to be completed by February 2019. The current worksites, as presented in Appendix A, Figure 1, include:

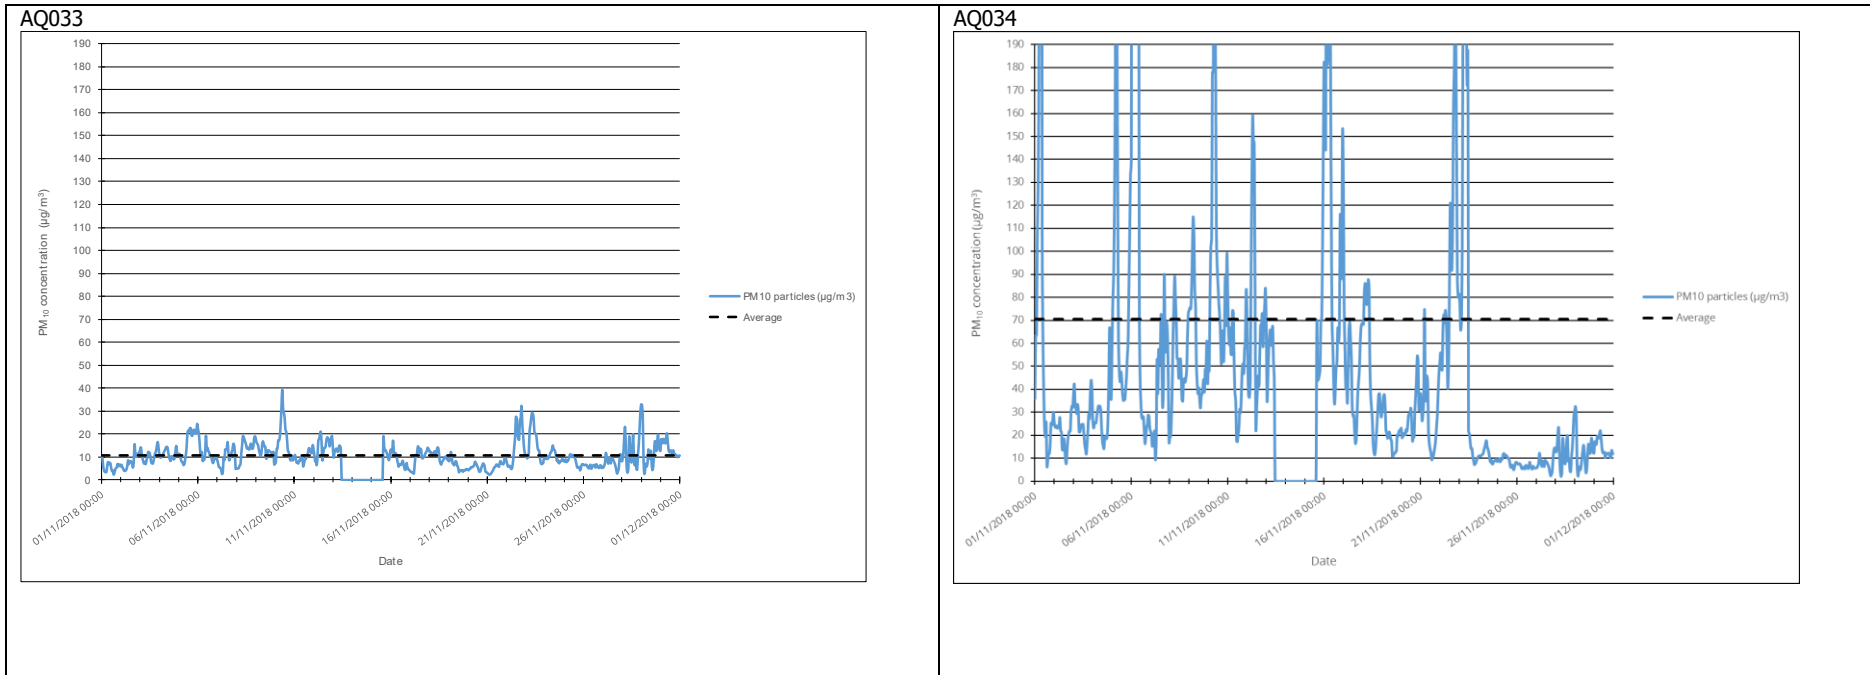
- 1.1.6 Dust monitoring locations and results are presented in Appendix B, Table 1, together with line charts of monthly data from each dust monitor.
- 1.1.7 There were twenty-six (26) exceedances of the dust trigger level recorded during the month of November 2018. Exceedances are presented in Appendix B, Table 2. All other results were in line with the expected ranges.

Figure 5: Construction dust 1-hour mean indicative PM₁₀ concentration for dust monitors

Period exceeding trigger level	Worksite reference	Monitoring site ID	Complaint reference number (if applicable)	Reason	Resolution
01/11/2018 05:00 - 01/11/2018 08:00 (3 x triggers)	S002-WS03	AQ034	n/a	No works were being undertaken at the time of the exceedance and no likely dust sources from nearby HS2 site. Alert potentially attributable to high humidity levels (mist) which can trigger false alerts. These appear to have been worsened by a faulty heater in the unit.	Unit was serviced and calibrated. However, false alerts persisted and the unit was temporarily replaced to undergo further servicing.
05/11/2018 04:00 - 05/11/2018 06:00 (2 x triggers)	S002-WS03	AQ034	n/a		
06/11/2018 00:00 - 06/11/2018 09:00 (9 x triggers)	S002-WS03	AQ034	n/a		
10/11/2018 06:00 - 10/11/2018 08:00 (2 x triggers)	S002-WS03	AQ034	n/a		
16/11/2018 02:00 - 16/11/2018 03:00	S002-WS03	AQ034	n/a		
16/11/2018 05:00 - 16/11/2018 07:00 (2 x triggers)	S002-WS03	AQ034	n/a
