Construction noise and vibration Monthly Report – March 2018

London Borough of Camden

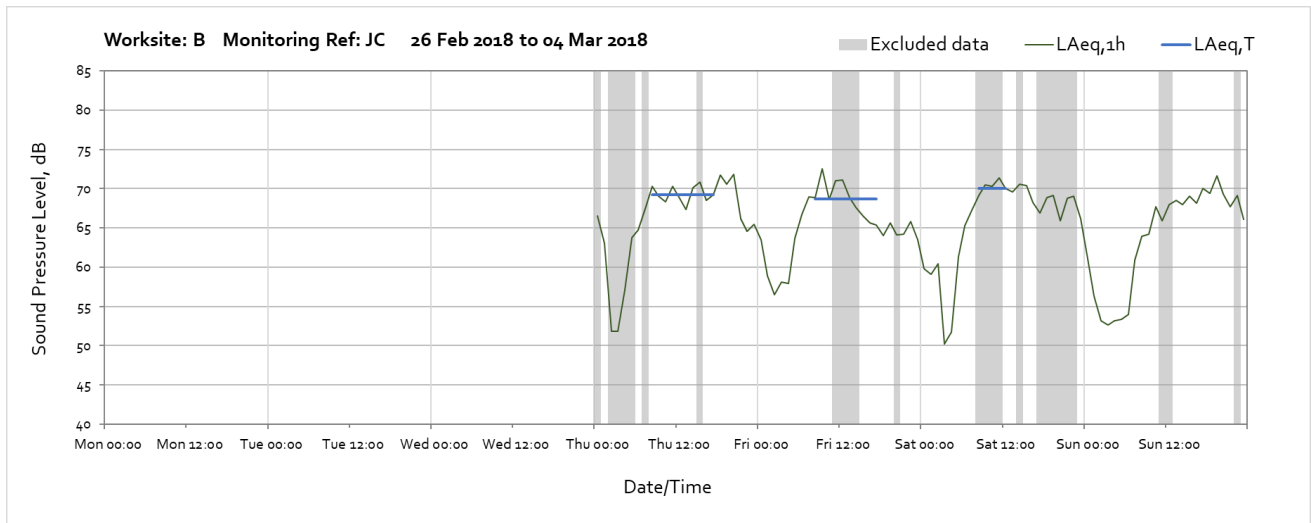
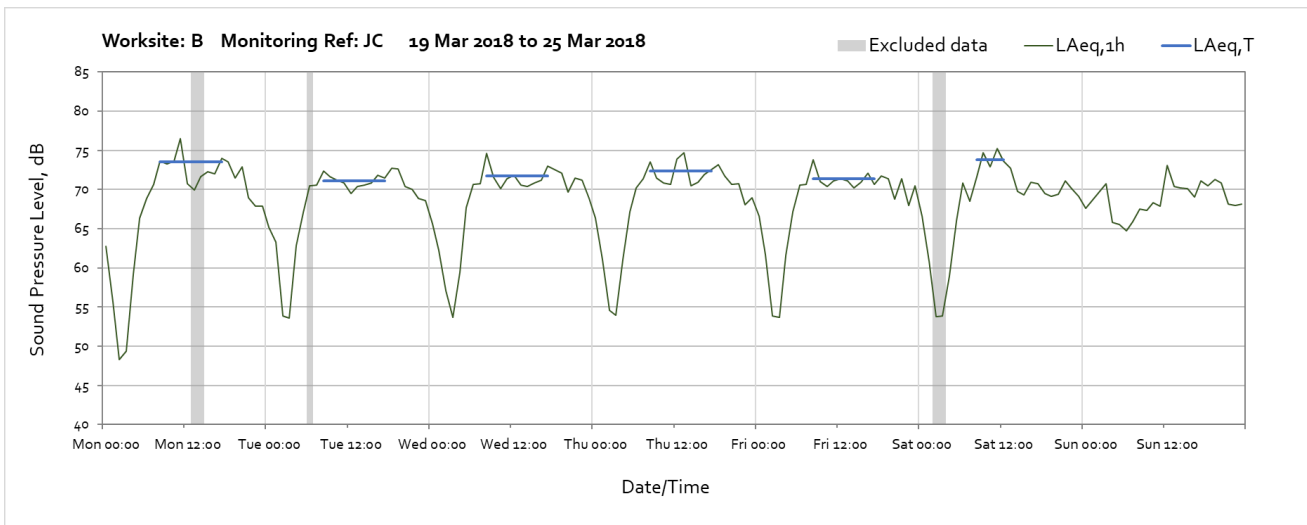
Worksite: B – Monitoring Ref: JC

The following graphs show the hourly measured ambient noise level $L_{Aeq,1h}$ and, where relevant, the averaged noise level $L_{Aeq,T}$ values, where the time period T is as specified in Table 1 of HS2 Information Paper E23. Periods with adversely weather affected noise levels are greyed out and have been excluded from the calculation of the $L_{Aeq,T}$ values.

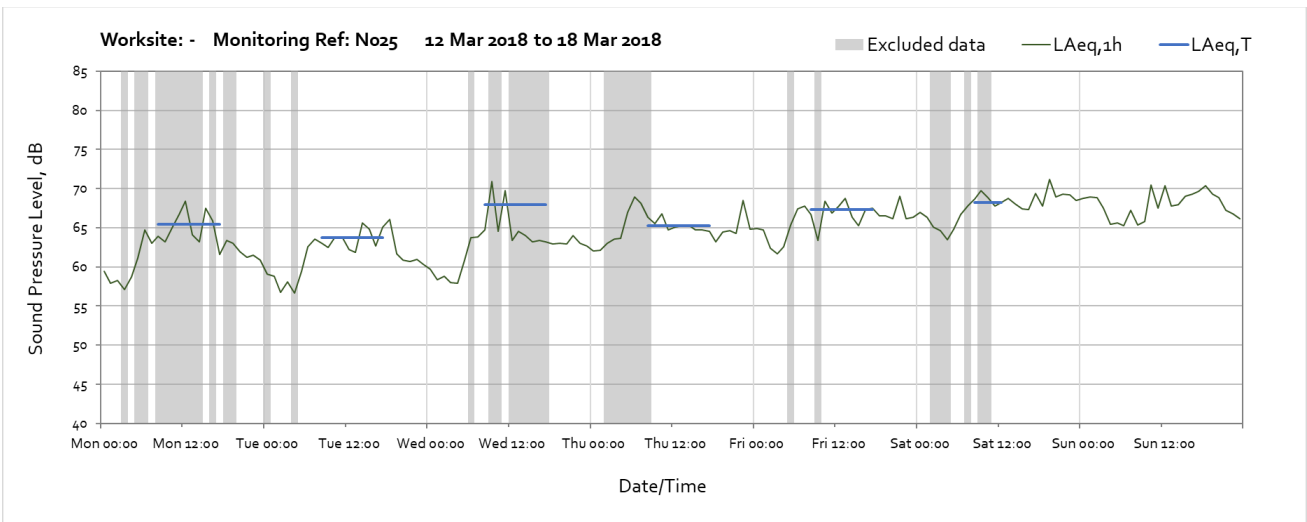
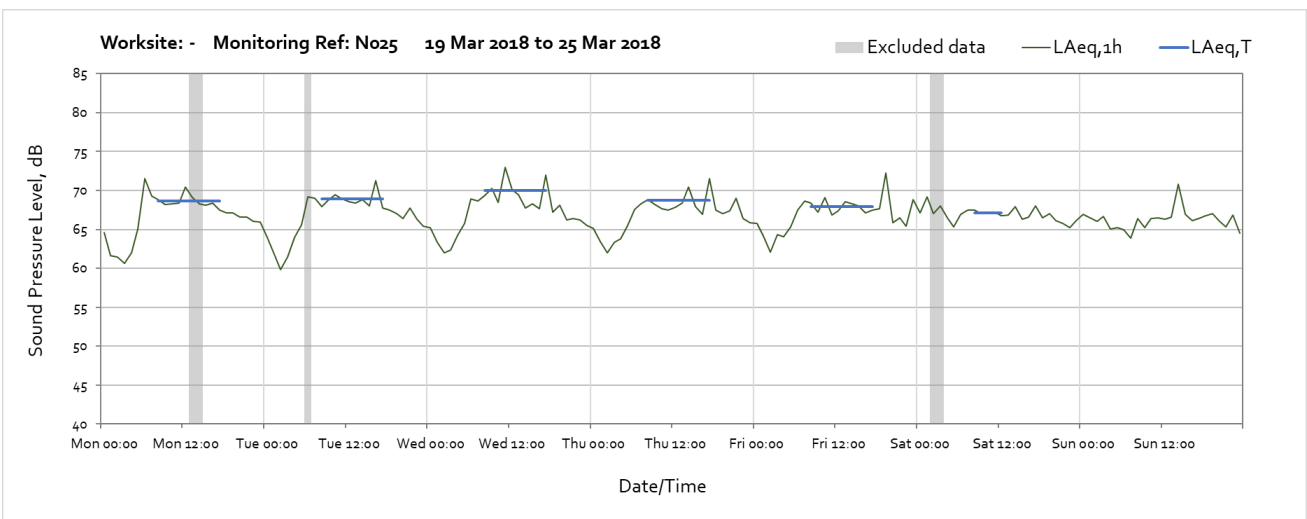
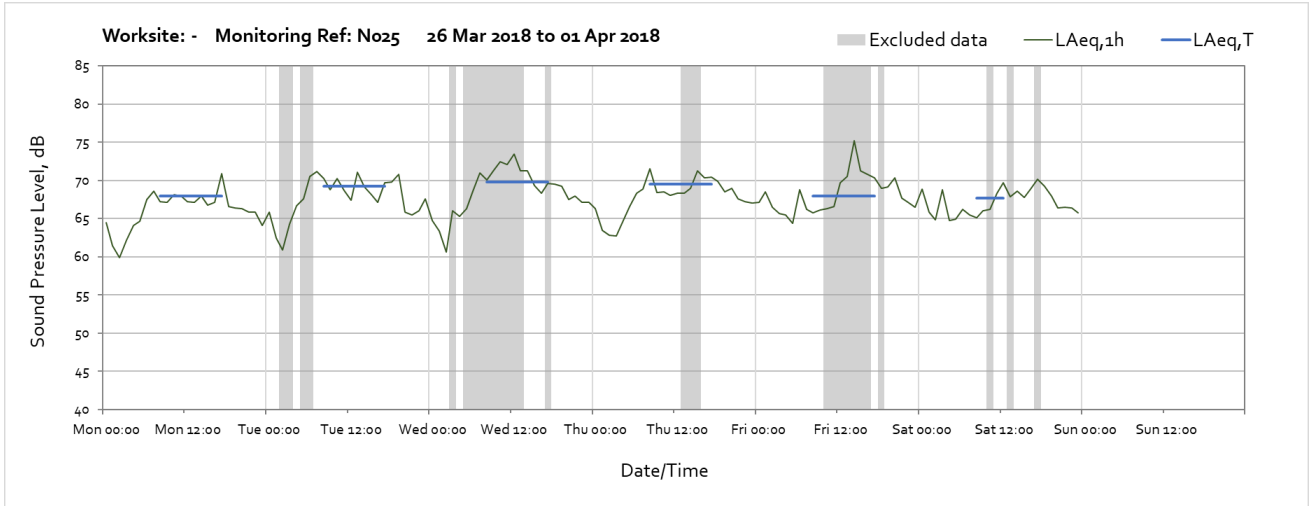
Monitoring Ref: N025

Note – Missing data between 07:00 and 10:00 on Friday 9th due to an internet connection failure.
