Construction noise and vibration Monthly Report – April 2018

London Borough of Camden

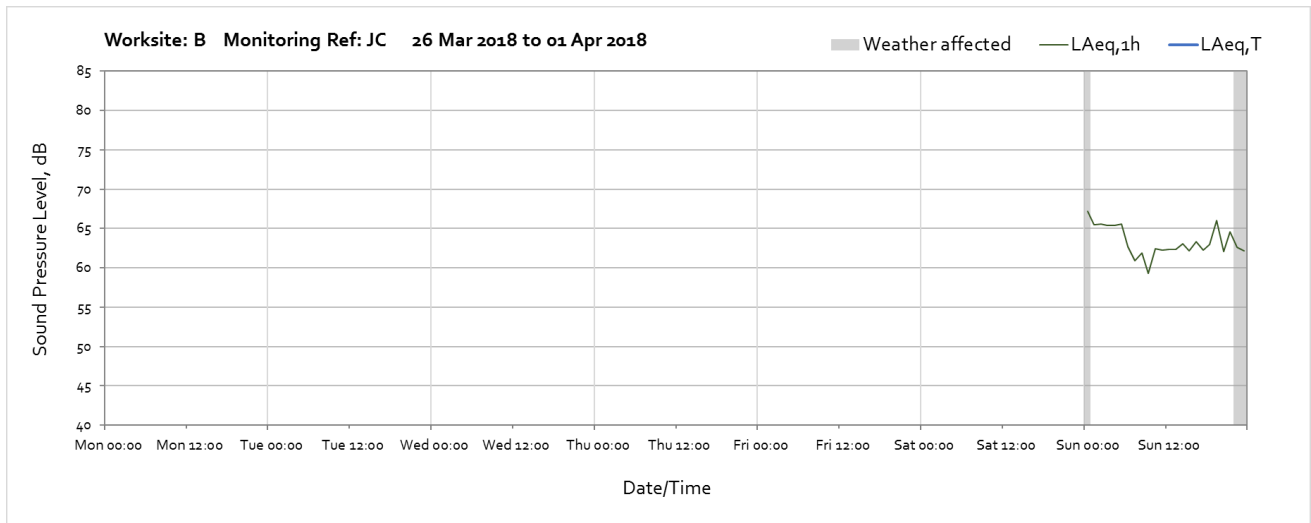
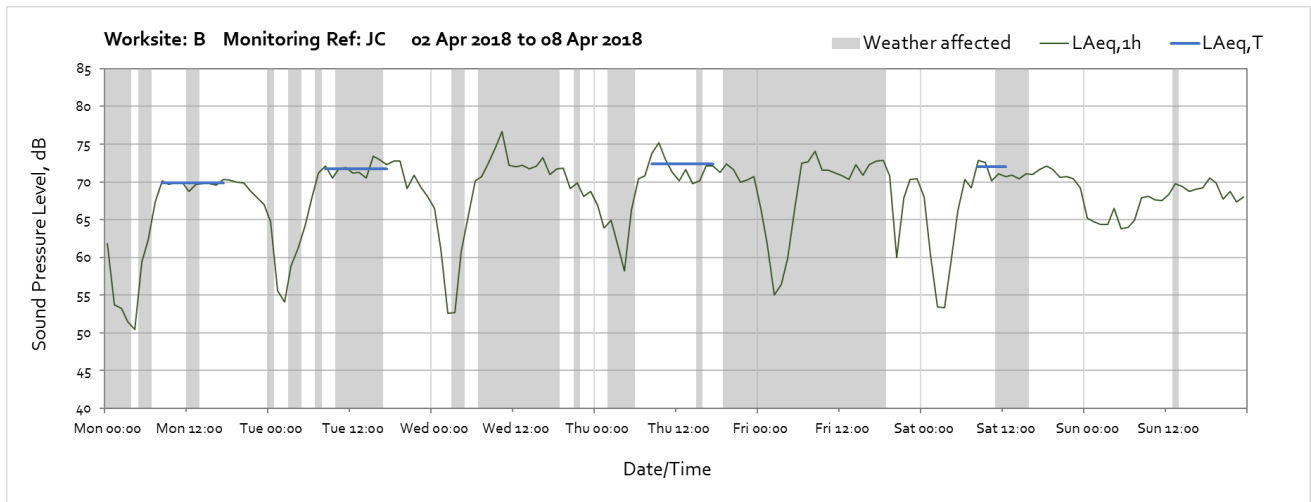
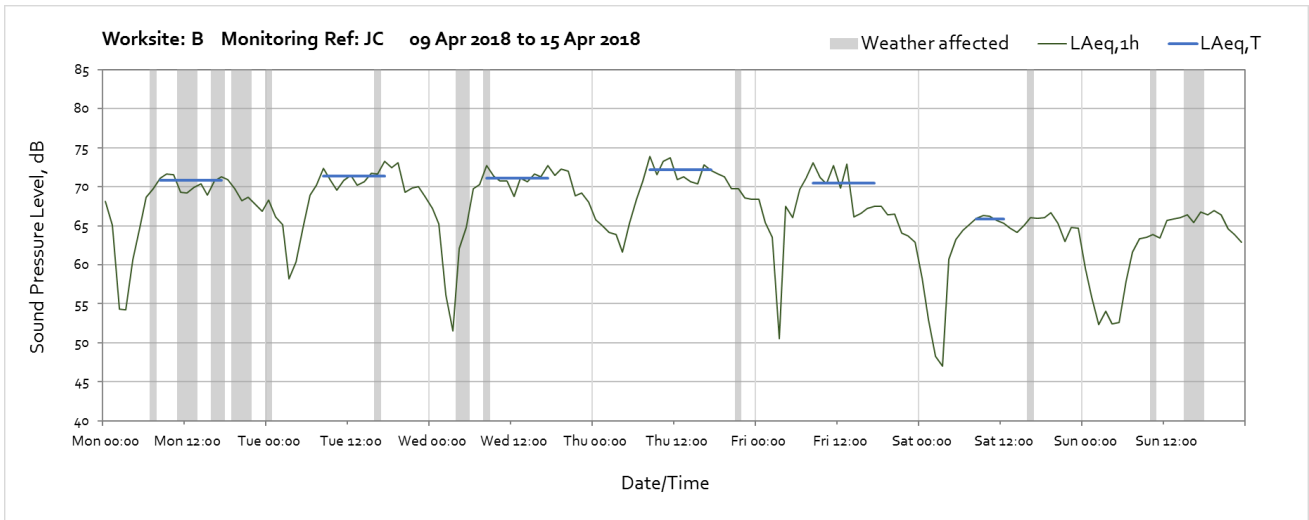
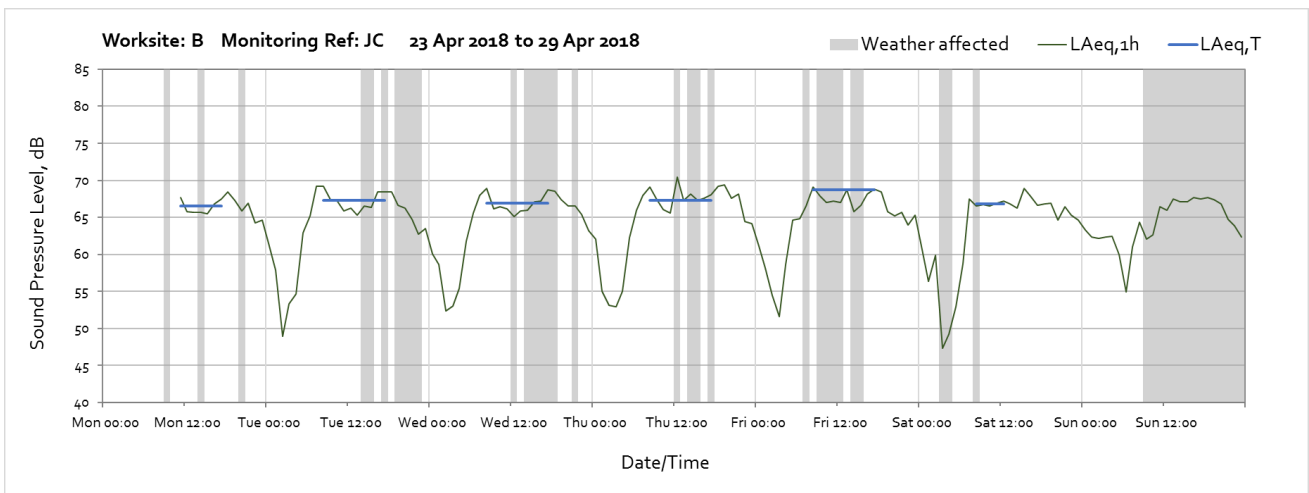
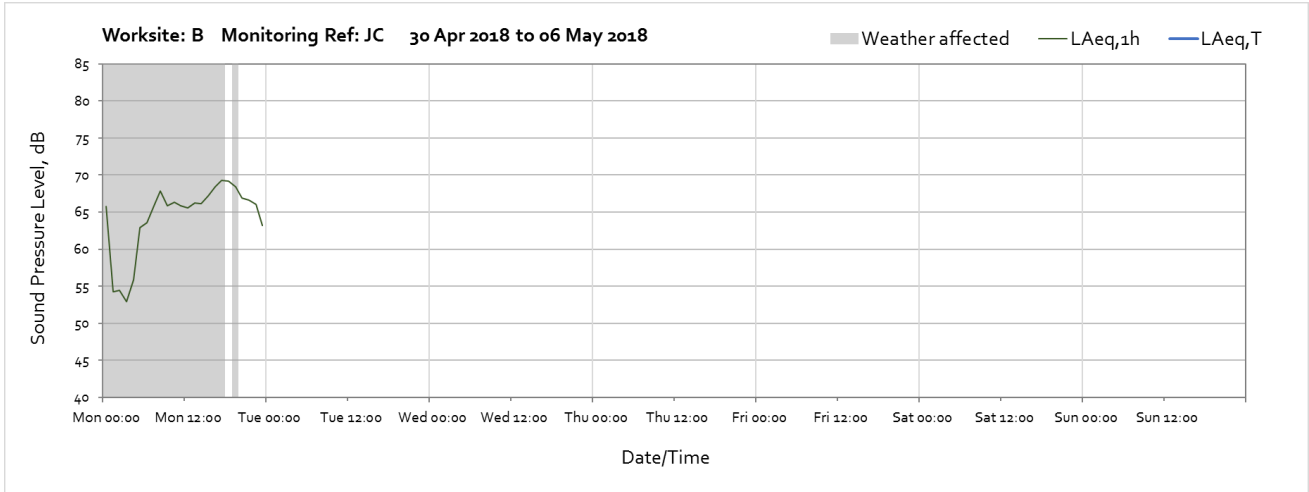
Worksite: B – Monitoring Ref: JC

The following graphs show the hourly measured ambient noise level $L_{Aeq,1h}$ and, where relevant, the averaged noise level $L_{Aeq,T}$ values, where the time period T is as specified in Table 1 of HS2 Information Paper E23. Periods with adversely weather affected noise levels are greyed out and have been excluded from the calculation of the $L_{Aeq,T}$ values.

Note – Missing data between 09:00 on Friday 20th and 11:00 on Monday 23rd due to a temporary loss of power.

Note – Missing data between 9:00 on Friday 20th and 11:00 on Monday 23rd due to a temporary loss of power.

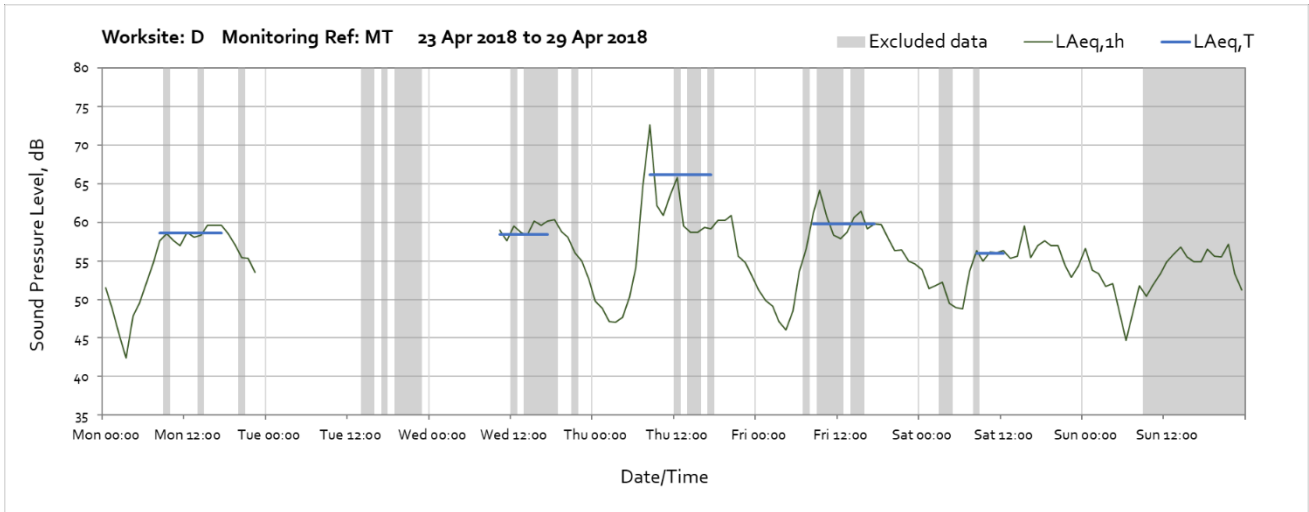
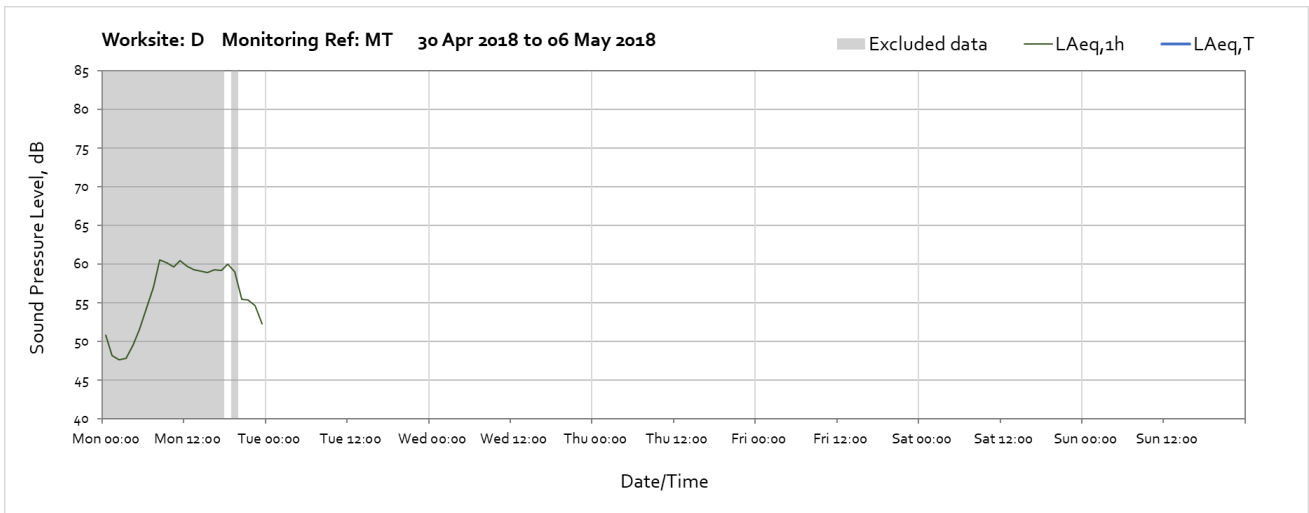
Worksite: D – Monitoring Ref: MT

Note – Missing data between beginning of month and 10:00 on Tuesday 3rd due to a temporary loss of power.

Note – Missing data between 00:00 and 12:00 on Wednesday 11th due to a temporary loss of power.

Note – Missing data between 11:00 on Thursday 19th and 12:00 on Friday 20th due to a temporary loss of power.

Note – Missing data between 22:00 on Monday 23rd and 10:00 on Wednesday 25th due to a temporary loss of power.
