## **Construction noise and vibration Monthly Report – October 2017**

### **London Borough of Camden**

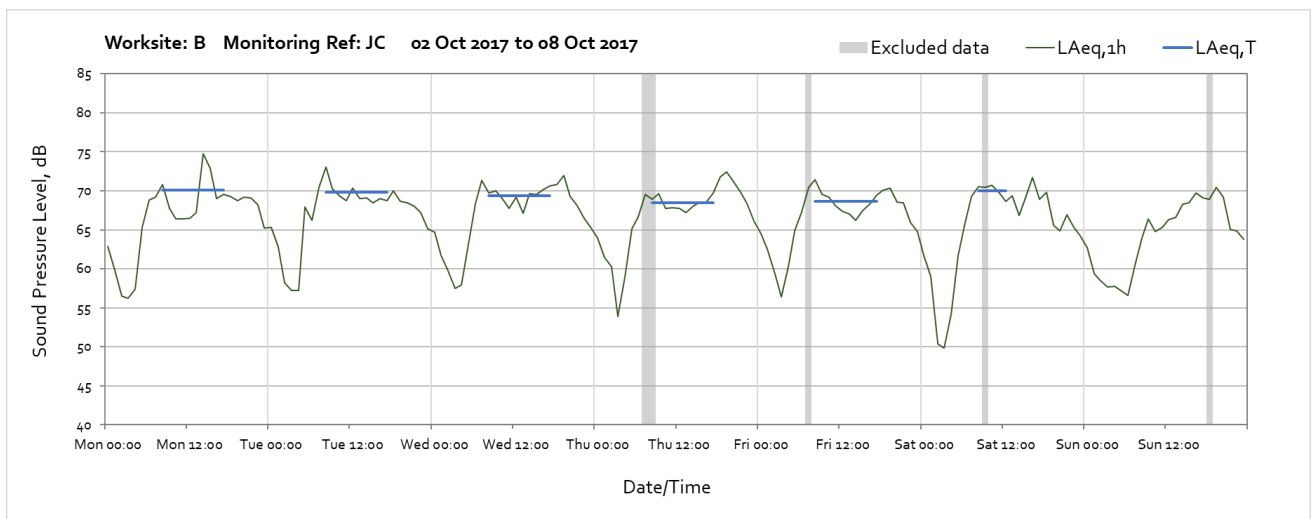
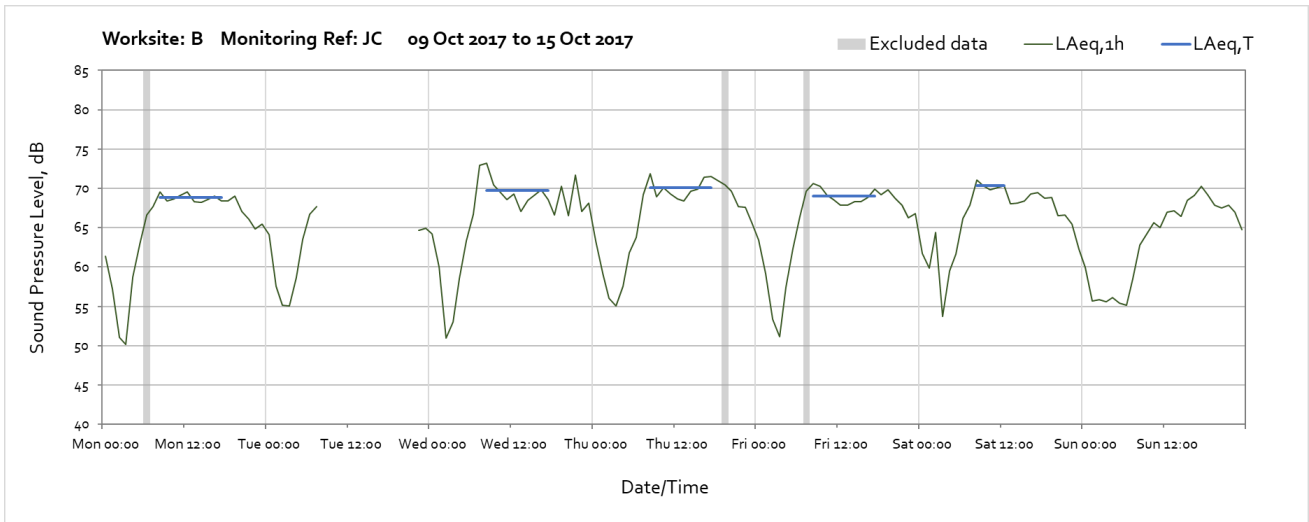
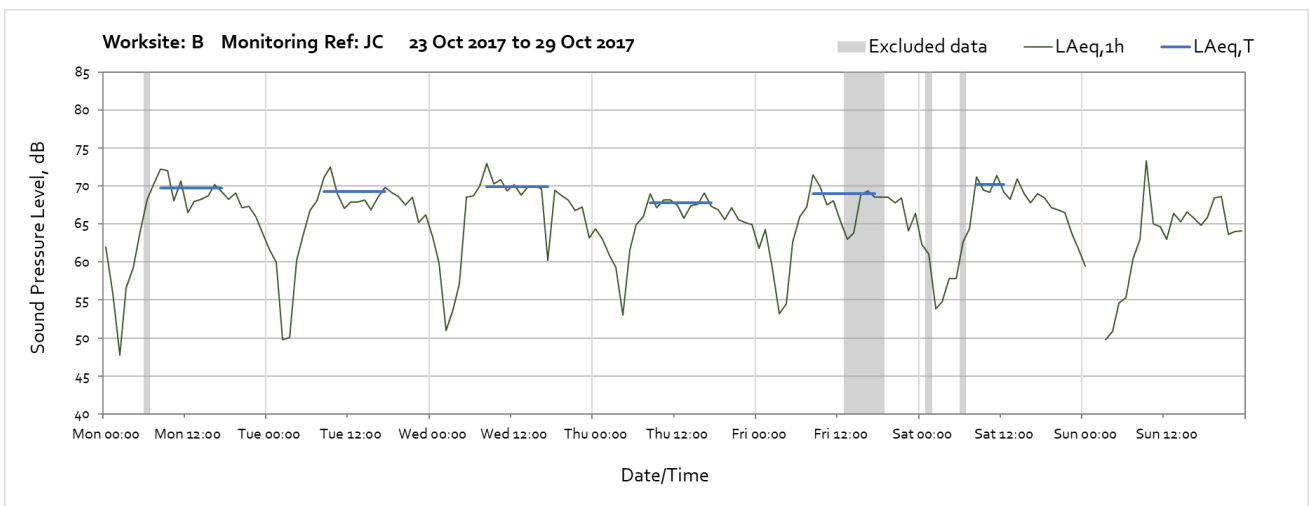
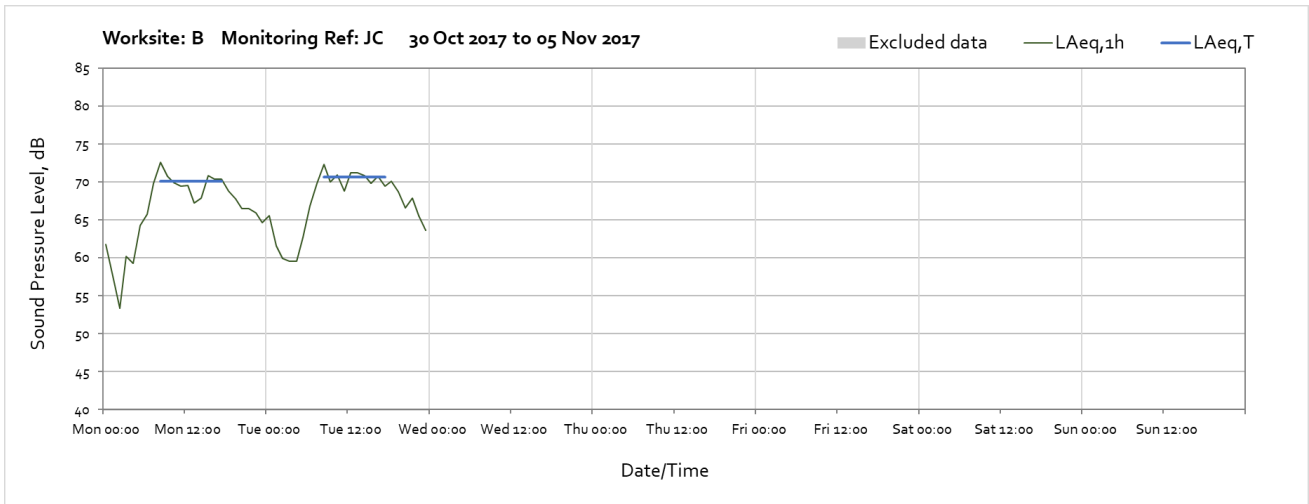
### Worksite: B – Monitoring Ref: JC

The following graphs show the hourly measured ambient noise level  $L_{Aeq,1h}$  and, where relevant, the averaged noise level  $L_{Aeq,T}$  values, where the time period T is as specified in Table 1 of HS2 Information Paper E23. Periods with adversely weather affected noise levels are greyed out and have been excluded from the calculation of the  $L_{Aeq,T}$  values in Table 5.

Note – Missing data between 07:00 and 22:00 on Tuesday 10<sup>th</sup> due to a loss of power at the noise monitor.

2.2.3 Appendix C presents graphs of noise monitoring data over the month for each of the measurement locations. Noise data presented consist of the hourly  $L_{Aeq}$  values and, where relevant, the  $L_{Aeq,T}$  values (where the time period T has been taken to be the averaging period as specified in Table 1 of HS2 Information Paper E23). The full data set for the monitoring equipment can be found at the following location:  
<https://data.gov.uk/dataset/24542ae7-dd44-444f-b259-871c4cc43b5e/environmental-monitoring-data>.

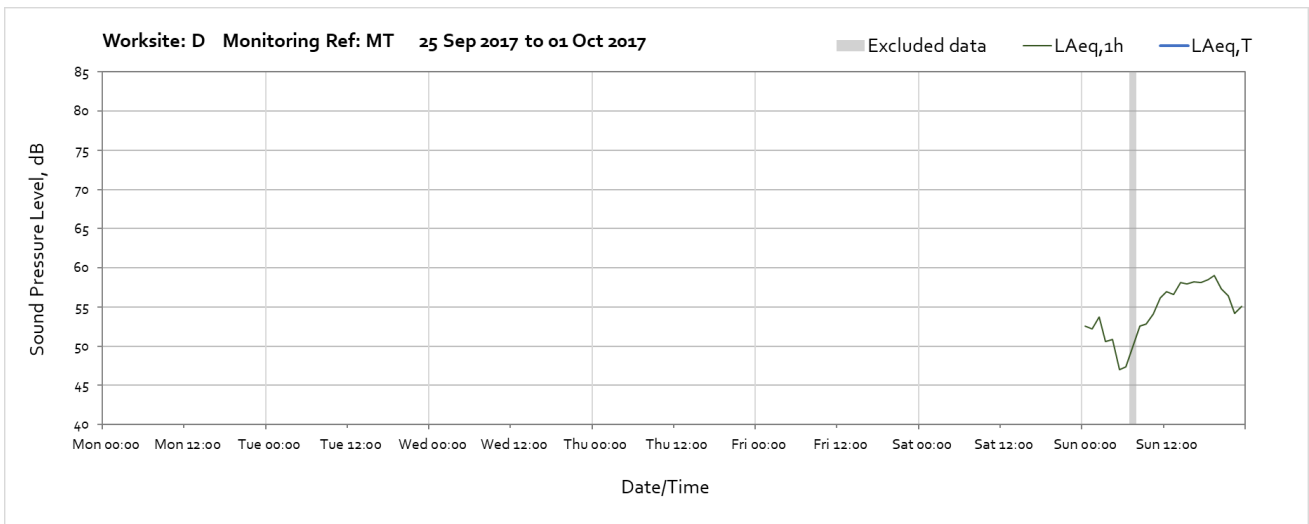
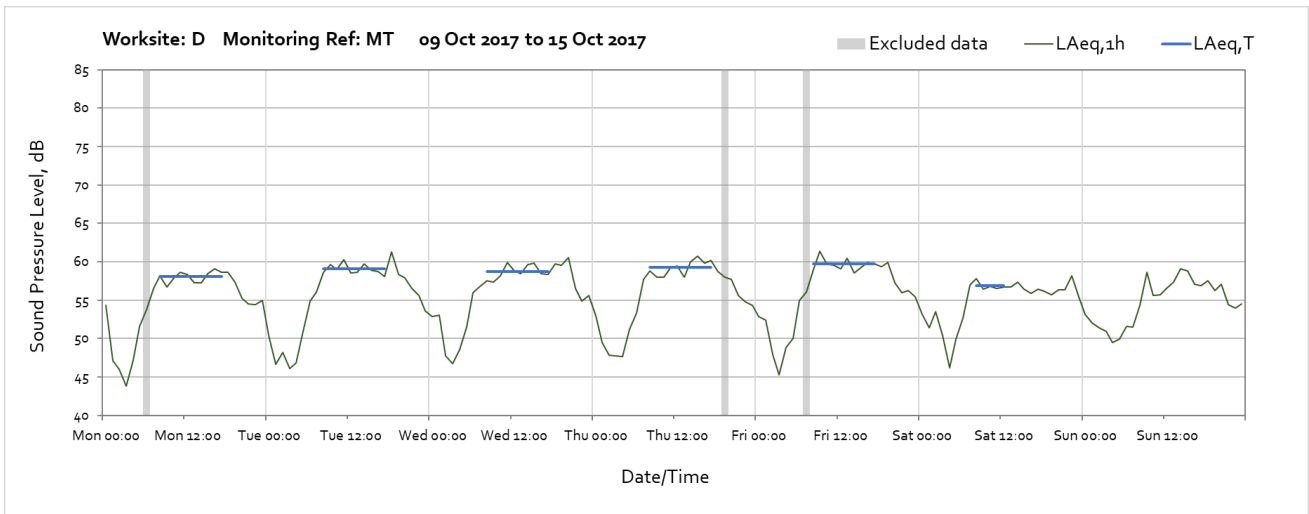
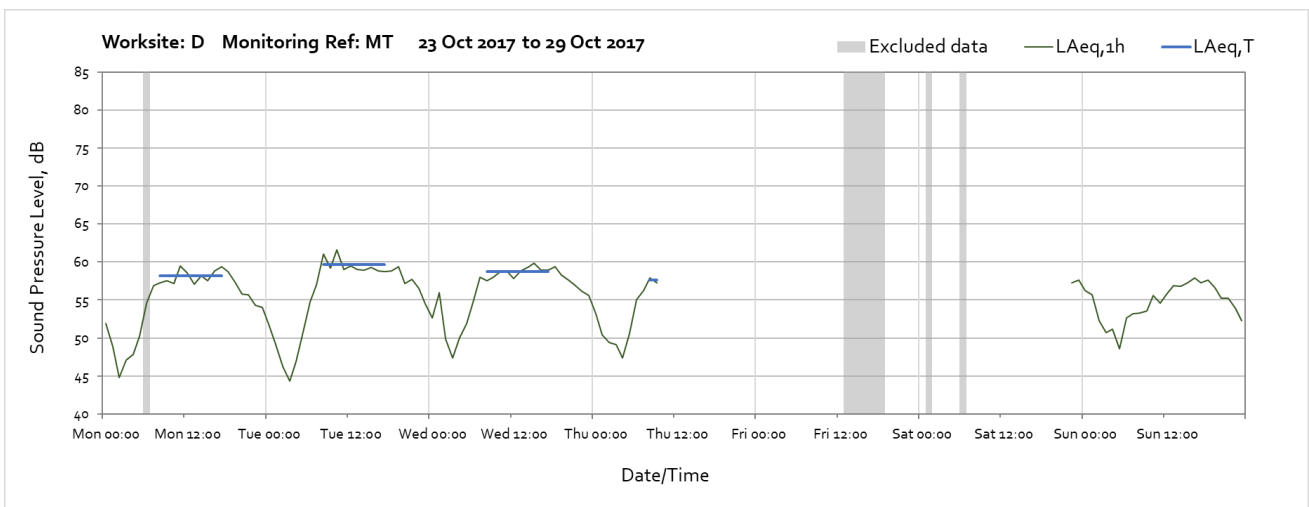
## Worksite: D – Monitoring Ref: MT

Note – Missing data between 15:00 on Friday 6<sup>th</sup> and 23:00 on Saturday 7<sup>th</sup> due to a loss of power at the noise monitor.

Note – Missing data between 05:00 on Monday 16<sup>th</sup> and 10:00 on Wednesday 18<sup>th</sup> due to a loss of power at the noise monitor.

Note – Missing data between 09:00 on Thursday 26<sup>th</sup> and 22:00 on Saturday 28<sup>th</sup> due to a loss of power at the noise monitor.

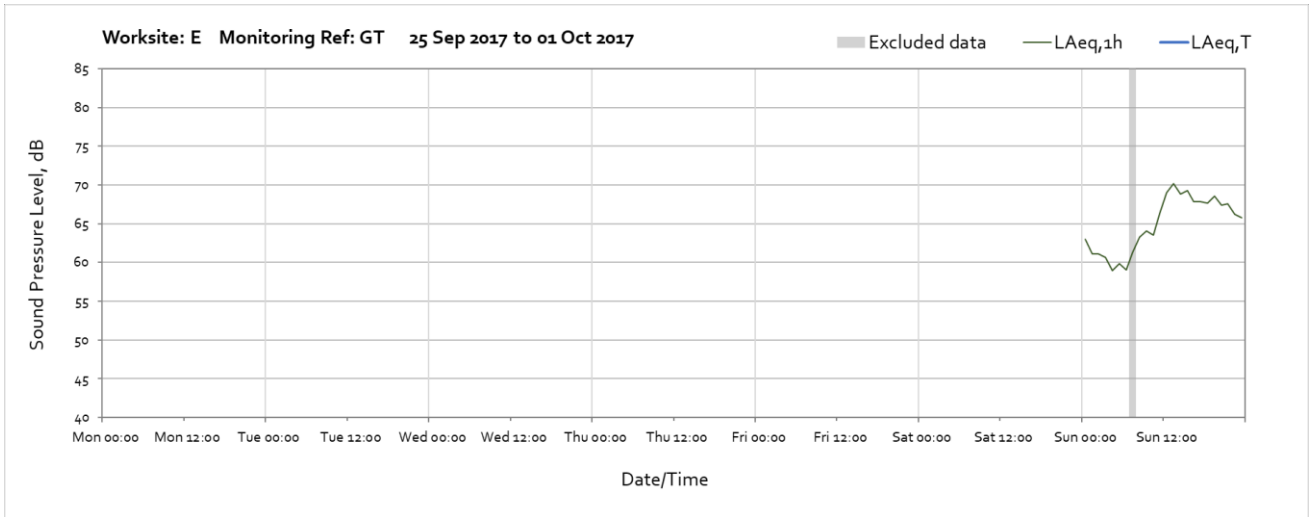
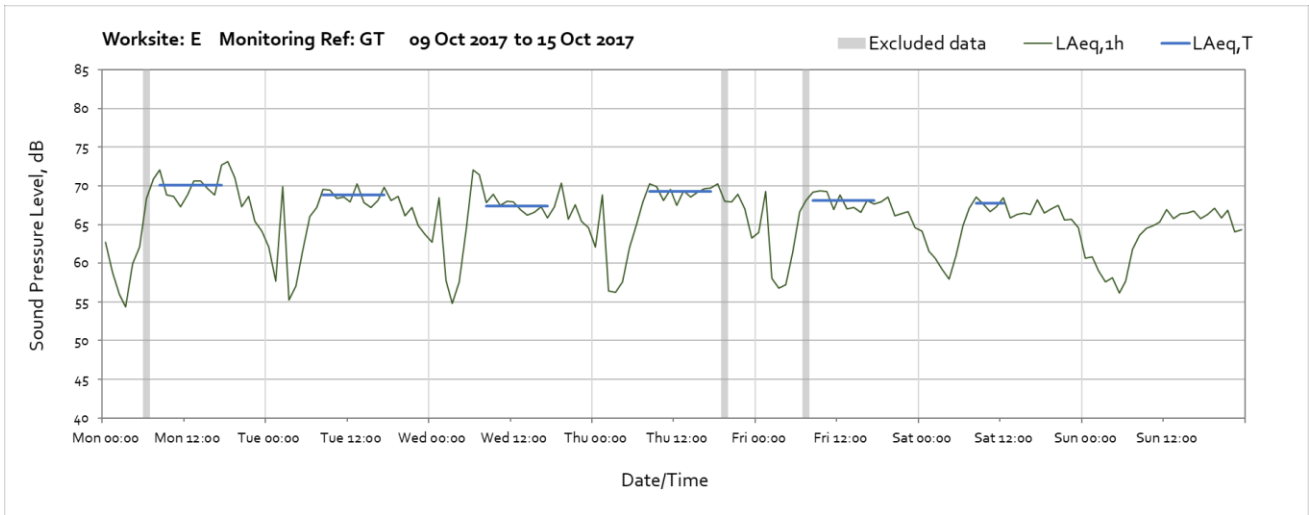
## Worksite: E – Monitoring Ref: GT

Note – Missing data between 16:00 on Friday 20<sup>th</sup> and 13:00 on Saturday 21<sup>st</sup>, between 15:00 on Saturday 21<sup>st</sup> and 09:00 on Sunday 22<sup>nd</sup> and between 12:00 on Sunday 22<sup>nd</sup> and 11:00 on Tuesday 24<sup>th</sup> due to a loss of power at the noise monitor.

Note – Missing data between 12:00 on Sunday 22<sup>nd</sup> and 11:00 on Tuesday 24<sup>th</sup> due to a loss of power at the noise monitor.
