Air Quality and Dust Monitoring Monthly Report – June 2019

London Borough of Brent

A report prepared by Costain Skanska on behalf of HS2 Ltd.

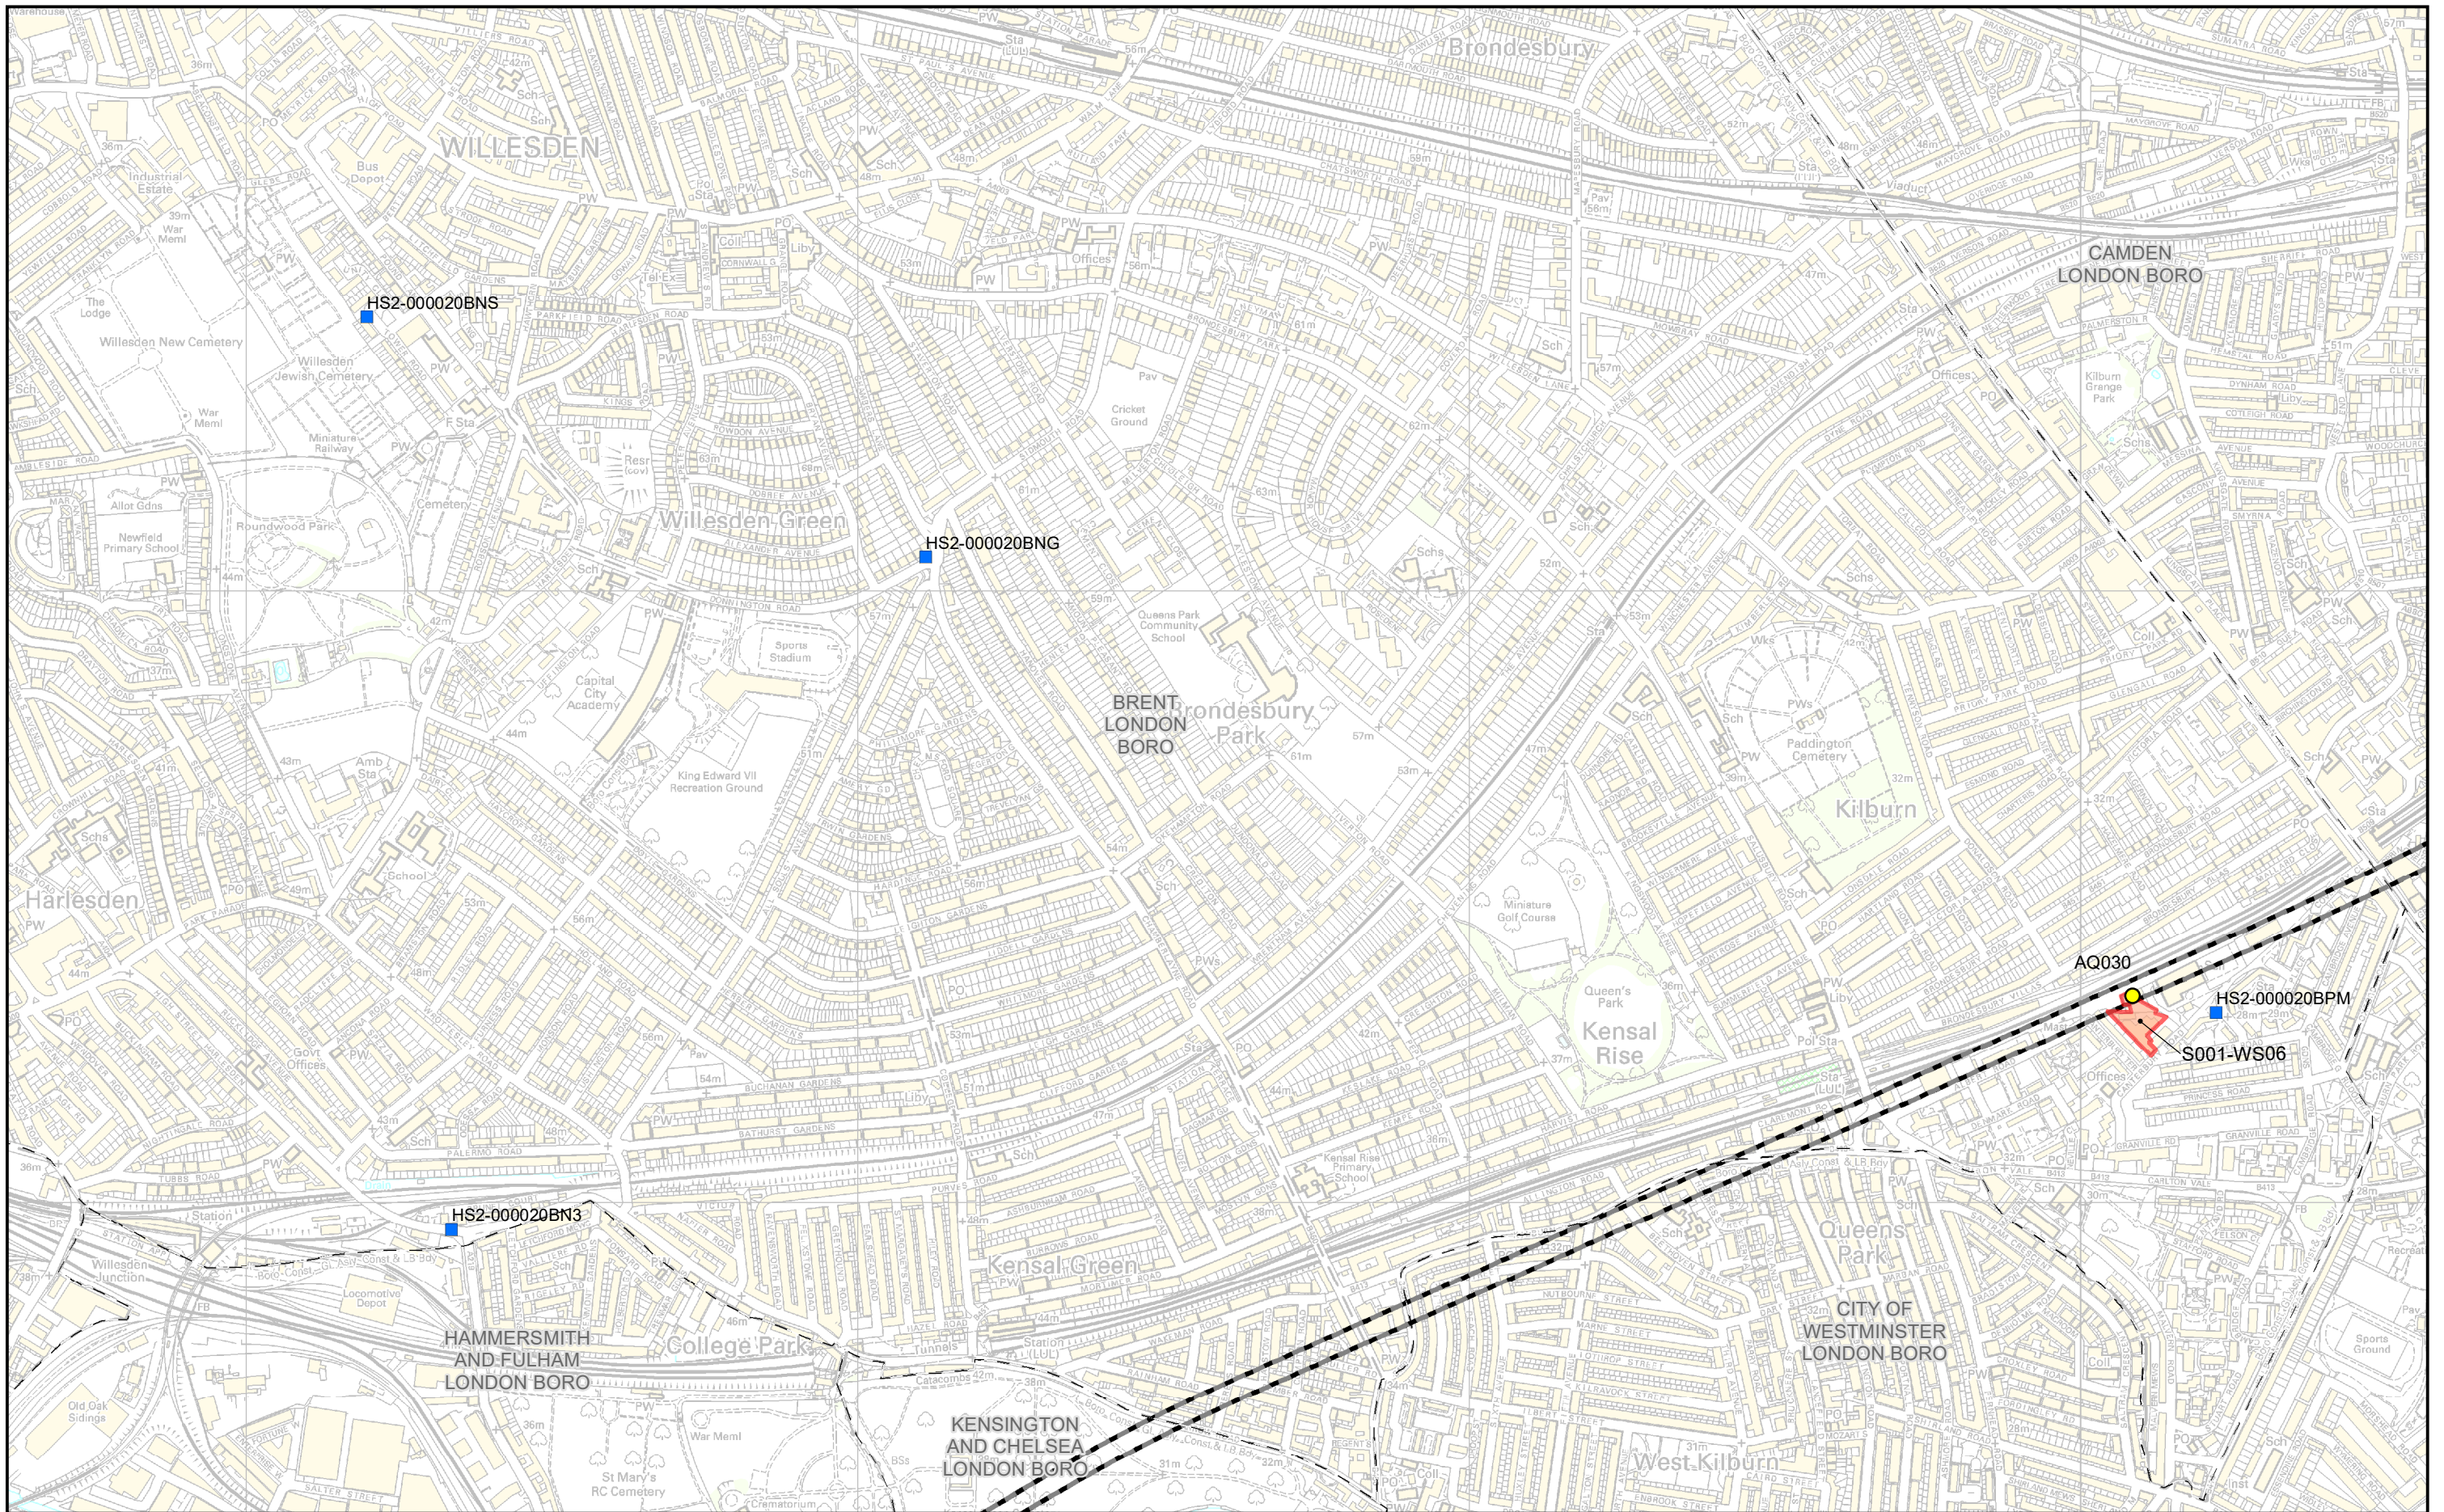
Figure 1: Current monitoring locations within the LBB

- 1.1.2 Figure 1 in Appendix A indicates the current worksites together with air quality and dust monitoring locations.
- 1.1.3 This summary should be read in conjunction with the overview monitoring report available from www.gov.uk/government/collections/monitoring-the-environmental-effects-of-hs2, which highlights: the applicable standards and guidance, as well as the air quality and dust monitoring methodologies to be implemented by nominated undertakers throughout construction.

- 1.1.4 The current phase of works commenced within the LBB during September 2018 and are expected to be completed by July 2019. The current worksite, as presented in Appendix A, Figure 1, includes:

- Canterbury Road Vent Shaft, securing of site, pre-demolition surveys and soft strip.
Worksite ref: S001-WS06.
- 1.1.5 One (1) dust monitor is installed on the worksite, where pre-demolition works are underway. This site returned a high dust risk rating.

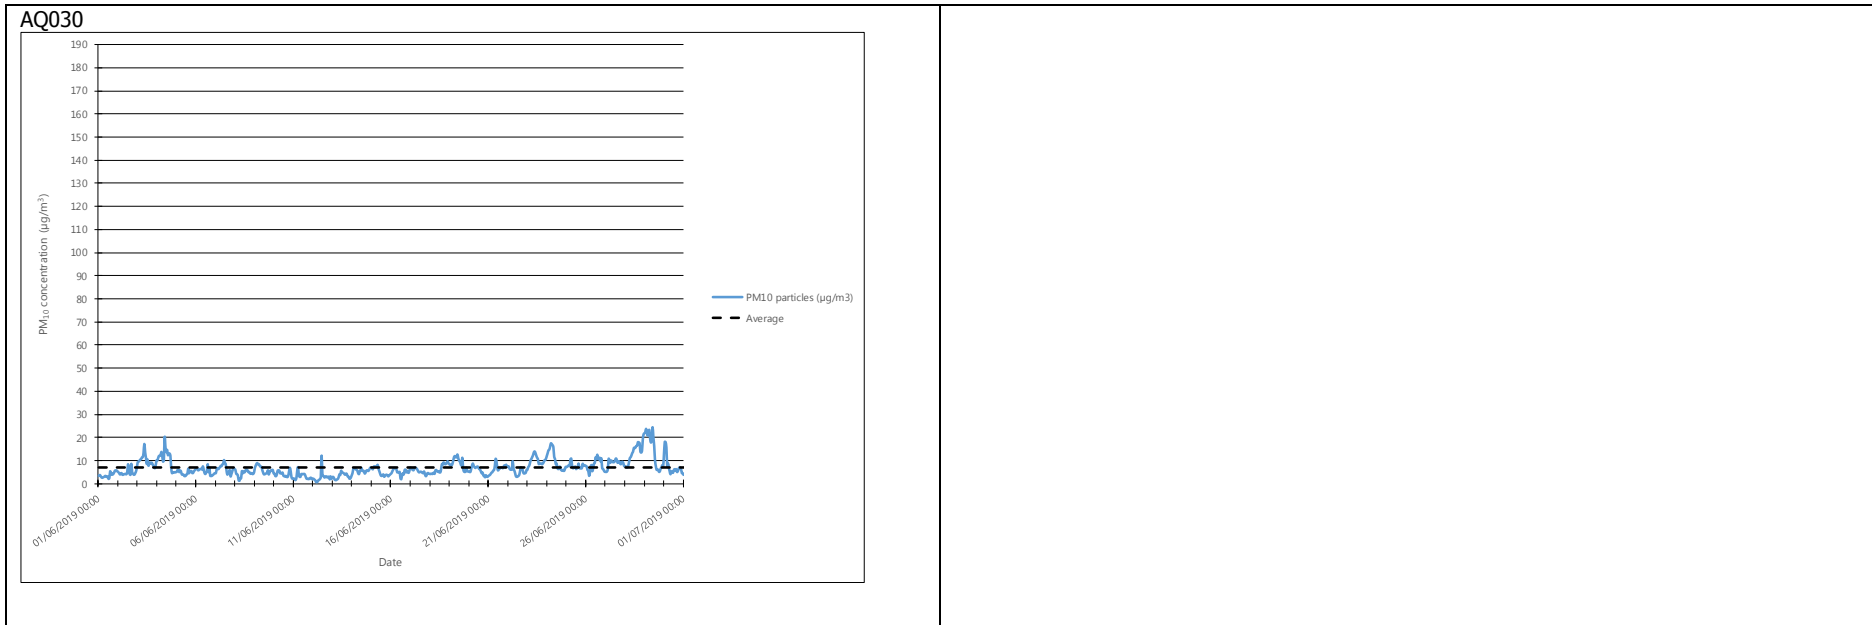
Figure 2: Construction dust 1-hour mean indicative PM₁₀ concentration for dust monitors

- 1.1.6 Dust monitoring locations and results are presented in Appendix B, Table 1, together with line charts of monthly data from each dust monitor in Figure 2. All continuous dust monitoring is undertaken using indicative monitors. Despite being Environment Agency (MCERTS) certified, indicative monitors carry a higher level of uncertainty than reference monitors, and therefore cannot be strictly compared with Air Quality Standards for human health and the environment. The purpose of the monitoring undertaken is to ensure the effectiveness of the on-site mitigations.

- 1.1.7 The trigger level of 190 $\mu\text{g}/\text{m}^3$, over a 1-hour period, in accordance with the updated guidance document 'Guidance on Monitoring in the Vicinity of Demolition and Construction Sites – October 2018' has been applied.

- 1.1.8 There were no (0) dust trigger alerts during the month of June 2019. All results were in line with expected ranges.
