Air Quality and Dust Monitoring Monthly Report – August 2019

London Borough of Hillingdon

A report prepared by Costain Skanska on behalf of HS2 Ltd.

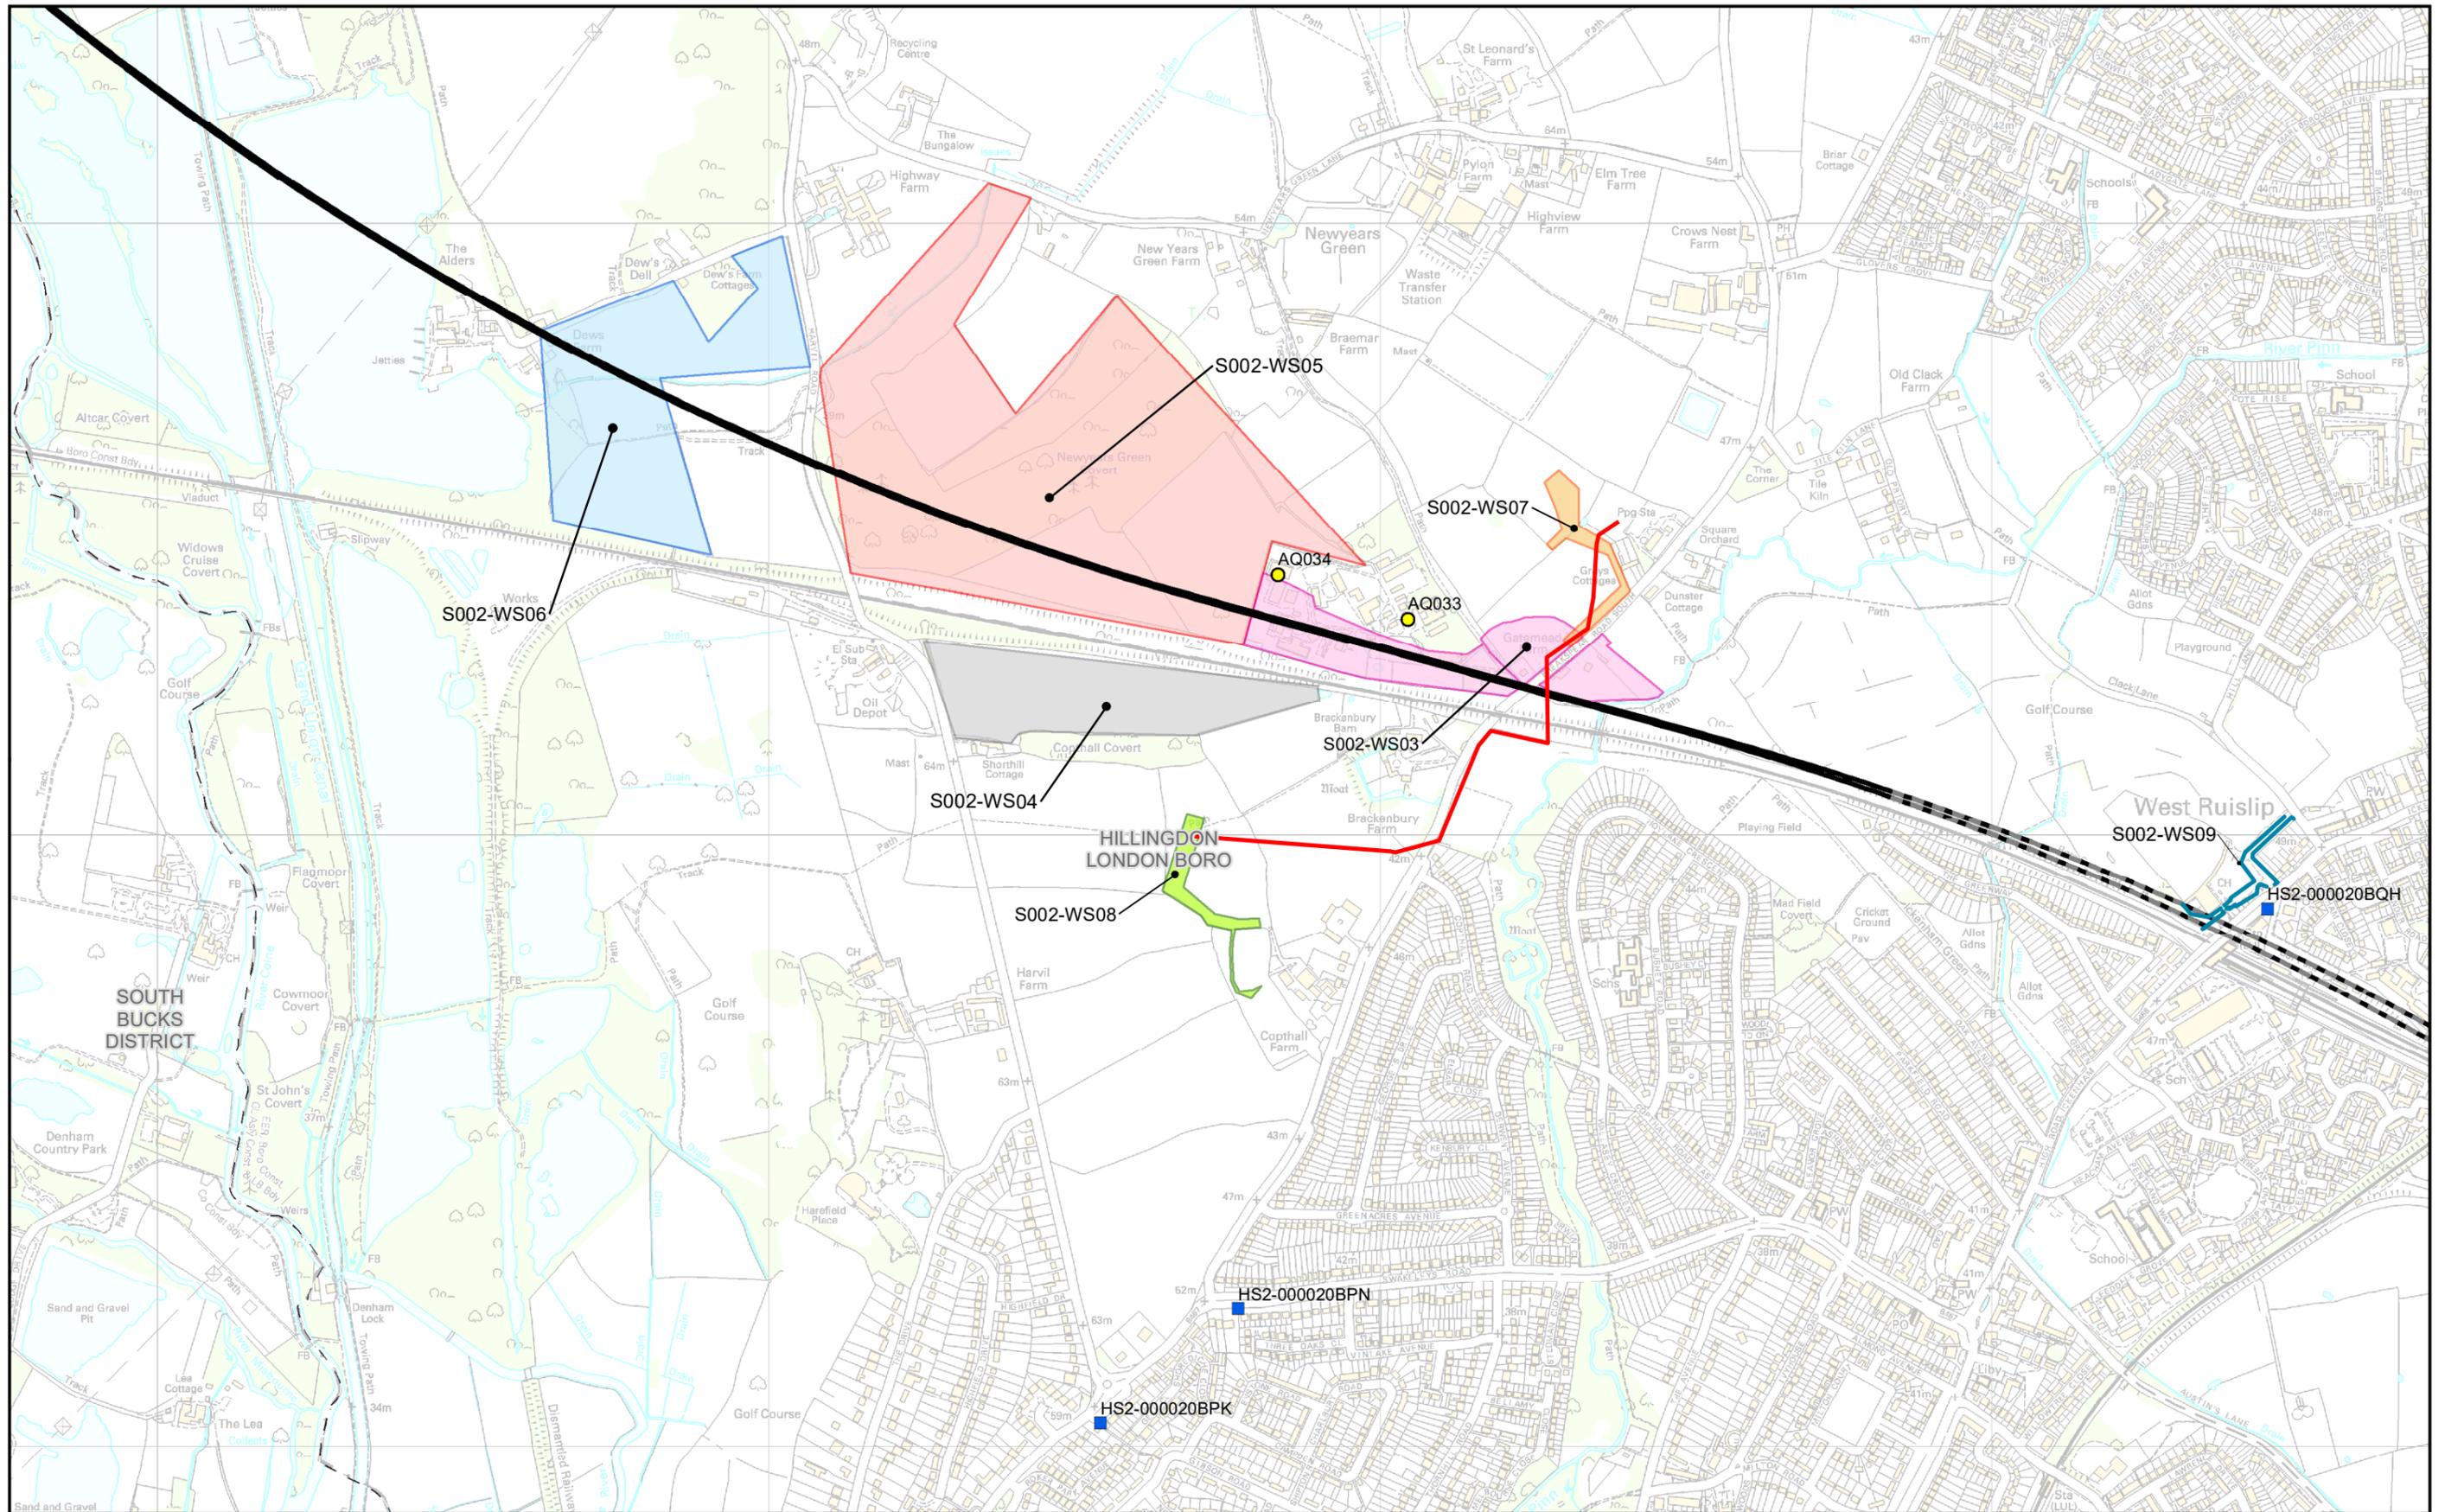
Figure Number	
Figure Name	Worksites and Monitoring locations in LBH (sheet 1)
London Borough of Hillingdon

- 1.1.4 The current phase of works commenced within the LBH during May 2018 and are expected to be completed by November 2019. The current worksites, as presented in Appendix A, Figure 1, include:

- Legend**
- Route in tunnel
 - Route on surface
 - Dust monitoring location
 - Diffusion tube monitoring location
 - Trunk Main Diversion Route
 - West Ruislip Golf Course
 - Copthall North worksite
 - Copthall South worksite
 - 18' and 48' gas pipeline diversions
 - Merck Sharpe Dhome worksite
 - Utility Diversion worksite north
 - Utility Diversion worksite south

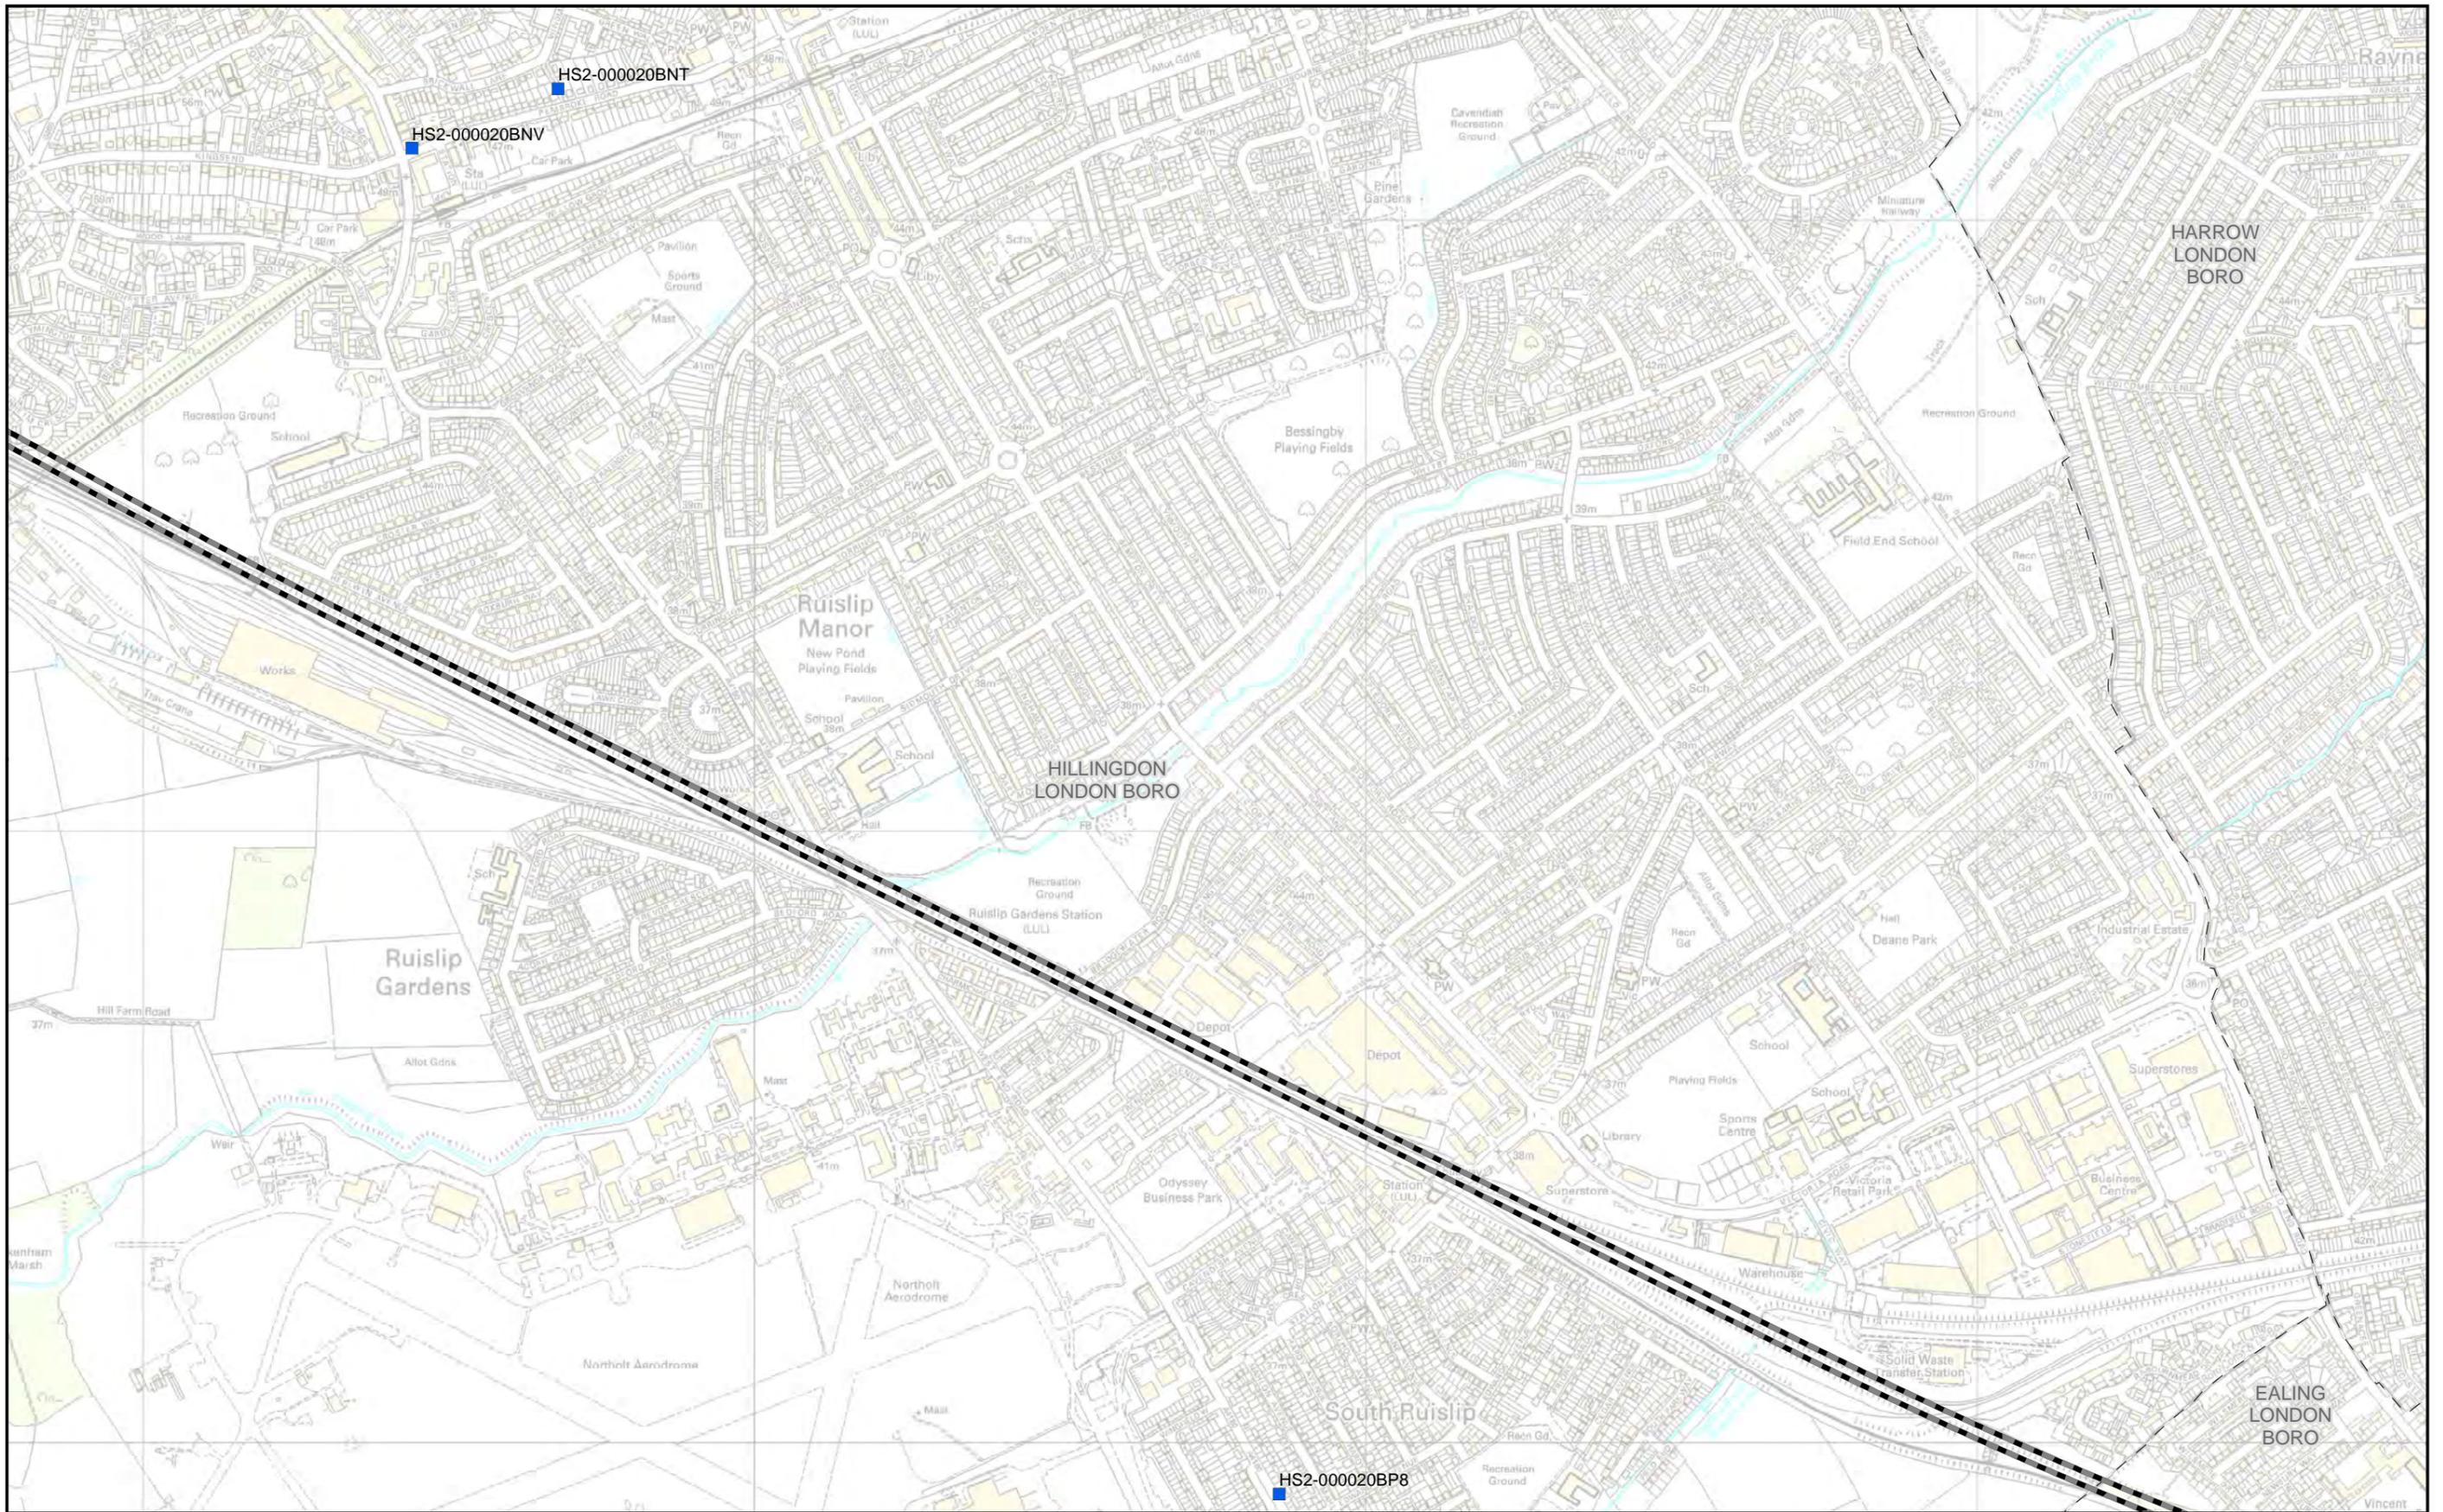
Figure Number
Figure Name Worksites and Monitoring locations in LBH (sheet 2)
London Borough of Hillingdon

- Legend**
- Route in tunnel
 - Route on surface
 - Diffusion tube monitoring location

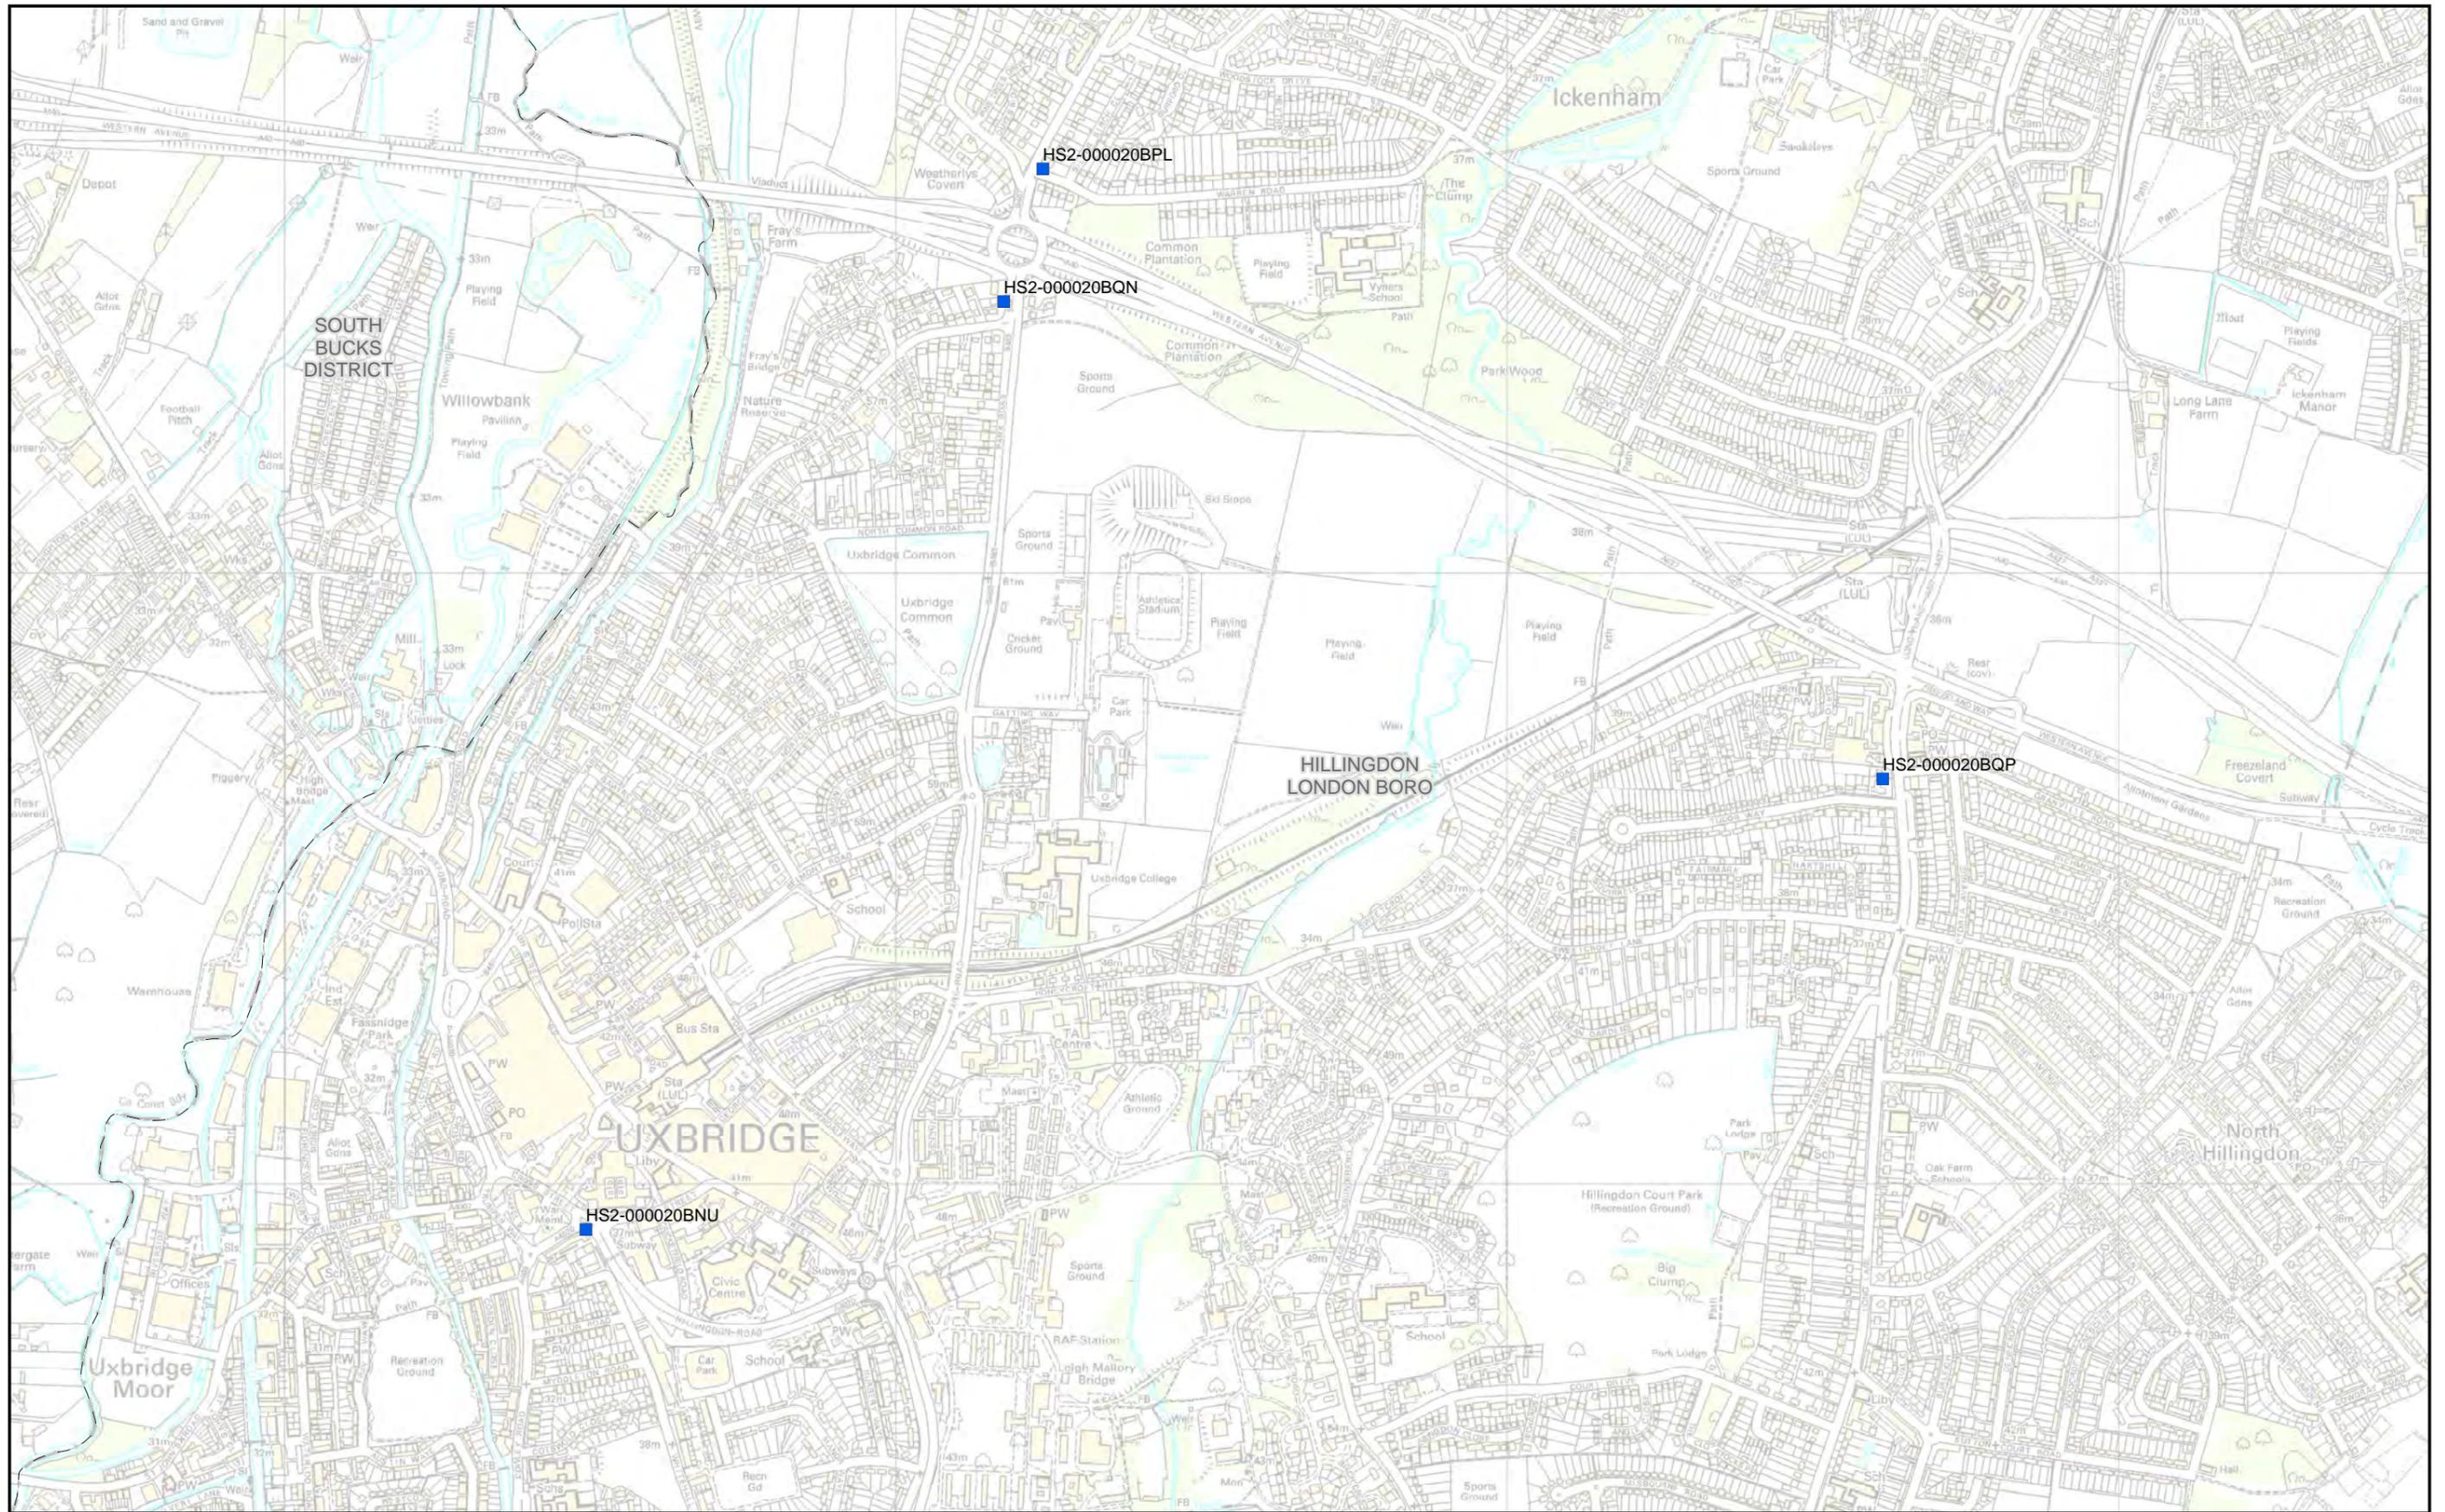
Figure Name
Worksites and Monitoring locations in LBH (sheet 3)

- Route in tunnel
- Route on surface
- Diffusion tube monitoring location

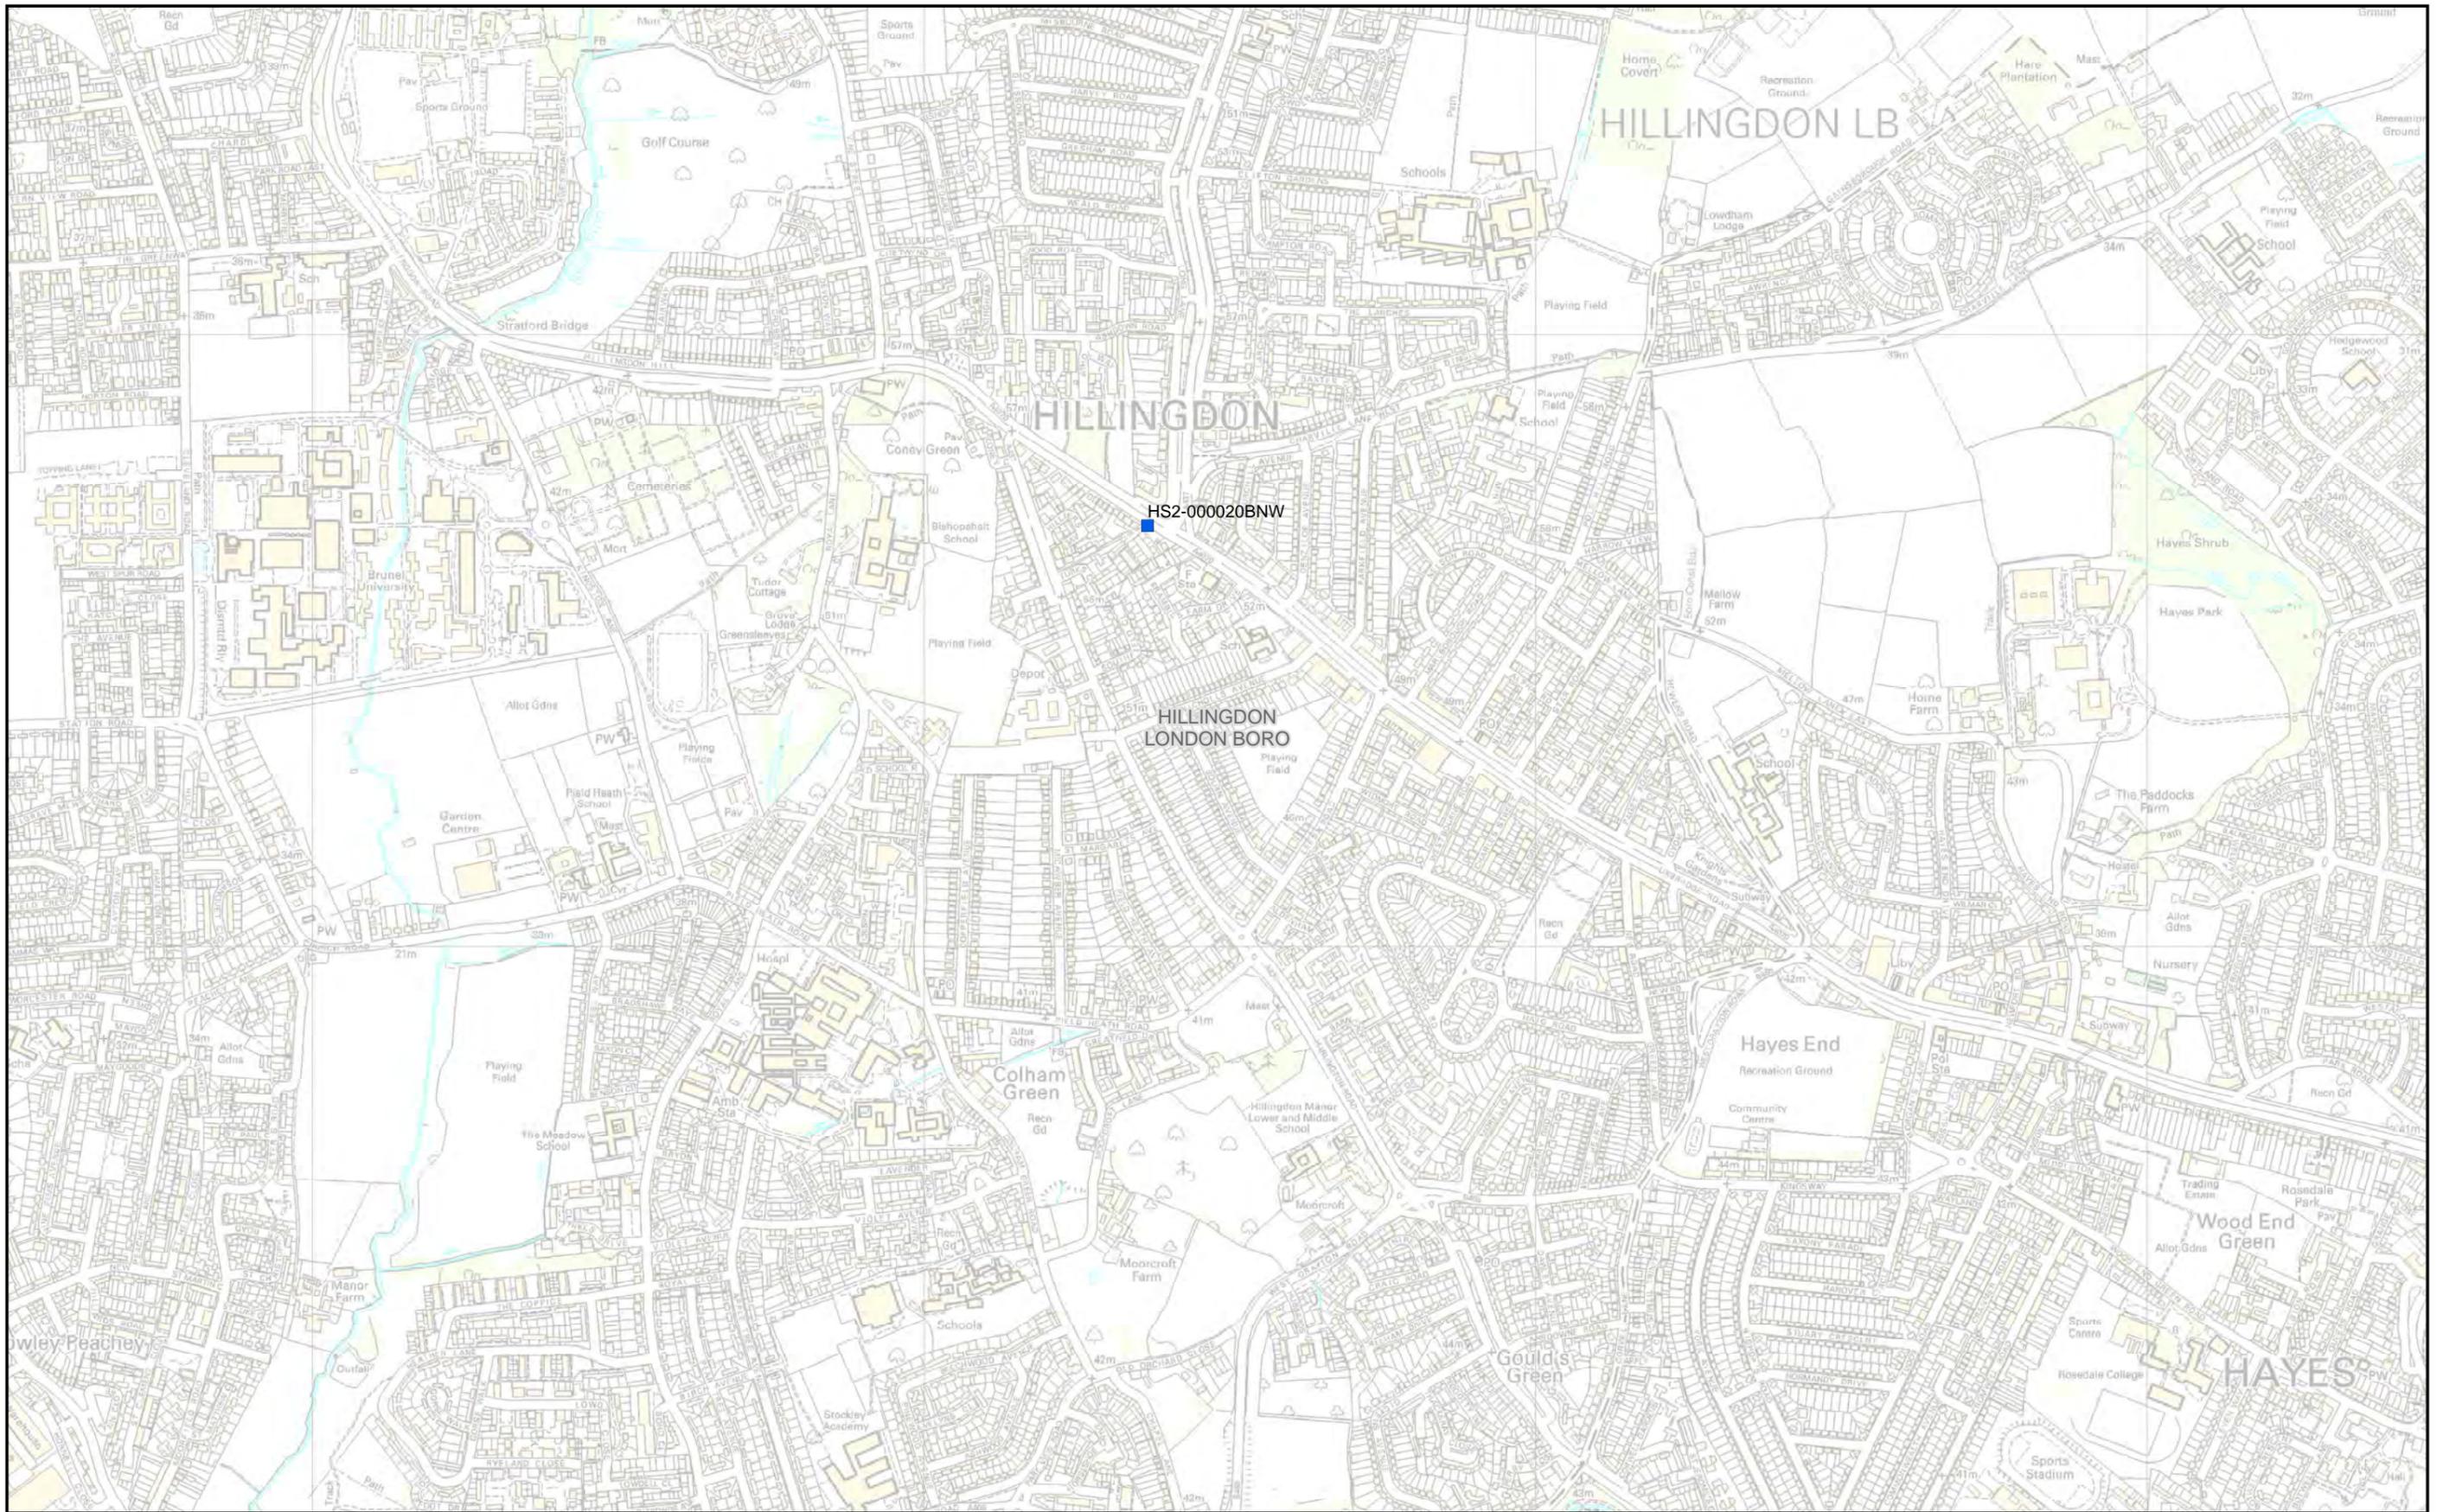
Figure Number
Figure Name Worksites and Monitoring locations in LBH (sheet 4)
London Borough of Hillingdon

Diffusion tube monitoring location

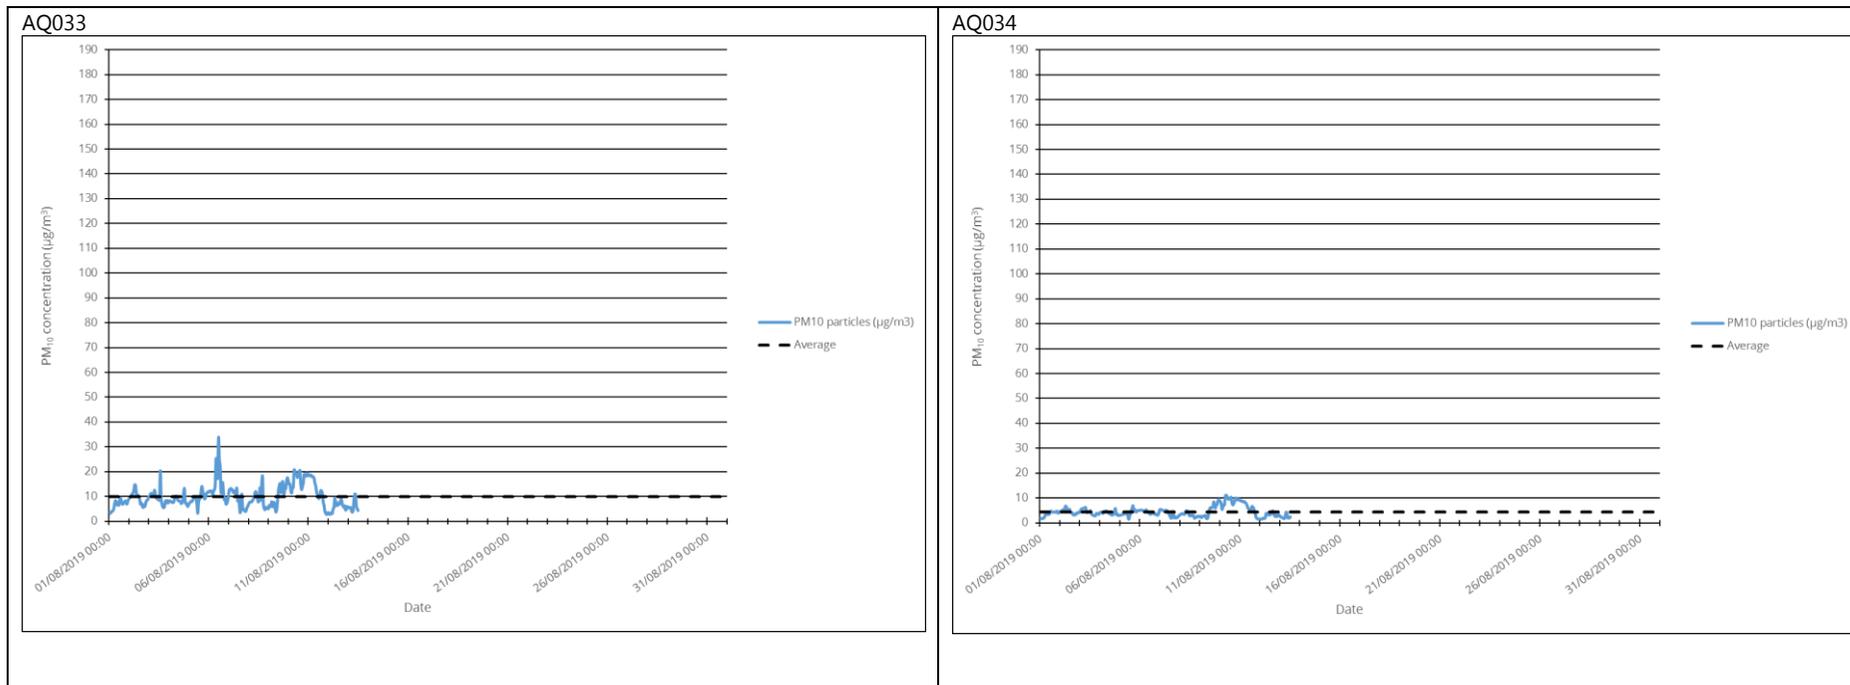
Figure 1: Construction dust 1-hour mean indicative PM₁₀ concentration for dust monitors

- 1.1.6 Dust monitoring locations and results are presented in Appendix B, Table 1 together with line charts of monthly data from each dust monitor. All continuous dust monitoring is undertaken using indicative monitors. Despite being Environment Agency (MCERTS) certified, indicative monitors carry a higher level of uncertainty than reference monitors, and therefore cannot be strictly compared with Air Quality Standards for human health and the environment. The purpose of the monitoring undertaken is to ensure the effectiveness of the on-site mitigation.

- 1.1.7 The trigger level of 190 µg/m³, over a 1-hour period, in accordance with the updated guidance document 'Guidance on Monitoring in the Vicinity of Demolition and Construction Sites – October 2018' has been applied.

- 1.1.8 There were no (0) dust trigger alerts recorded during this monitoring period (August 2019).

- 1.1.9 Data capture for AQ033 and AQ034 were below 90% for the month of August 2019. Further to the recent completion of demolition works on the MSD site and following the completion of a further dust risk assessment (resulting in a classification of low risk during the current cease in works) the monitors were temporarily removed. These monitors will be reinstated prior to the commencement of any medium or high risk activities.
