Air Quality and Dust Monitoring Monthly Report – December 2019

London Borough of Ealing

A report prepared by Costain Skanska on behalf of HS2 Ltd.

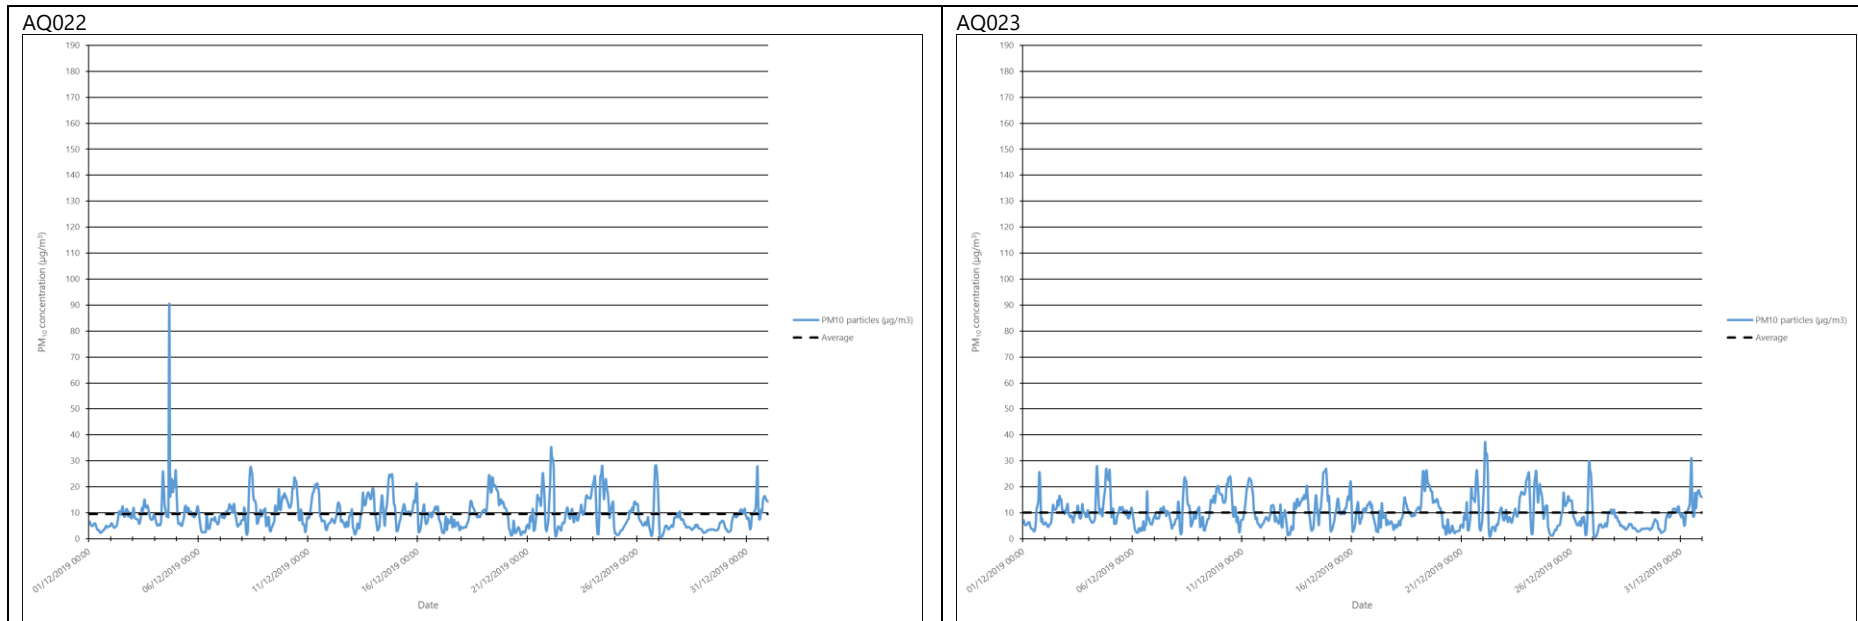
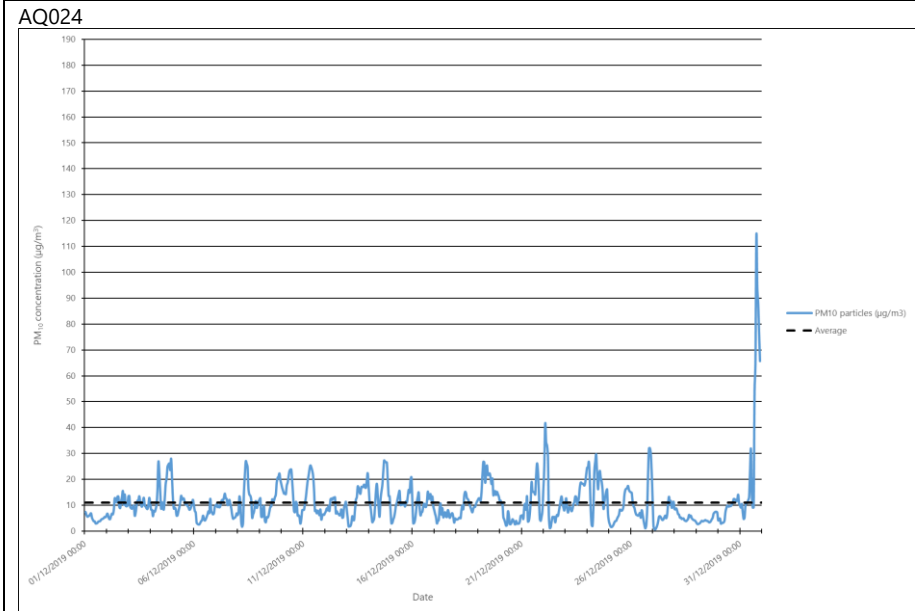
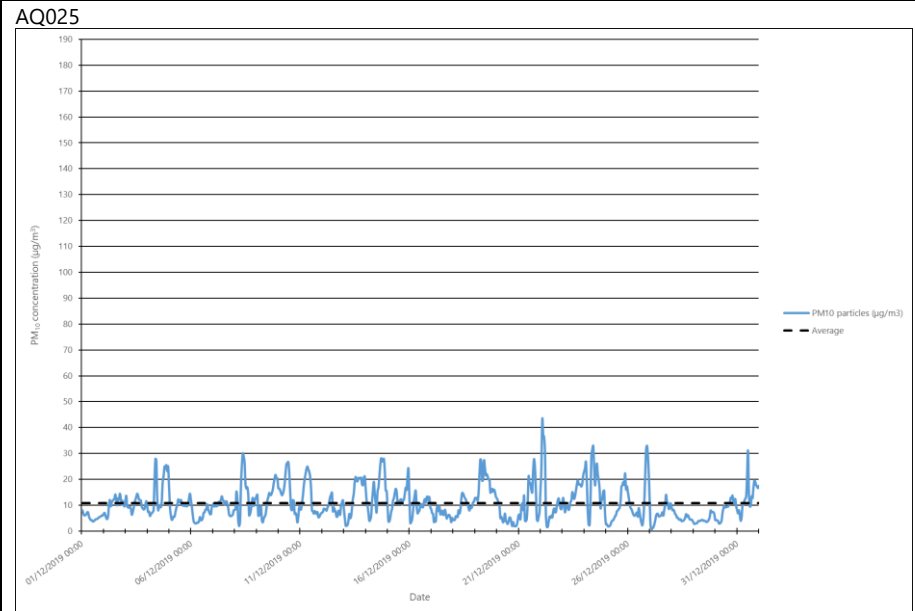
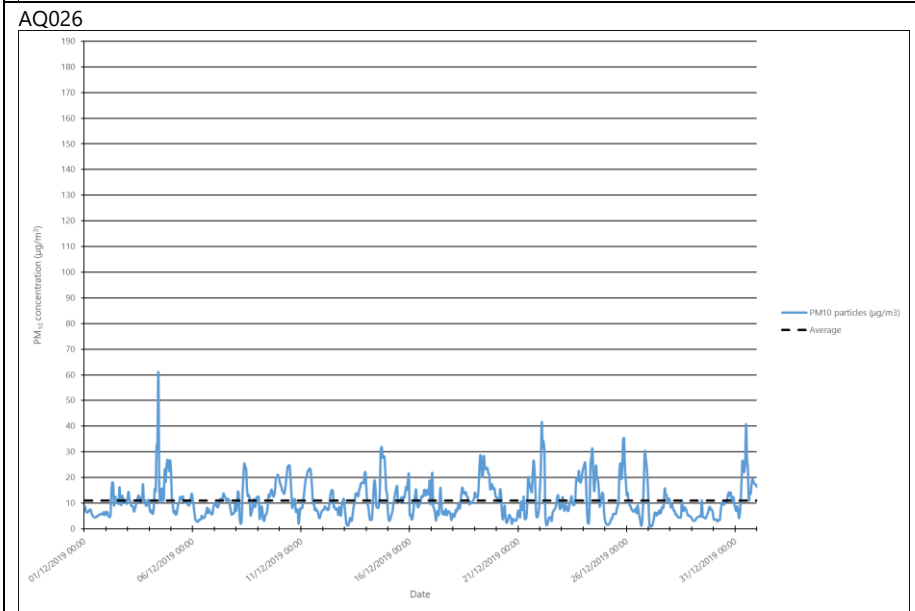
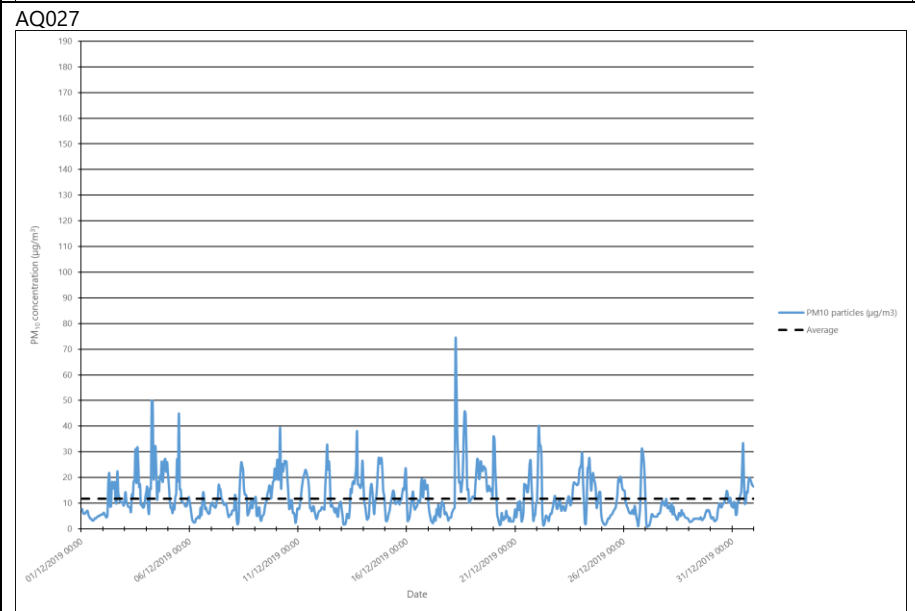
Figure 1: Construction dust 1-hour mean indicative PM₁₀ concentration for dust monitors

- 1.1.5 Nine (9) dust monitors were installed around worksites, where works are underway. These sites returned a medium or high dust risk rating.
- 1.1.6 Dust monitoring locations and results are presented in Appendix B, Table 2, together with line charts of monthly data from each dust monitor. All continuous dust monitoring is undertaken using indicative monitors. Despite being Environment Agency (MCERTS) certified, indicative monitors carry a higher level of uncertainty than reference monitors, and therefore cannot be

- 1.1.8 There were no (0) dust trigger alerts recorded during this monitoring period (December 2019). All results were in line with expected ranges.
- 1.1.9 Data capture for AQ037 was below 90% for the month of December 2019 due to the cut in power supply to the area of the site where the monitor is located. No works are currently underway. The site and power supply will be resumed upon mobilisation of the main works late January, early February 2020. Nearby monitors near the site perimeter, AQ025 and AQ026, remain operational.
