May 2020

## **Construction noise and vibration Monthly Report – March 2020**

**Birmingham City Council**

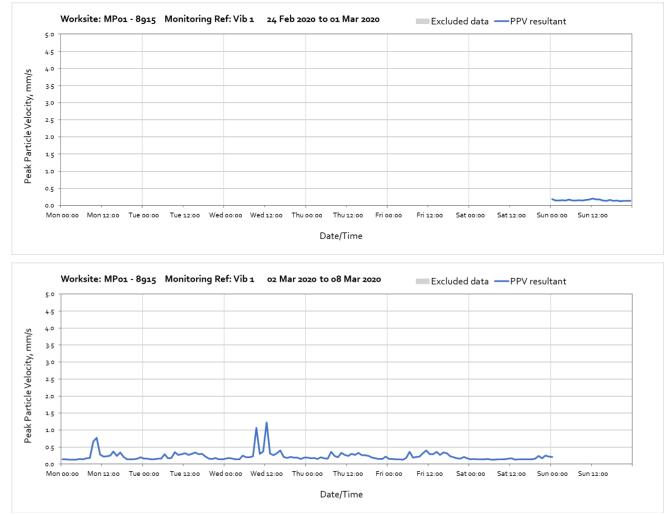
## Worksite: Museum Collection Centre – Monitoring Ref: Vib 1

Note: Missing data between 01:00 on Sunday 8<sup>th</sup> and 00:00 on Monday 9<sup>th</sup> March were due to the equipment manufacturer undertaking software mainenance.

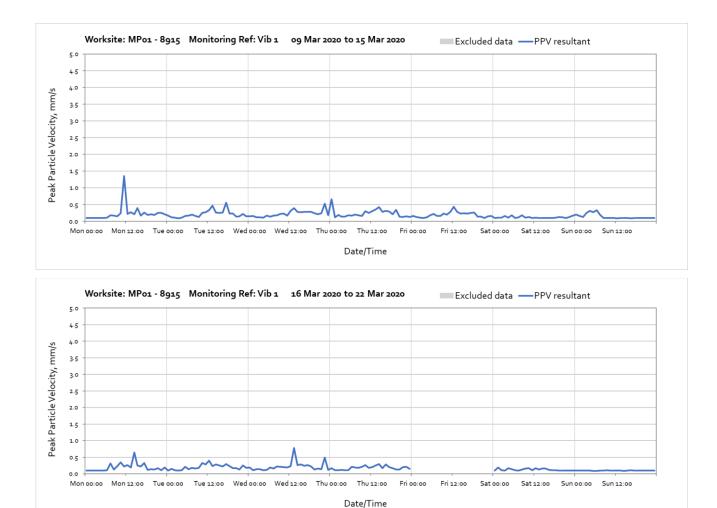
Note: Missing data between 00:00 on Friday 19<sup>th</sup> and 00:00 on Saturday 20<sup>th</sup> March were due to the equipment manufacturer undertaking software mainenance.

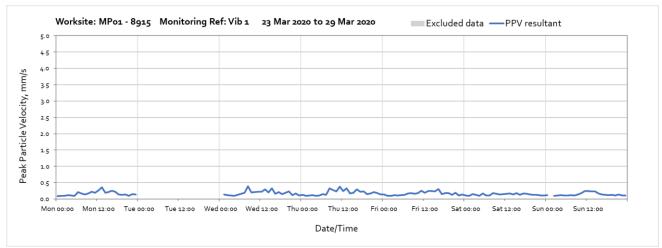
Note: Missing data between 00:00 on Tuesday 24<sup>th</sup> and 01:00 on Wednesday 25<sup>th</sup> March were due to the equipment manufacturer undertaking software mainenance. Missing data at 01:00 on Sunday 29<sup>th</sup> March was due to the clocks going forward at the start of British Summertime.

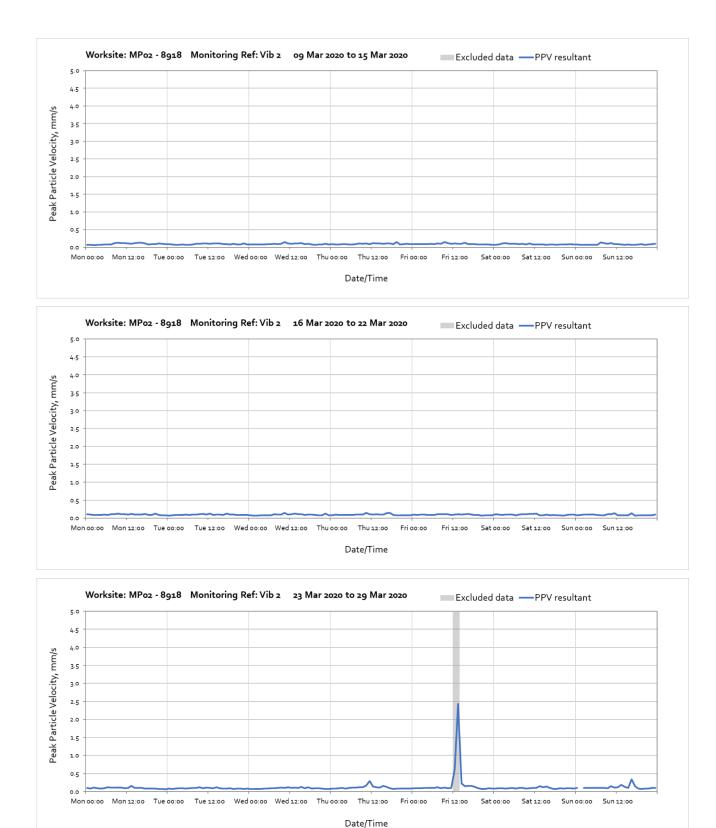
### Worksite: Museum Collection Centre – Monitoring Ref: Vib 2

The following graphs show the hourly measured peak particle velocity PPV recorded during the monitoring period. The graphs show the resultant PPV due to vibration components on three orthogonal axis x, y and z. High values of PPV were measured on one occasion at Vib 2. This was due to local interference with the vibration monitor and are not representative of baseline vibration levels at this location. This data entry has been greyed out in the chart and has been excluded to calculate values in Table 3.

Note: High vibration levels measured at 13:00 on Friday 27<sup>th</sup> March were due to local interference and are not representative of typical baseline vibration levels at this location. Missing data at 01:00 on Sunday 29<sup>th</sup> March was due to the clocks going forward at the start of British Summertime.
