## **Construction noise and vibration Monthly Report – June 2020**

**London Borough of Camden**

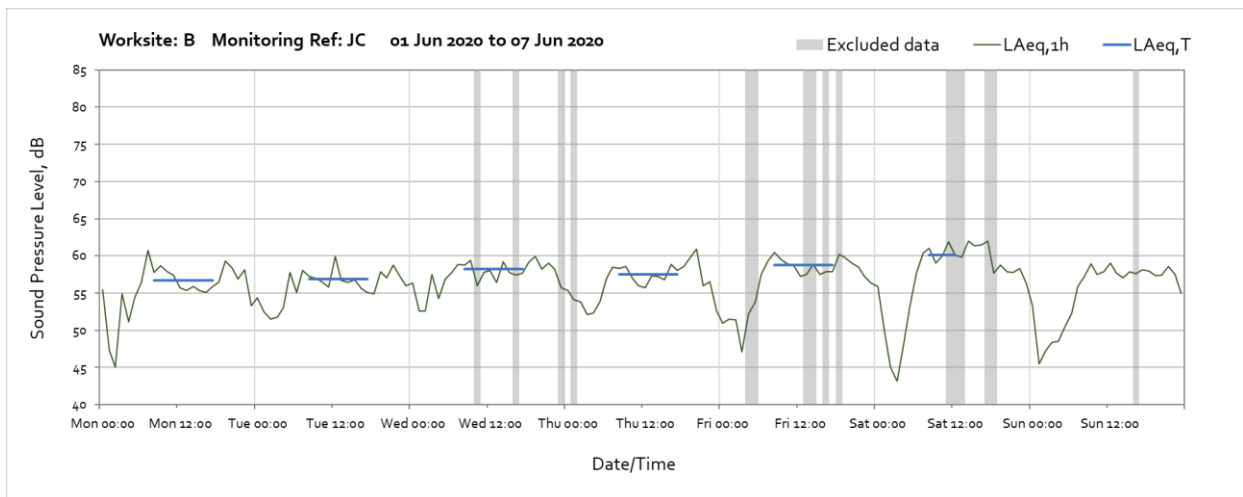
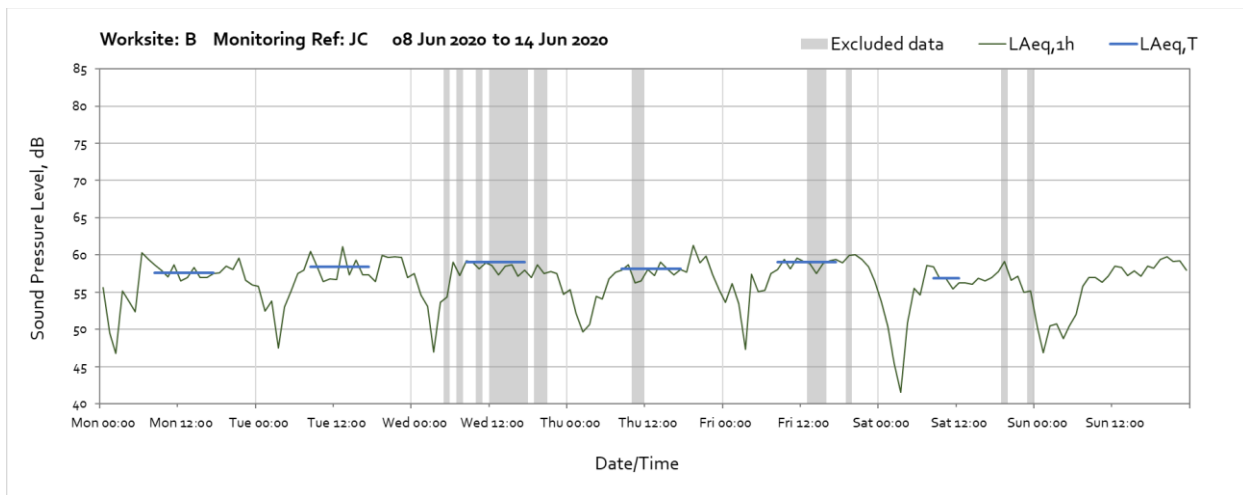
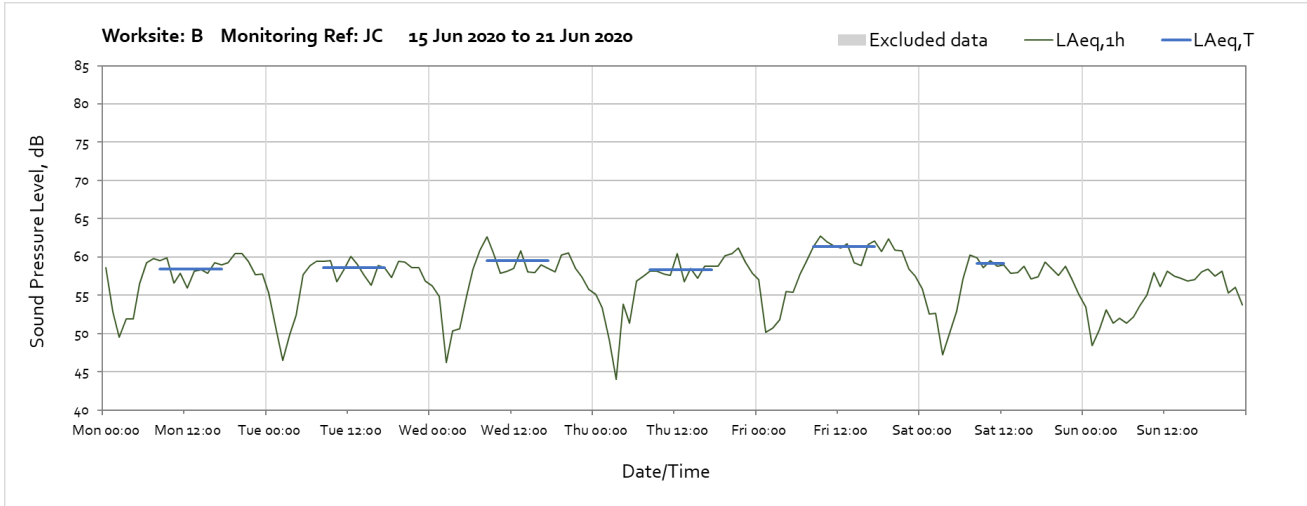
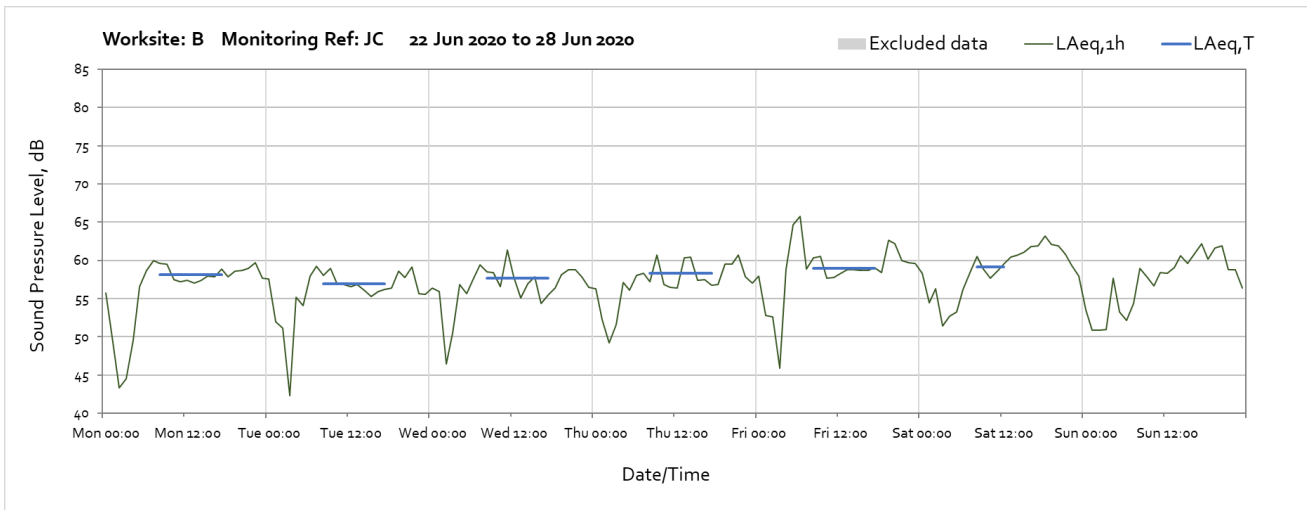
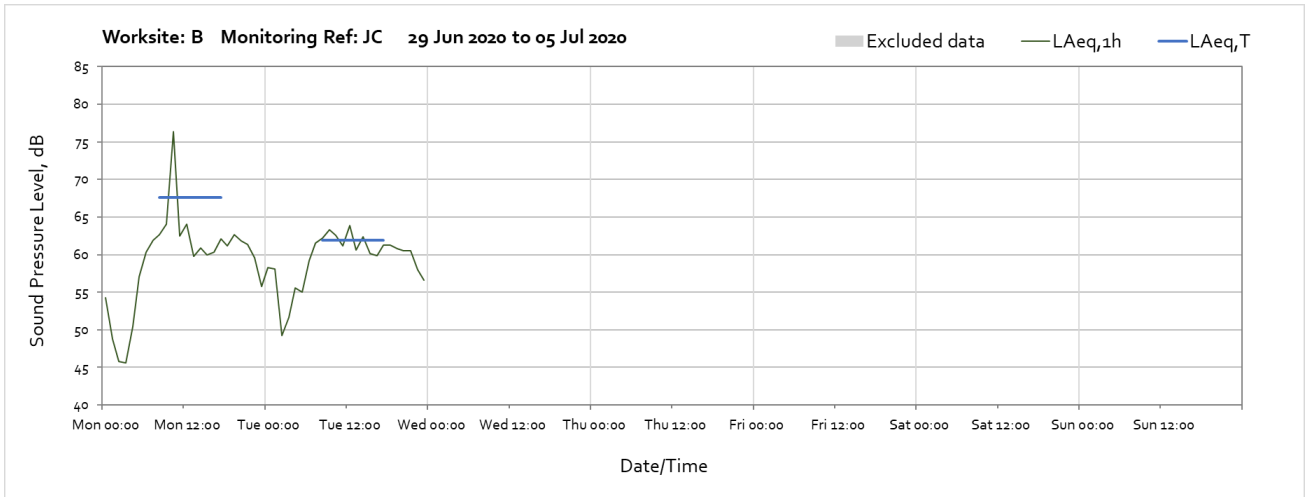
### Worksite: B – Monitoring Ref: JC

The following graphs show the hourly measured ambient noise level  $L_{Aeq,1h}$  and, where relevant, the averaged noise level  $L_{Aeq,T}$  values, where the time period T is as specified in Table 1 of HS2 Information Paper E23. Periods with adversely weather affected noise levels are greyed out and have been excluded from the calculation of the  $L_{Aeq,T}$  values in Table 4.

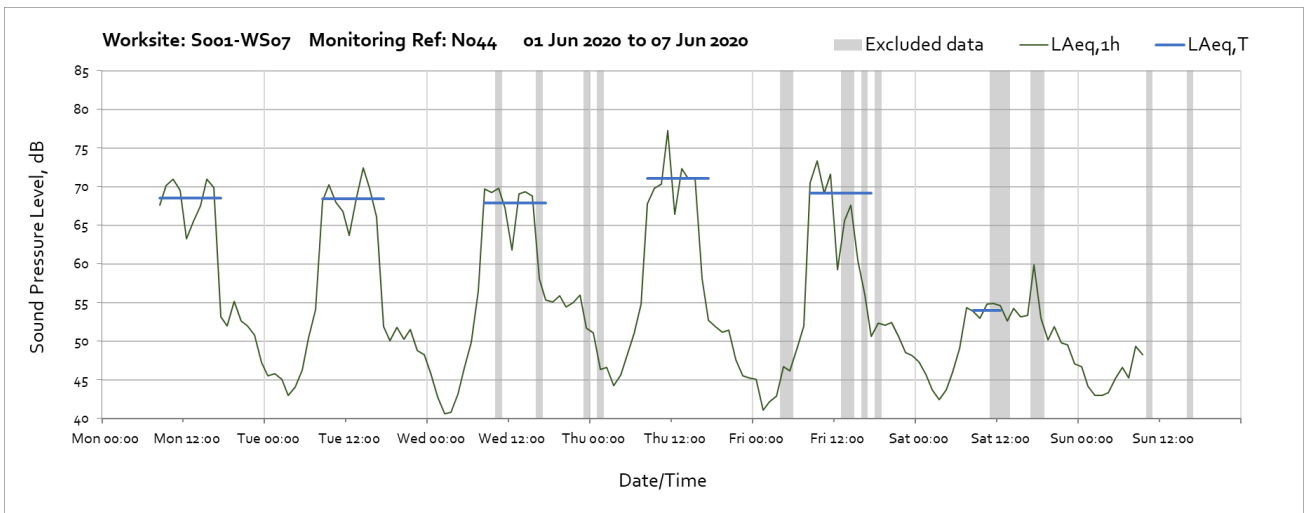
## Worksite: S001-WS07 – Monitoring Ref: N044

Note: Missing data between 00:00 and 08:00 on Monday 1<sup>st</sup> June and between 10:00 and 00:00 on Sunday 7<sup>th</sup> June was due to loss of site power (under investigation). No HS2 construction works were undertaken during these periods.

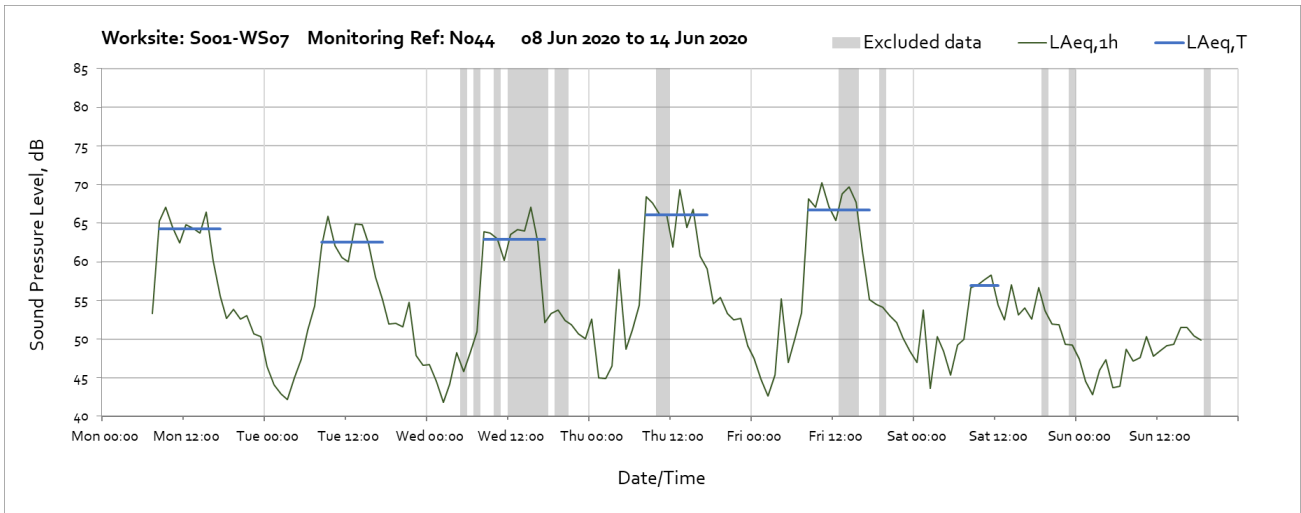
Note: Missing data between 00:00 and 07:00 on Monday 8<sup>th</sup> June and between 19:00 and 00:00 on Sunday 14<sup>th</sup> June was due to loss of site power (under investigation). No HS2 construction works were undertaken during these periods.

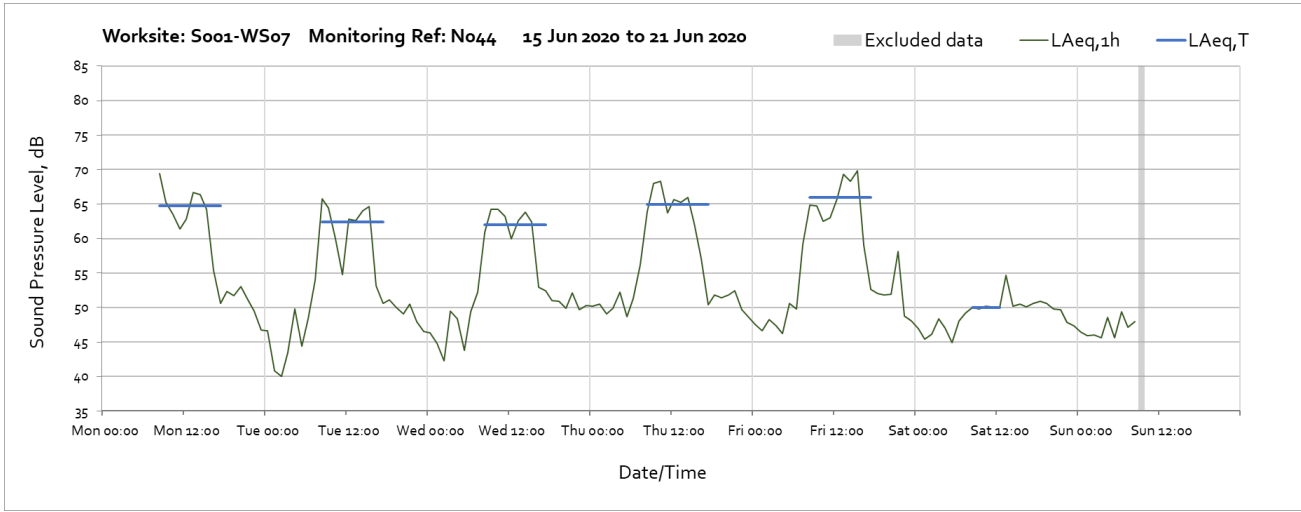
Note: Missing data between 00:00 and 08:00 on Monday 15<sup>th</sup> June and between 09:00 and 00:00 on Sunday 21<sup>st</sup> June was due to loss of site power (under investigation). No HS2 construction works were undertaken during these periods.

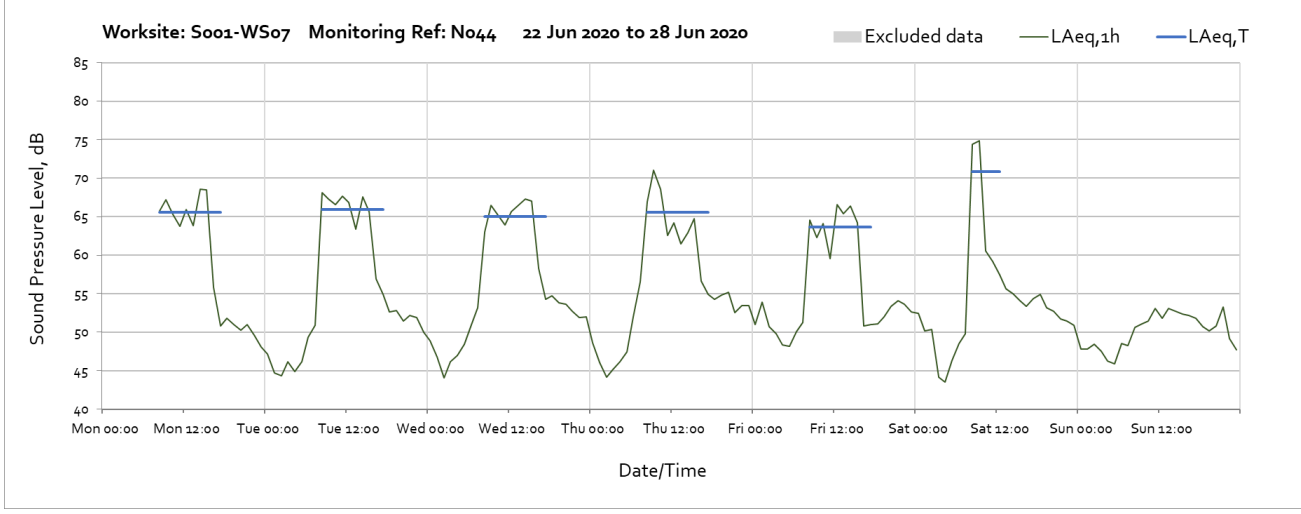
Note: Missing data between 00:00 and 08:00 on Monday 22<sup>nd</sup> June was due to loss of site power (under investigation). No HS2 construction works were undertaken during these periods.

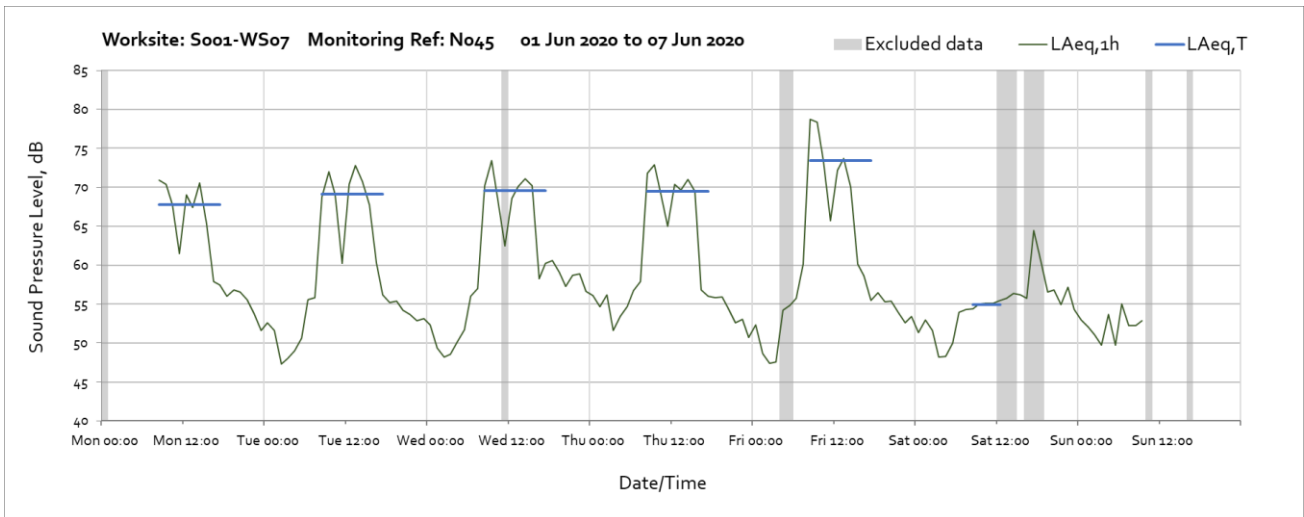
## Worksite: S001-WS07 – Monitoring Ref: N045

Note: Missing data between 00:00 and 08:00 on Monday 1<sup>st</sup> June and between 10:00 and 00:00 on Sunday 7<sup>th</sup> June was due to loss of site power (under investigation). No HS2 construction works were undertaken during these periods.

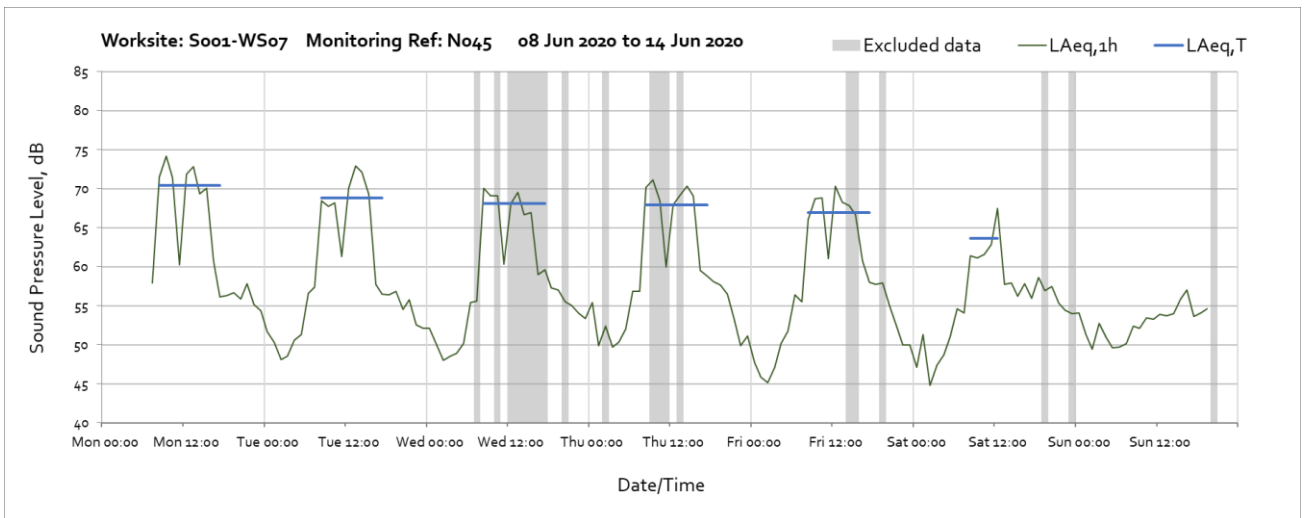
Note: Missing data between 00:00 and 07:00 on Monday 8<sup>th</sup> June and between 20:00 and 00:00 on Sunday 14<sup>th</sup> June was due to loss of site power (under investigation). No HS2 construction works were undertaken during these periods.

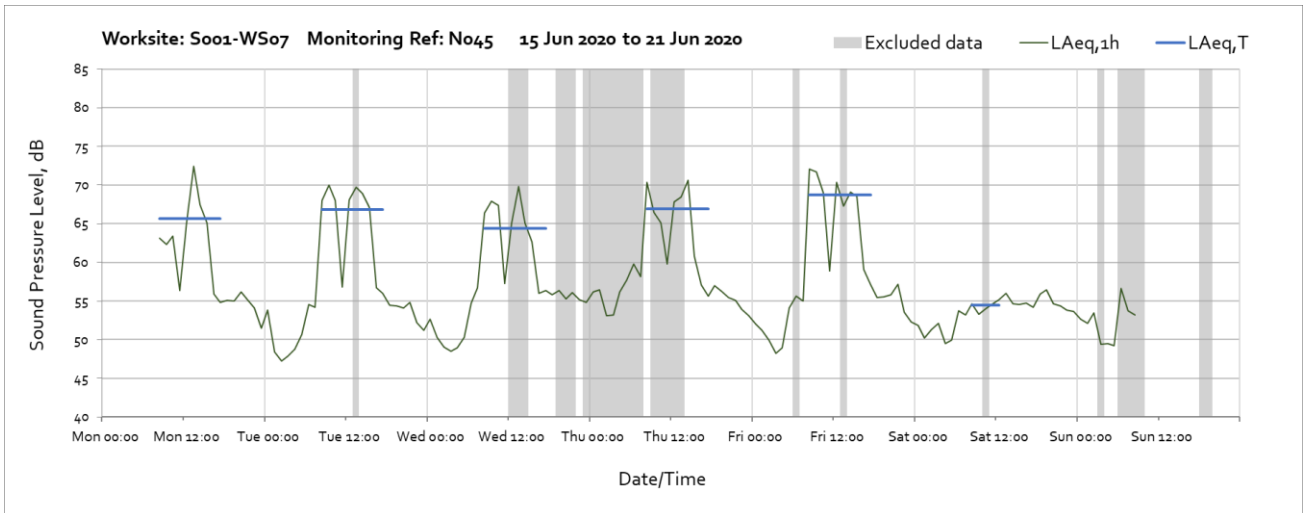
Note: Missing data between 00:00 and 08:00 on Monday 15<sup>th</sup> June and between 09:00 and 00:00 on Sunday 21<sup>st</sup> June was due to loss of site power (under investigation). No HS2 construction works were undertaken during these periods.

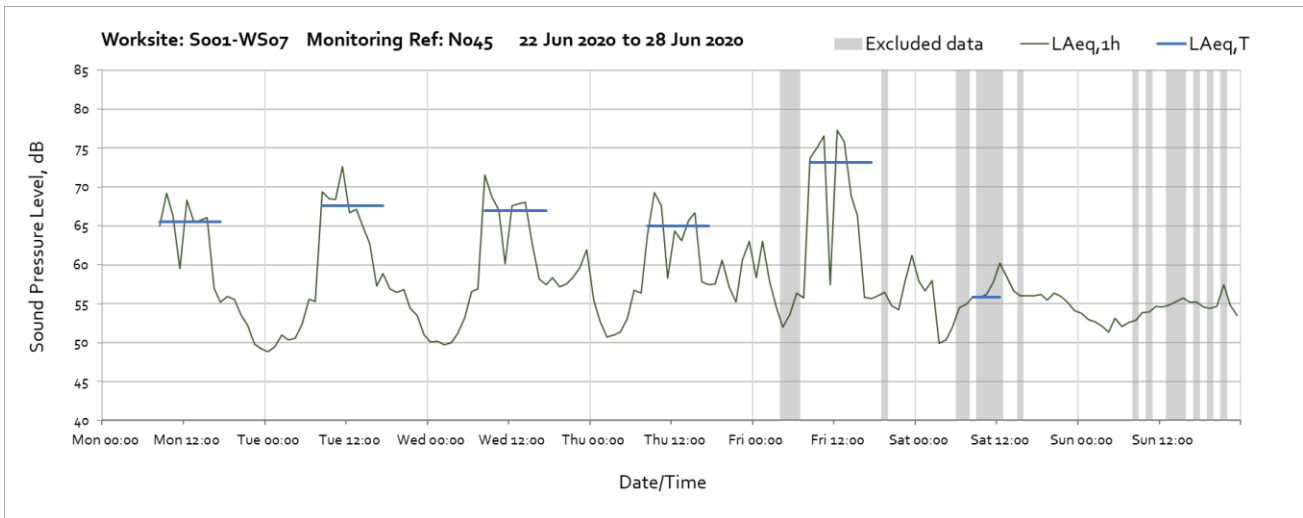
Note: Missing data between 00:00 and 08:00 on Monday 22<sup>nd</sup> June was due to loss of site power (under investigation). No HS2 construction works were undertaken during these periods.

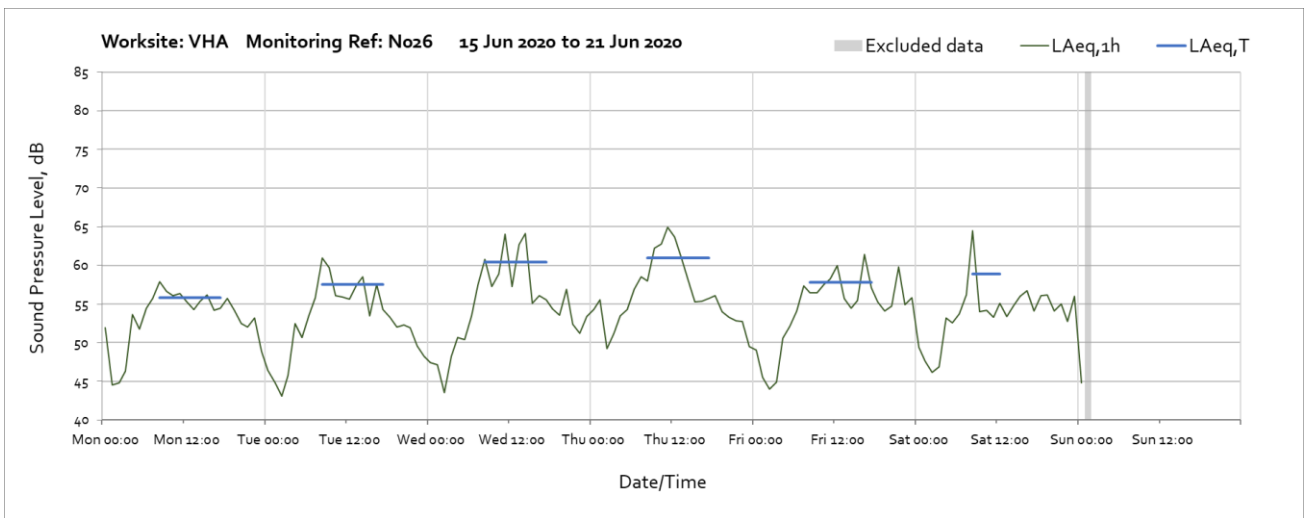
## Vehicle Holding Area (VHA) – Monitoring Ref: N026

Note: Missing data from 01:00 on Sunday 15<sup>th</sup> June was due to loss of power at the monitor due to removal of power.

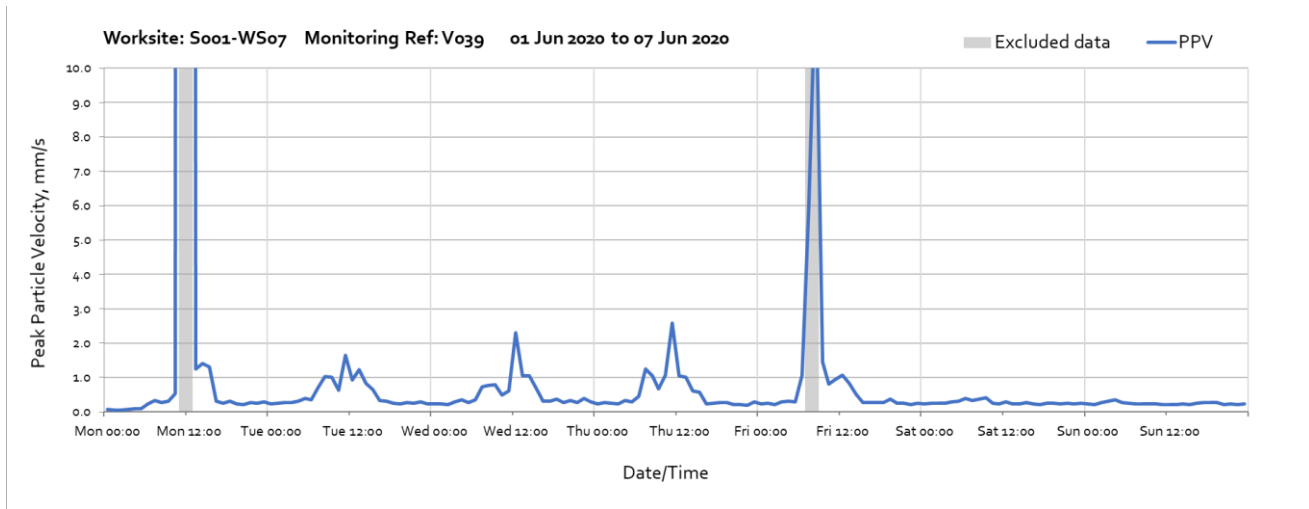
## Worksite: S001-WS07 – Monitoring Ref: V039

Note: High vibration levels measured between 11:00 and 12:00 on Monday 1<sup>st</sup> June and between 07:00 and 08:00 on Friday 5<sup>th</sup> June were due to local disturbance of the monitor and are not representative of HS2 vibration levels.

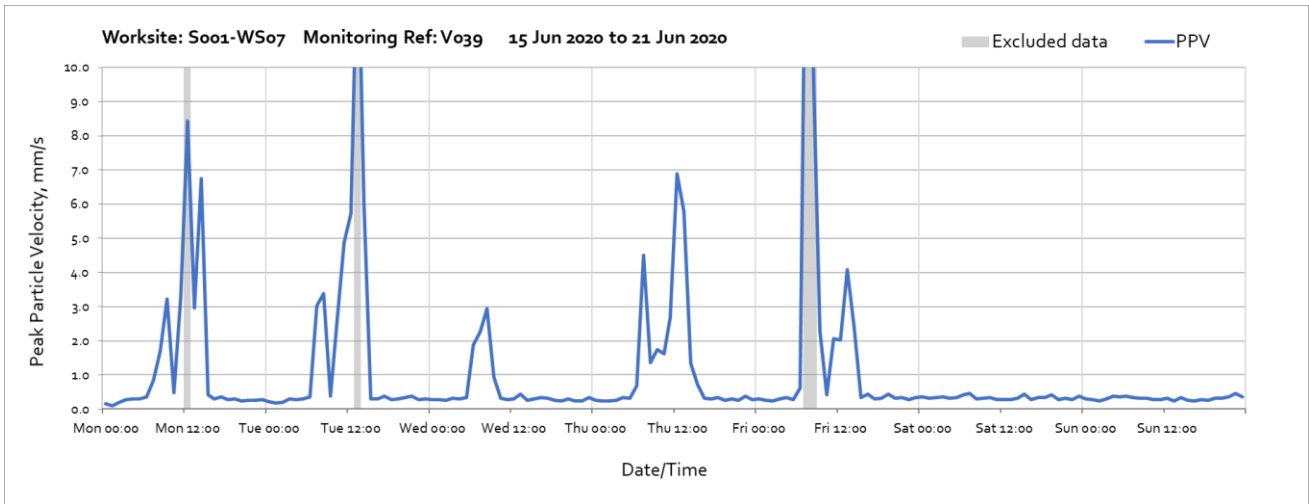
Note: High vibration levels measured between 12:00 and 13:00 on Monday 15<sup>th</sup> June, between 13:00 and 14:00 on Tuesday 16<sup>th</sup> June and between 07:00 and 09:00 were due to local disturbance of the monitor and are not representative of HS2 vibration levels.

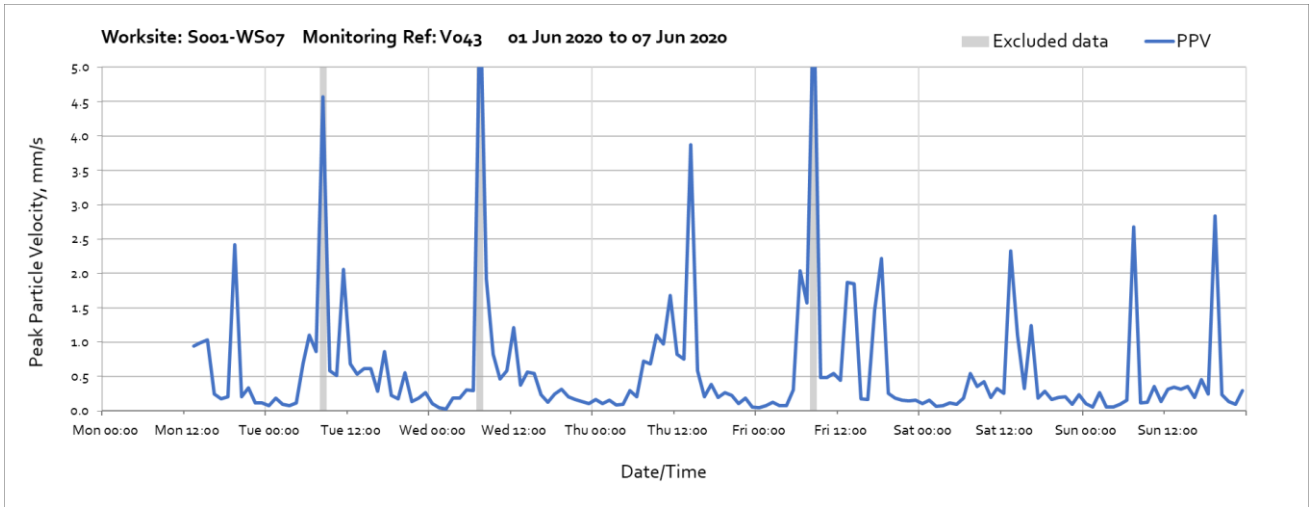
## Worksite: S001-WS07 – Monitoring Ref: V043

Note: Missing data from 00:00 until 13:00 on Monday 1<sup>st</sup> June was due to depletion of batteries at the monitor. High vibration levels measured throughout the week were due to local disturbance of the vibration monitor and are not representative of HS2 vibration levels.

2.2.2 Table 5 presents a summary of the measured vibration levels at monitoring locations over the reporting period. During the monitoring high values of PPV were measured at V043 and V002 which were due to local disturbance of the vibration monitors and are not representative of HS2 construction works. These have been greyed out in the charts alongside other periods of local disturbance of the monitor as shown in Appendix B, and have been excluded to calculate values in Table 5. The highest PPV measured during the monitoring along any axis is presented in the table.

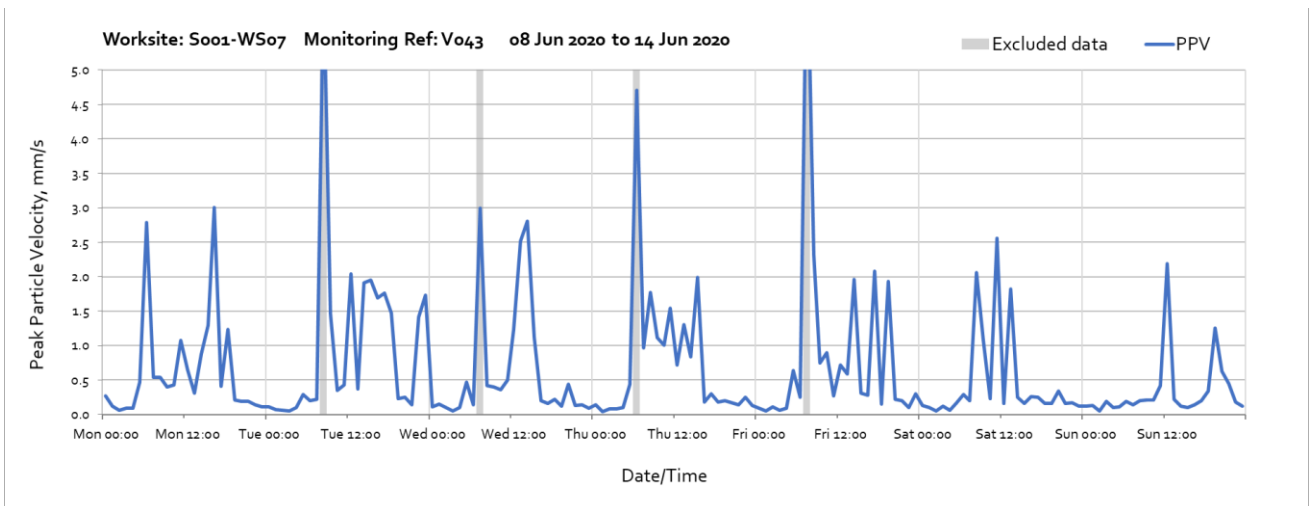
Note: High vibration levels measured throughout the week were due to local disturbance of the vibration monitor and are not representative of HS2 vibration levels.

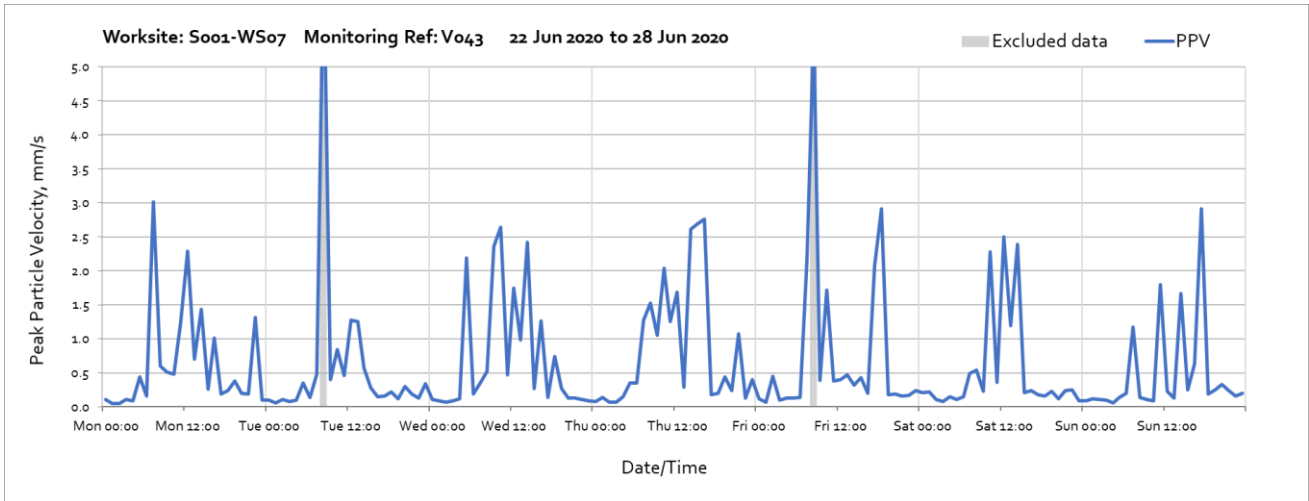
Note: High vibration levels measured throughout the week were due to local disturbance of the vibration monitor and are not representative of HS2 vibration levels.

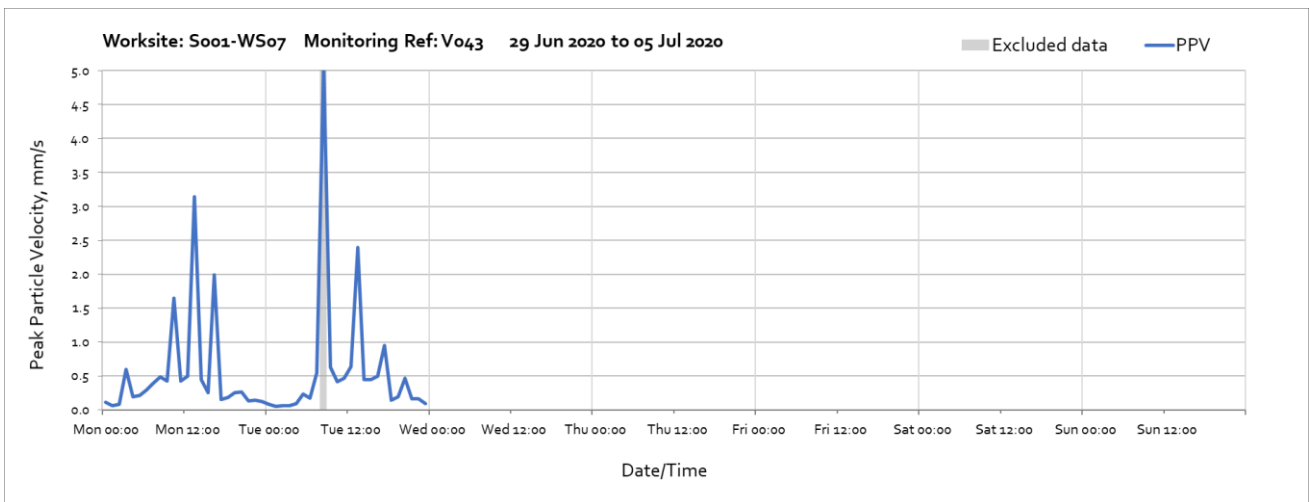
Note: High vibration levels measured throughout the week were due to local disturbance of the vibration monitor and are not representative of HS2 vibration levels.

Note: High vibration levels measured at 08:00 on Tuesday 30<sup>th</sup> June were due to local disturbance of the vibration monitor and are not representative of HS2 vibration levels.

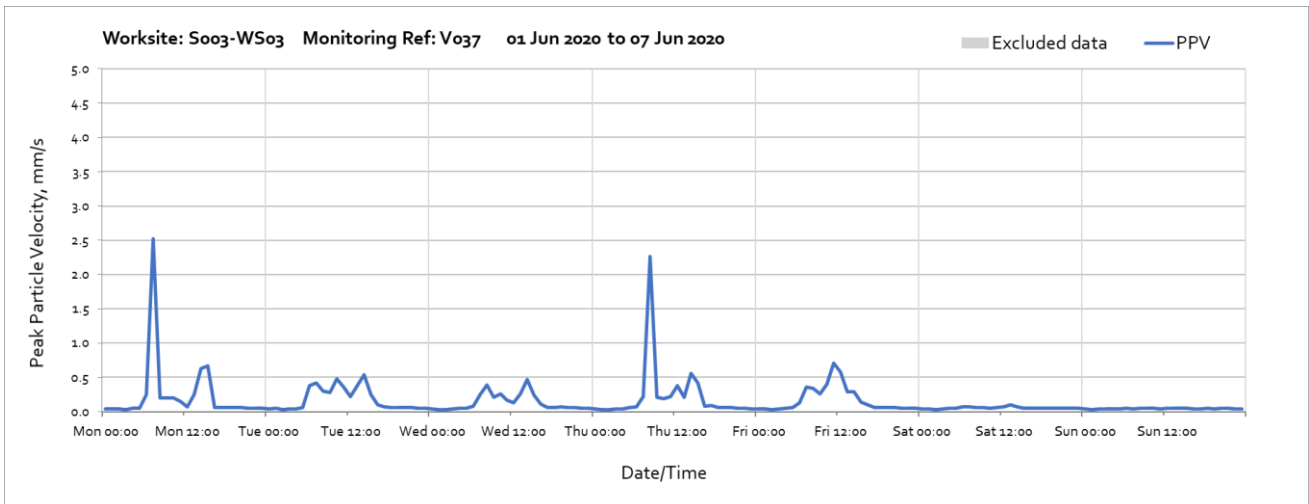
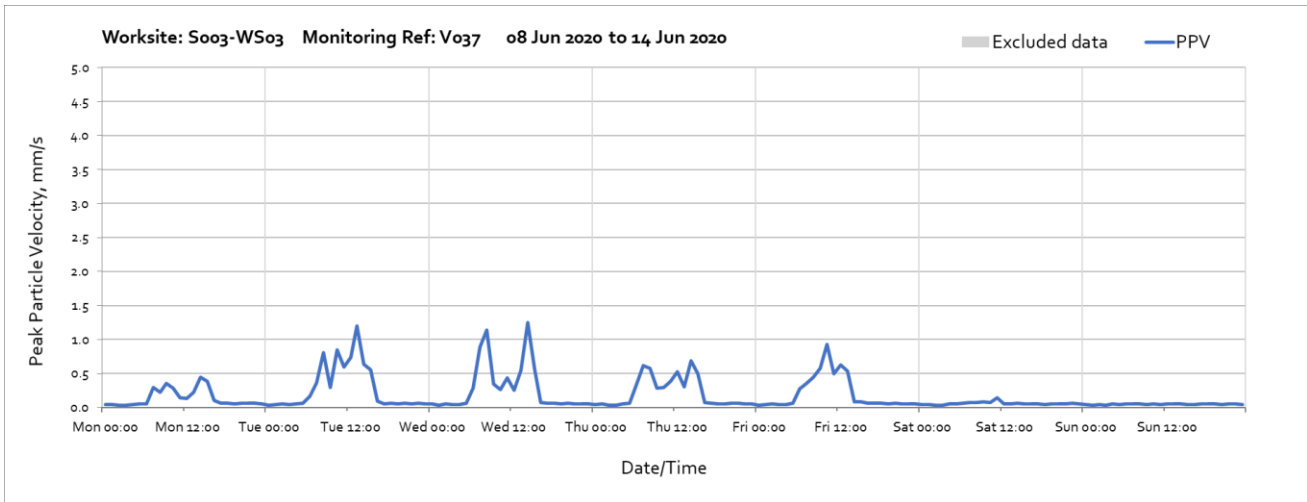
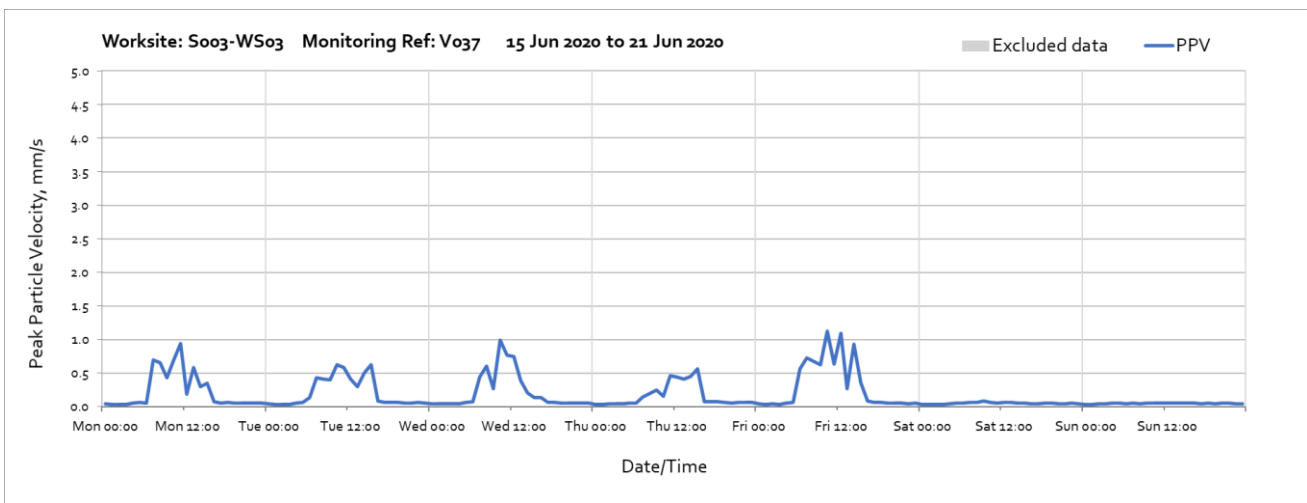
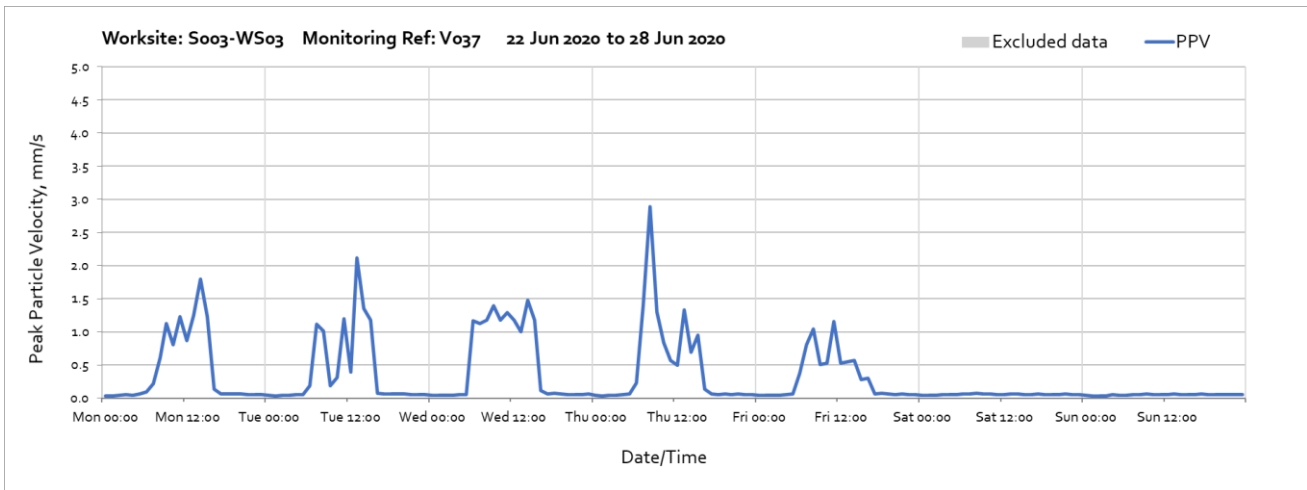
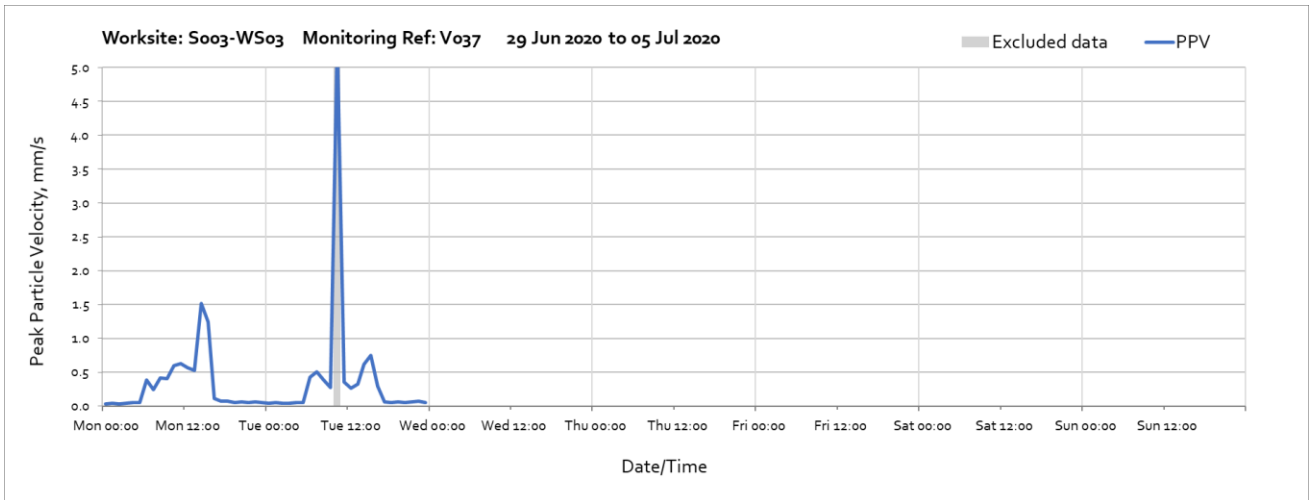
## Worksite: S003-WS03 – Monitoring Ref: V037

Note: High vibration levels measured at 10:00 on Tuesday 30<sup>th</sup> June were due to local disturbance of the vibration monitor and are not representative of HS2 vibration levels.

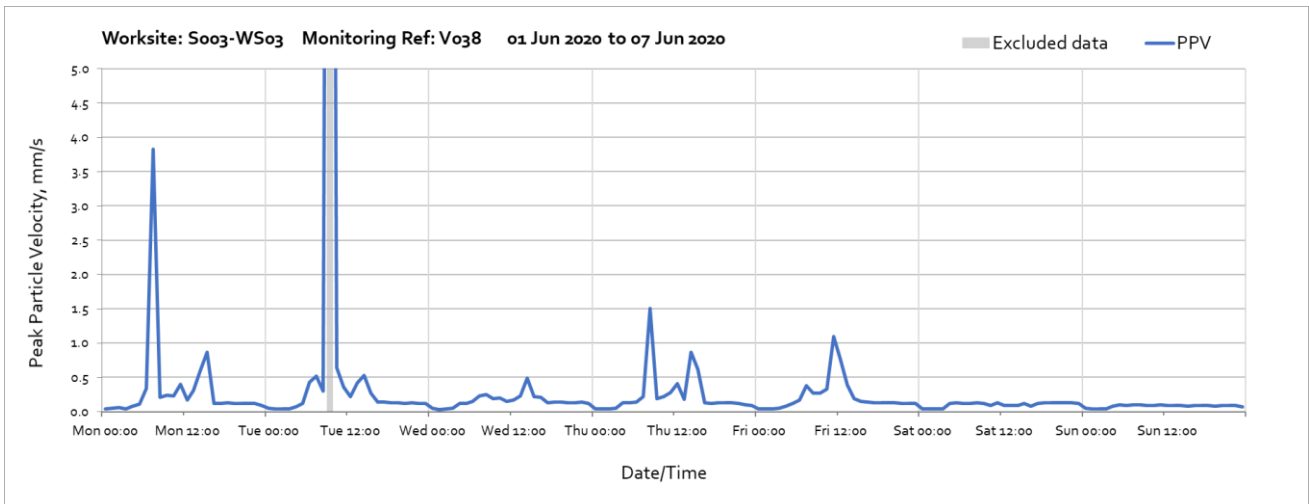
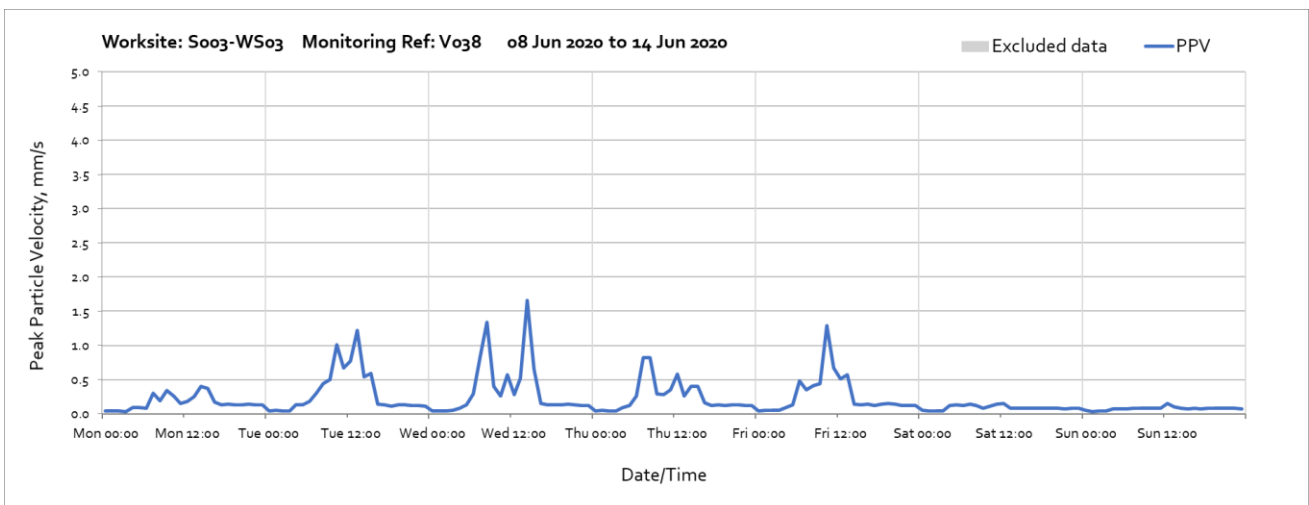
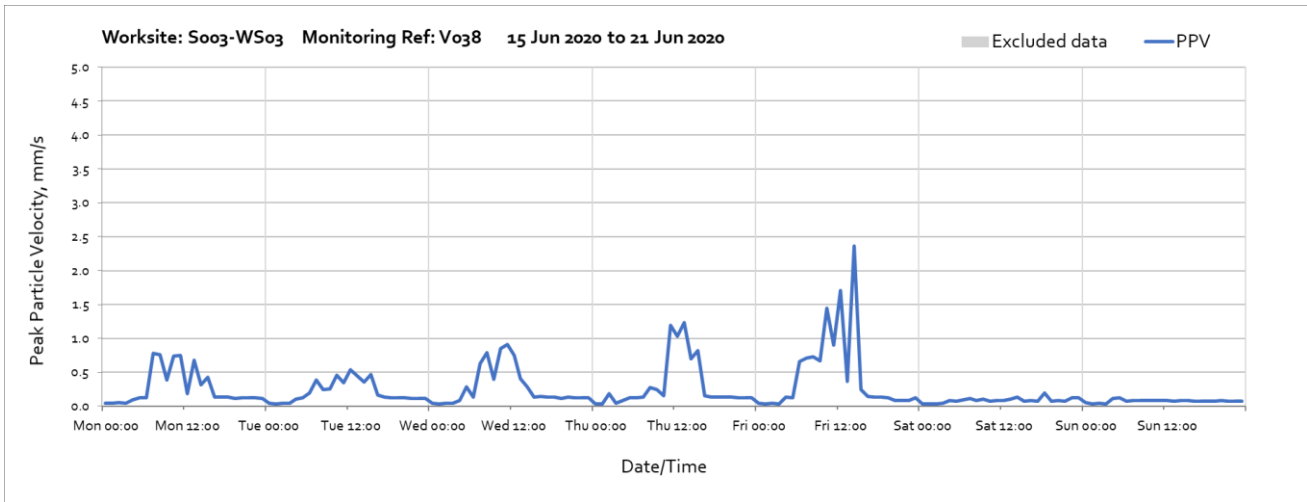
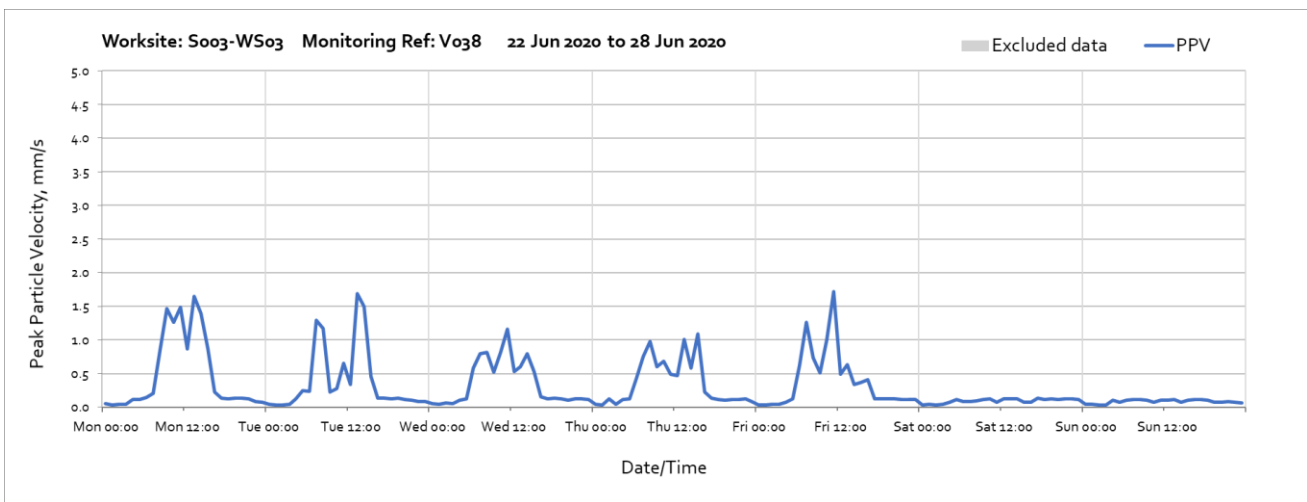
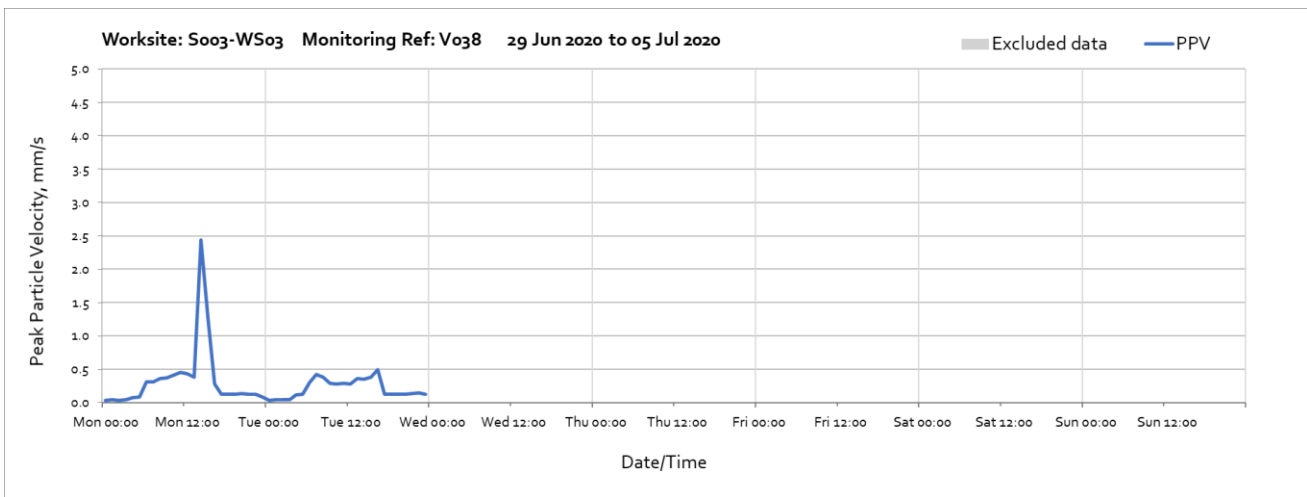
## Worksite: S003-WS03 – Monitoring Ref: V038

Note: High vibration levels measured at 09:00 on Tuesday 2<sup>nd</sup> June were due to local disturbance of the vibration monitor and are not representative of HS2 vibration levels.
