## **Construction noise and vibration Monthly Report – June 2020**

**London Borough of Camden**

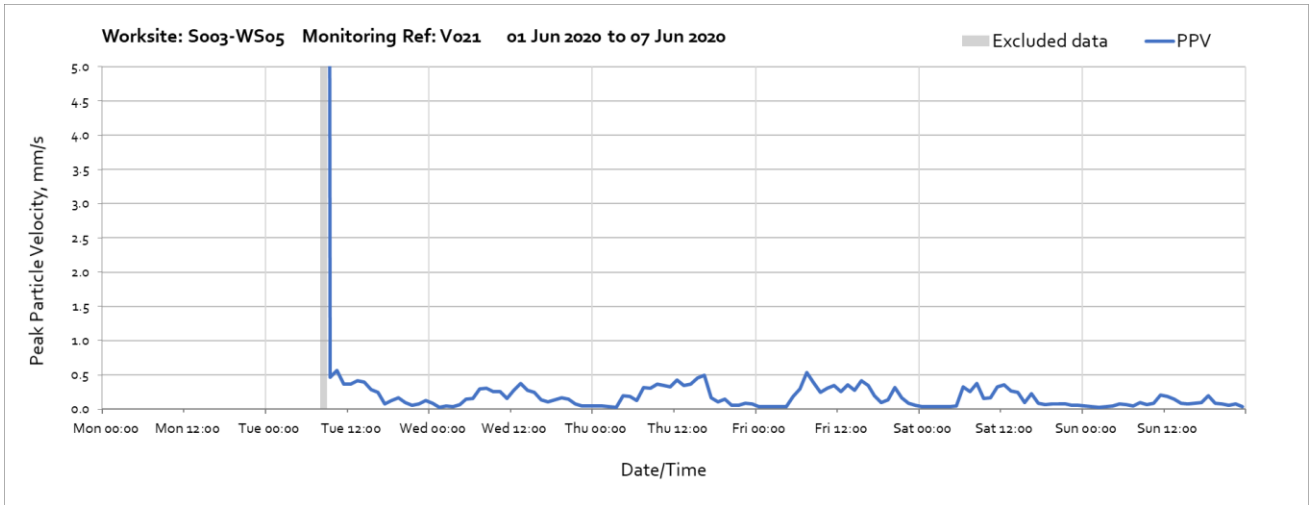
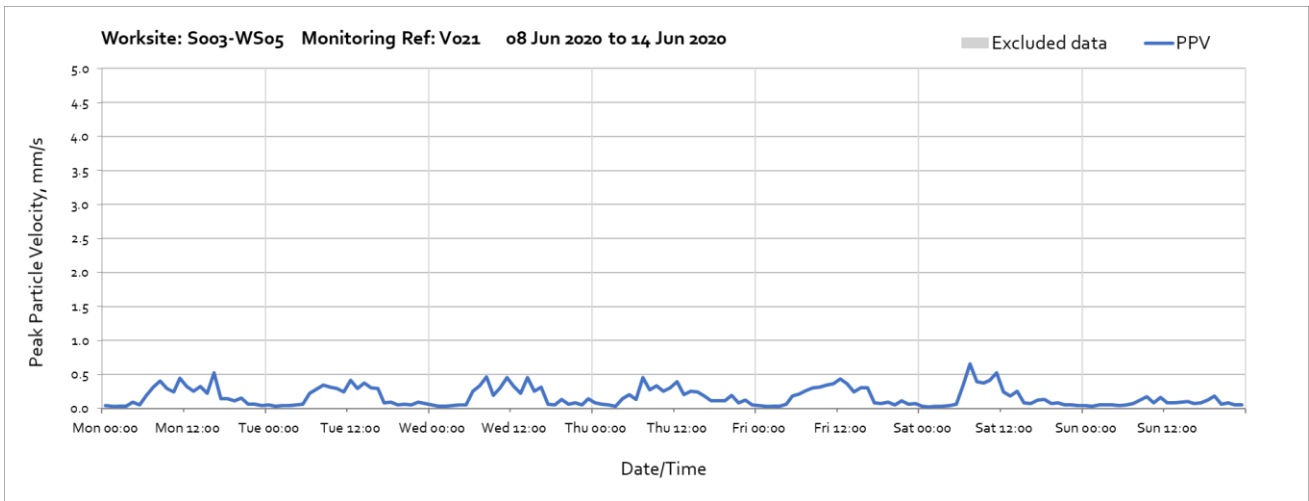
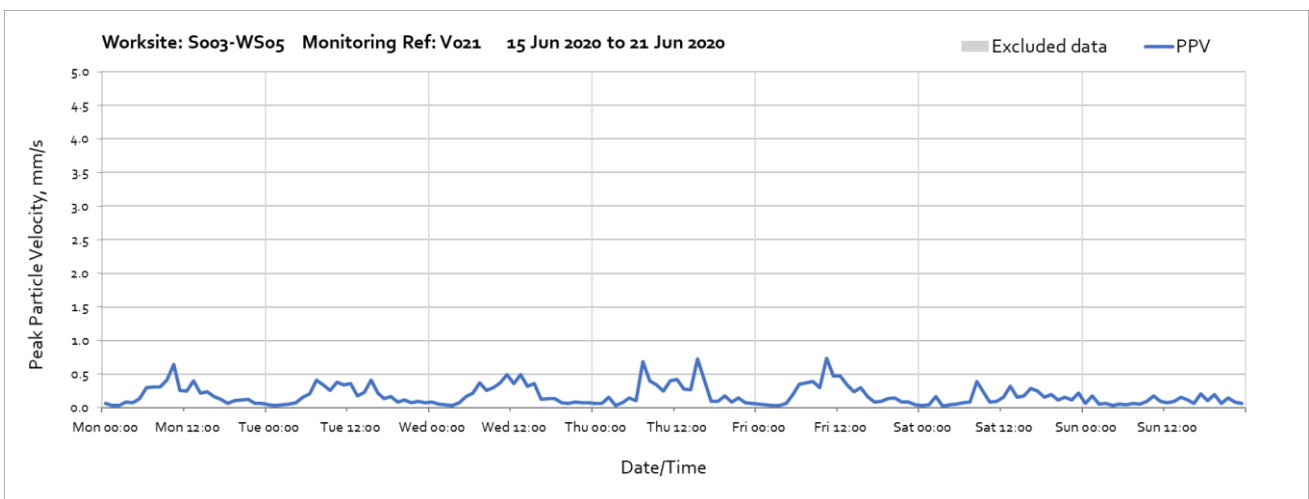
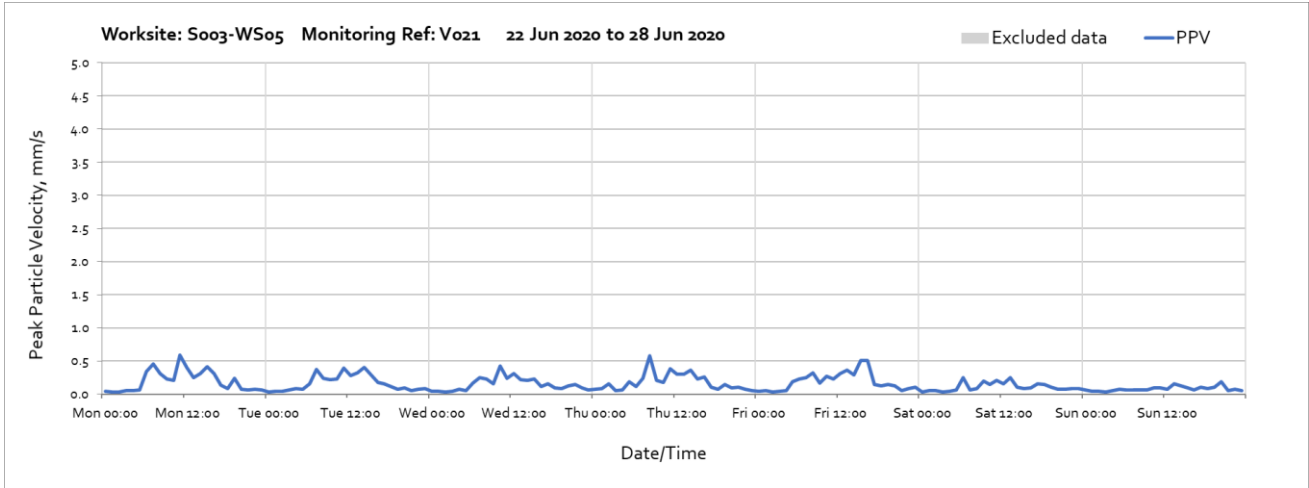
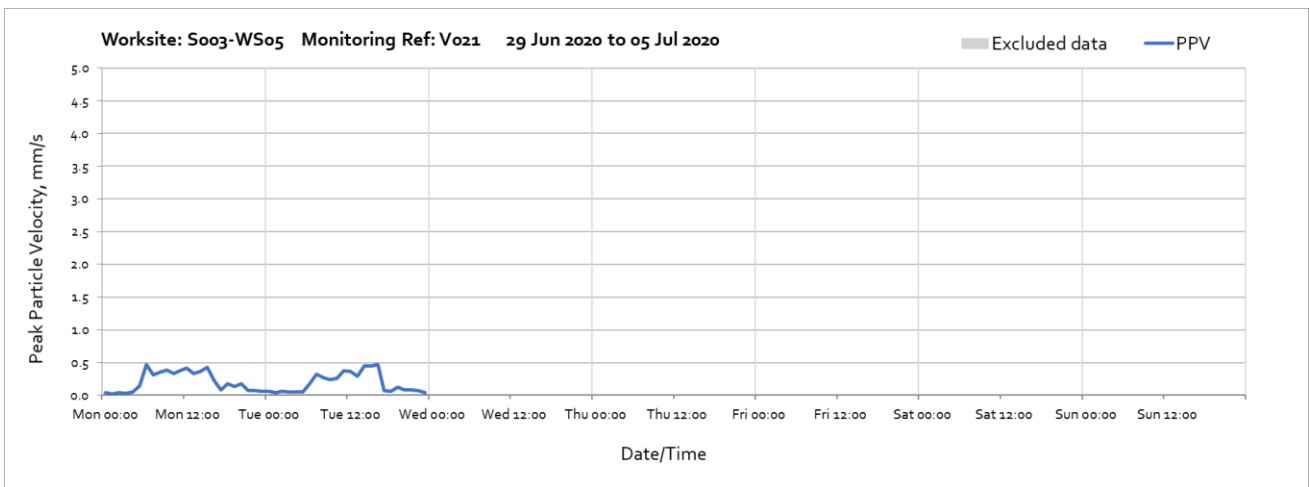
# Worksite: S003-WS05 – Monitoring Ref: V021

Note: High vibration levels measured at 08:00 on Tuesday 2<sup>nd</sup> June were due to local disturbance of the vibration monitor whilst the monitor batteries were changed and are not representative of HS2 vibration levels.
