SAFETY FLYER TO THE FISHING INDUSTRY

Fatal man overboard from the single-handed fishing boat *May C* (SY213) at Loch Carnan, Outer Hebrides, Scotland on 24 July 2019

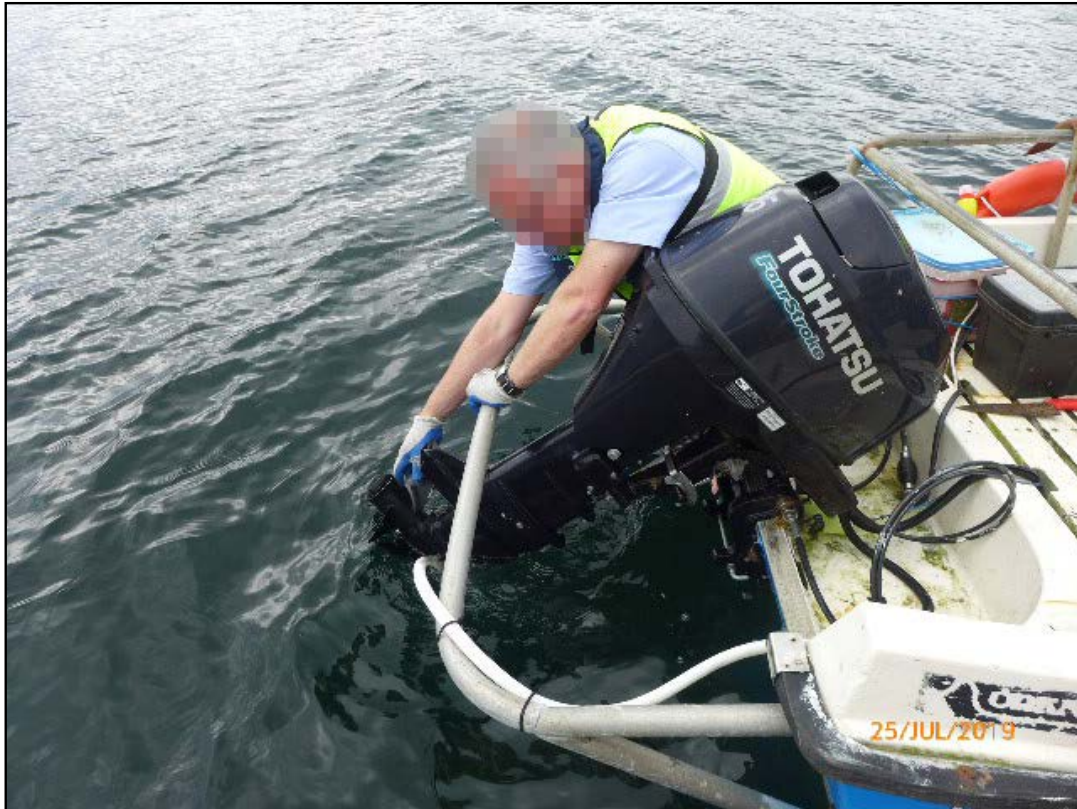
Reconstruction of outboard motor propeller being cleared

1. The exact circumstances of this accident are unknown because the skipper's fall overboard was not witnessed. However, the boat's engine was found in the raised position so it is most likely that he fell overboard and drowned while trying to clear weed or some other obstruction from the propeller. To get to the propeller the skipper had to climb onto *May C*'s narrow transom, which circumvented the only significant safety barrier to prevent him falling overboard, the raised guardrails, specifically in place to prevent crew falling over the side.

3. Single-handed fishing operations are extremely hazardous, primarily because there is no-one there to help if you get into difficulties. It is important to recognise the severe hazard associated with falling overboard. The best way to combat this is to ensure that every precaution has been taken to prevent going in the sea in the first place, and if that does happen, then measures are in place to increase your chances of survival and rescue.

4. Every fishing vessel should have a method of recovering a man overboard back into the boat. The fact that the two crew of the fishing boat who found *May C's* skipper were unable to immediately recover him out of the water is testament of the extreme physical effort required to haul someone out of the sea. For that reason, it is very important to have a ready means of recovering a person from the water and to conduct regular manoverboard recovery drills.
