Air Quality and Dust Monitoring Monthly Report – **August** 2020

Three Rivers District Council

A report prepared by Align JV on behalf of HS2 Ltd.

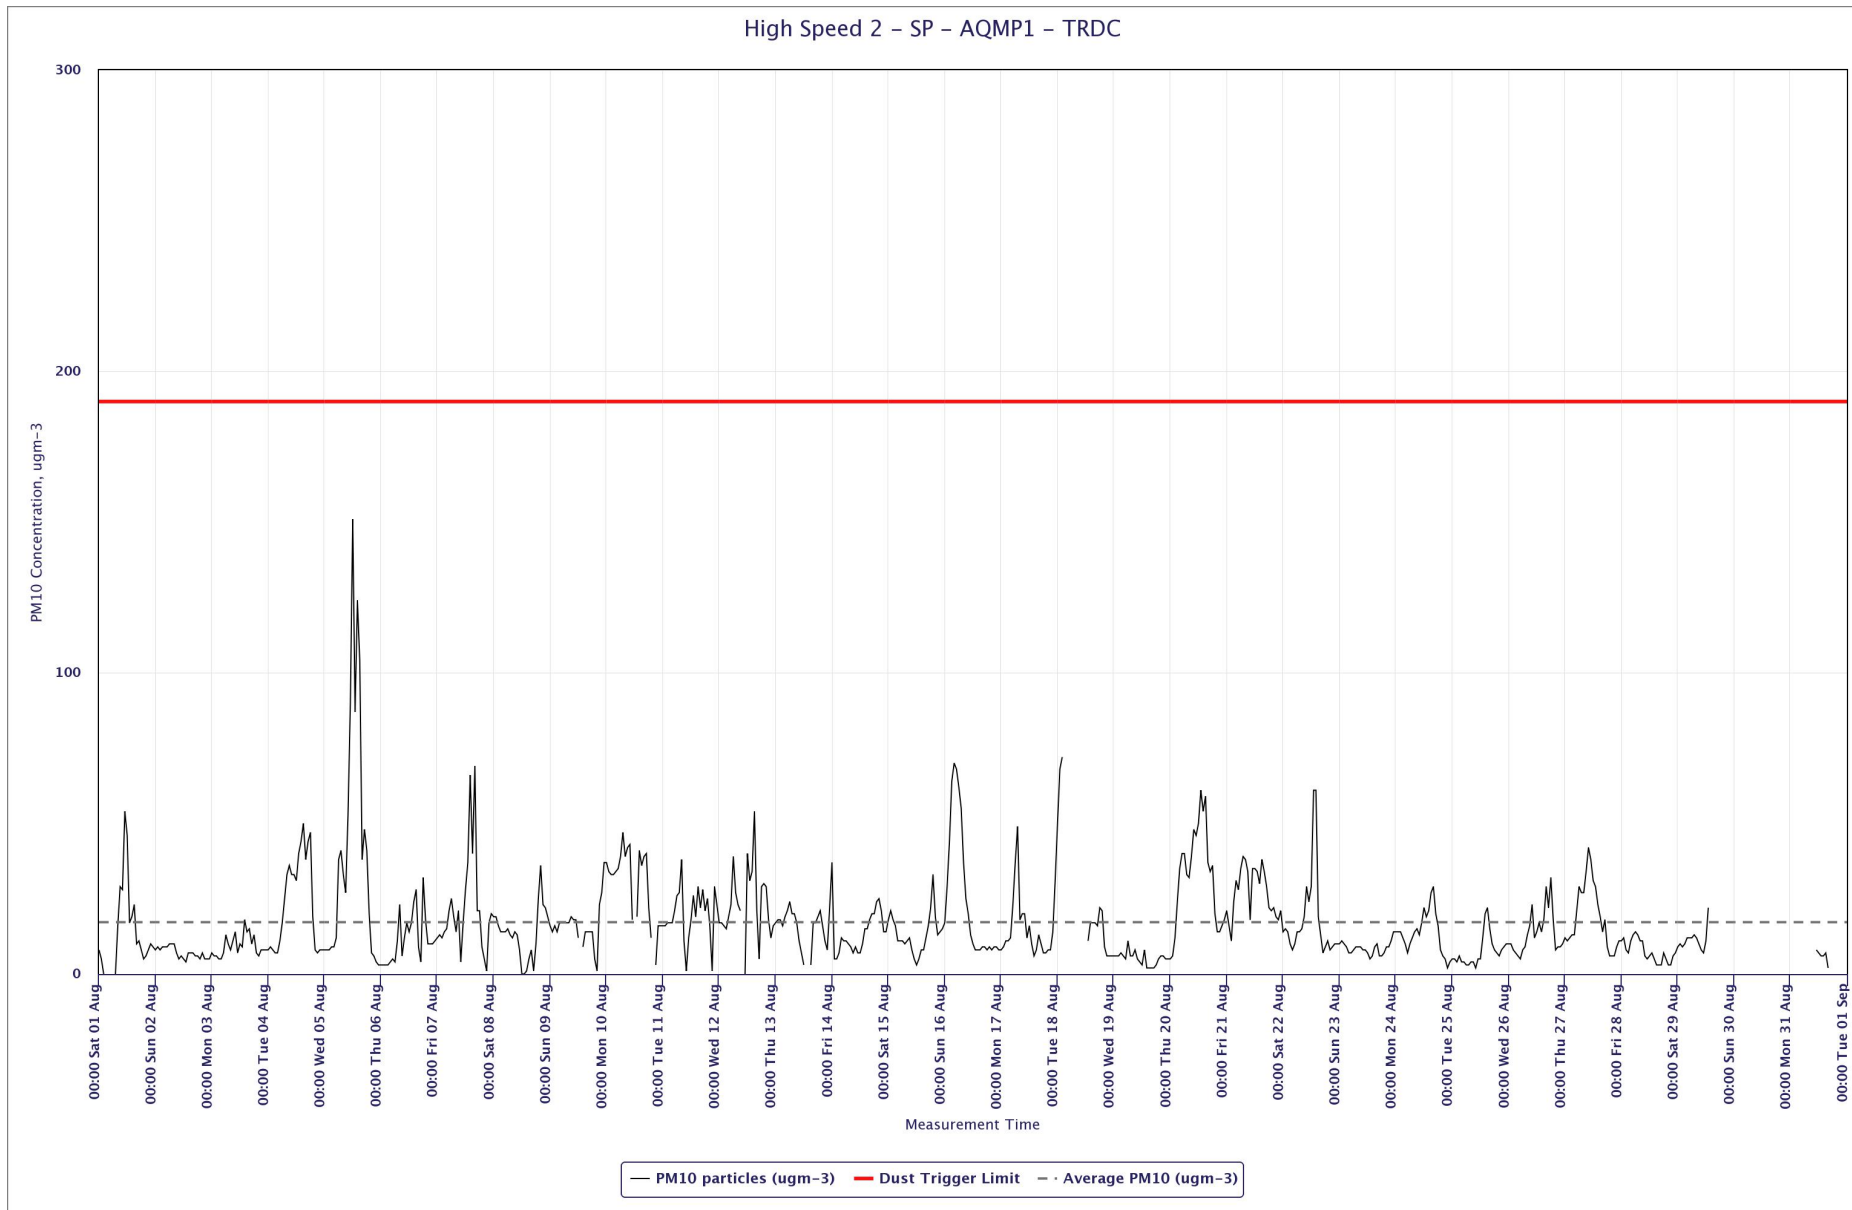
Figure 2: Continuous dust 1-hour mean indicative PM₁₀ concentration for SP-AQMP1-TRDC for August 2020

- 1.1.6 Dust monitoring locations and results are presented in Appendix B, Table 1, together with a line chart of monthly data from each dust monitor presented in Figures 2, 3 and 4. All continuous dust monitoring is undertaken using indicative monitors. Despite being Environment Agency (MCERTS) certified, indicative monitors carry a higher level of uncertainty than reference monitors, and therefore cannot be strictly compared with Air Quality Standards for human health and the environment. The purpose of the monitoring undertaken is to ensure the effectiveness of the on-site mitigation.

- 1.1.7 The trigger level for PM₁₀ concentrations of 190 µg/m³, over a 1-hour period, in accordance with the updated guidance document '*Guidance on Monitoring in the Vicinity of Demolition and Construction Sites – (October 2018)*' has been applied.

- 1.1.8 There were no (0) dust trigger alerts recorded during the monitoring period (August 2020). All results were in line with expected ranges.
- 1.1.9 Data capture was below 90% for SP-AQMP2-TRDC for the month of August. This was due to a fault with the solar controller and the loss of power supply from the leisure batteries. Following each instance of power loss, the leisure batteries were replaced. The fault with the solar controller was resolved on 21/08/20. Actions including additional system alerts, spare monitor equipment and accessories on hand, and a dedicated team to oversee the monitor functionality, have been put in place to avoid re-occurrence.

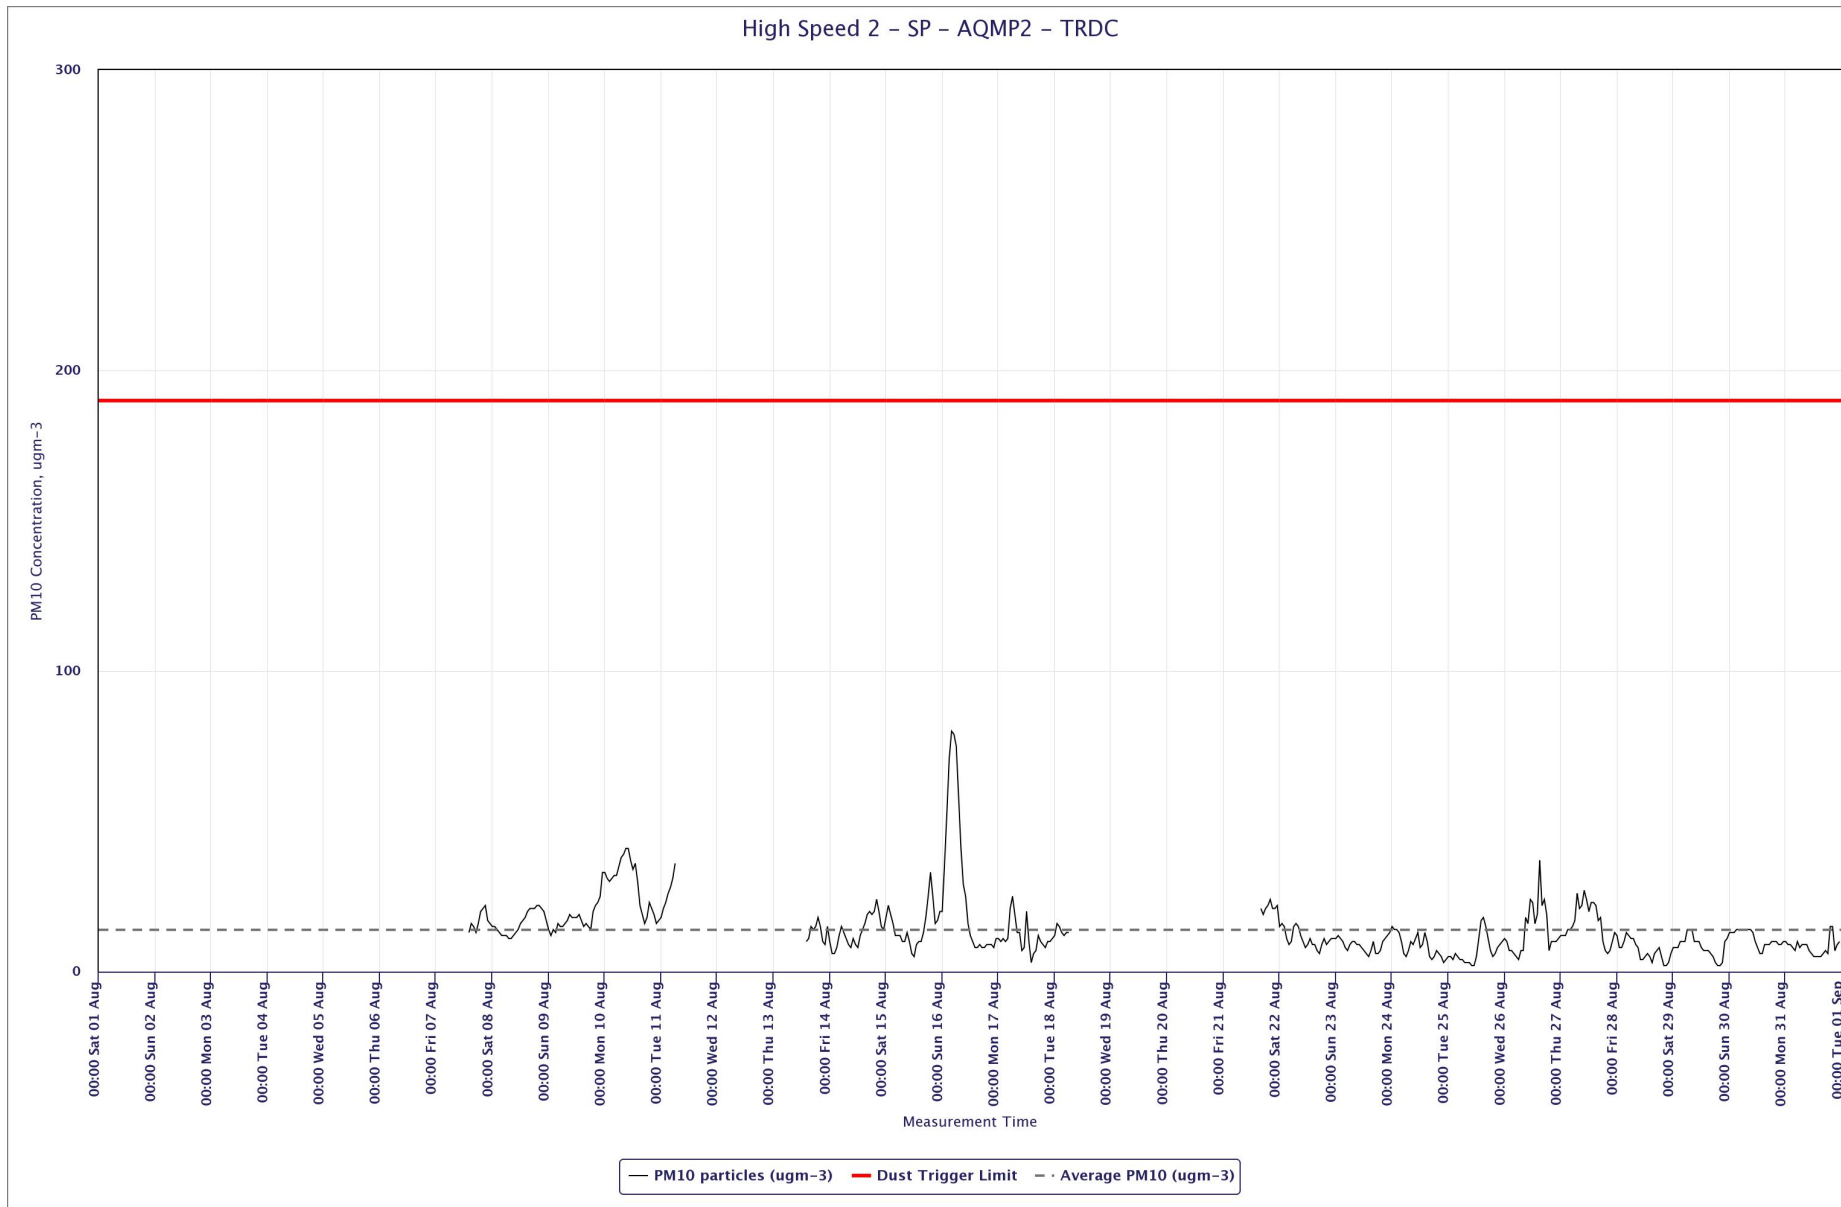
Figure 3: Continuous dust 1-hour mean indicative PM₁₀ concentration for SP-AQMP2-TRDC for August 2020

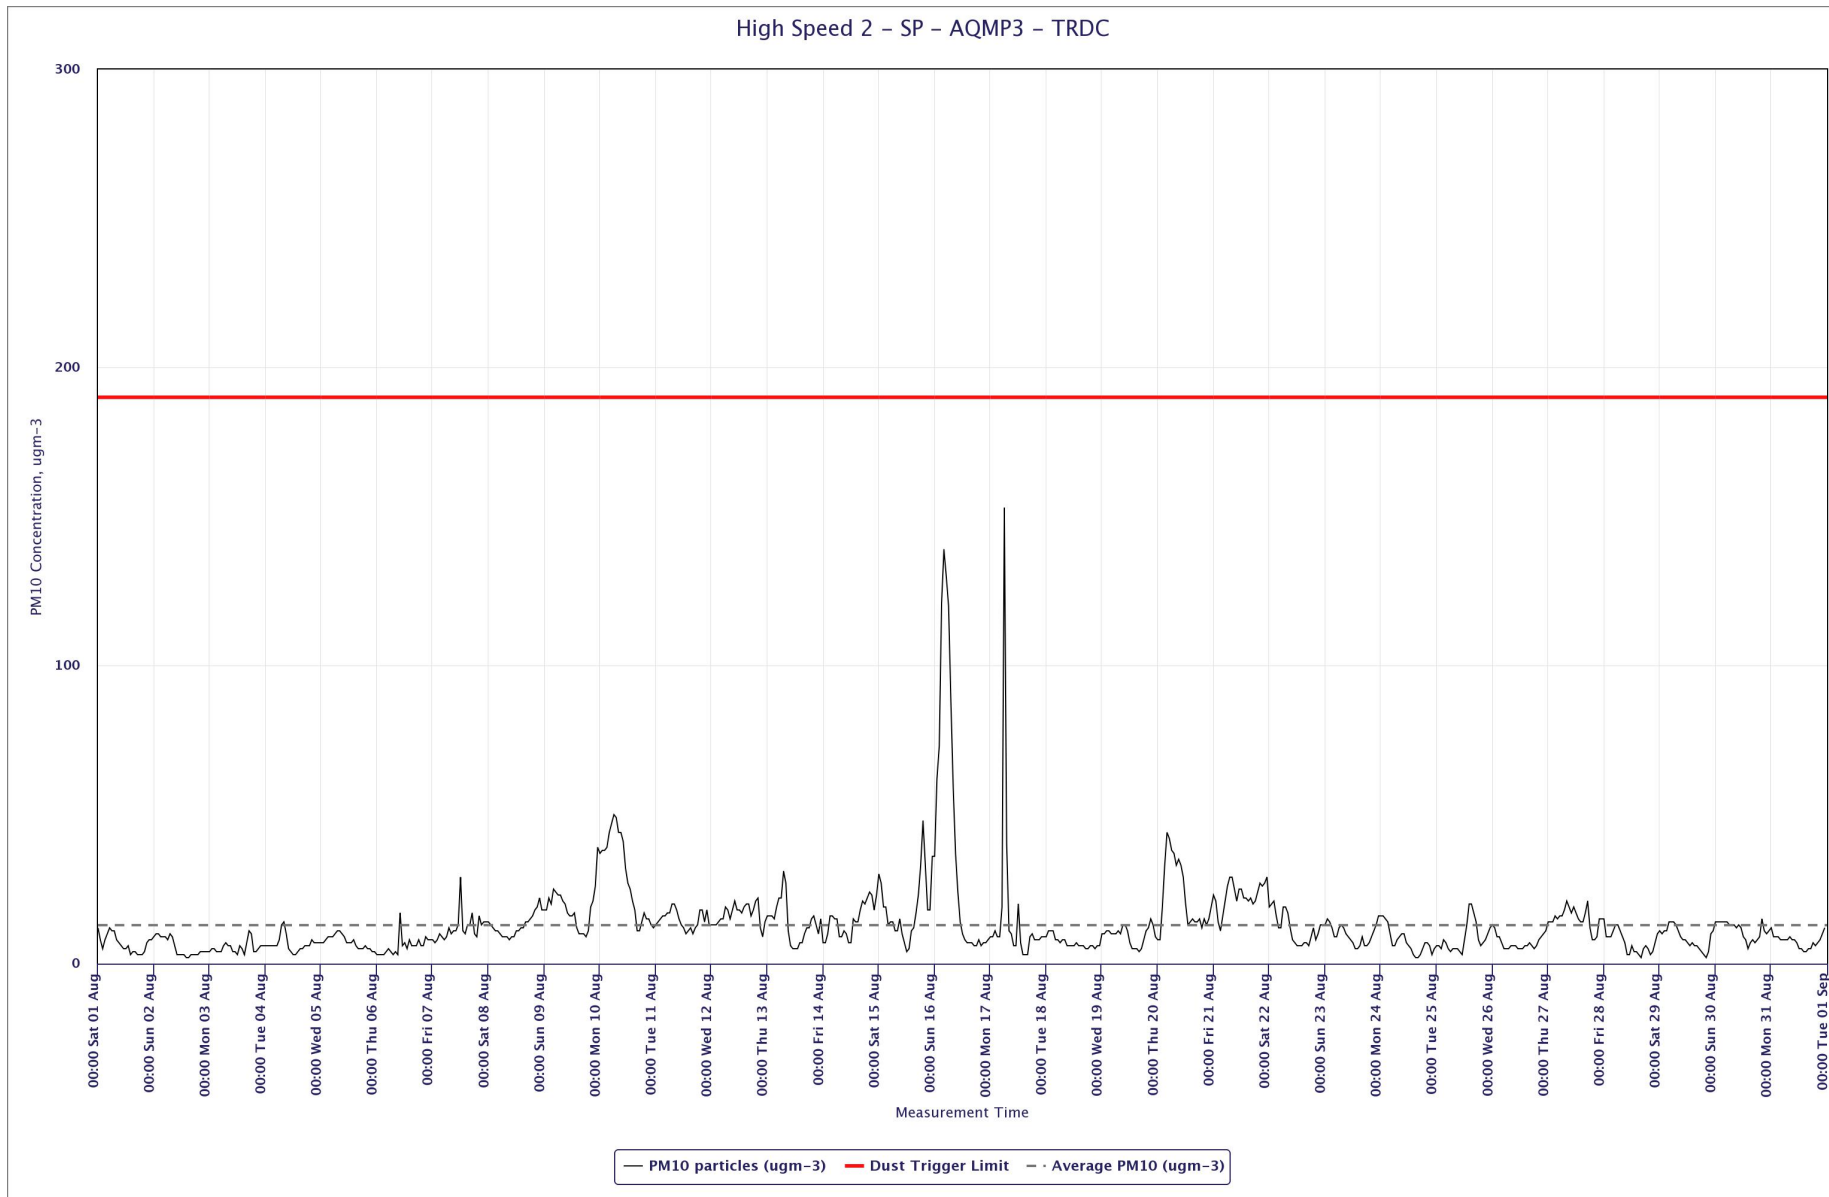
Figure 4: Continuous dust 1-hour mean indicative PM₁₀ concentration for SP-AQMP3-TRDC for August 2020
