## **Construction noise and vibration Monthly Report – August 2020**

**London Borough of Hillingdon**

This Noise and Vibration Monitoring Report fulfils HS2 Limited's commitment detailed in the Environmental Minimum Requirements (EMRs), Annex 1, Code of Construction Practice, to present the results of noise monitoring carried out within the London Borough of Hillingdon during the month of August 2020.

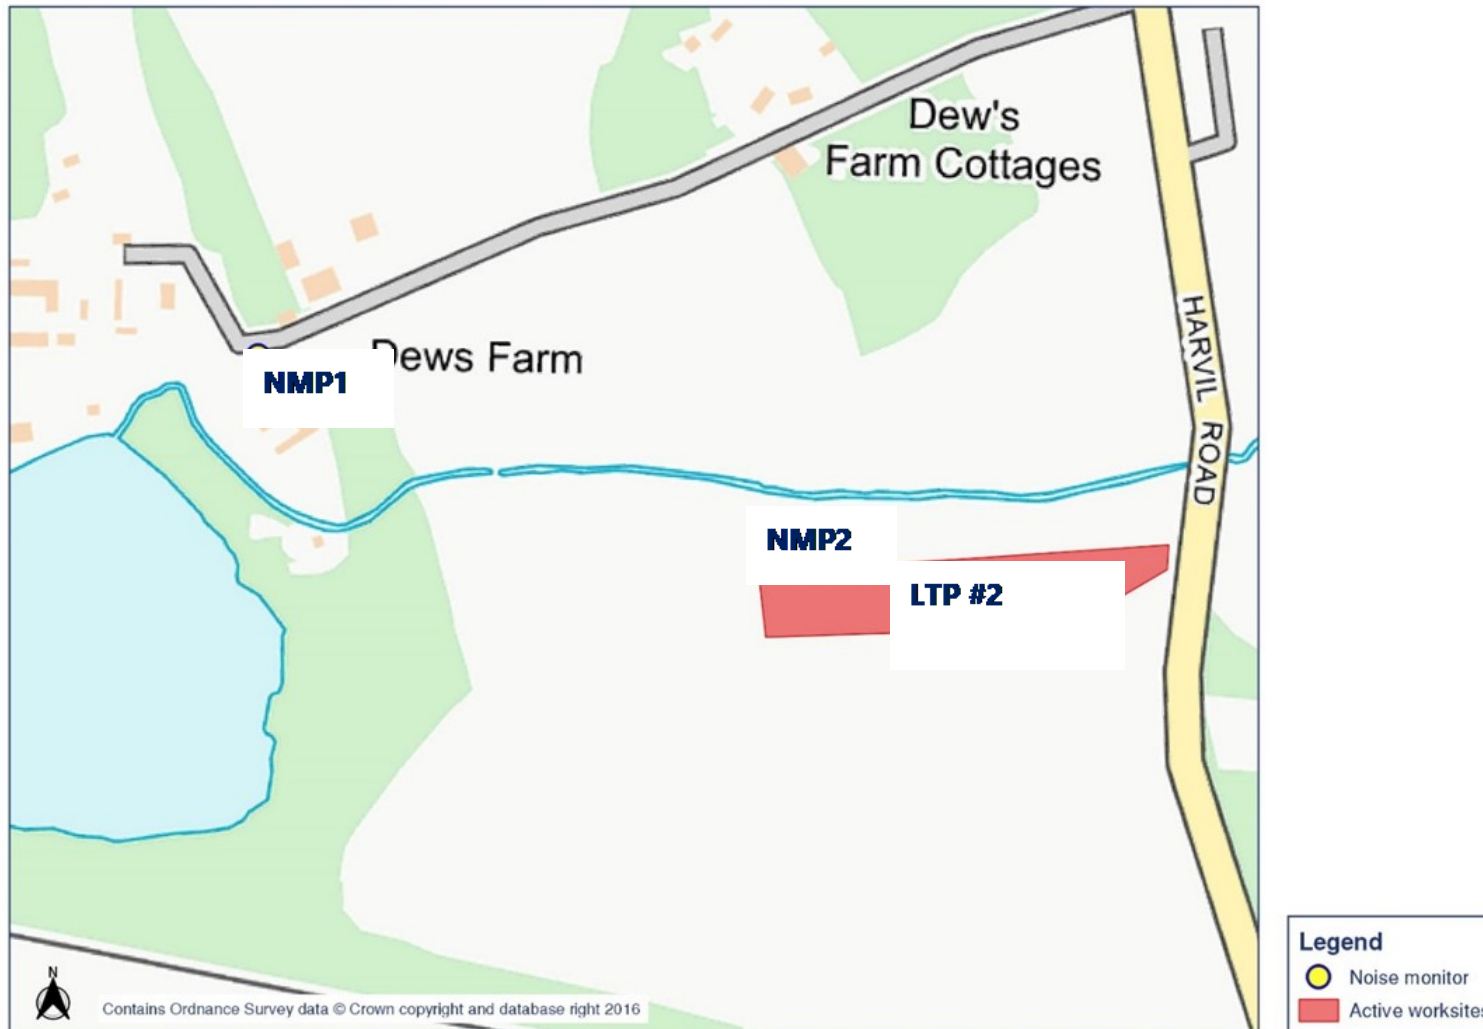
# Appendix B Monitoring Locations

1.2.2 Maps showing the position of noise monitoring installations are presented in Appendix B.

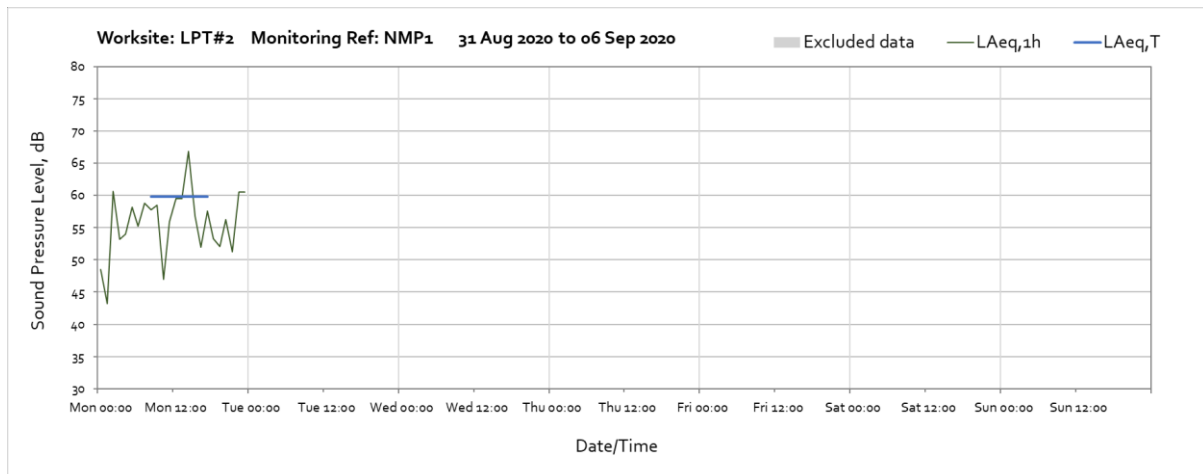
## Worksite: LPT #2 – Monitoring Ref: NMP1

The following graphs show the hourly measured ambient noise level  $L_{Aeq,1h}$  and, where relevant, the averaged noise level  $L_{Aeq,T}$  values, where the time period T is as specified in Table 1 of HS2 Information Paper E23. Periods with adversely weather affected noise levels are greyed out and have been excluded from the calculation of the  $L_{Aeq,T}$  values in Table 3 of the main report.

Note: Missing data between from Monday 10<sup>th</sup> August were due to failure of the noise monitor. A new monitor was installed at 11:00 on Tuesday 18<sup>th</sup> August to replace faulty equipment.

- 2.1.2 Appendix C presents graphs of the noise monitoring data over the month for each of the measurement locations. Noise data presented consists of the hourly  $L_{Aeq}$  values and, where relevant, the  $L_{Aeq,T}$  values (where the time period T has been taken to be the averaging period as specified in Table 1 of HS2 Information Paper E23). The full data set for the monitoring equipment can be found at the following location:  
<https://data.gov.uk/dataset/24542ae7-dd44-444f-b259-871c4cc43b5e/environmental-monitoring-data>.

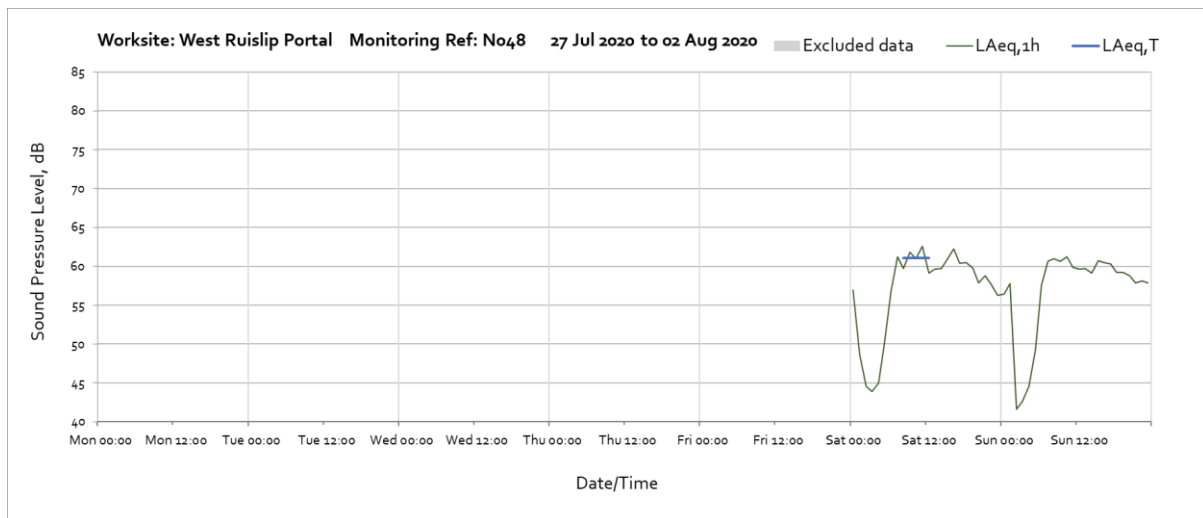
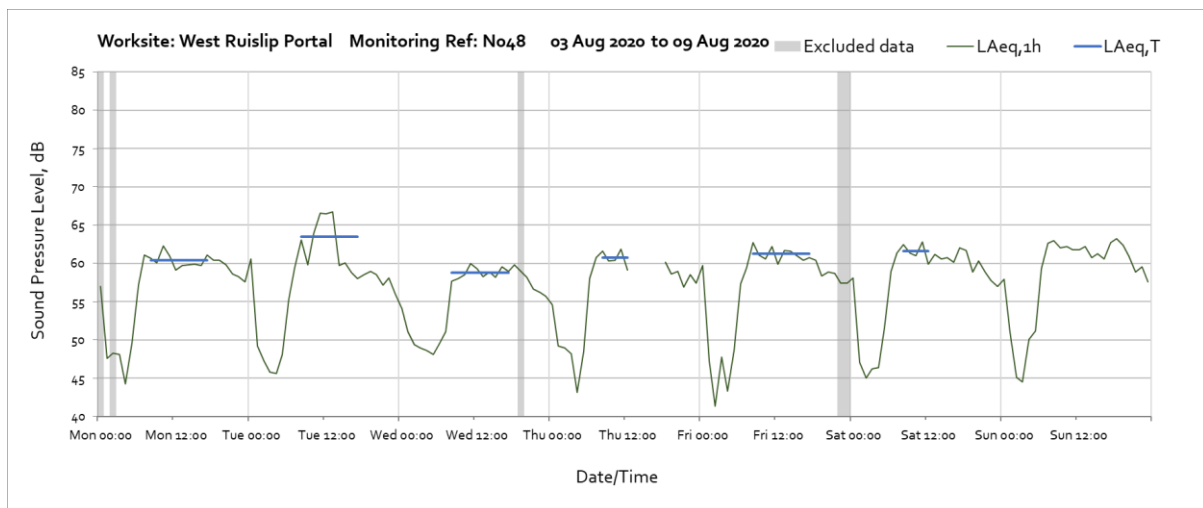
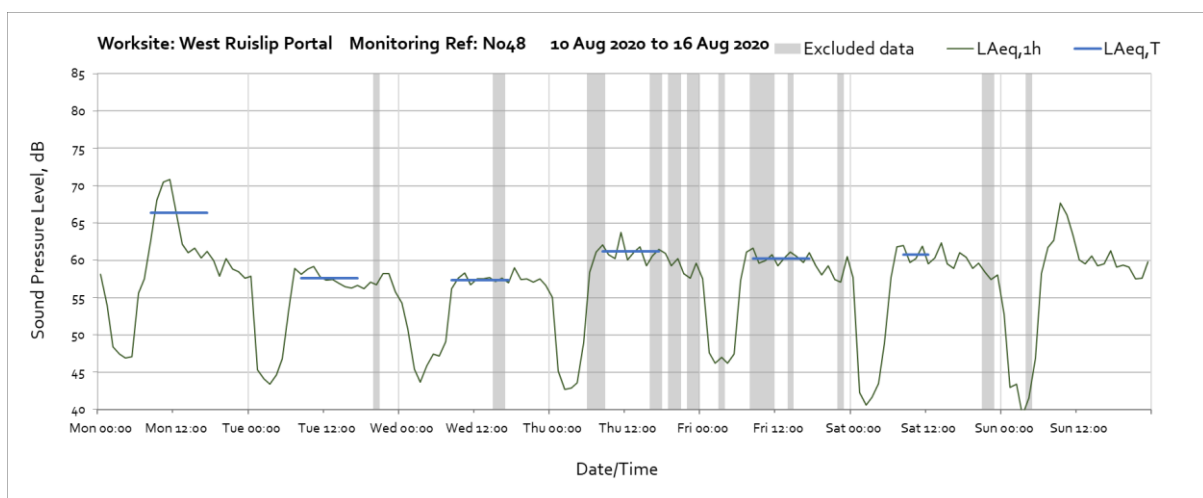
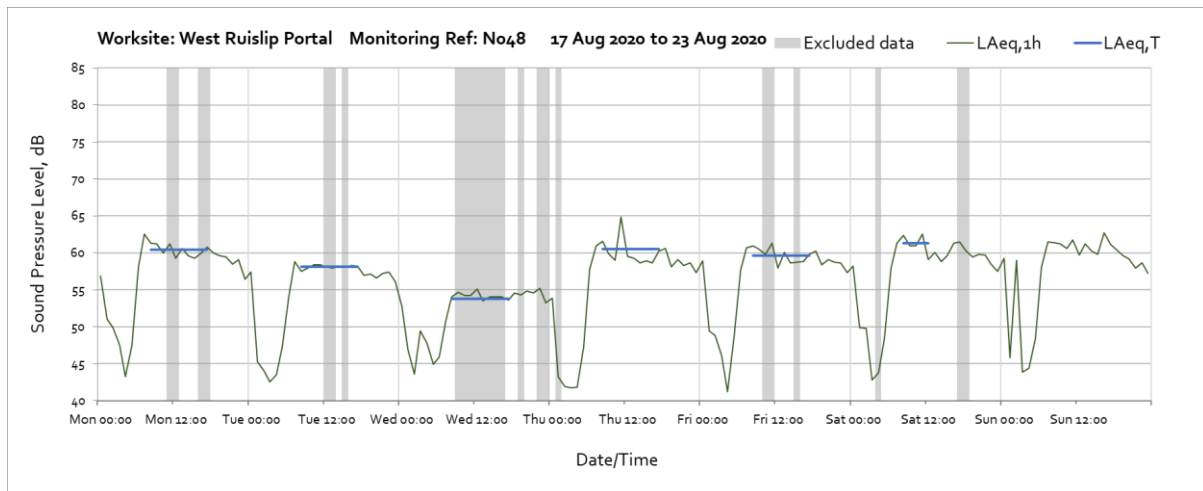
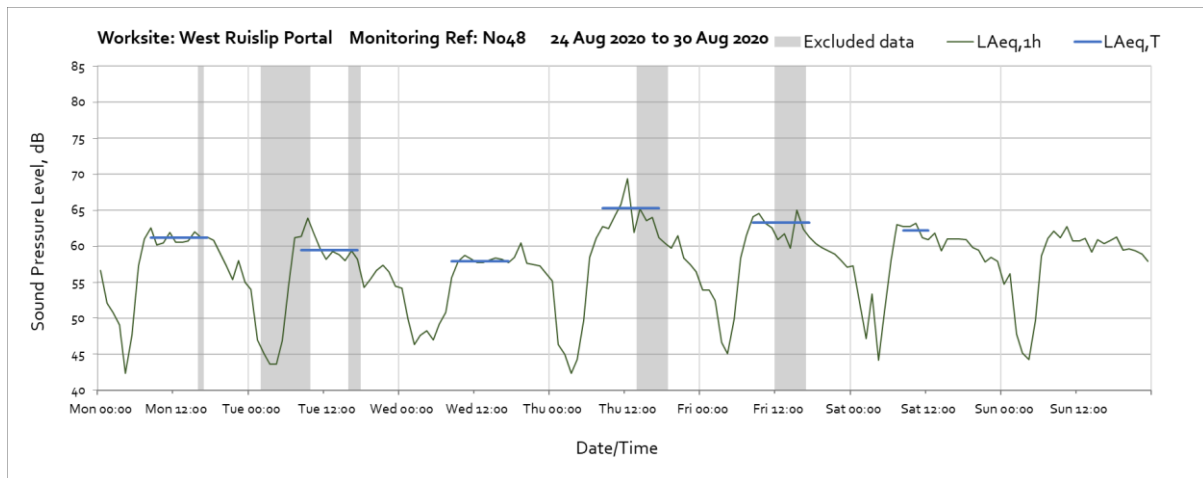
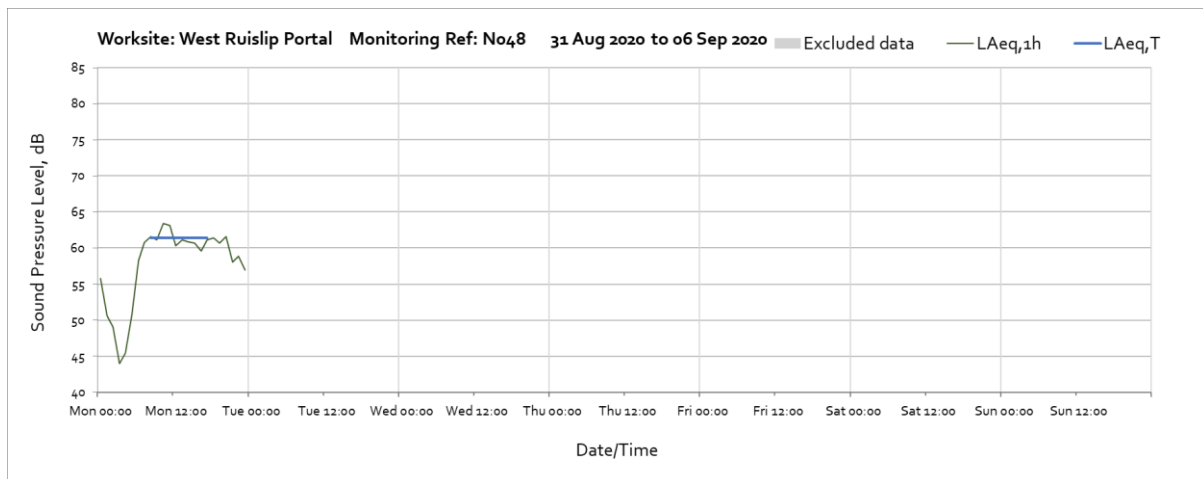
## Worksite: West Ruislip Portal – Monitoring Ref: N048

Note: Missing data between 13:00 on Thursday 6<sup>th</sup> August and 18:00 on Thursday 6<sup>th</sup> August was due to routine maintenance of the monitoring station.
