Construction noise and vibration Monthly Report – August 2020

North Warwickshire Borough Council

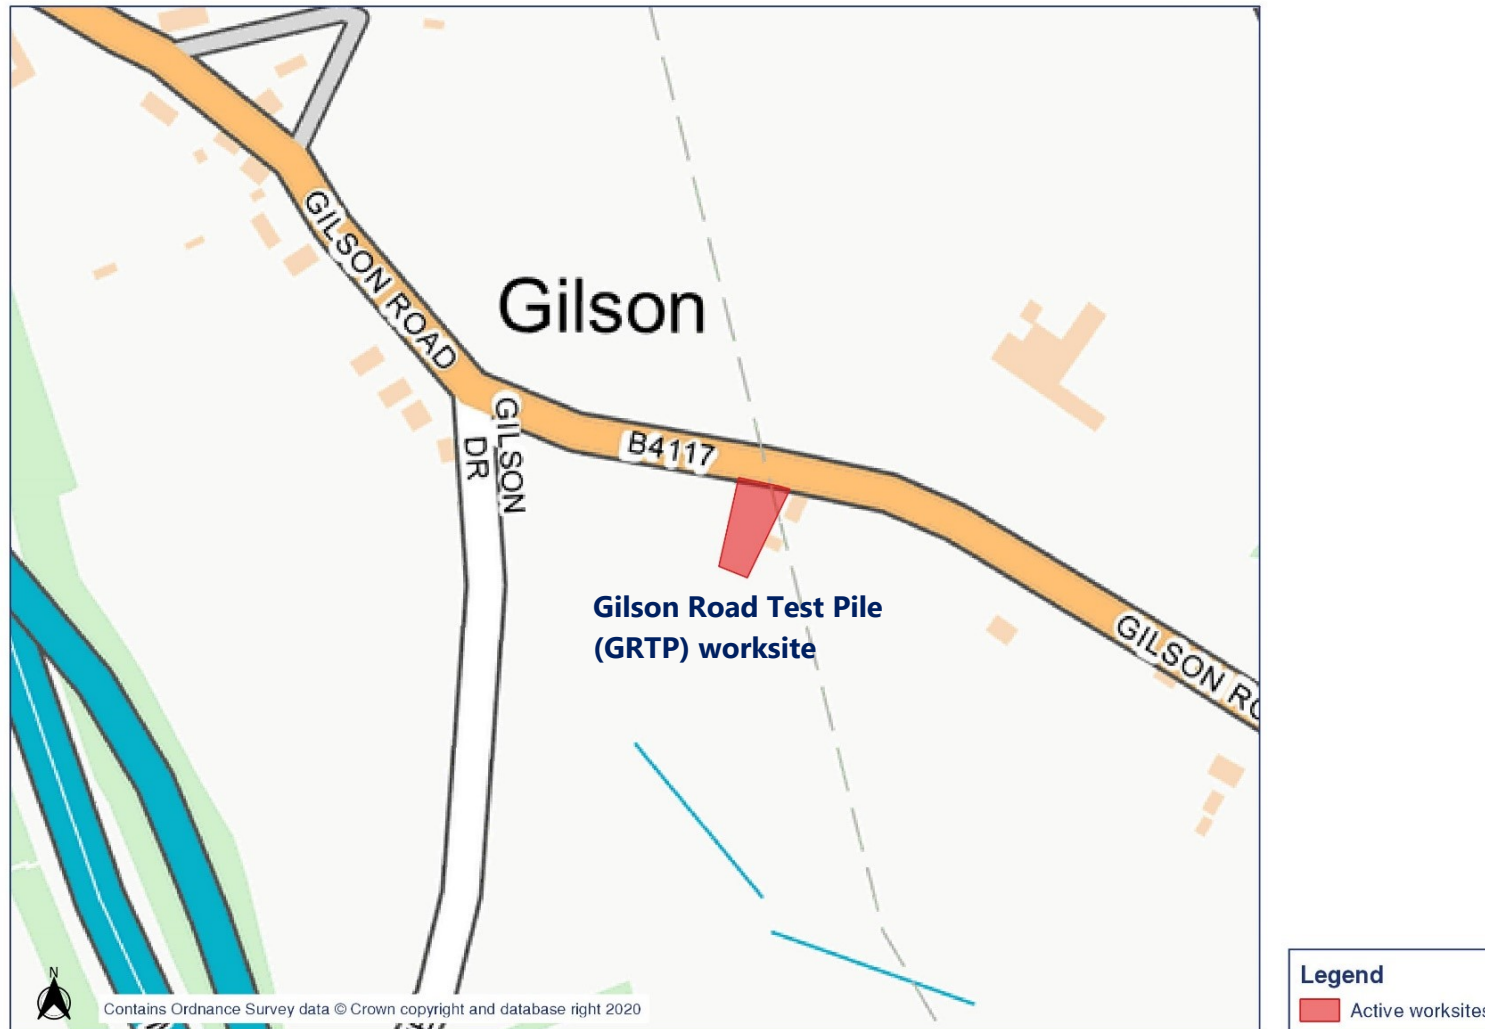
Appendix A Site Locations

- Test Gilson Road Test Pile Worksite , ref. GRTP (see plan 1 in Appendix A), where work activities included:
 - The mobilisation of piling equipment;
 - The start of constructing the test piles.

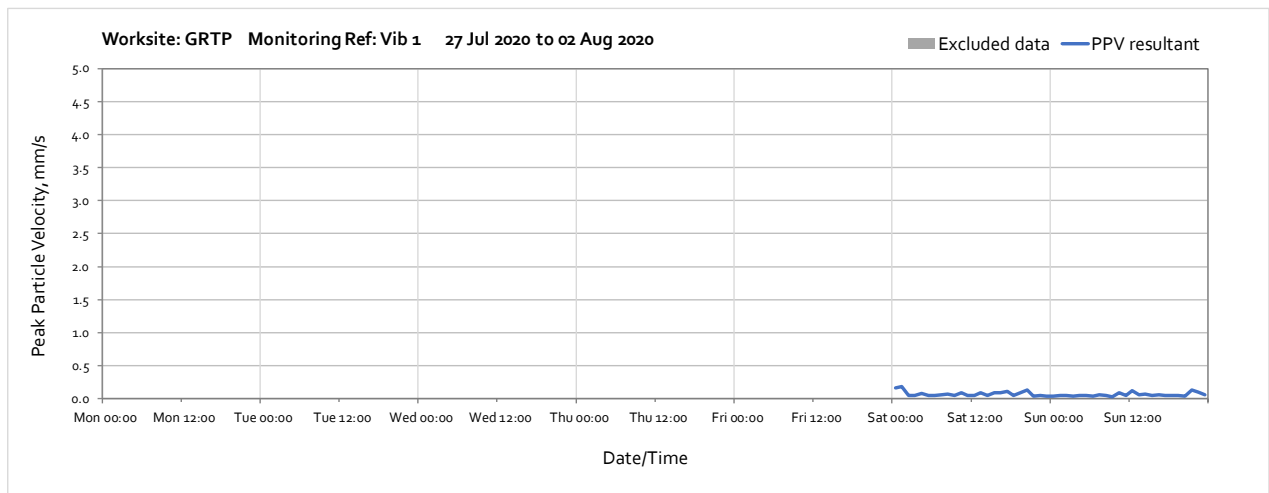
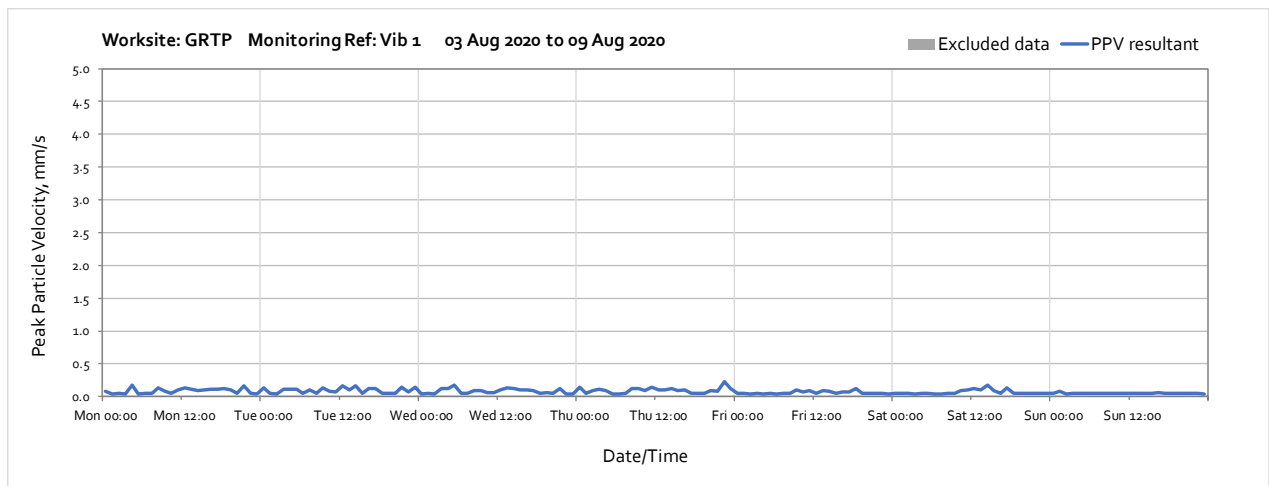
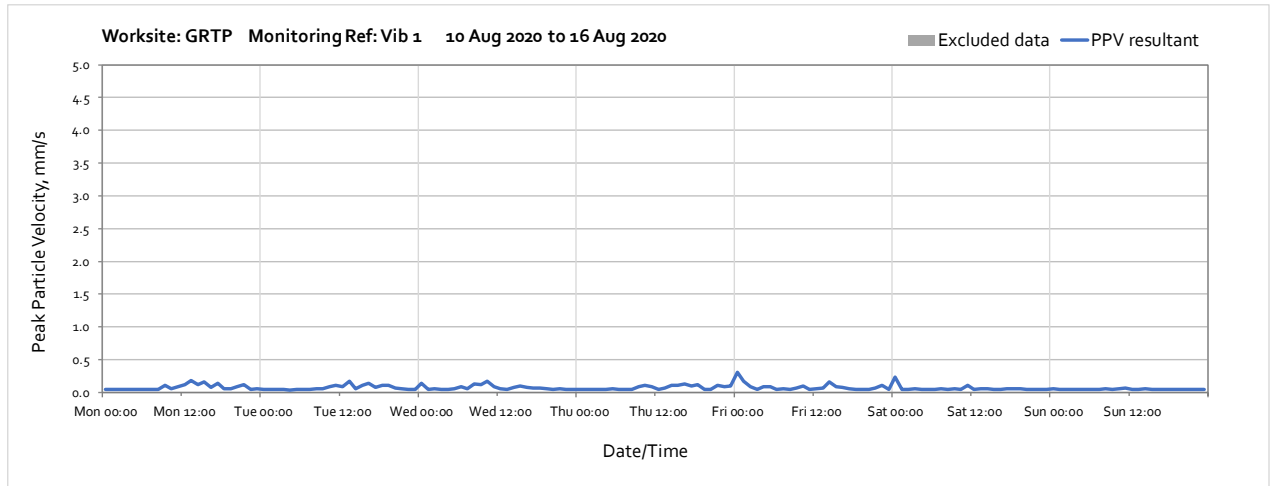
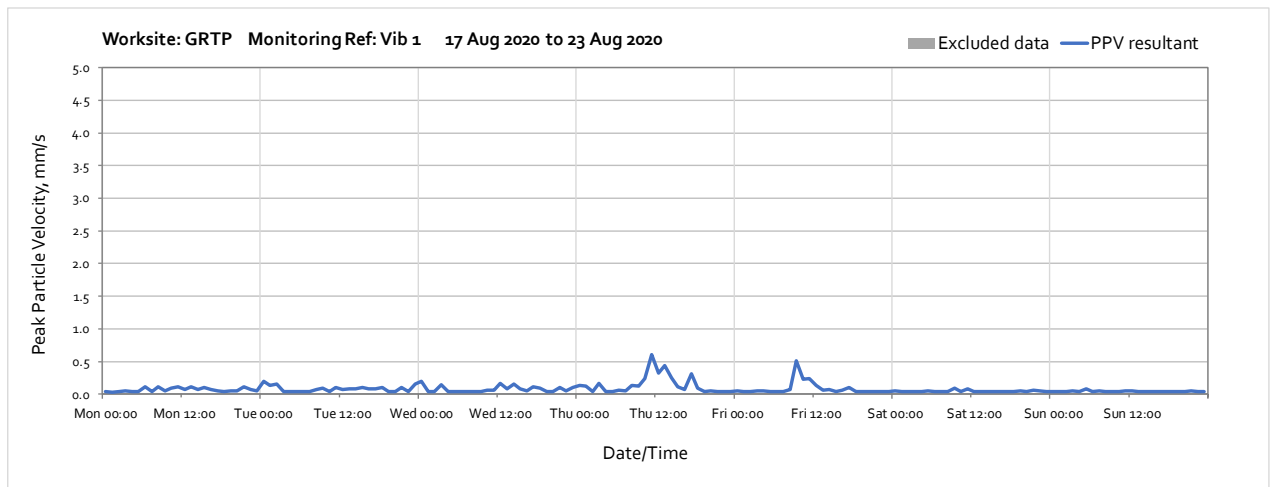
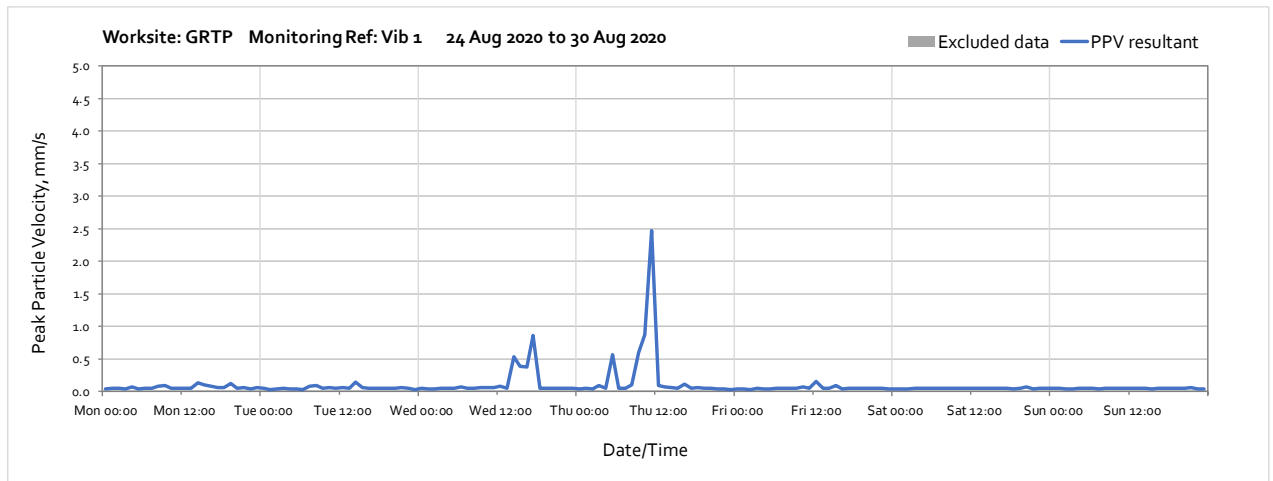
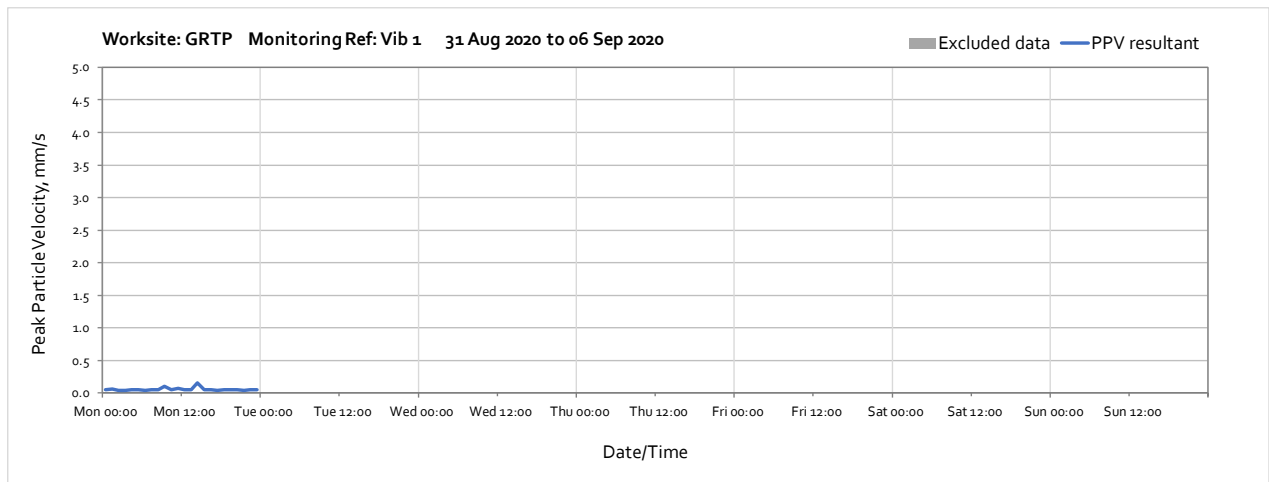
Worksite: Gilson Road Test Pile (GRTP) – Monitoring Ref: Vib 1

Worksite Reference	Measurement Reference	Site Address	Highest PPV measured in any axis, mm/s
Gilson Road Test Pile Worksite (GRTP)	Vib 1	The Cottage, Gilson Road (garage)	1.94 (Z-axis)
	Vib 2	The Cottage, Gilson Road (house)	2.38 (Z-axis)

The following graphs show the hourly measured peak particle velocity PPV recorded during the monitoring period. The graphs show the resultant PPV due to vibration components on three orthogonal axis x, y and z. Where high values of PPV were caused by local interference with the vibration monitor, which are not representative of HS2 construction works, these values have been greyed out in the following charts and have been excluded to calculate values in Table 3 of the main report.
