## **Construction noise and vibration Monthly Report – September 2020**

**London Borough of Ealing**

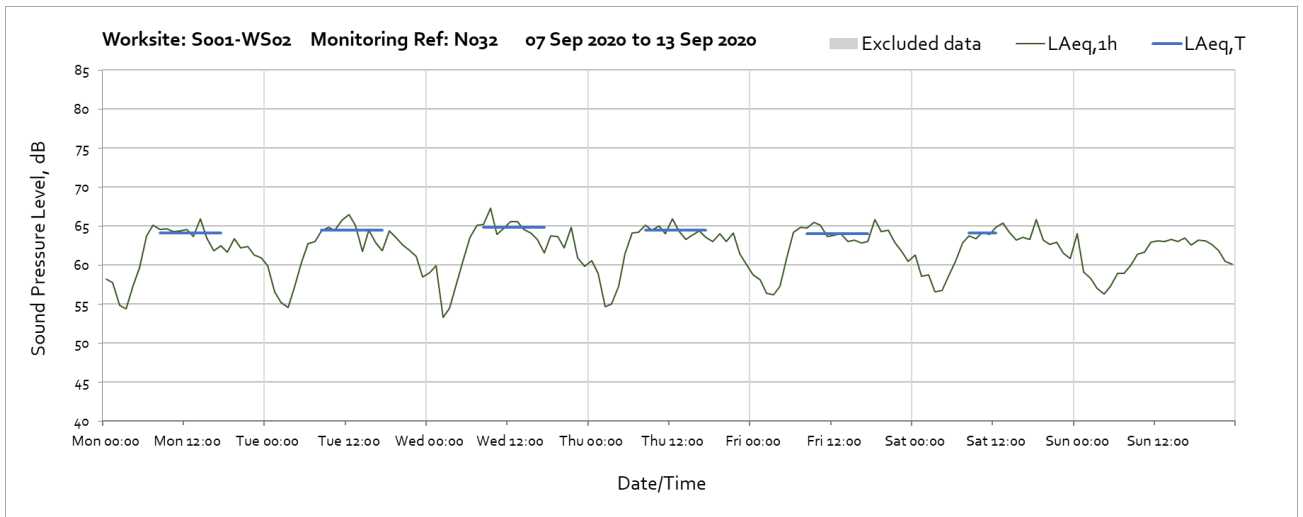
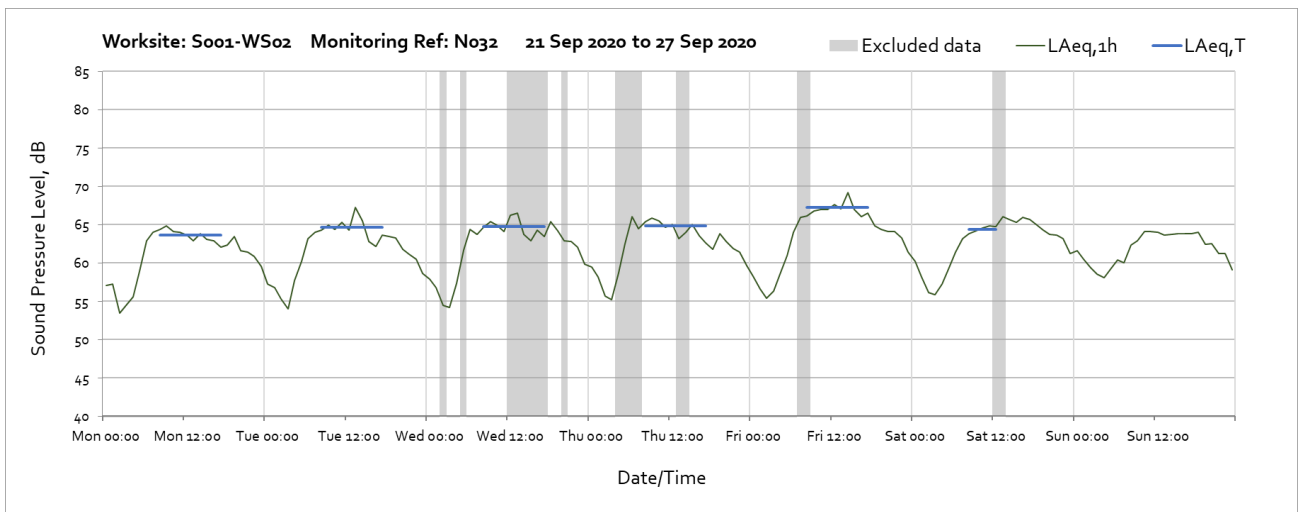
### Worksite: S001-WS02 – Monitoring Ref: N032

The following graphs show the hourly measured ambient noise level  $L_{Aeq,1h}$  and, where relevant, the averaged noise level  $L_{Aeq,T}$  values, where the time period T is as specified in Table 1 of HS2 Information Paper E23. Periods with adversely weather affected noise levels are greyed out and have been excluded from the calculation of the  $L_{Aeq,T}$  values in Table 3 of the main report.

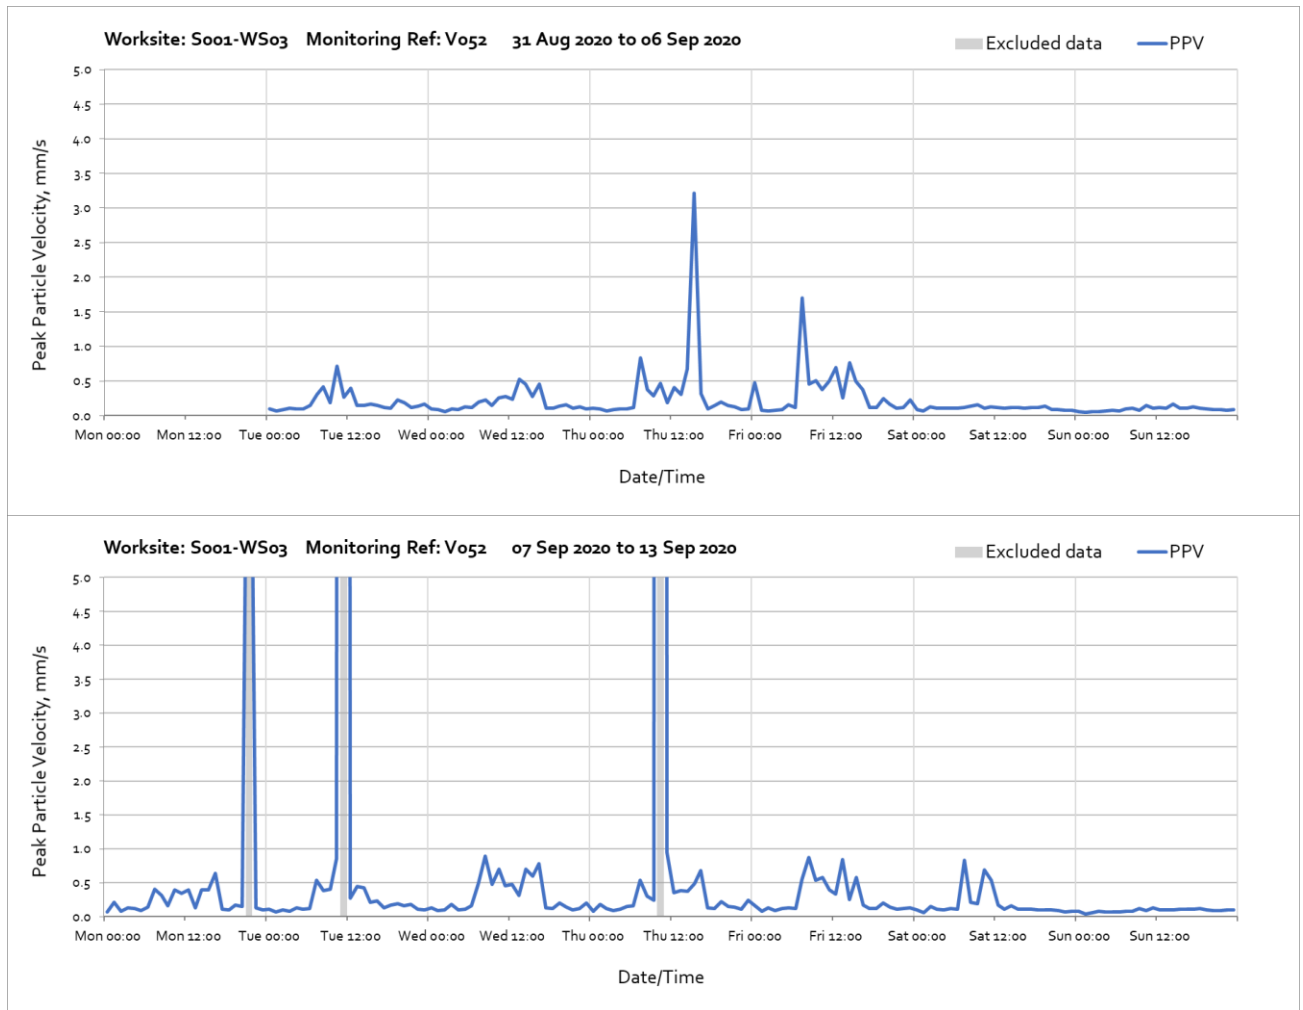
### Worksite: S001-WS03 – Monitoring Ref: V052

The following graphs show the hourly measured peak particle velocity PPV recorded during the monitoring period. The graphs show the resultant PPV due to vibration components on three orthogonal axis x, y and z. Where high values of PPV were caused by local interference with the vibration monitor, which are not representative of HS2 construction works, these values have been greyed out in the following charts and have been excluded to calculate values in Table 4 of the main report.

Note: High vibration levels measured between 21:00 and 22:00 on Monday 7<sup>th</sup>, between 11:00 and 12:00 on Tuesday 8<sup>th</sup>, between 10:00 and 11:00 on Thursday 9<sup>th</sup> were due to disturbance of the monitor.

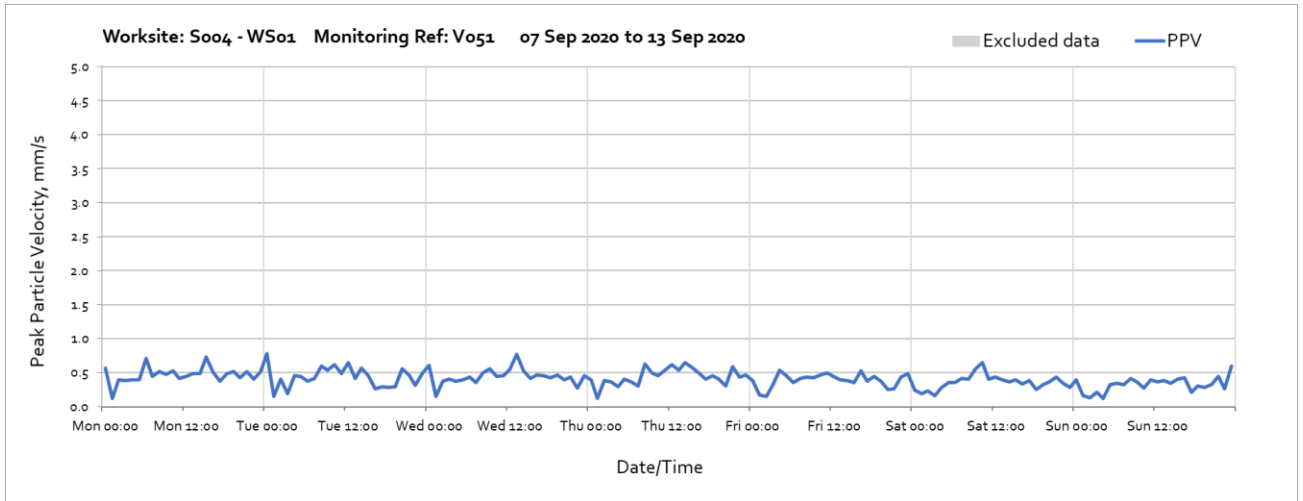
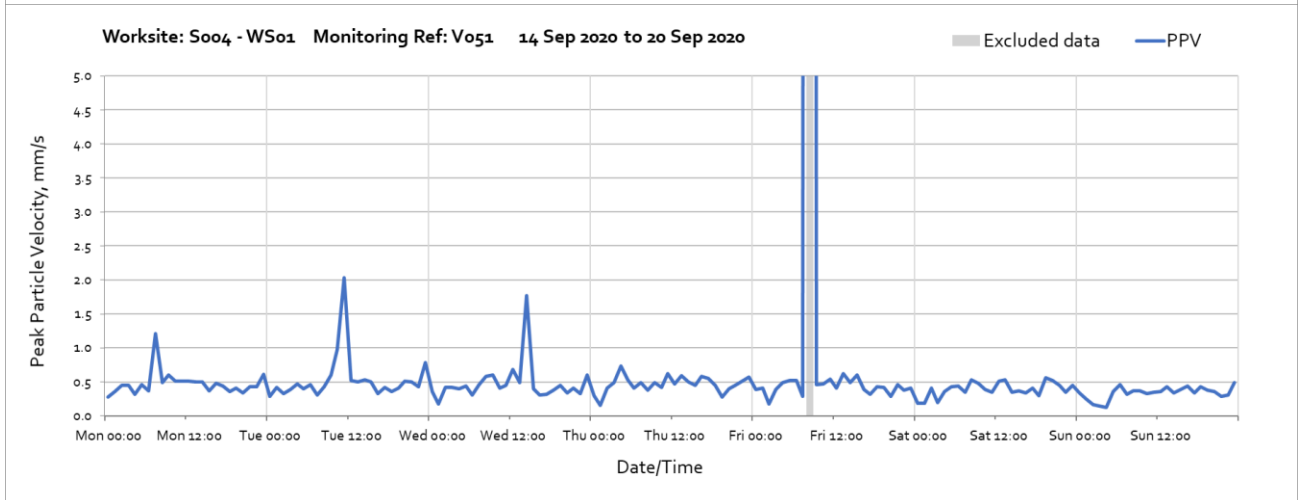
**Worksite: S004-WSo1 – Monitoring Ref: V051**

Note: High vibration levels measured between 08:00 and 09:00 on Friday 18<sup>th</sup> September were due to disturbance of the monitor.

Note: High vibration levels measured between 11:00 and 11:00 and between 13:00 and 14:00 on Wednesday 23<sup>rd</sup> September were due to disturbance of the monitor.

Note: High vibration levels measured between 14:00 and 15:00 on Tuesday 29<sup>th</sup> September were due to disturbance of the monitor.
