# Sewage-related contaminants in Isles of Scilly groundwater: concentrations, spatial distribution, sources and risk

Project ENVRESW001361

September 2016

Part 2 of 4

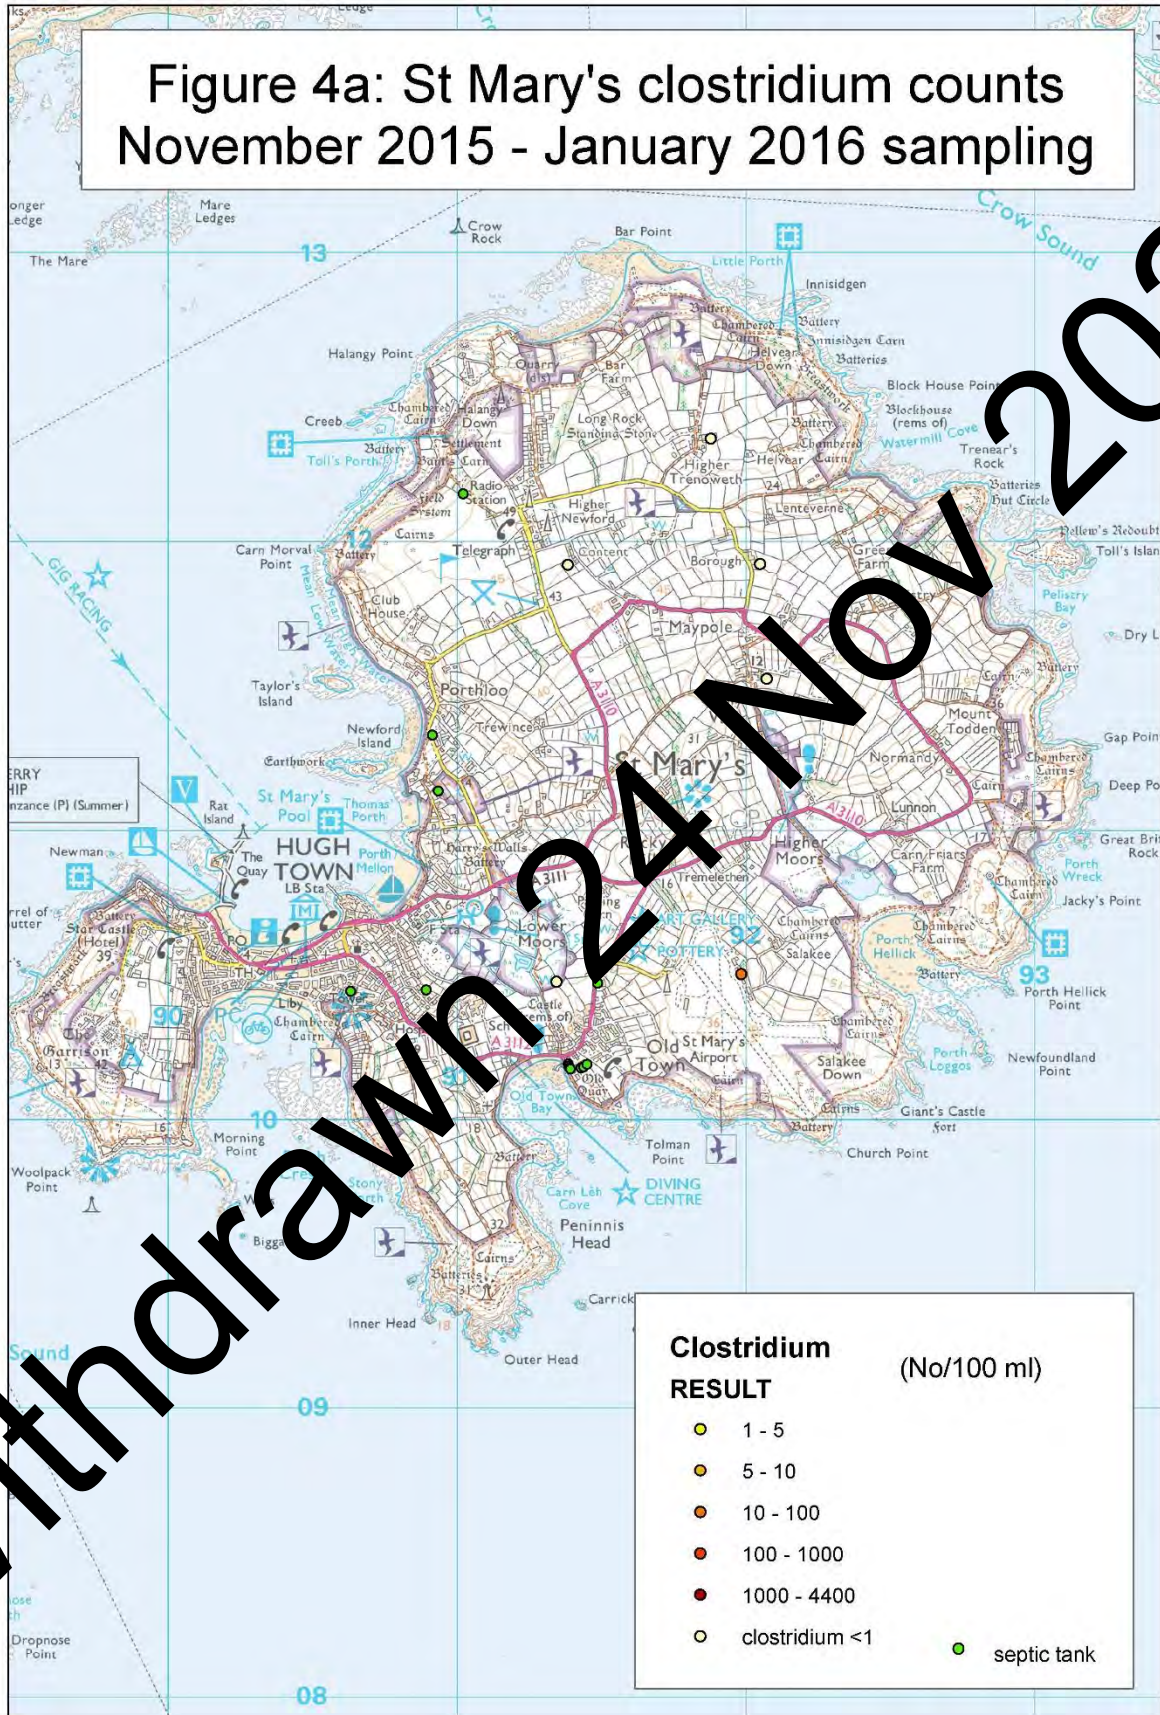
Figure 4a: St Mary's clostridium counts  
November 2015 - January 2016 sampling

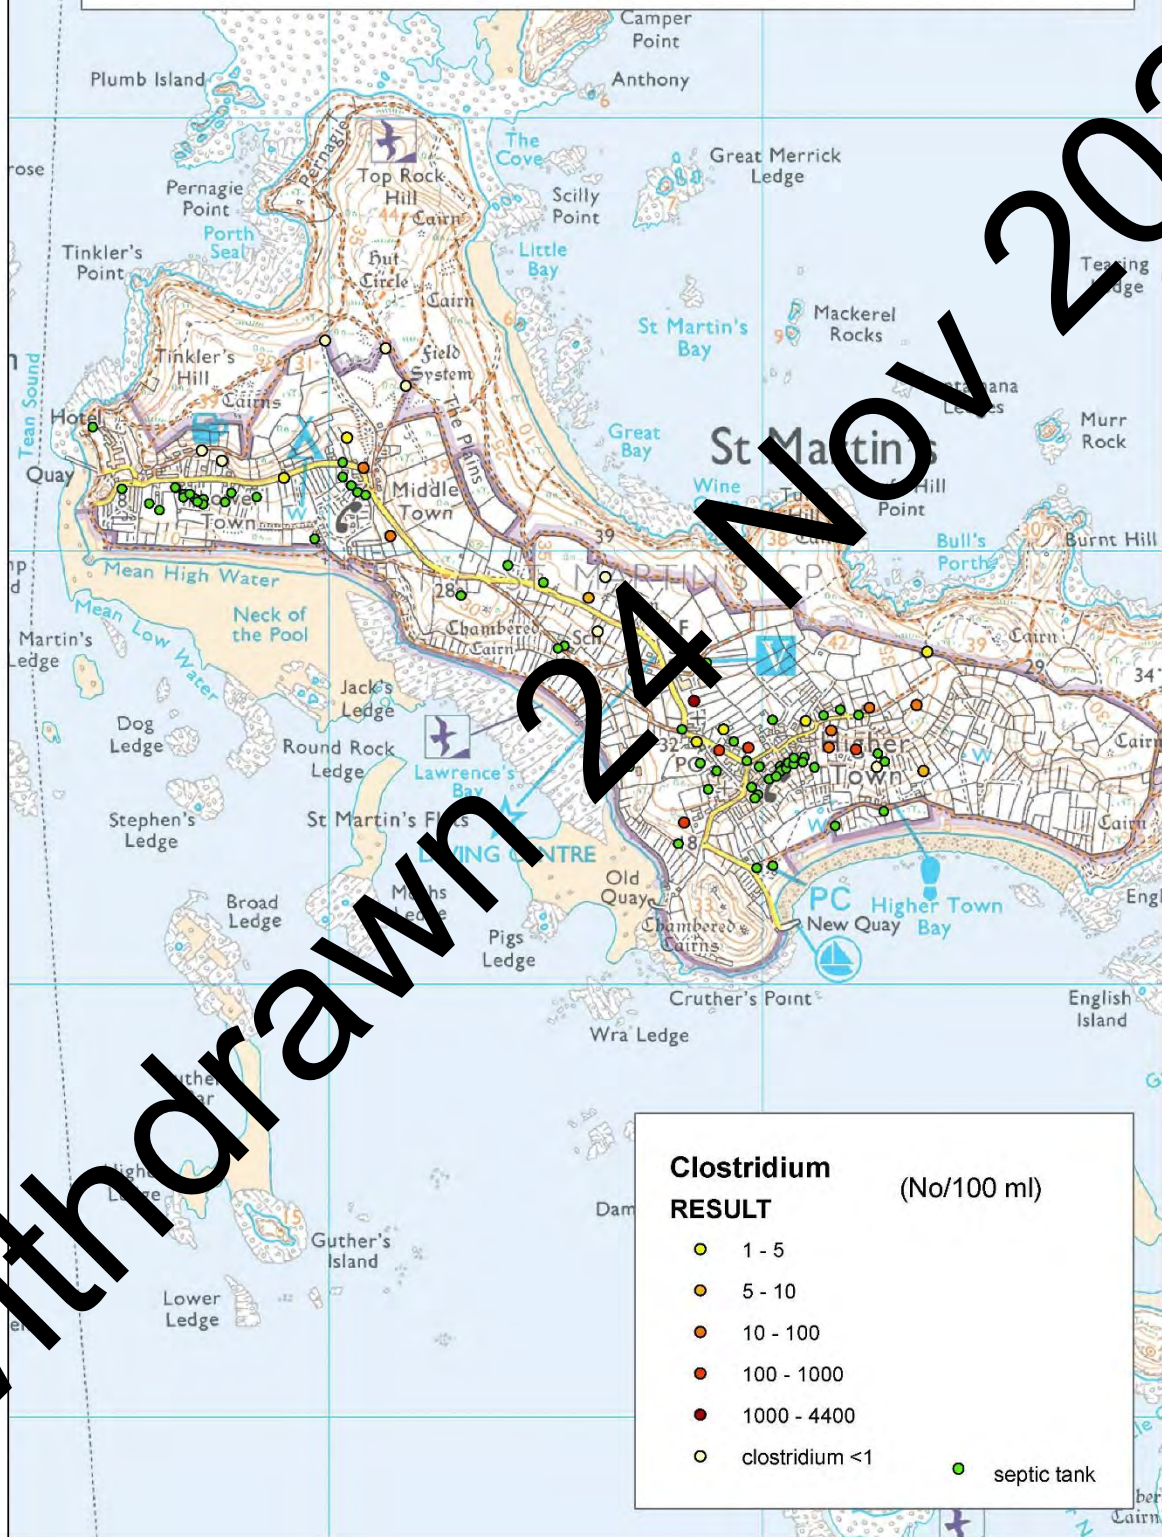
Figure 4b: St Martin's clostridium counts  
November 2015 - January 2016 sampling

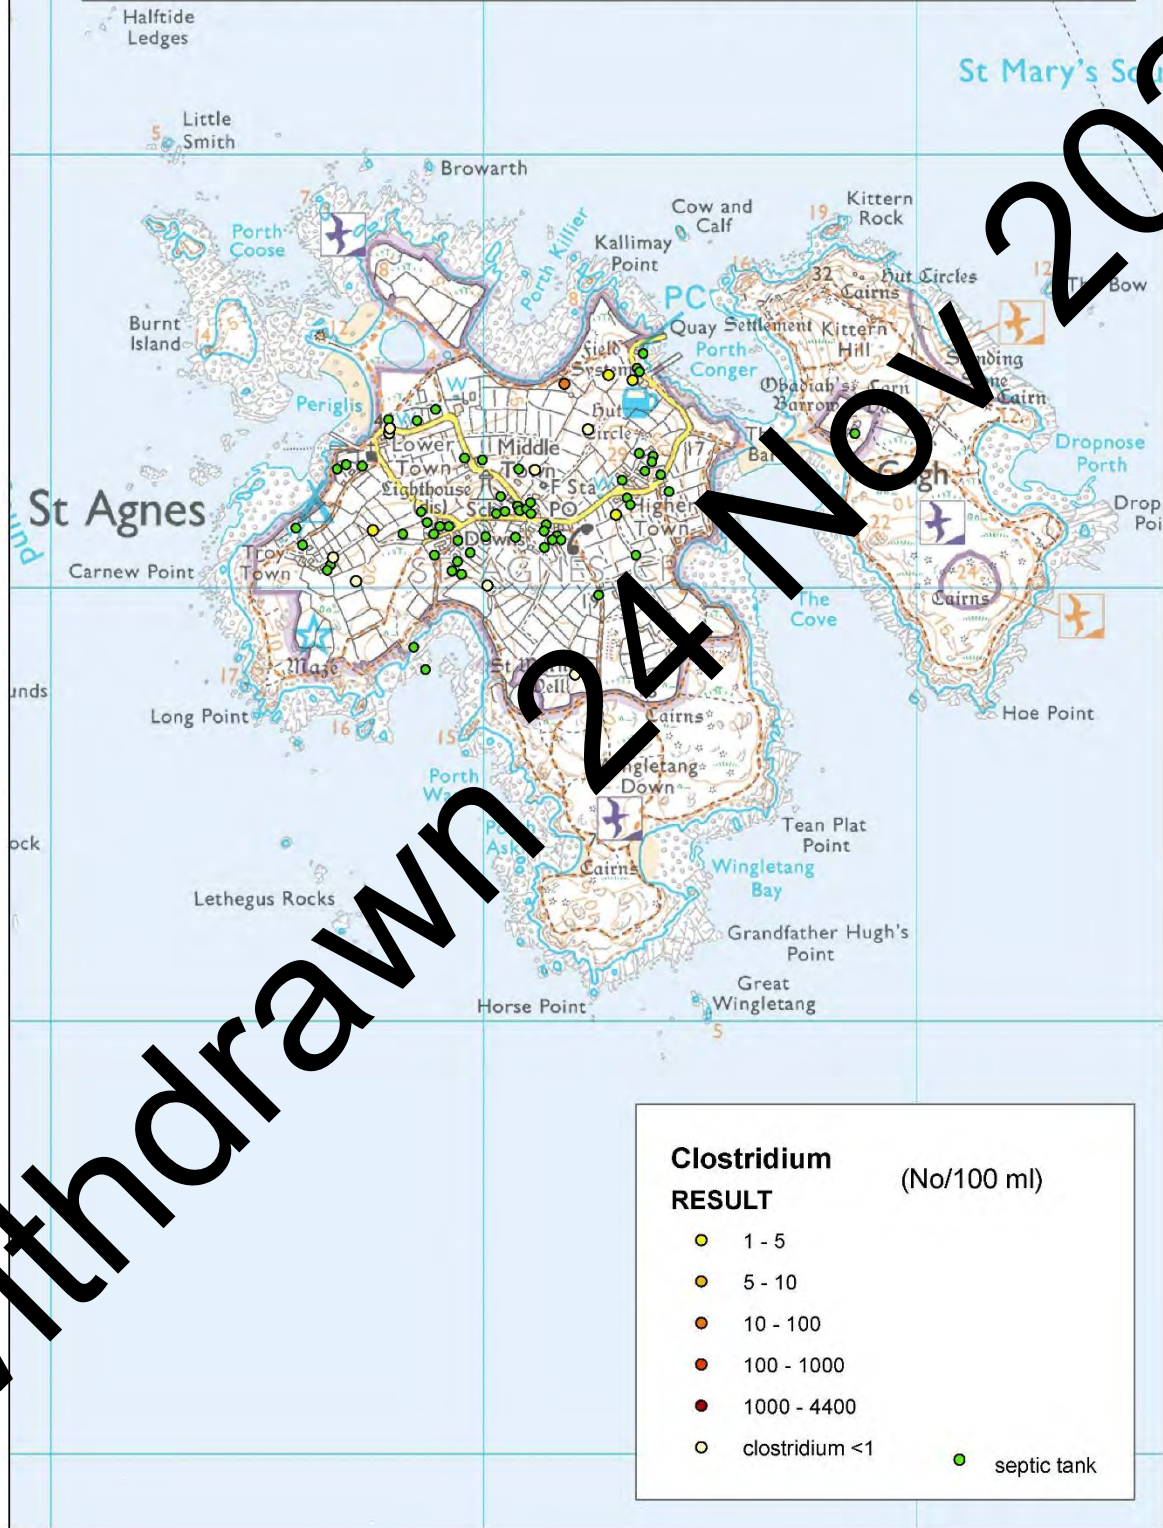
Figure 4c: St Agnes clostridium counts  
November 2015 - January 2016 sampling

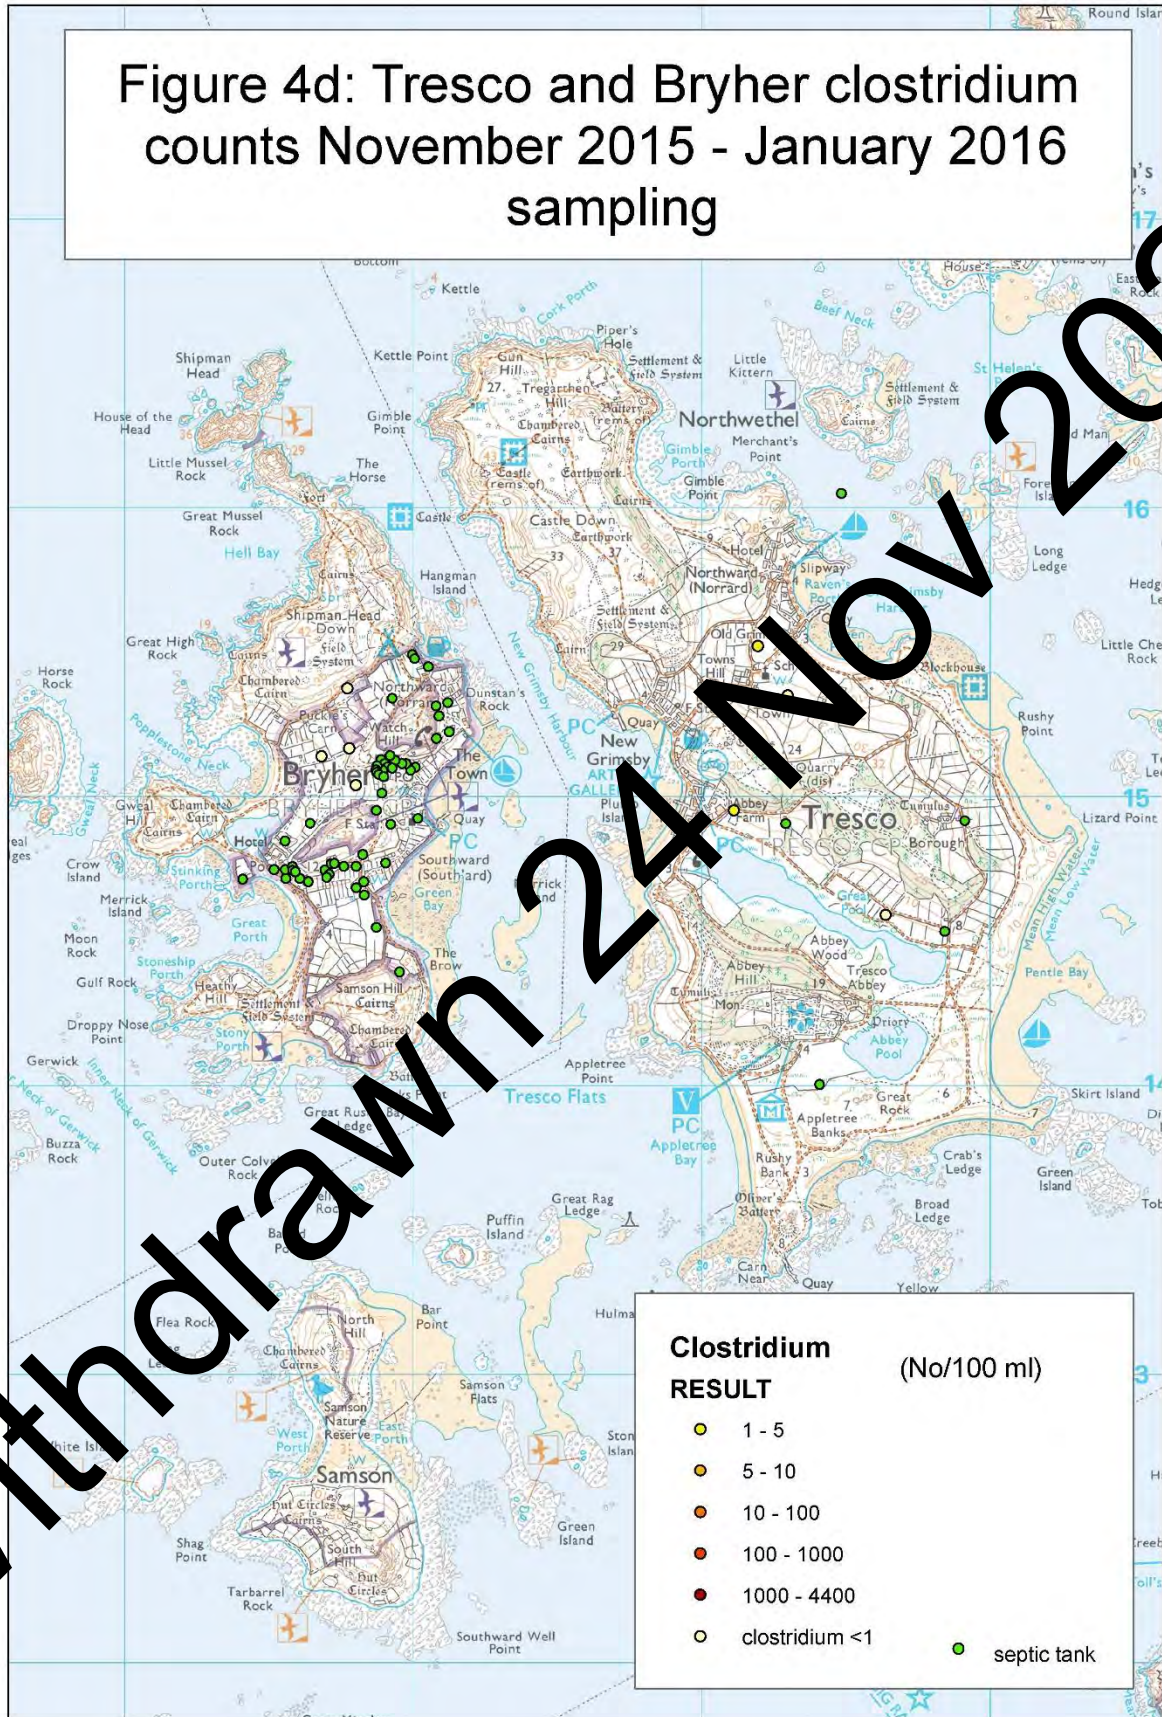
Figure 4d: Tresco and Bryher clostridium counts November 2015 - January 2016 sampling

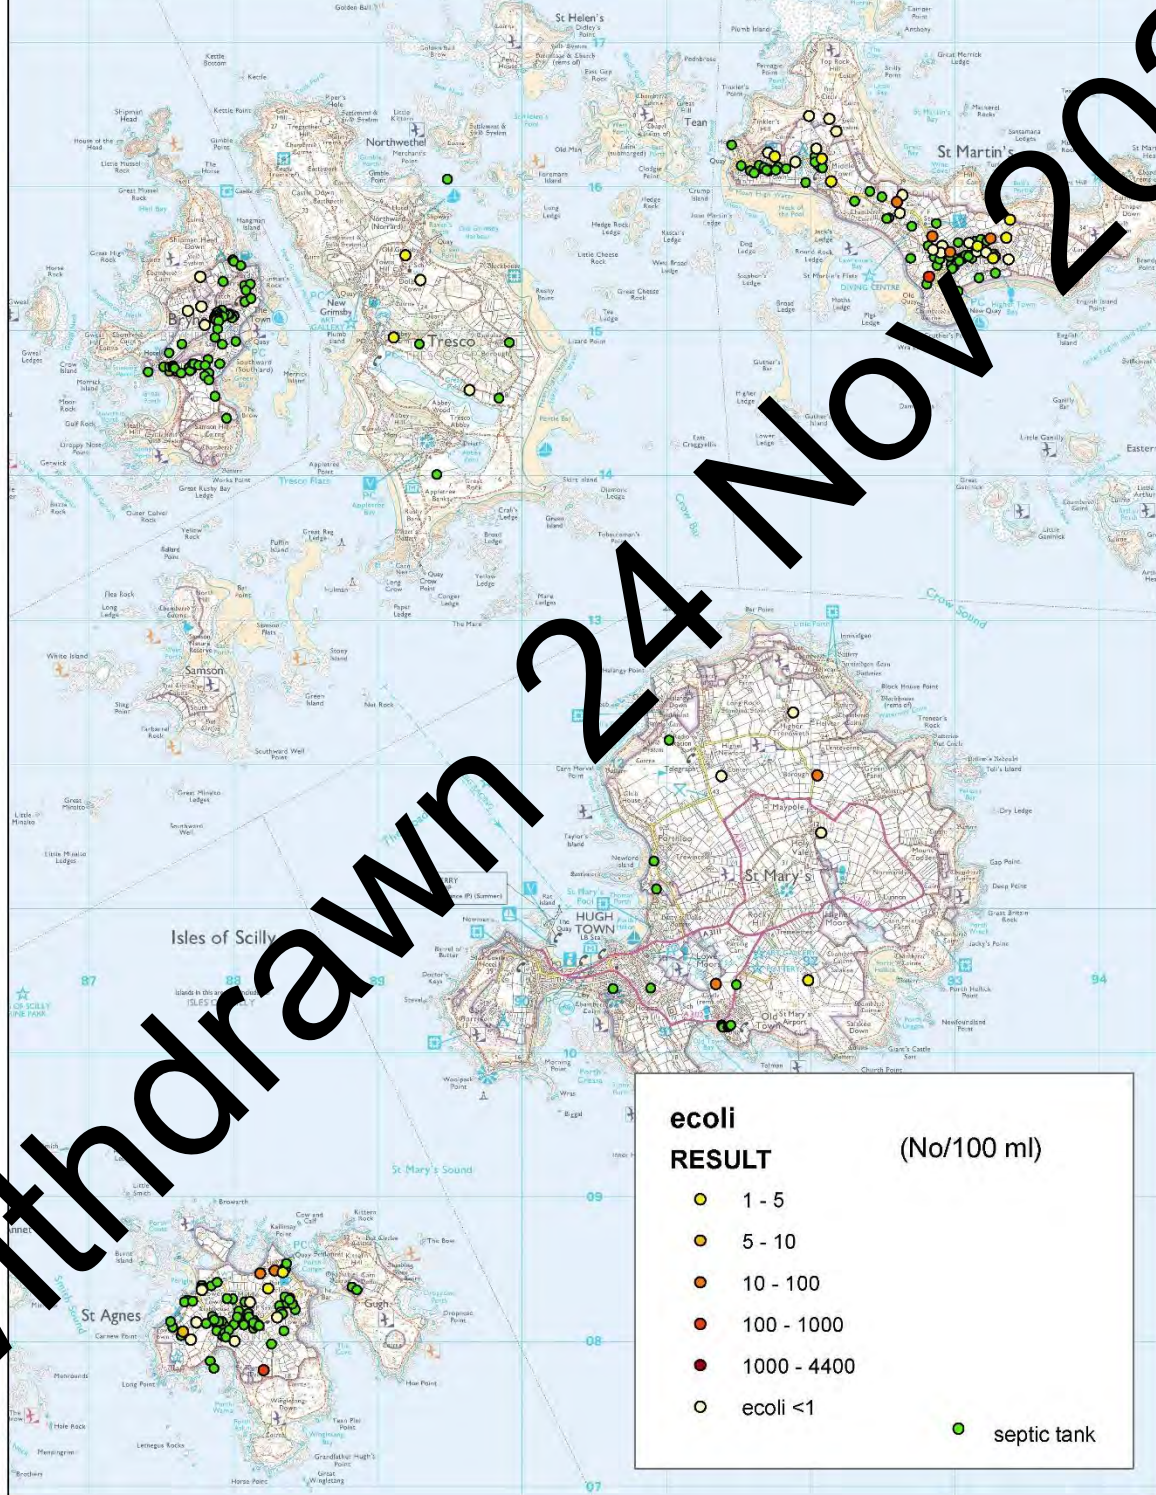
Figure 5: Isles of Scilly e-coli counts  
November 2015 - January 2016 sampling

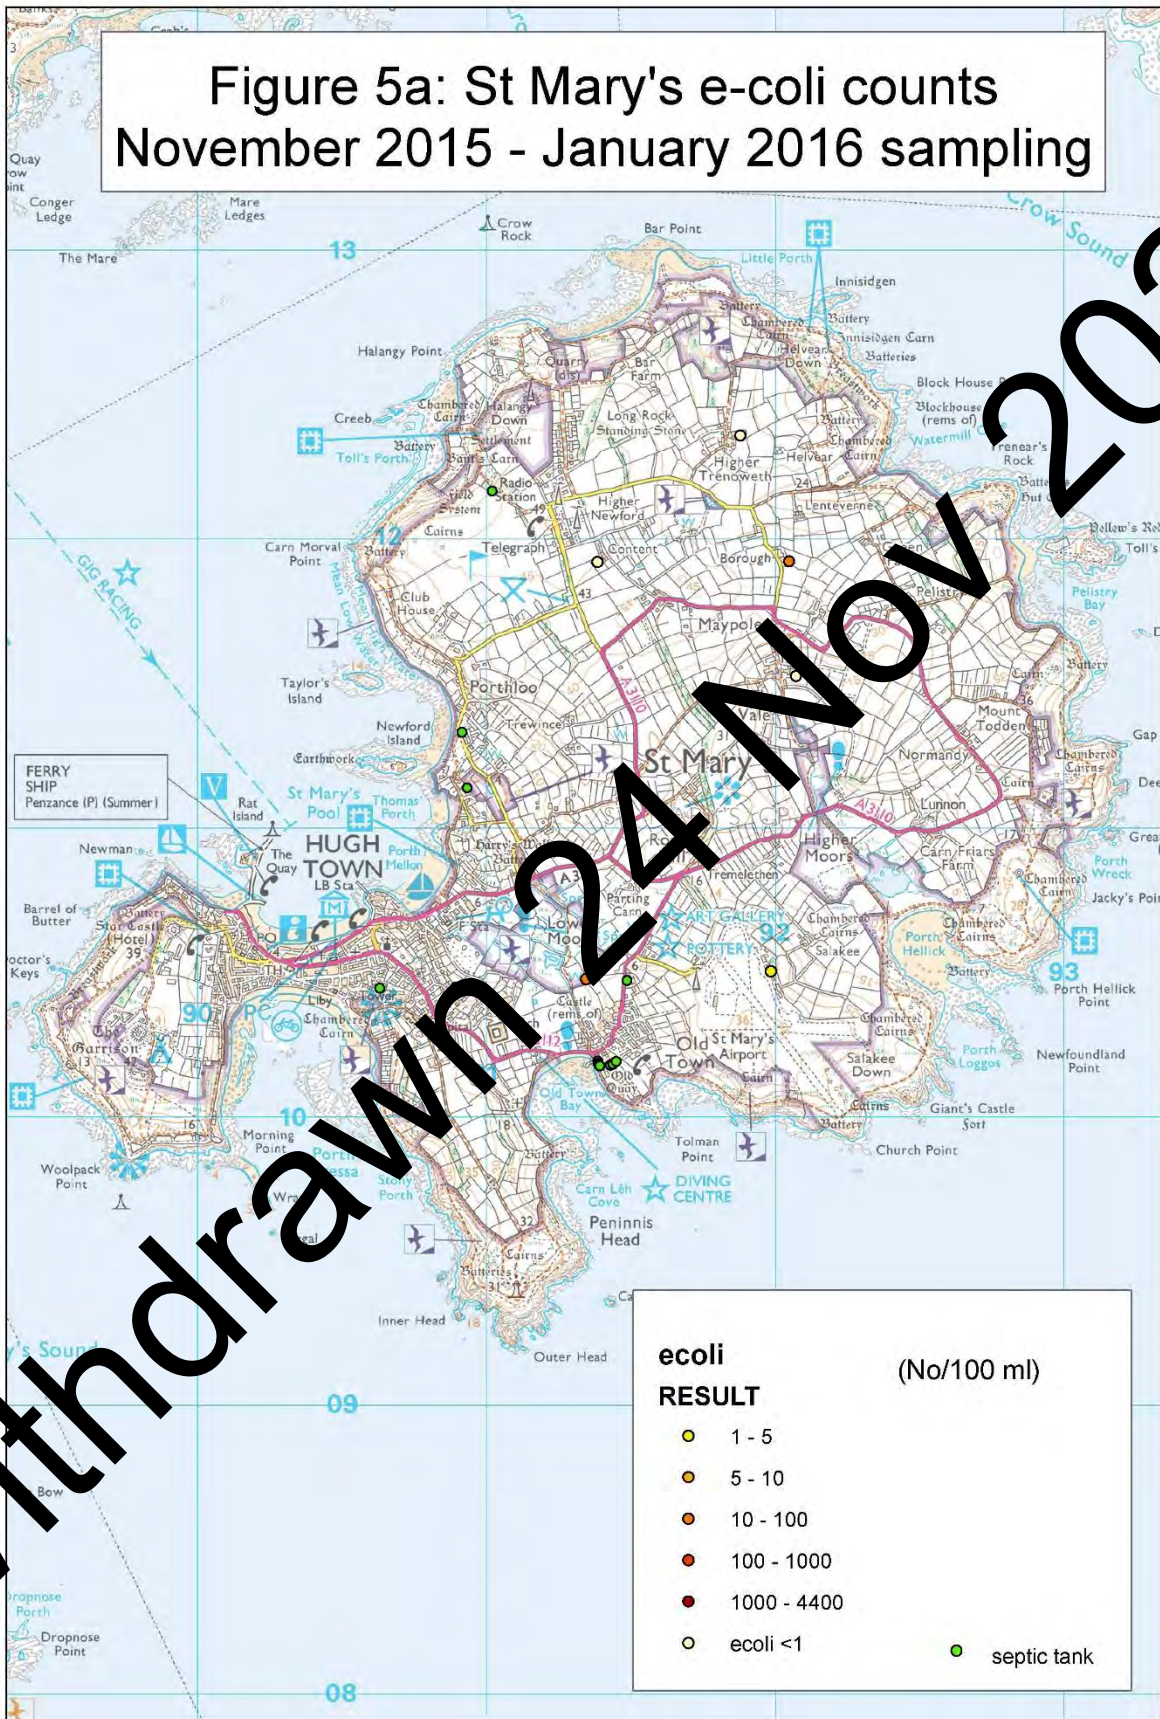
Figure 5a: St Mary's e-coli counts  
November 2015 - January 2016 sampling

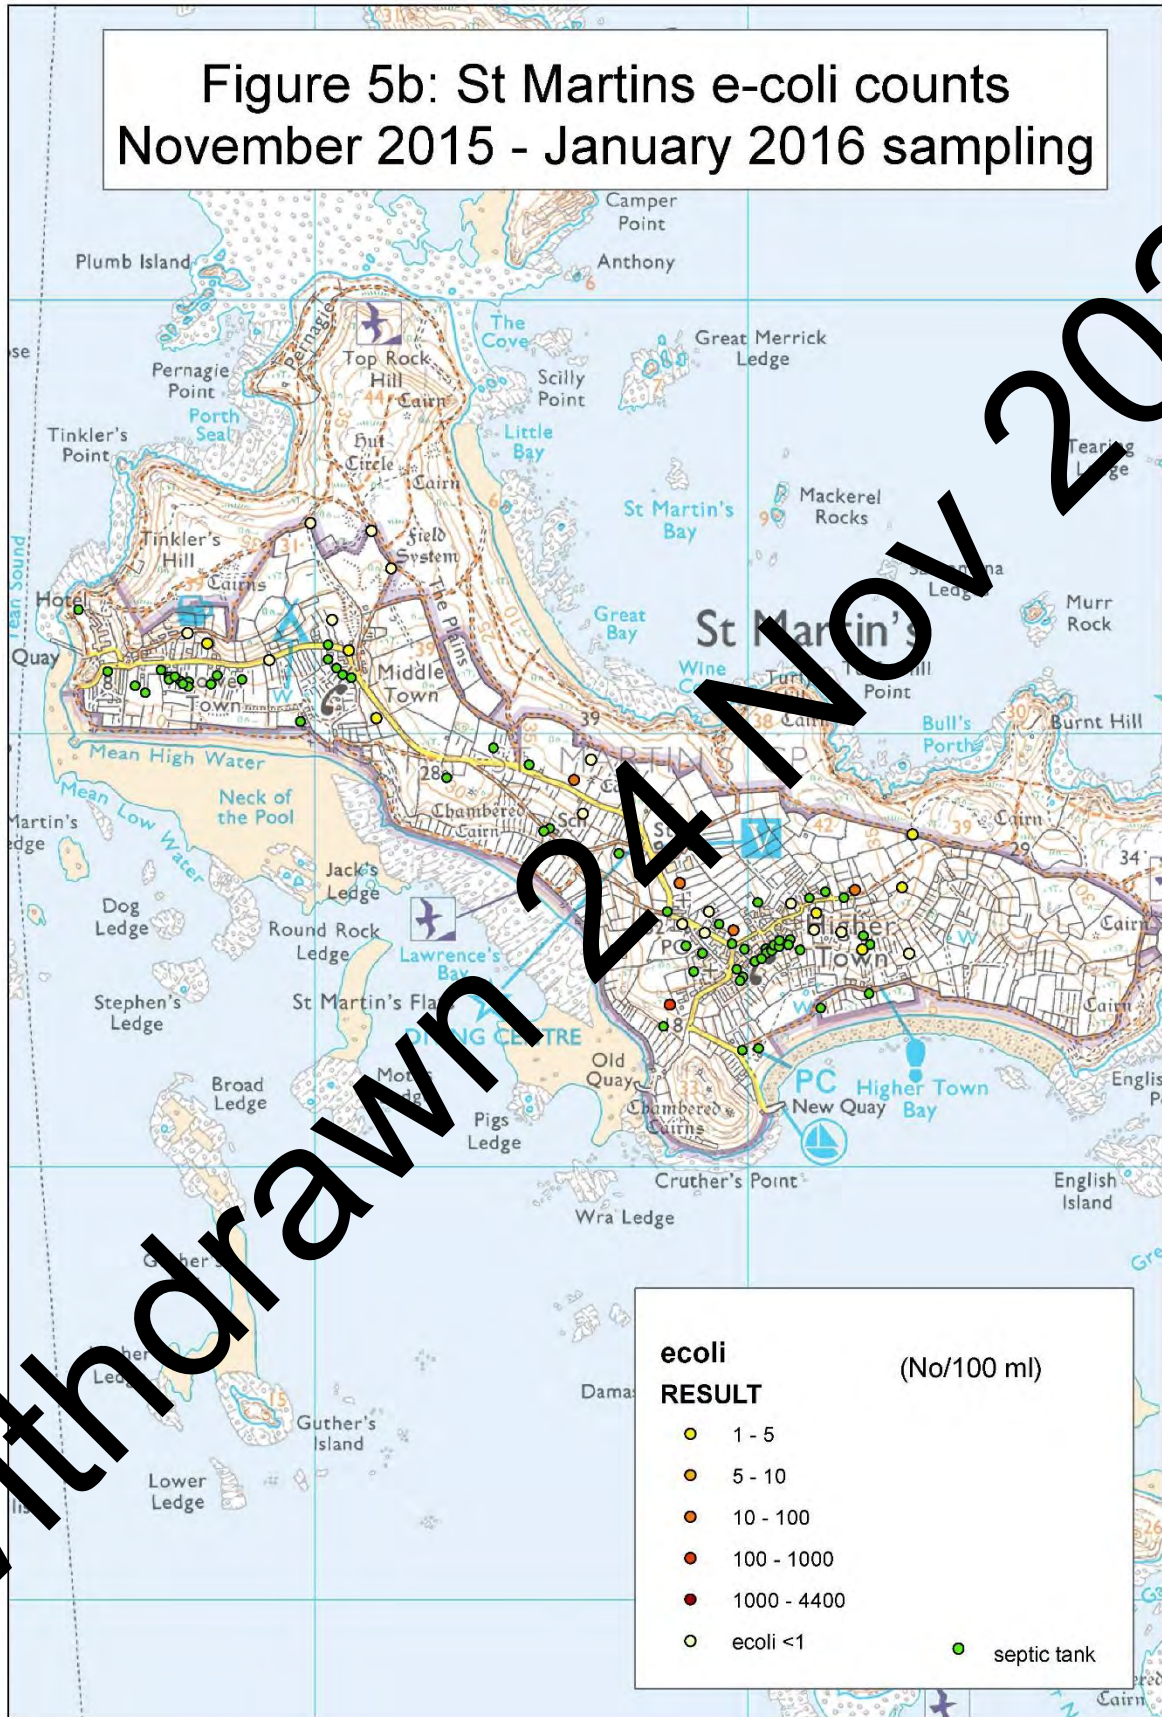
Figure 5b: St Martins e-coli counts  
November 2015 - January 2016 sampling

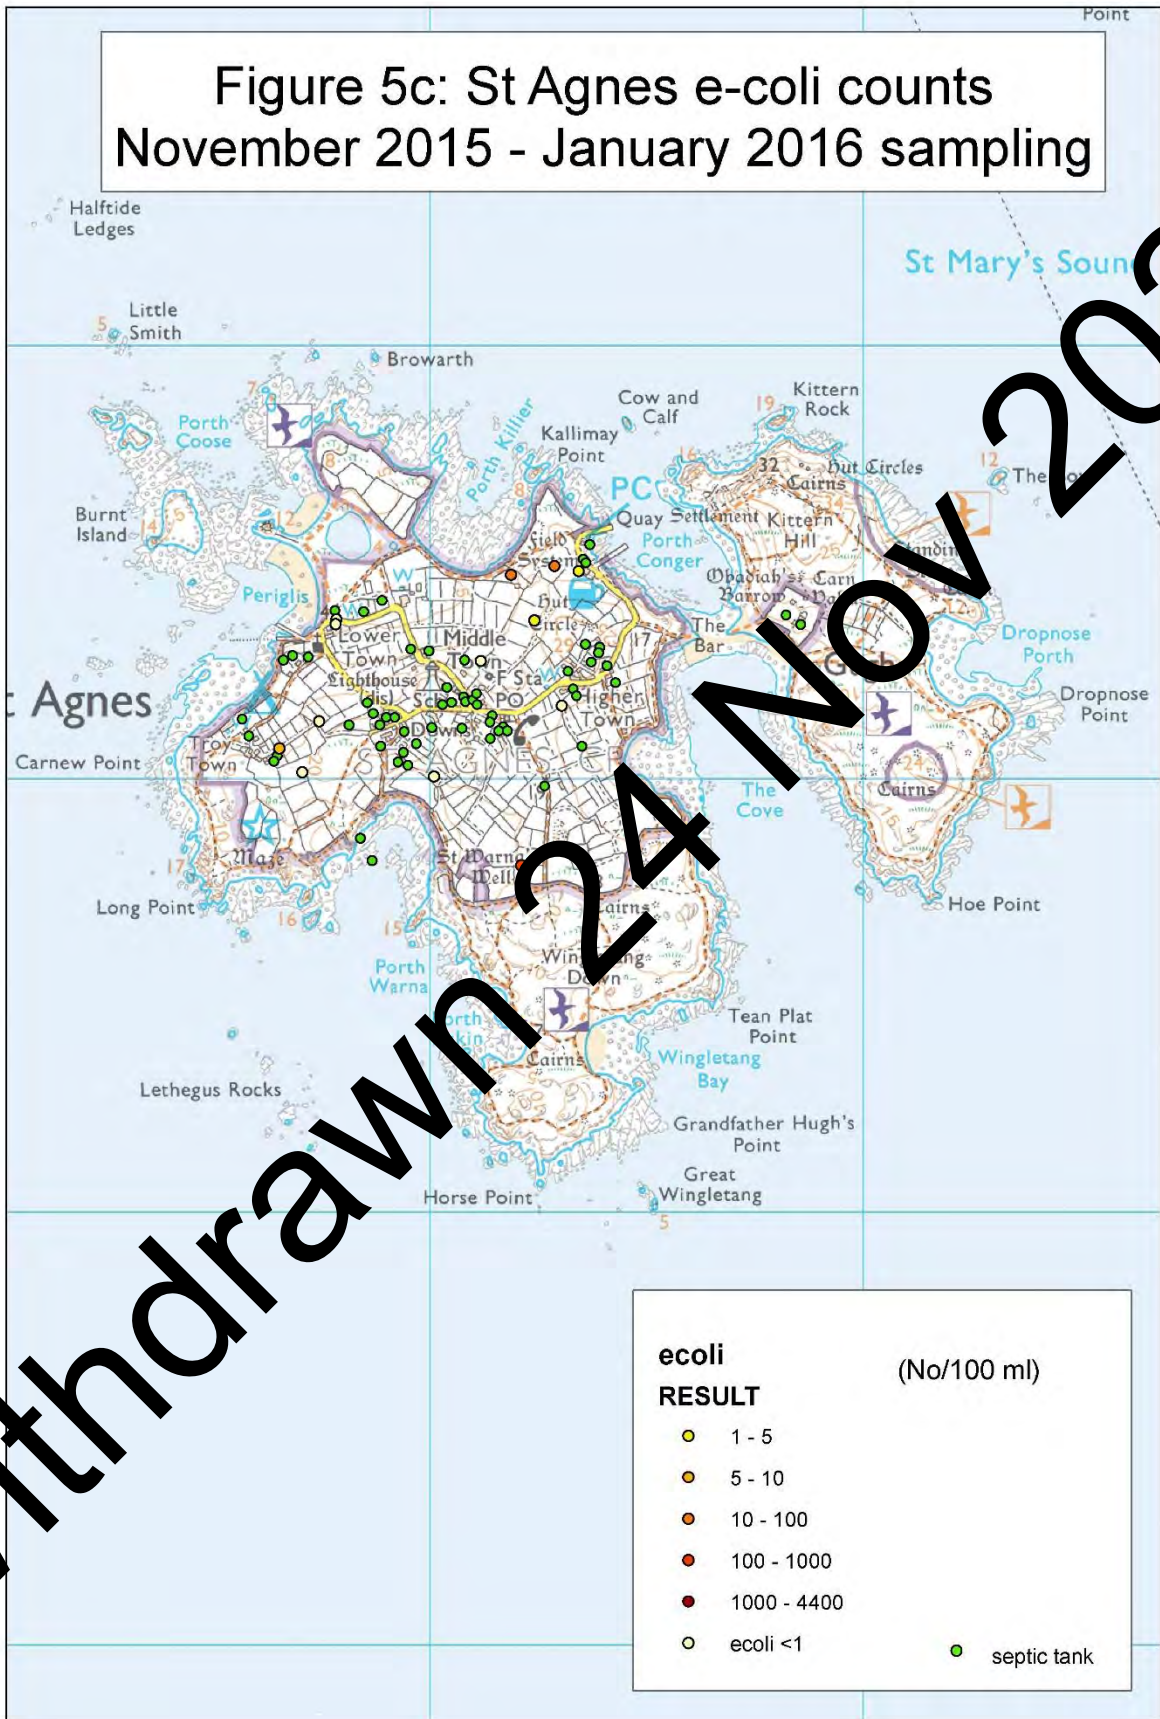
Figure 5c: St Agnes e-coli counts  
November 2015 - January 2016 sampling

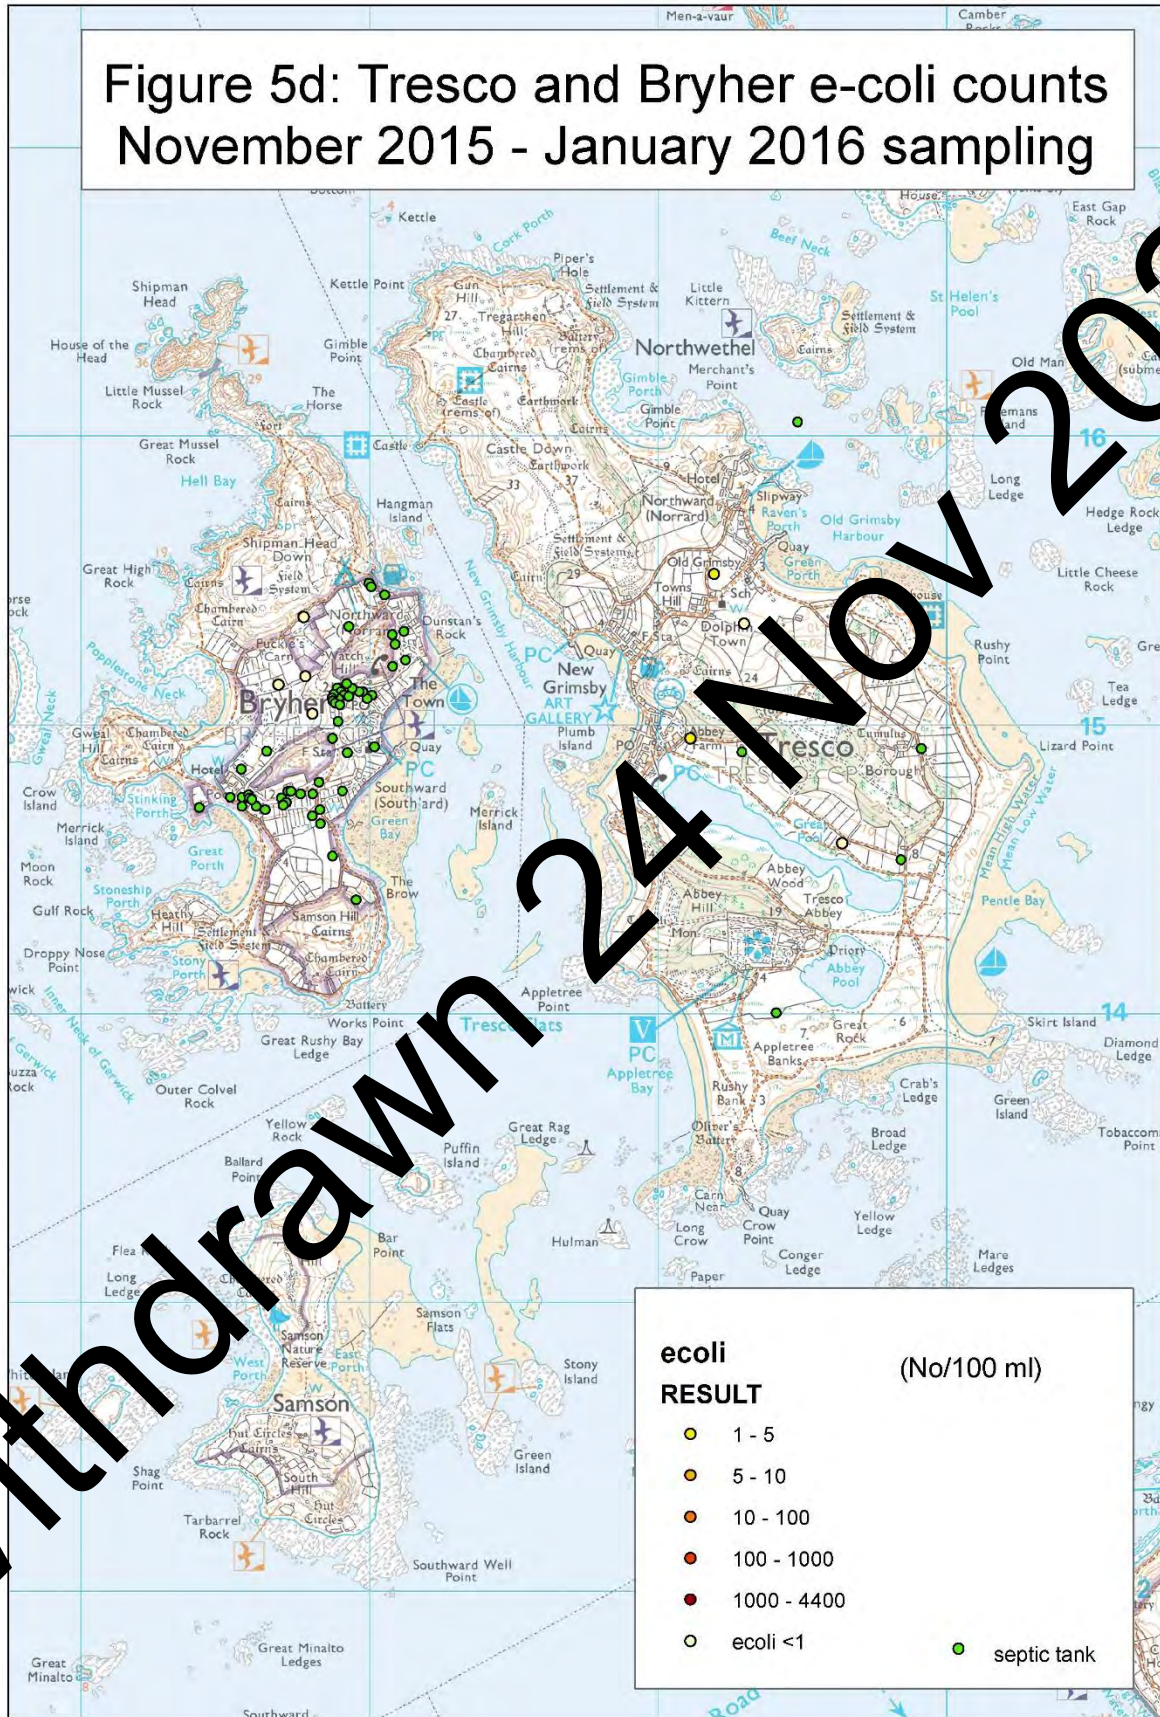
Figure 5d: Tresco and Bryher e-coli counts  
November 2015 - January 2016 sampling

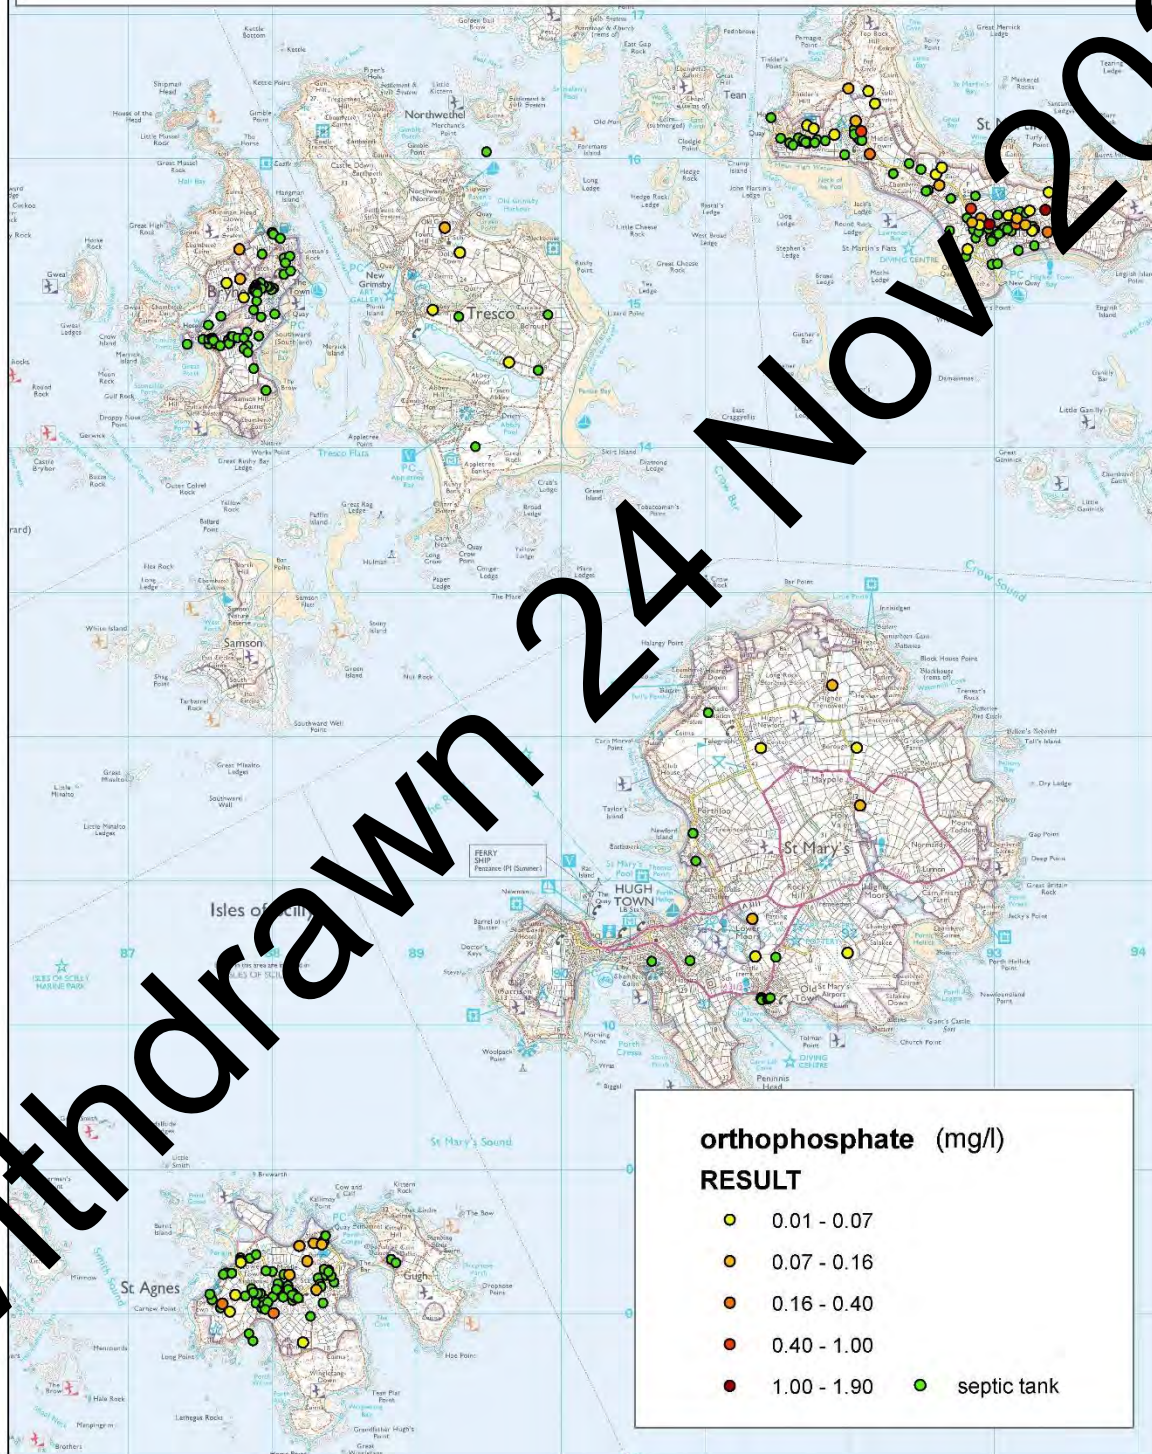
Figure 6: Isles of Scilly orthophosphate concentrations. November 2015 - January 2016 sampling

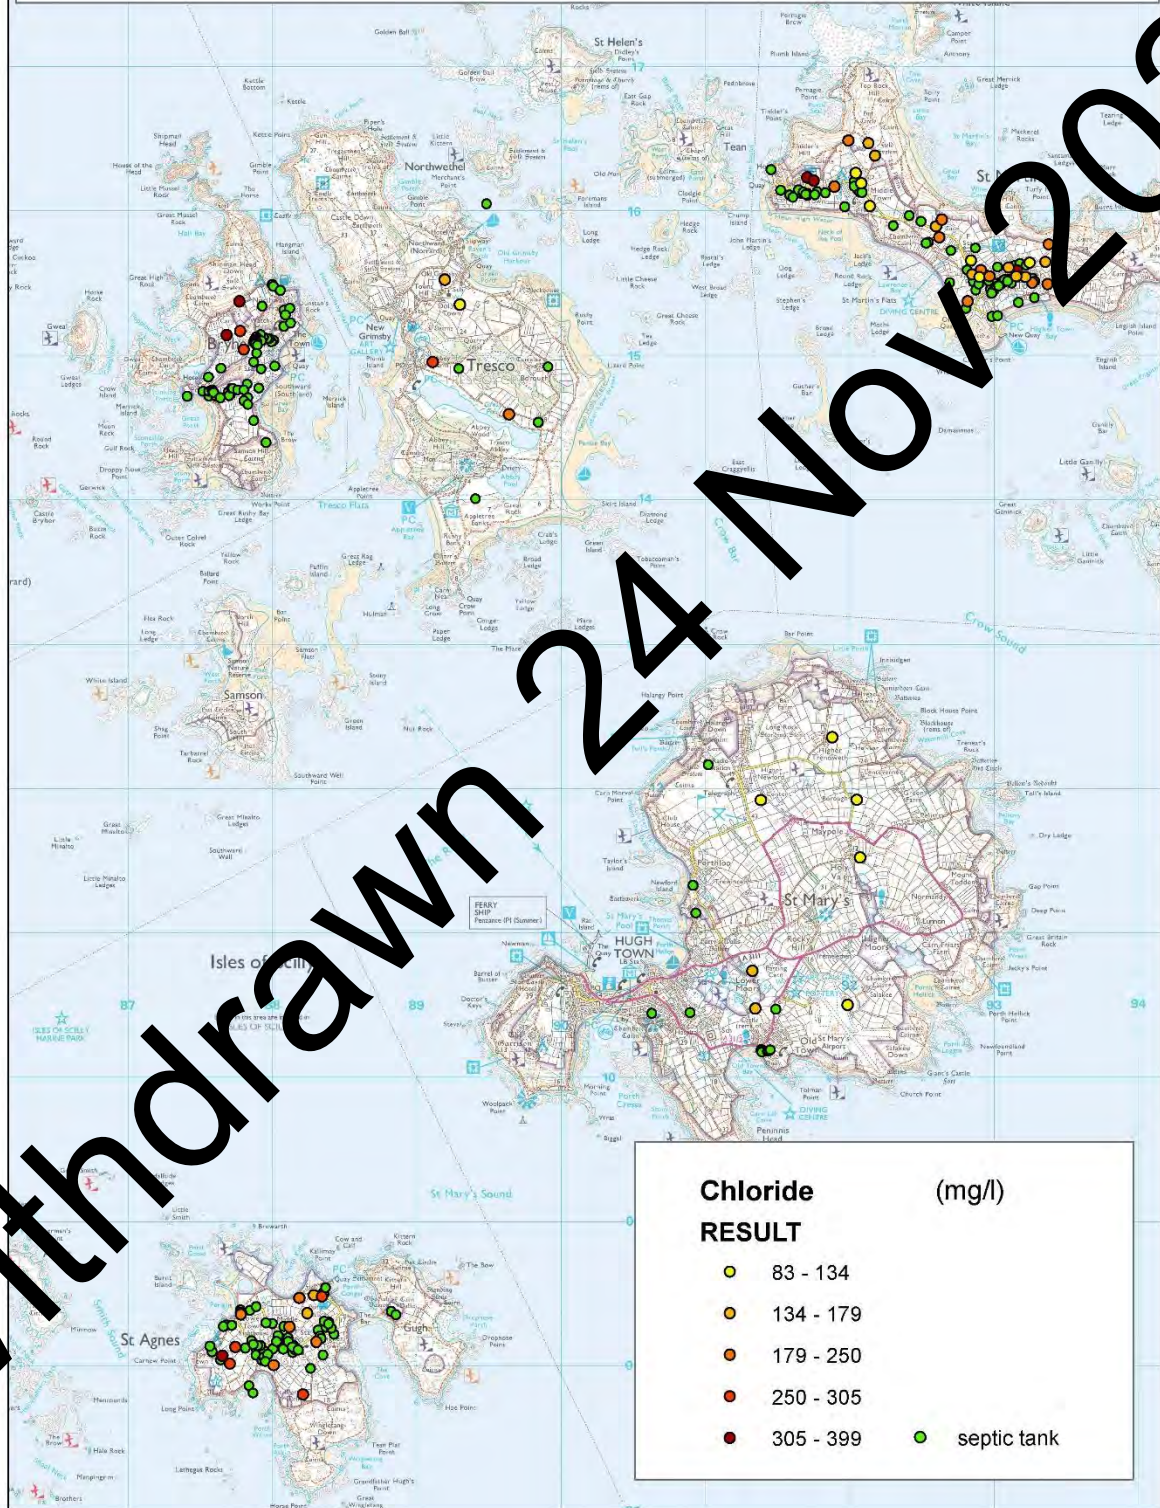
Figure 7: Isles of Scilly chloride concentrations  
November 2015 - January 2016 sampling

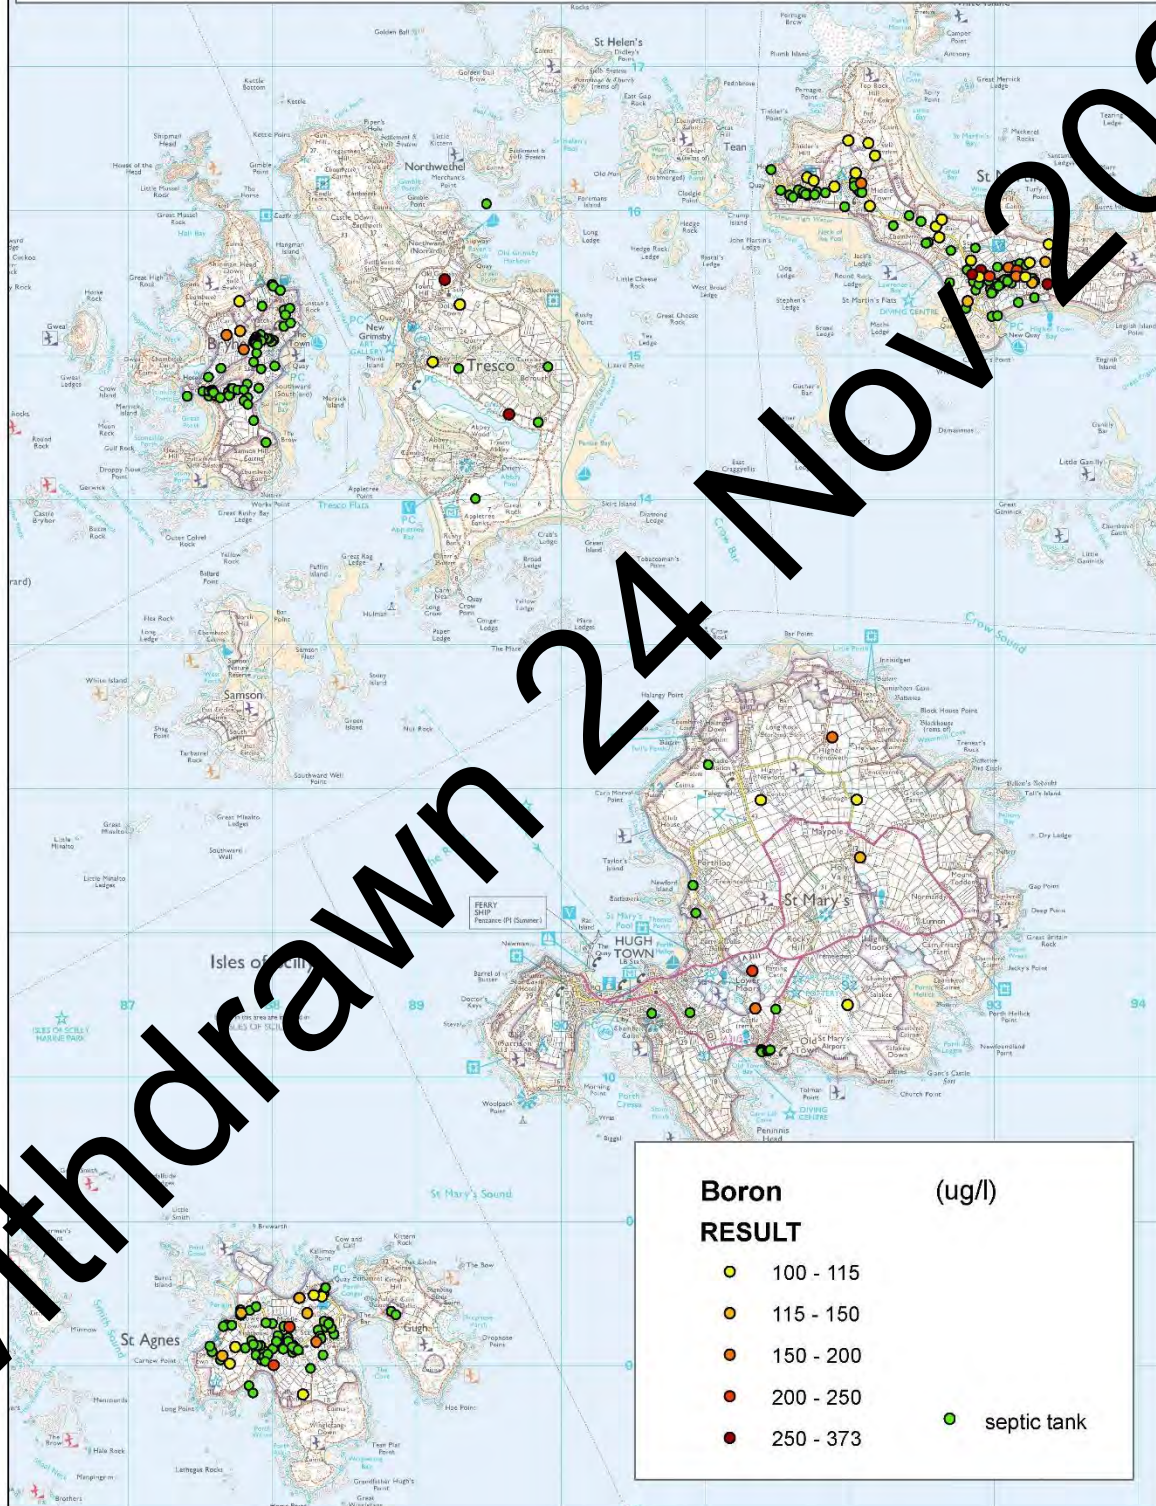
Figure 8: Isles of Scilly boron concentrations  
November 2015 - January 2016 sampling
