Sewage-related contaminants in Isles of Scilly groundwater: concentrations, spatial distribution, sources and risk

Project ENVRESW001361

September 2016

Part 4 of 4

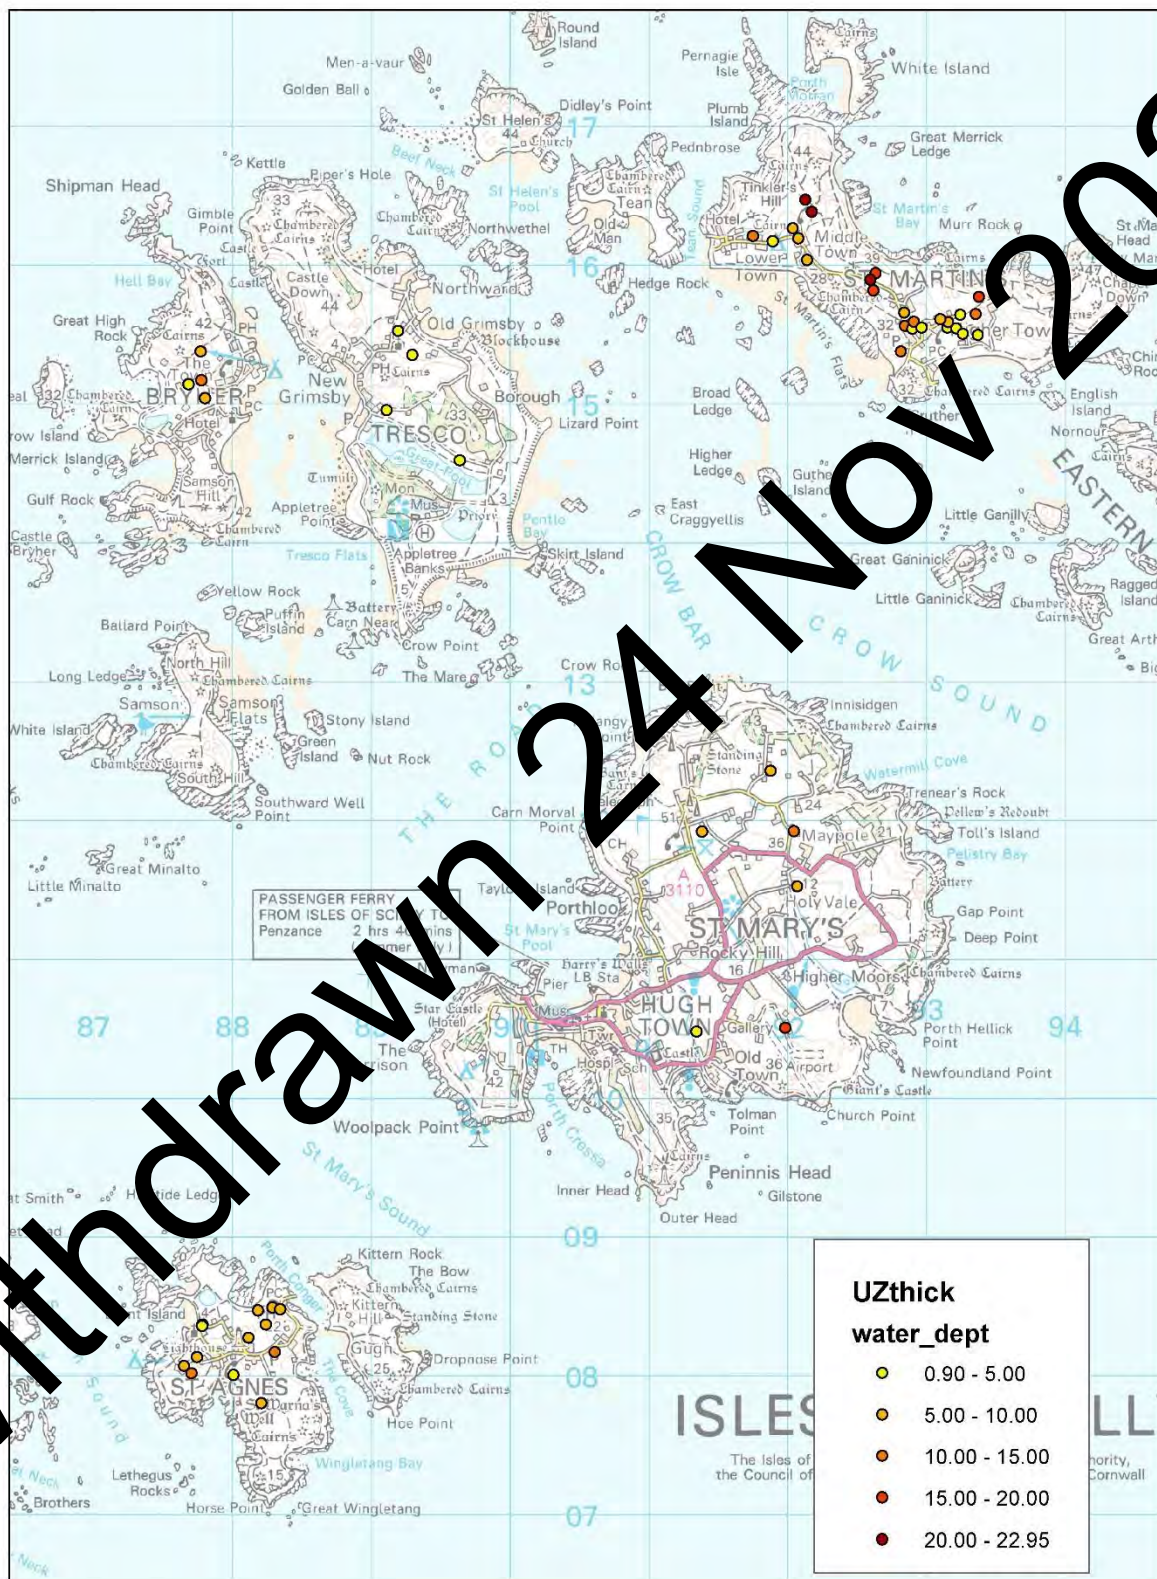
Figure 35: Unsaturated zone thicknesses (m) measured Nov 2015 - Jan 2016

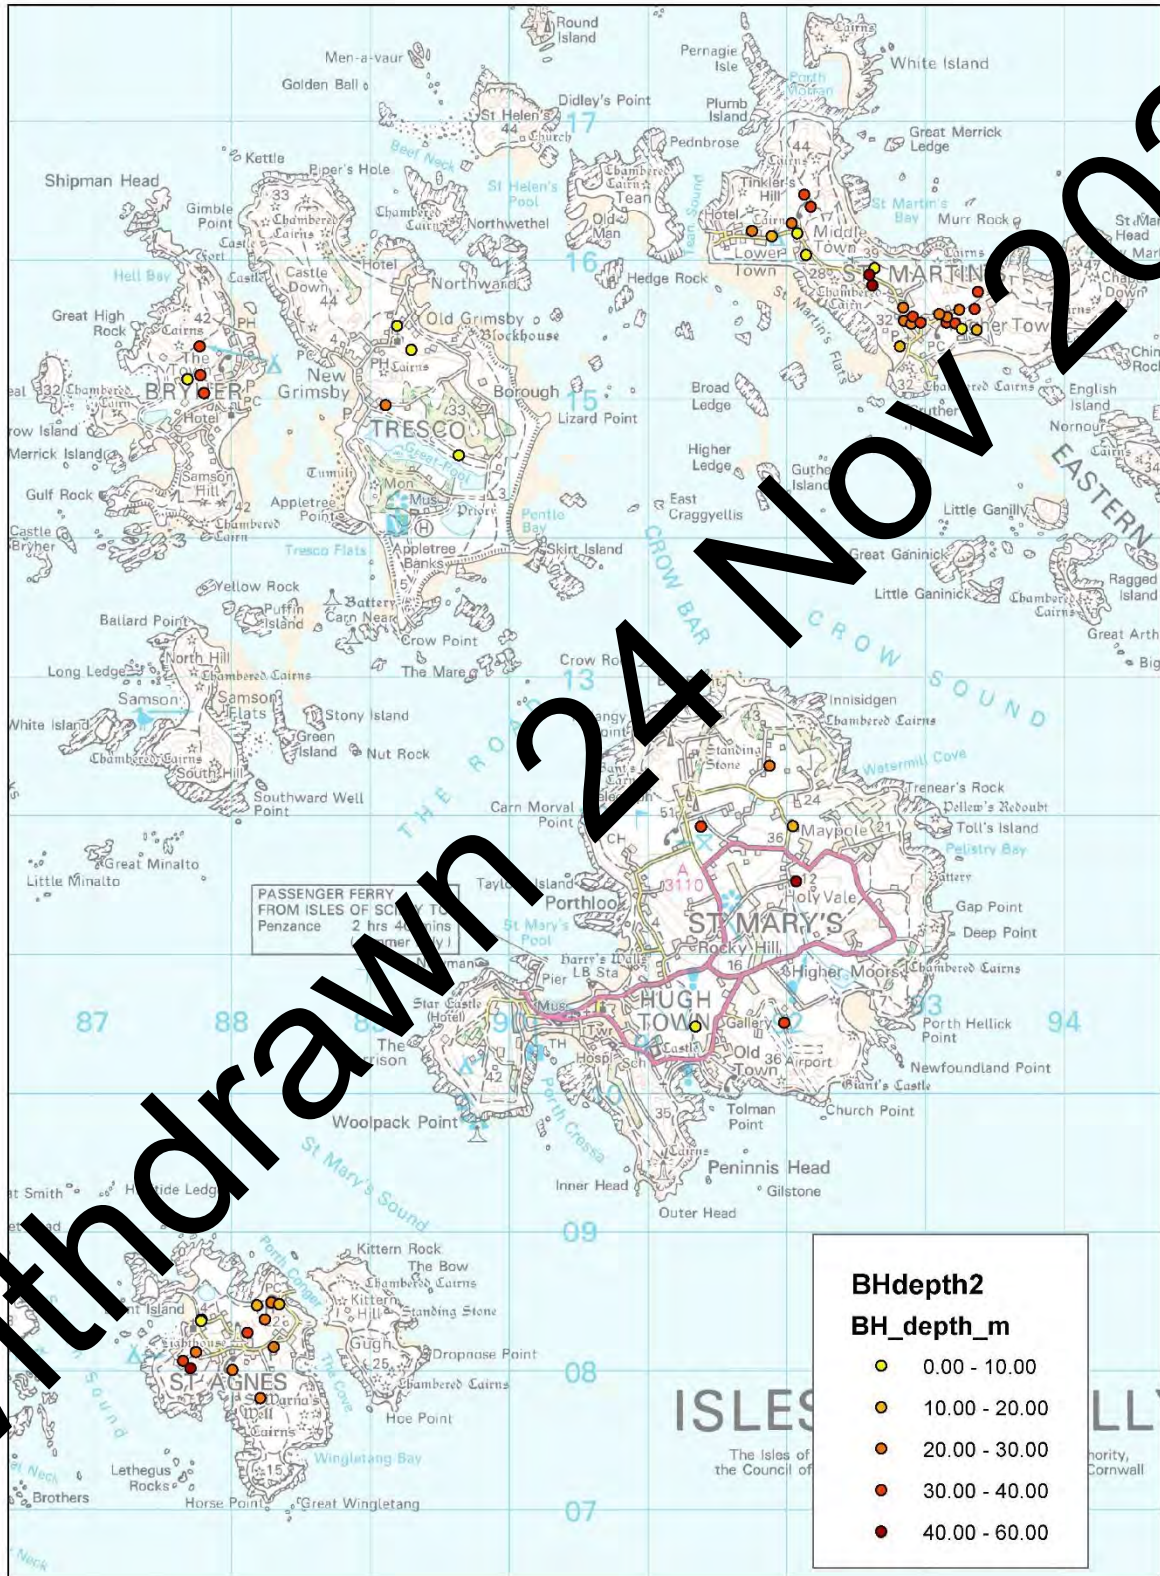
Figure 36: Isles of Scilly borehole depths (m)

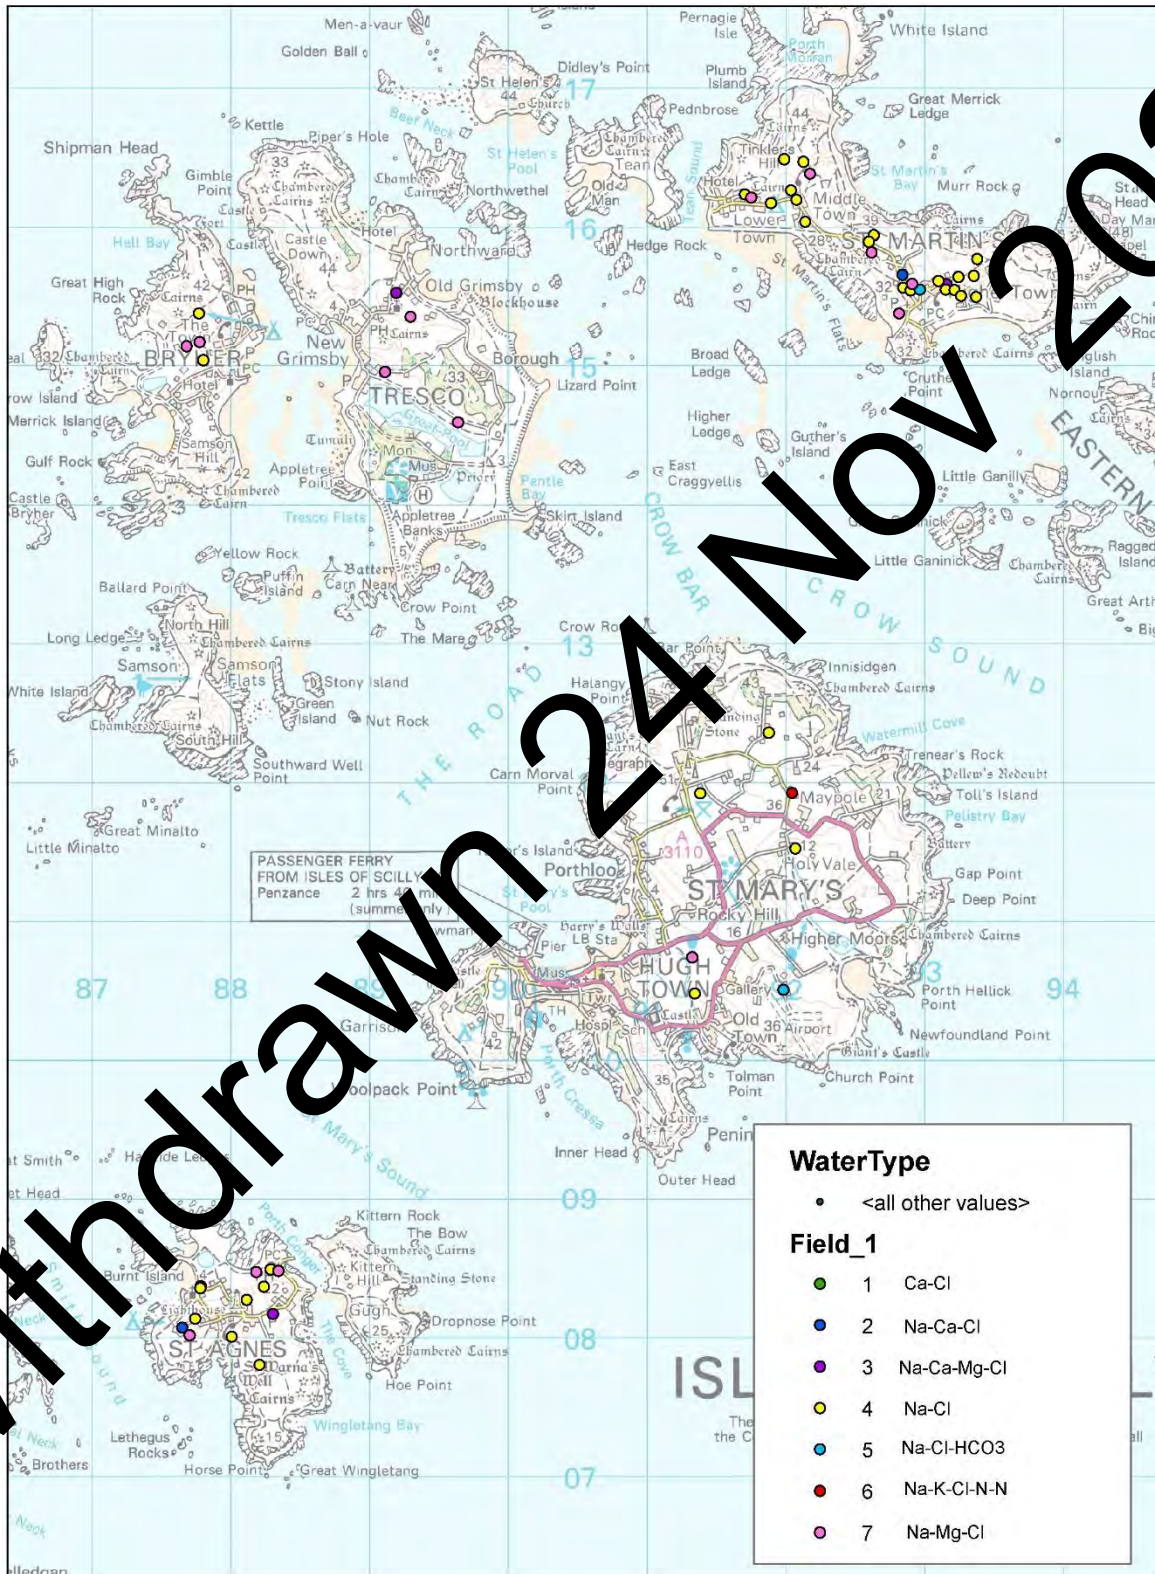
Figure 37: Major Ions water types recorded Nov 2015 - Jan 2016

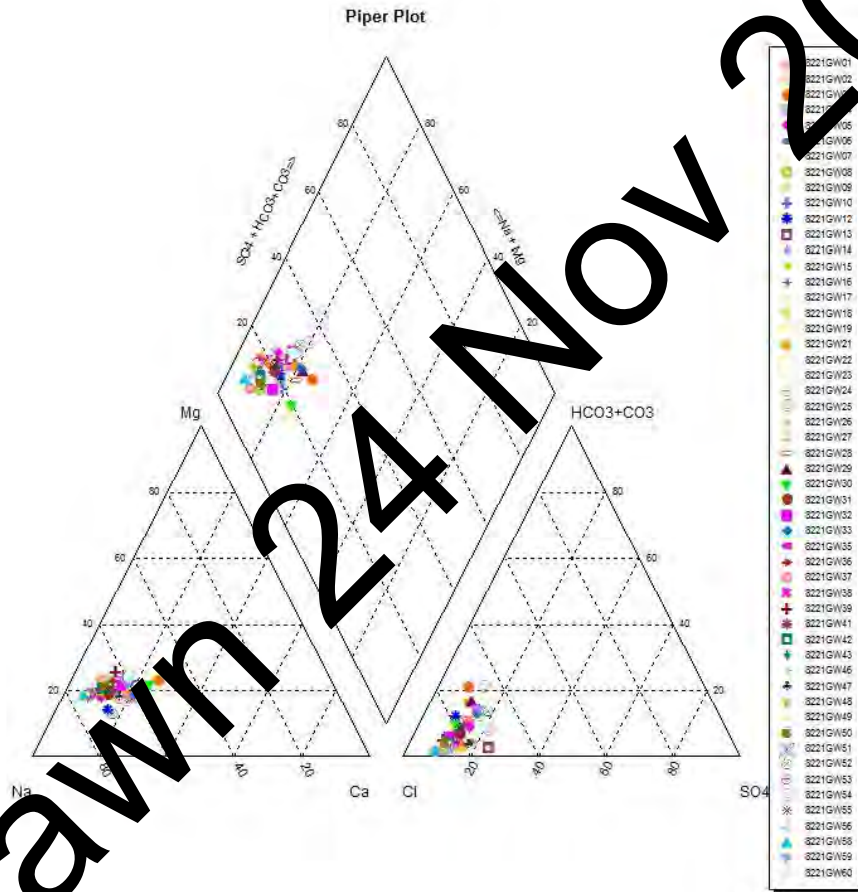
Figure 38: Piper Plot – Isles of Scilly groundwater data Nov 2015
– Jan 2016

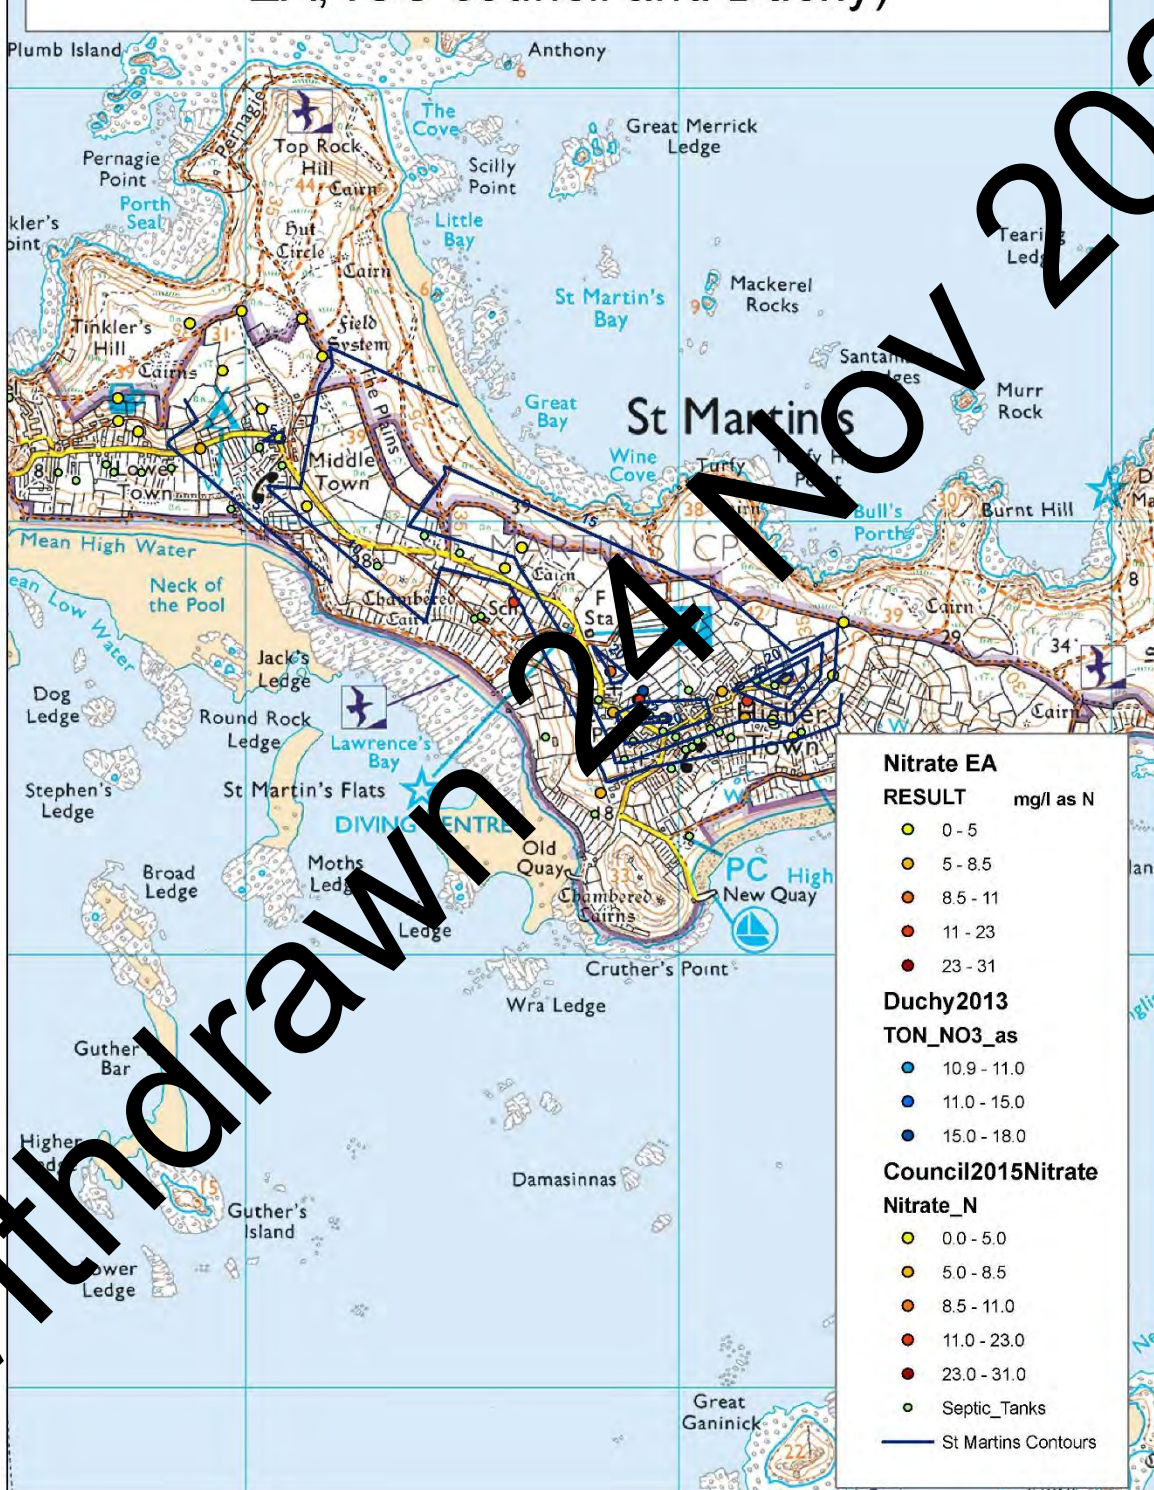
Figure 40: St Martin's piezometric contours and nitrate concentrations (nitrate data from EA, IOS council and Duchy)

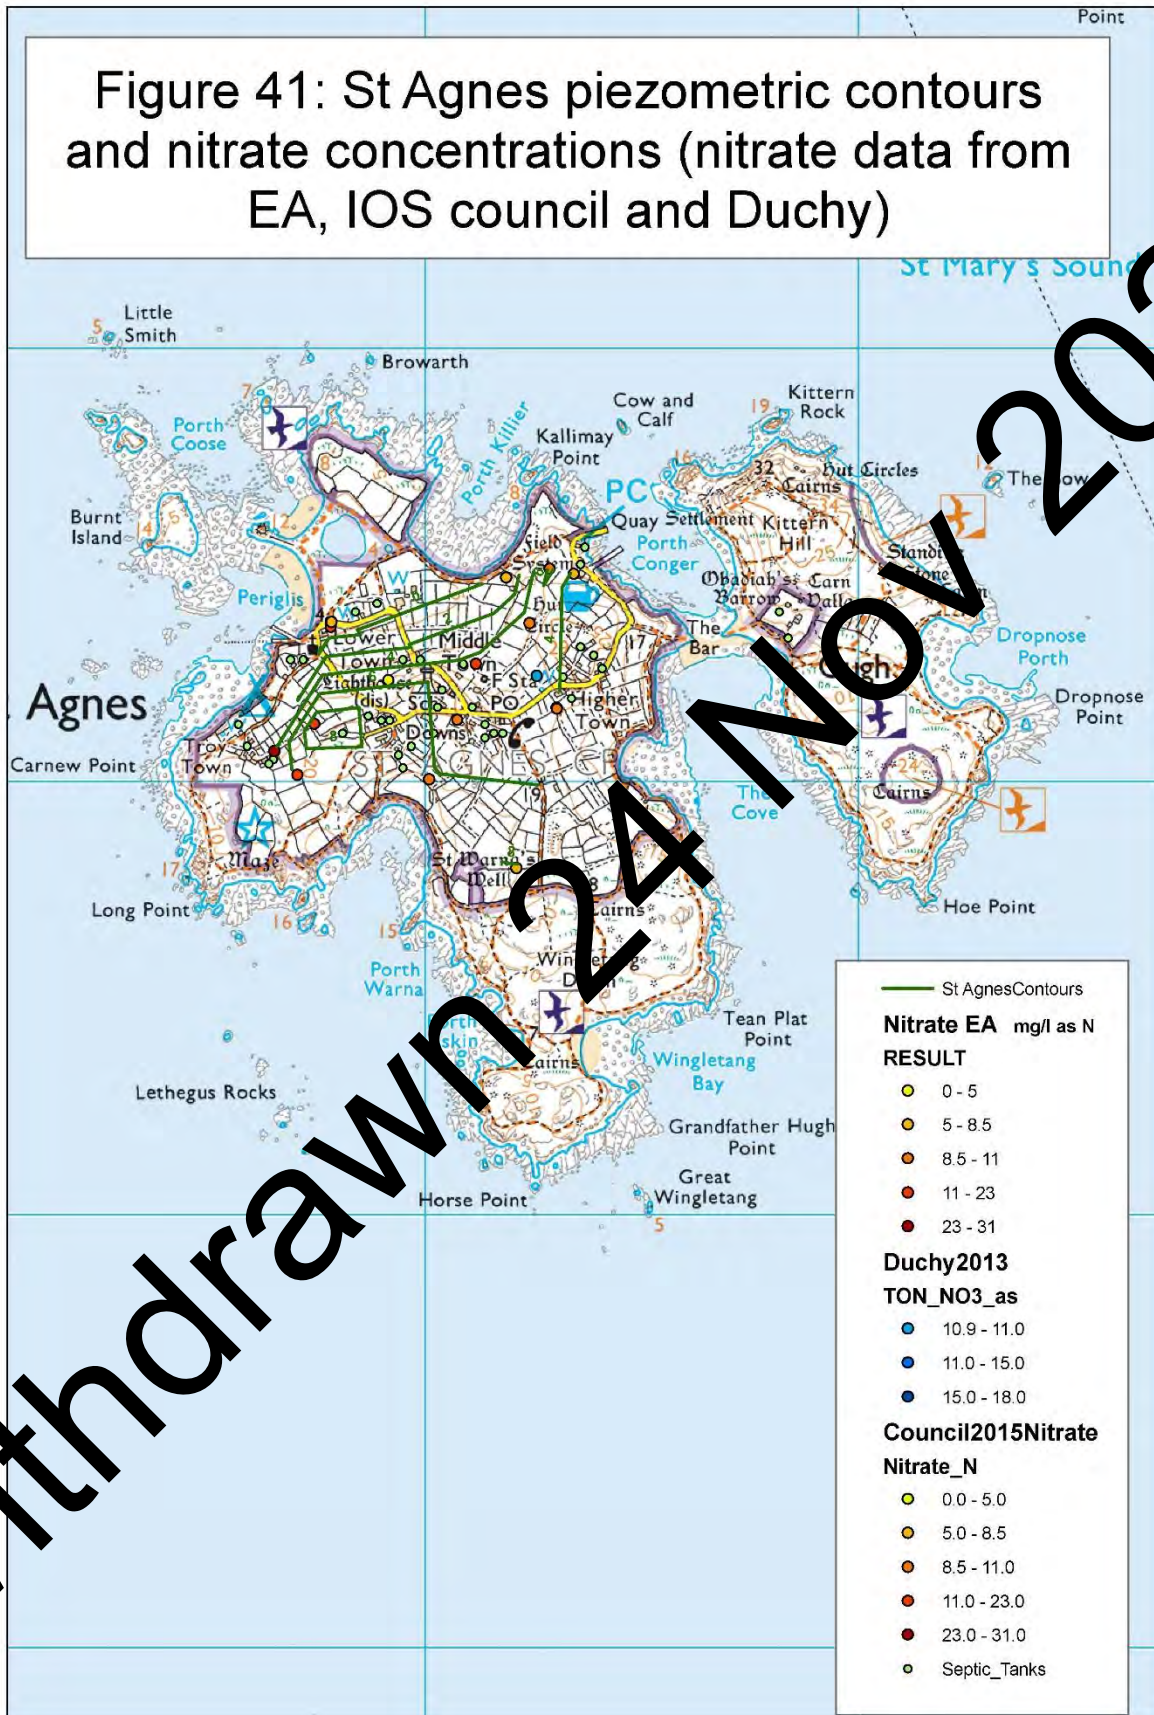
Figure 41: St Agnes piezometric contours and nitrate concentrations (nitrate data from EA, IOS council and Duchy)
