# **Construction noise and vibration Monthly Report – October 2020**

**London Borough of Hillingdon**

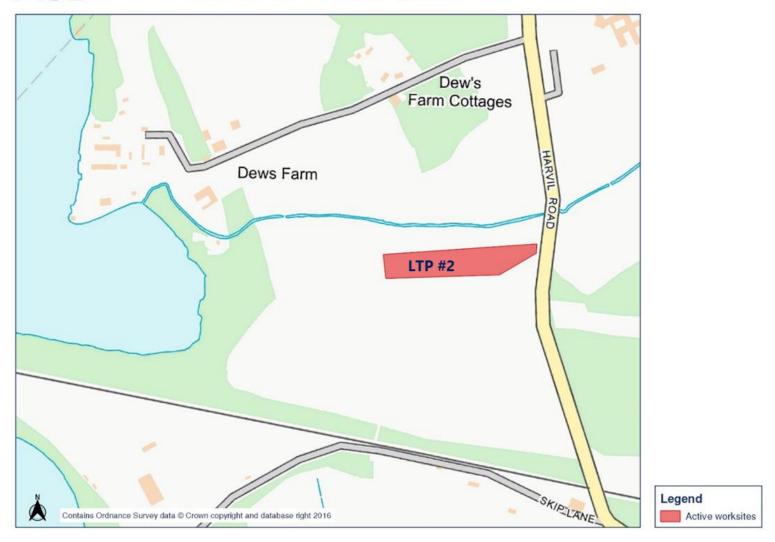
### Worksite identification plan - 2

- 1.1.3 Active construction sites in the local authority area where monitoring was undertaken during this period include:
  - Load Test Pile Worksite, reference LPT #2 (see plan 2 in Appendix A), where work activities included:

- At the main worksite, ground drainage survey works;
    - Near the Hillingdon Outdoor Activities Centre; site clearance and ground investigation works.

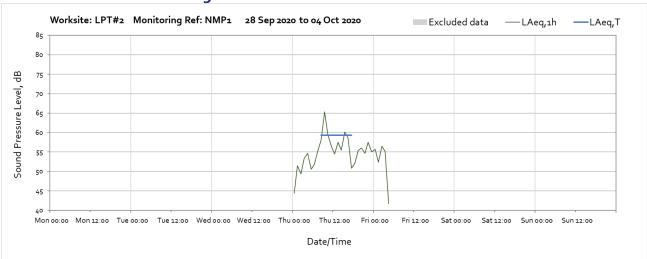
#### Worksite: LPT #2 - Monitoring Ref: NMP1

The following graphs show the hourly measured ambient noise level  $L_{Aeq,1h}$  and, where relevant, the averaged noise level  $L_{Aeq,T}$  values, where the time period T is as specified in Table 1 of HS2 Information Paper E23. Periods with adversely weather affected noise levels are greyed out and have been excluded from the calculation of the  $L_{Aeq,T}$  values in Table 3 of the main report.

Note: Missing data between from 05:00 on Friday 2<sup>nd</sup> October and 10:00 Tuesday 6<sup>th</sup> October was due to a fault with the power cable.

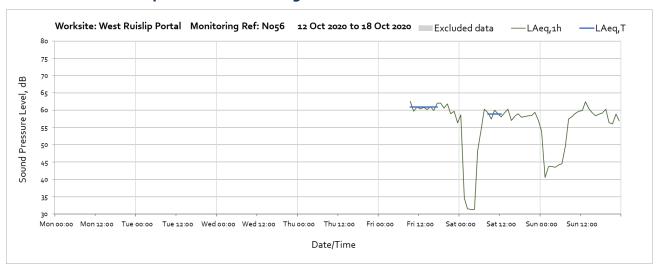
#### Worksite: West Ruislip Portal - Monitoring Ref: N056

Note: Missing data between from 00:00 on Thursday 1st October and 09:00 Friday 16th October was due to a fault with the noise monitor. The noise monitor unit has been replaced with a new one on Friday 16th October.
