Air Quality and Dust Monitoring Monthly Report – October 2020

London Borough of Ealing

A report prepared by Costain Skanska on behalf of HS₂ Ltd.

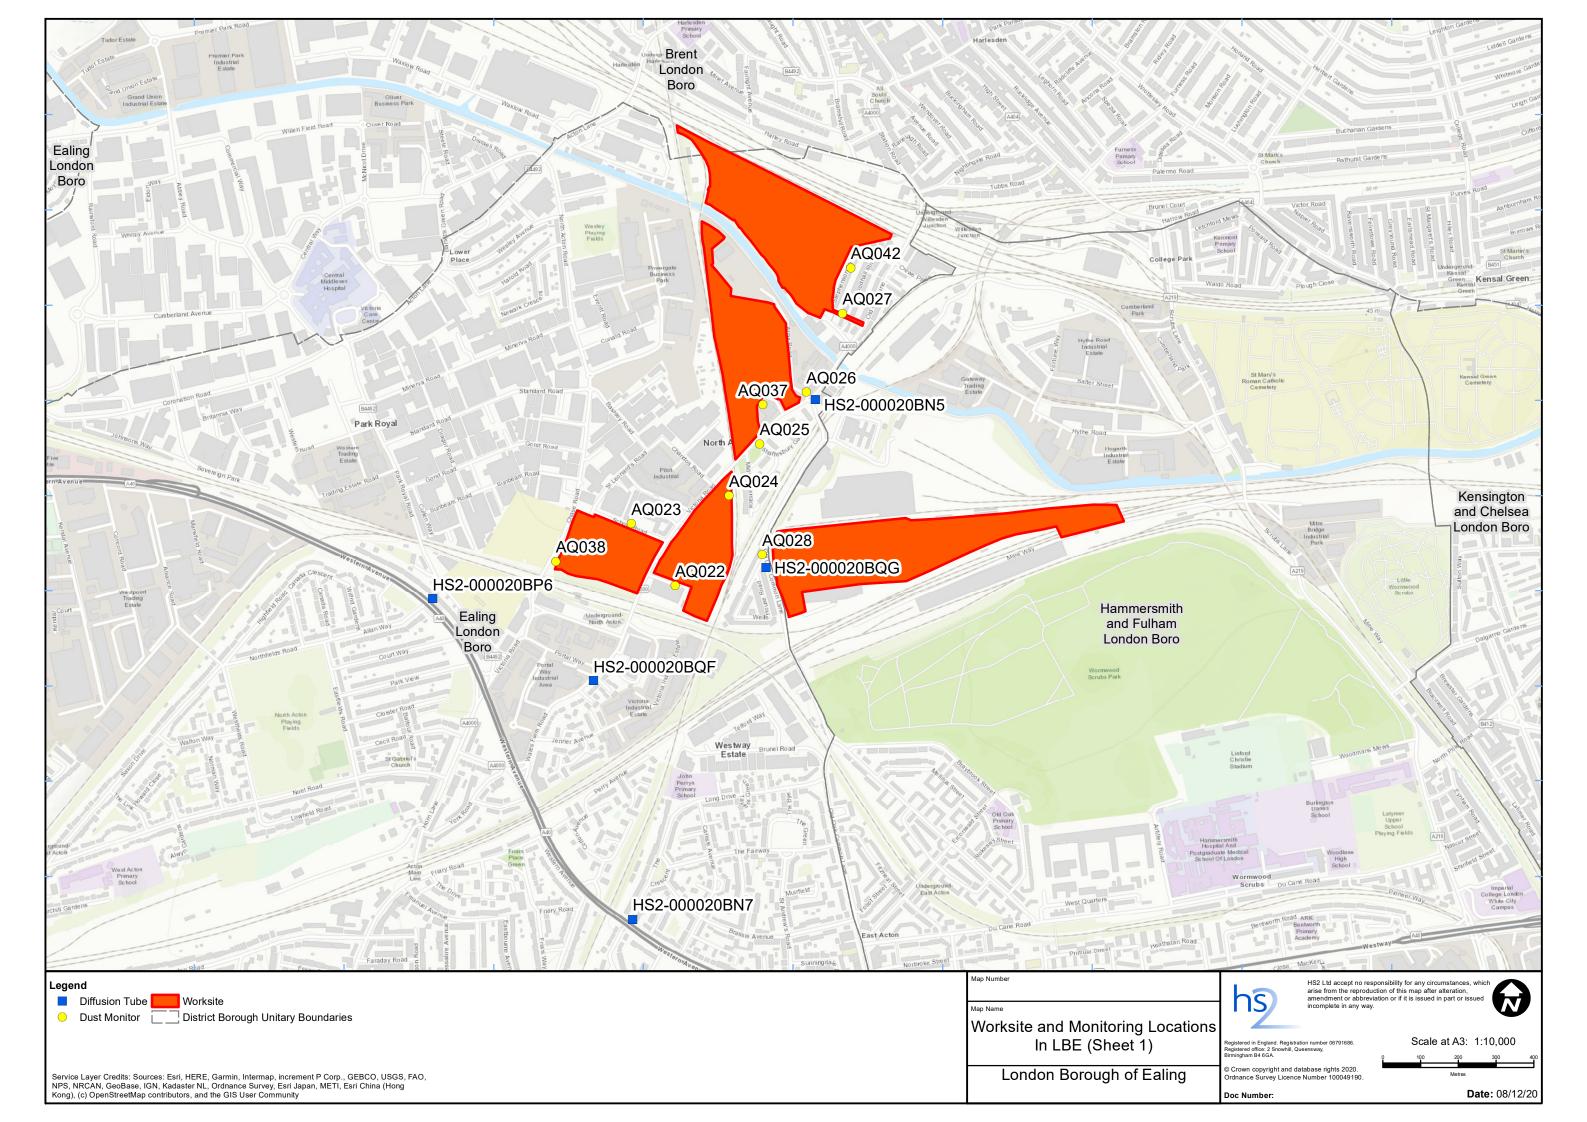
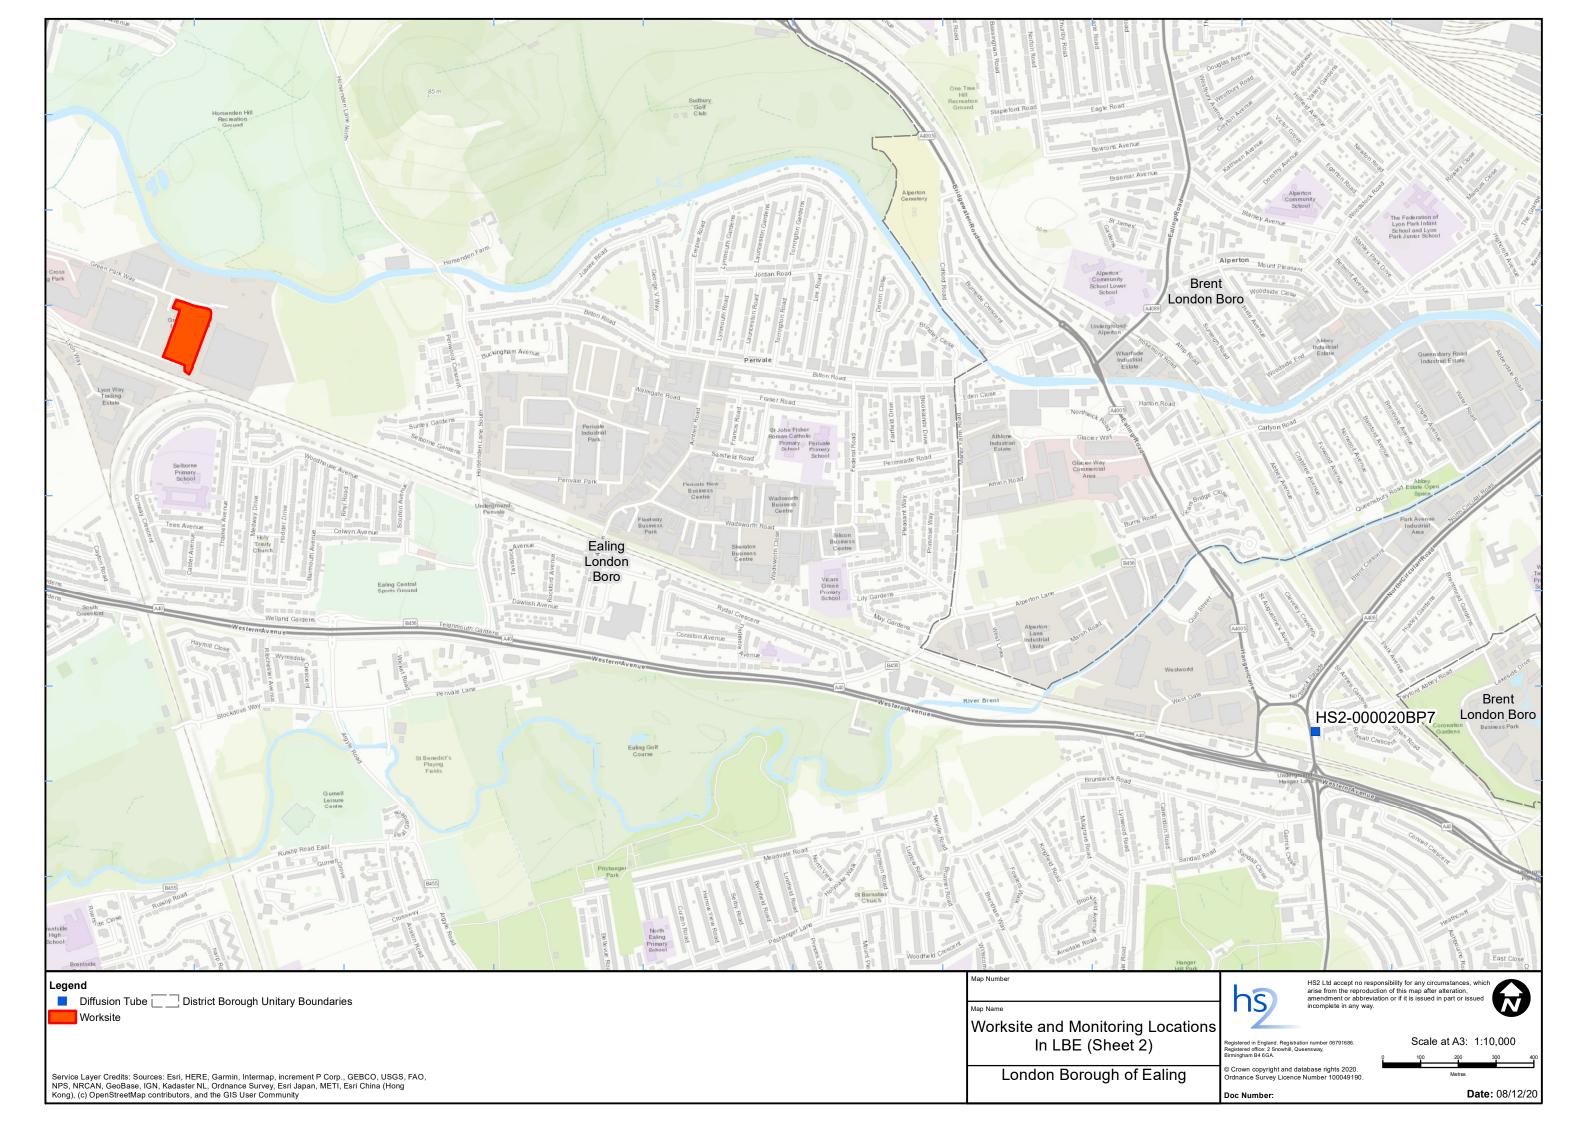
Figure 1 and 2: Worksites and monitoring locations within the LBE

- 1.1.2 Figure 1 and Figure 2 in Appendix A indicate the current worksites together with air quality and dust monitoring locations.
- 1.1.3 This summary should be read in conjunction with the overview monitoring report available from www.gov.uk/government/collections/monitoring-the-environmental-effects-of-hs2, which highlights: the applicable standards and guidance, as well as the air quality and dust monitoring methodologies to be implemented by nominated undertakers throughout construction.

- 1.1.4The current phase of works commenced in October 2019 and is expected to be completed by
2025. The current worksites, as presented in Appendix A, Figure 1 and Figure 2, include:

- Old Oak Common Depot (located in the London Borough of Hammersmith and Fulham) mobilisation and new site set up for the station works contractors;
 - Victoria Road Crossover Box and Flat Iron Site groundworks and utilities;

- Willesden Euro Terminal groundworks;
 - Atlas Road site set up and groundworks;
 - Green Park Way Vent Shaft mobilisation and site set up; and
 - Mandeville Road Vent Shaft mobilisation and site set up.

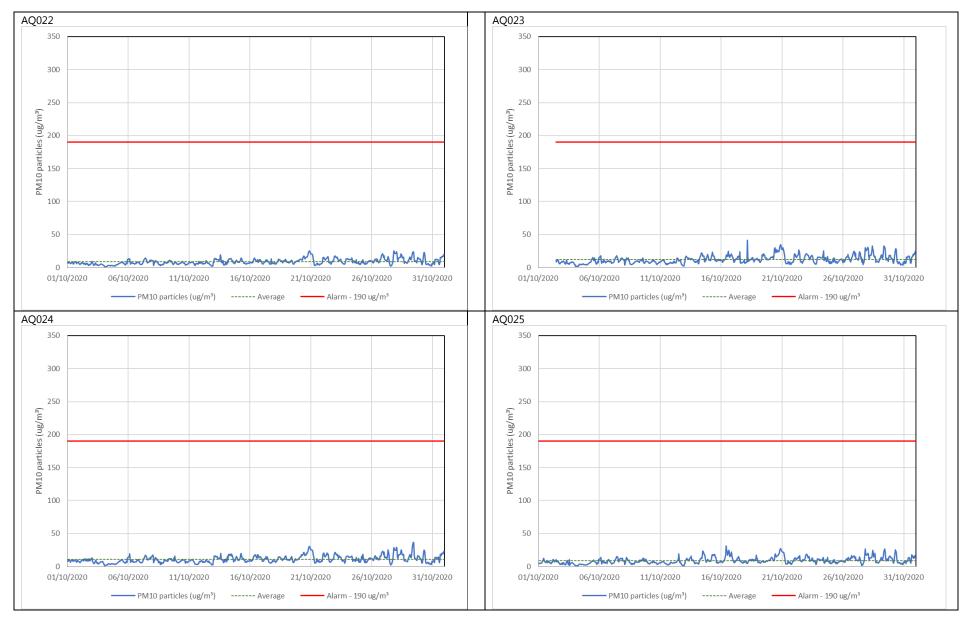
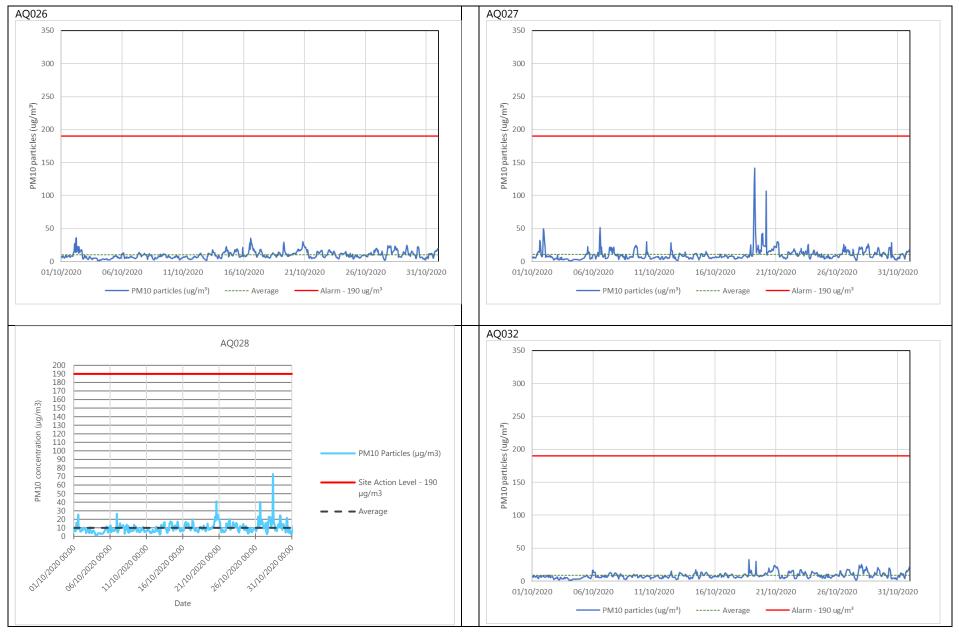
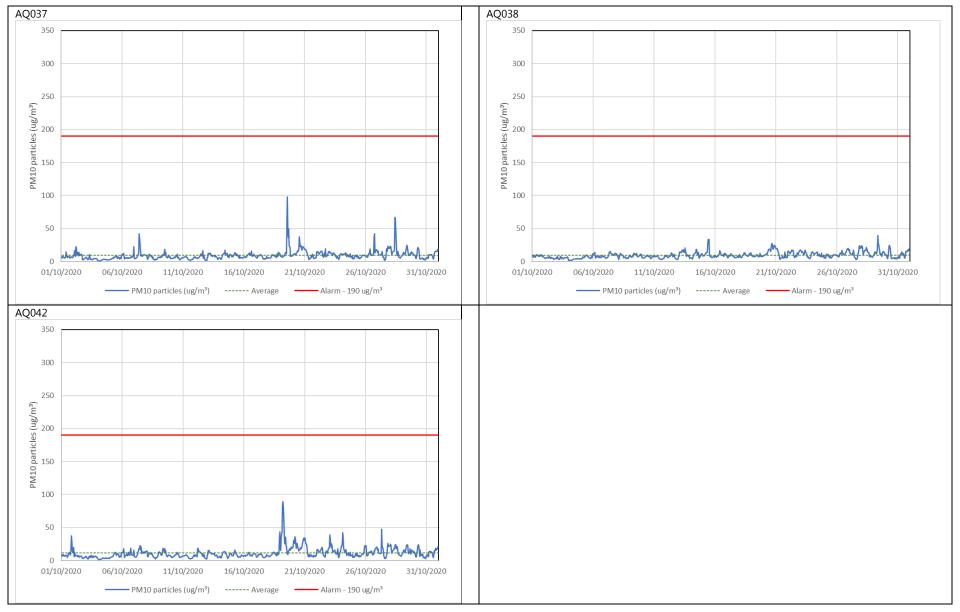
Figure 3: Construction dust 1-hour mean indicative PM_{10} concentration for dust monitors

- 1.1.5 Eleven (11) dust monitors were installed around worksites, where works are underway. These sites returned a medium dust risk rating.
- 1.1.6 Dust monitoring locations and results are presented in Appendix B, Table 2, together with line charts of monthly data from each dust monitor in Figure 3. All continuous dust monitoring is undertaken using indicative monitors. Despite being Environment Agency (MCERTS) certified, indicative monitors carry a higher level of uncertainty than reference monitors, and therefore cannot be strictly compared with Air Quality Standards for human health and the environment. The purpose of the monitoring undertaken is to ensure the effectiveness of the on-site mitigation.

- 1.1.7 The trigger level for PM₁₀ concentrations of 190 μg/m³, over a 1-hour period, in accordance with the updated guidance document '*Guidance on Monitoring in the Vicinity of Demolition and Construction Sites (October 2018)*' has been applied.

- 1.1.8 There were no (0) dust trigger alerts recorded during the monitoring period (October 2020).
