## Air Quality and Dust Monitoring Monthly Report – **November** 2020

London Borough of Ealing

A report prepared by EWCs and MWCCs on behalf of HS2 Ltd.

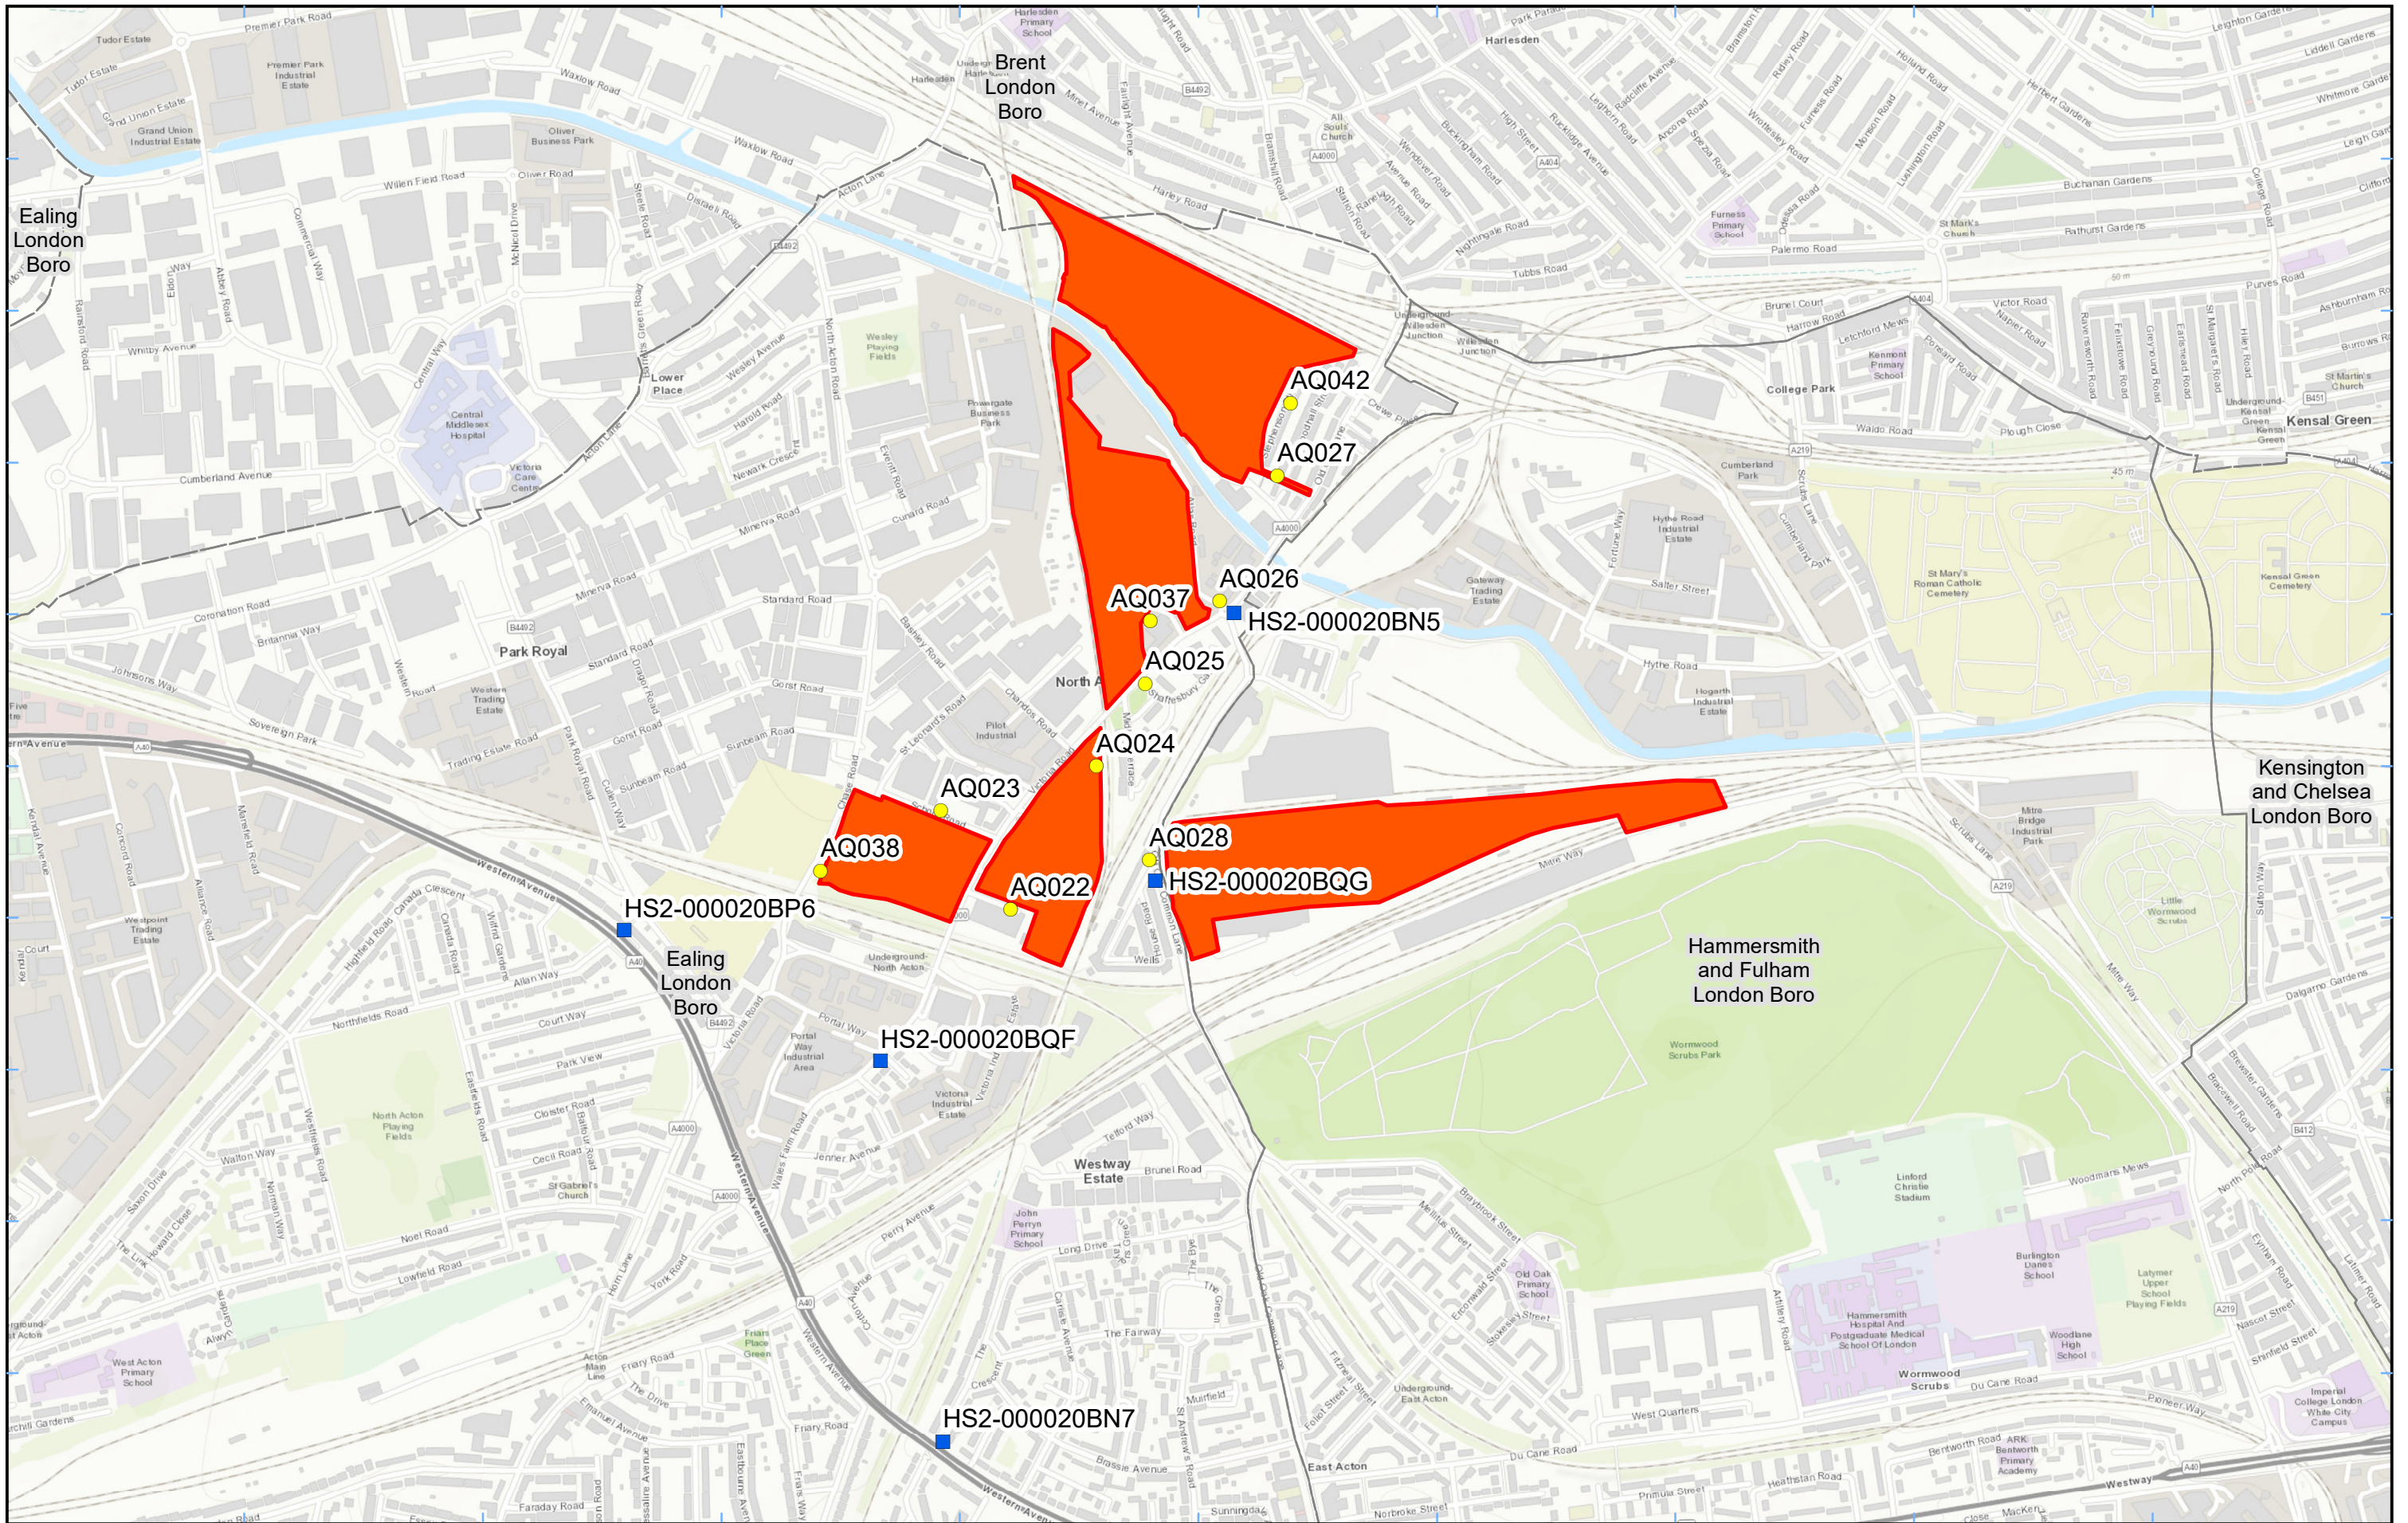
Map Number  
 Map Name  
**Worksite and Monitoring Locations  
 In LBE (Sheet 1)**  
 London Borough of Ealing

- 1.1.4 The current phase of works commenced in October 2019 and is expected to be completed by 2025. The current worksites, as presented in Appendix A, Figure 1 and Figure 2, include:

Figure 1 and 2: Worksites and monitoring locations within the LBE

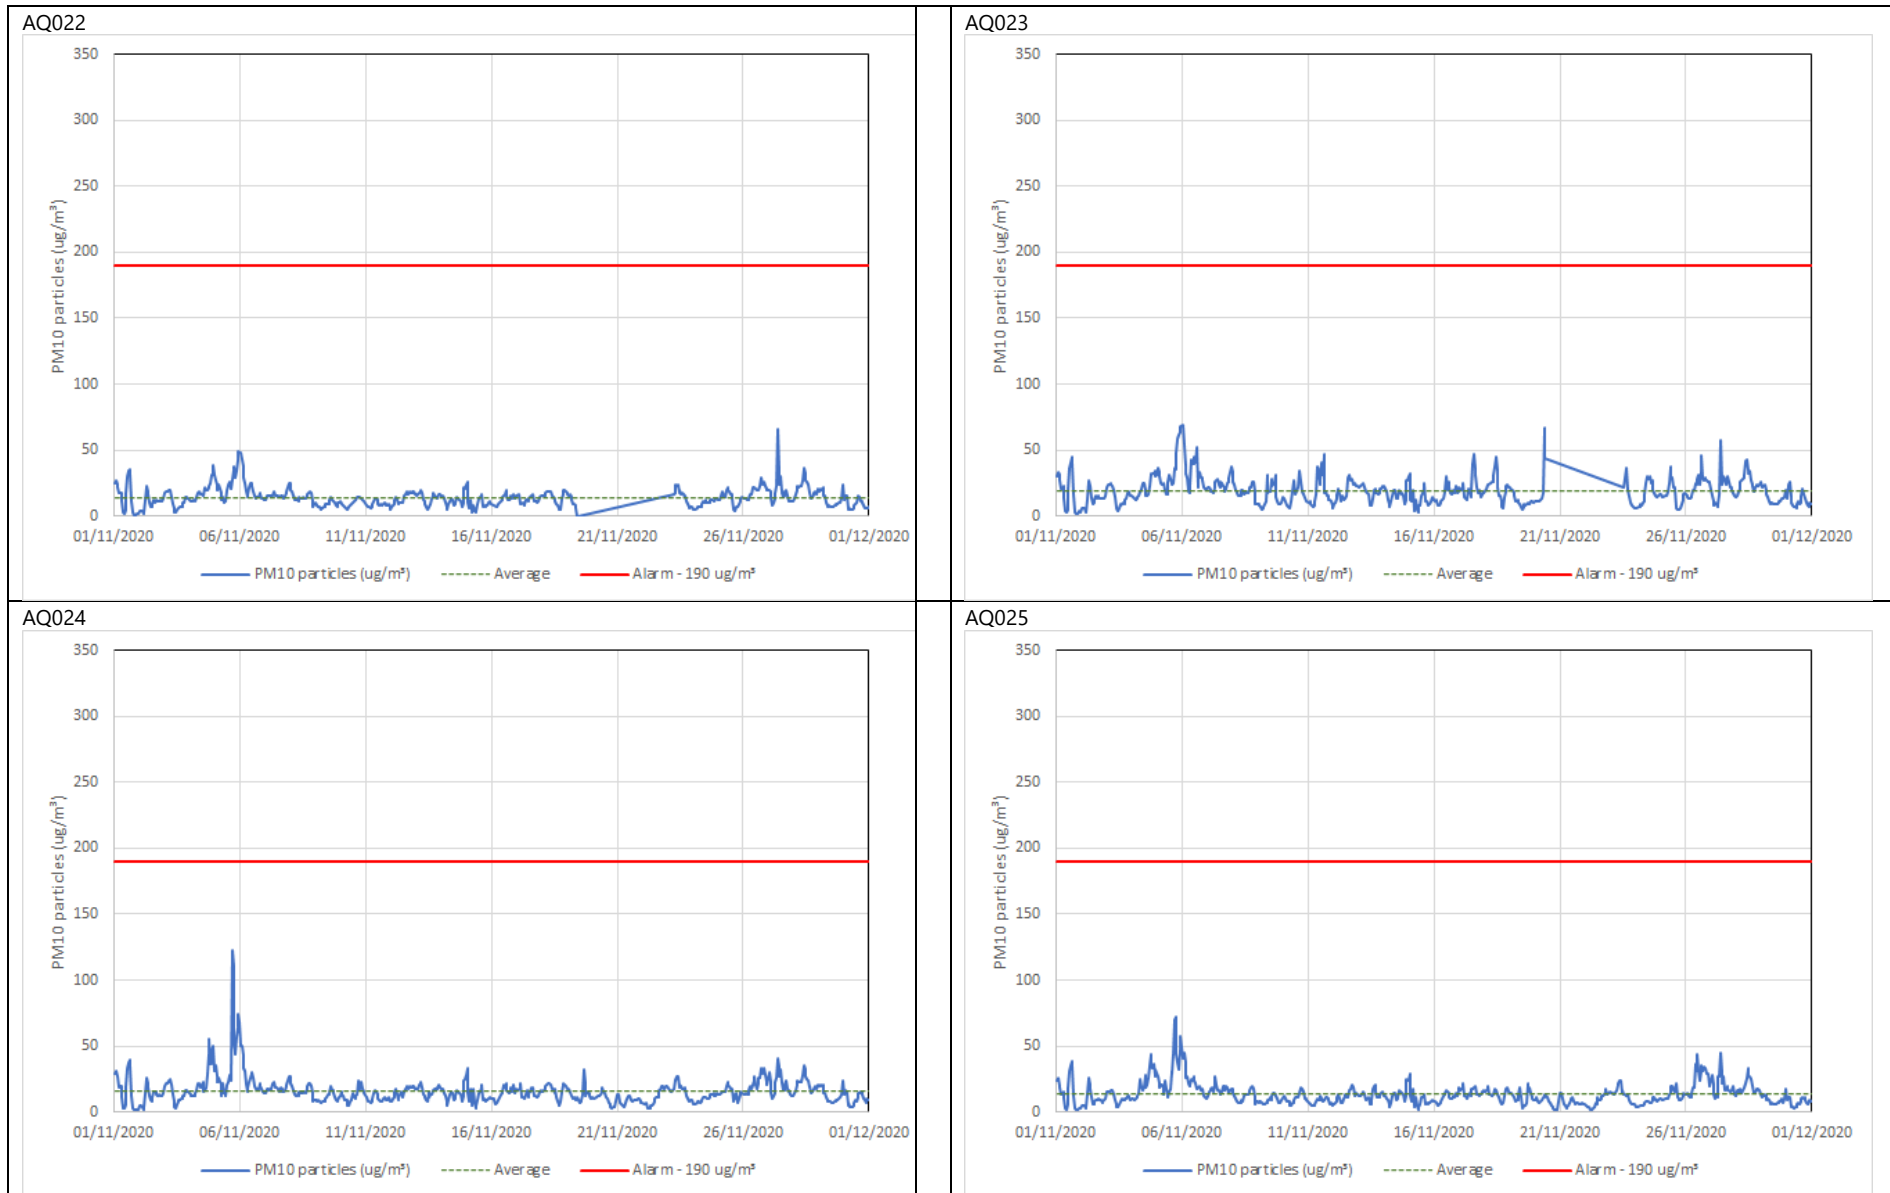
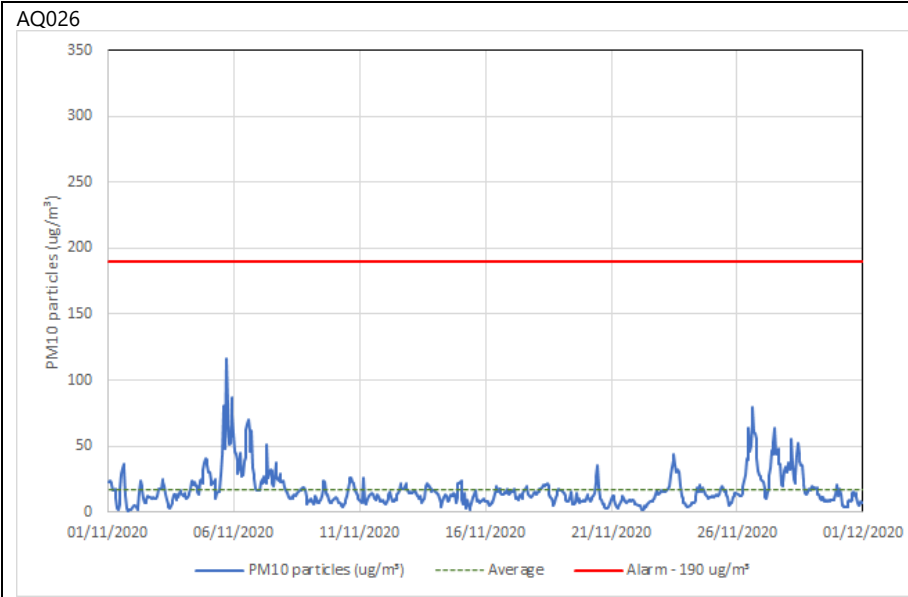
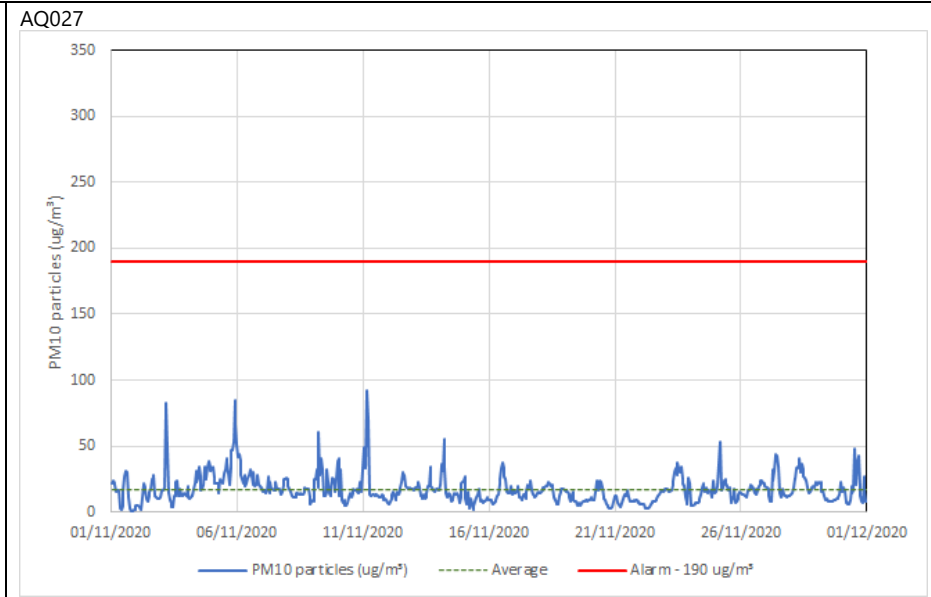
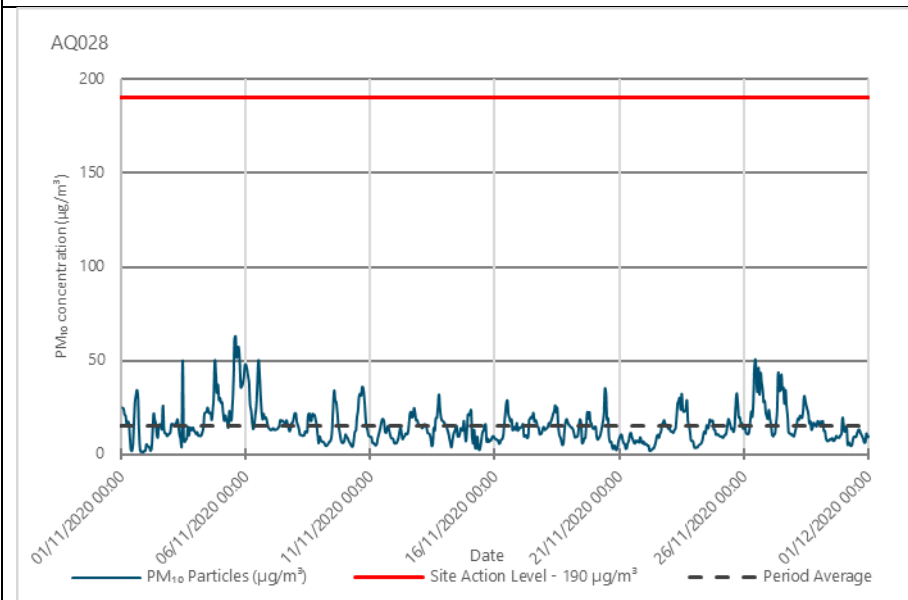
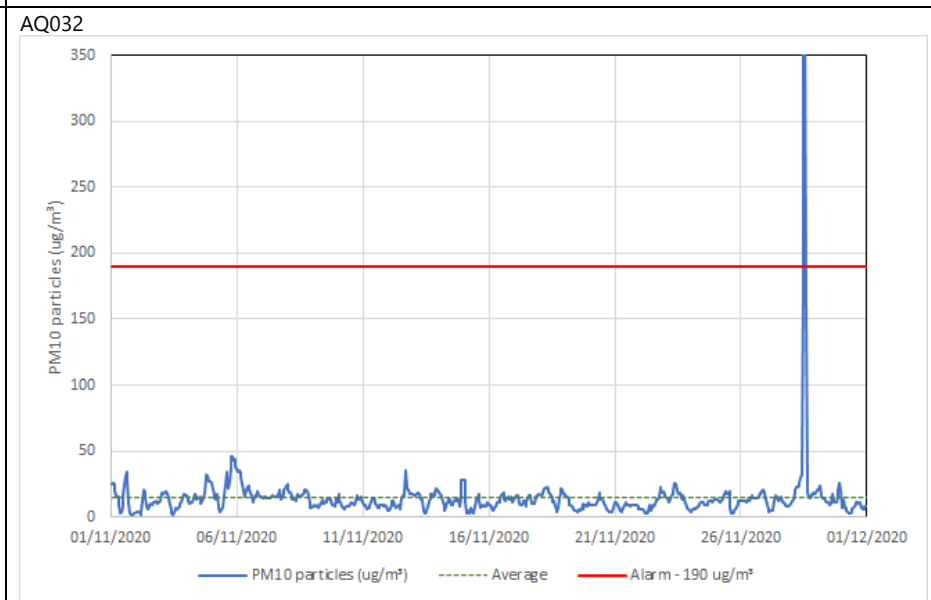
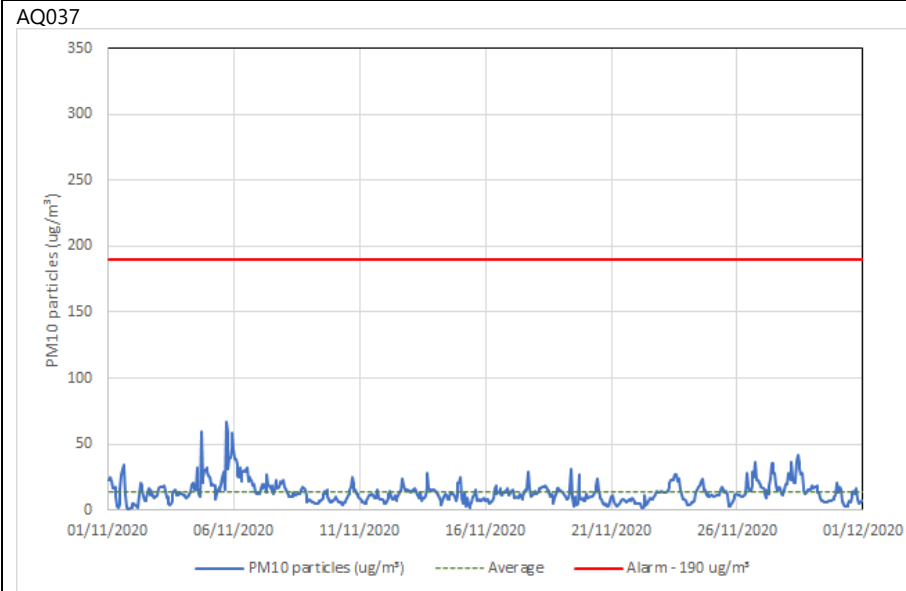
Figure 3: Construction dust 1-hour mean indicative PM<sub>10</sub> concentration for dust monitors

- 1.1.6 Dust monitoring locations and results are presented in Appendix B, Table 1, together with line charts of monthly data from each dust monitor in Figure 3. All continuous dust monitoring is undertaken using indicative monitors. Despite being Environment Agency (MCERTS) certified, indicative monitors carry a higher level of uncertainty than reference monitors, and therefore cannot be strictly compared with Air Quality Standards for human health and the environment. The purpose of the monitoring undertaken is to ensure the effectiveness of the on-site mitigation.

- 1.1.7 The trigger level for PM<sub>10</sub> concentrations of 190 µg/m<sup>3</sup>, over a 1-hour period, in accordance with the updated guidance document '*Guidance on Monitoring in the Vicinity of Demolition and Construction Sites – (October 2018)*' has been applied.

- 1.1.8 There were two (2) dust trigger alerts recorded during the monitoring period (November 2020). Exceedances are presented in Appendix B, Table 2. All other results were in line with expected ranges.

Monitoring Site ID	Period of trigger alert & Concentration recorded	Investigation	Outcomes / Resolution / Remedial measures implemented
AQ032	28/11/2020 11:00 - 13:00: 551.5 µg/m <sup>3</sup> and 388.7 µg/m <sup>3</sup> (2x triggers)	<p>Given the limited works being undertaken near AQ032 on the Saturday 28/11/20 when the site would have been shutting and the fact that both readings were uncharacteristically high, it is considered that both triggers were associated with the persistent wet weather conditions throughout November rather than dust generated by site activities.</p> <p>The combination of moisture and debris build-up and subsequent loosening within the monitor inlets is considered to be the most likely cause and has been evident in other monitors during the month.</p>	The monitor is due its quarterly service and maintenance.
