Middlewick Ranges Colchester Essex

Archaeological Desk-Based Assessment

Document Ref.: 228290.01
October 2020

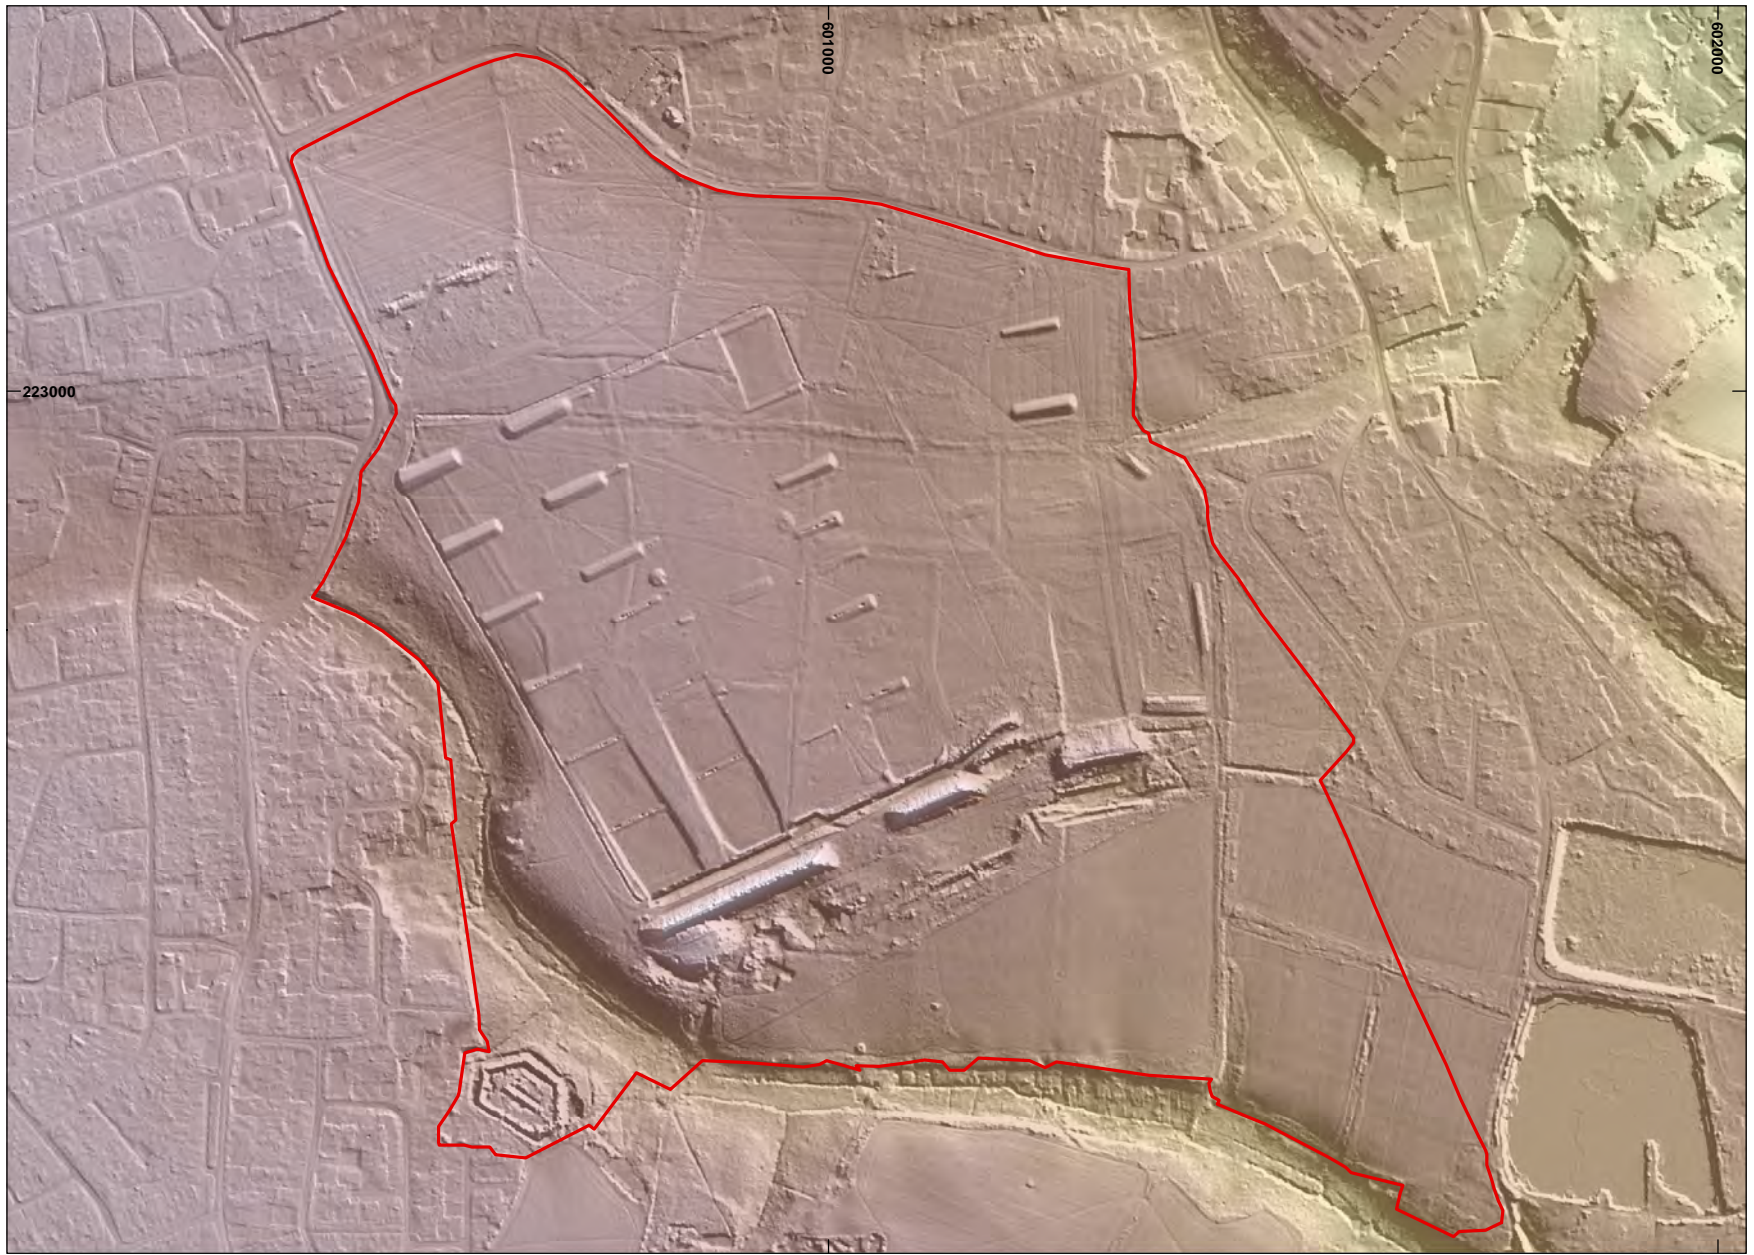
A) LiDAR data (2018 1m National LiDAR dataset) and topographic information covering the Site

5.2.8 The western area of the Site is currently under woodland coverage. Earthworks relating to the redoubt are known to exist within this area, visible on the LIDAR image. The density of the tree coverage and scrub (**Plates 29 & 30**) is likely to have damaged archaeological remains through rooting, however the earthworks associated with the redoubt are substantial and are likely to have survived well, as attested by the LIDAR data. It is also

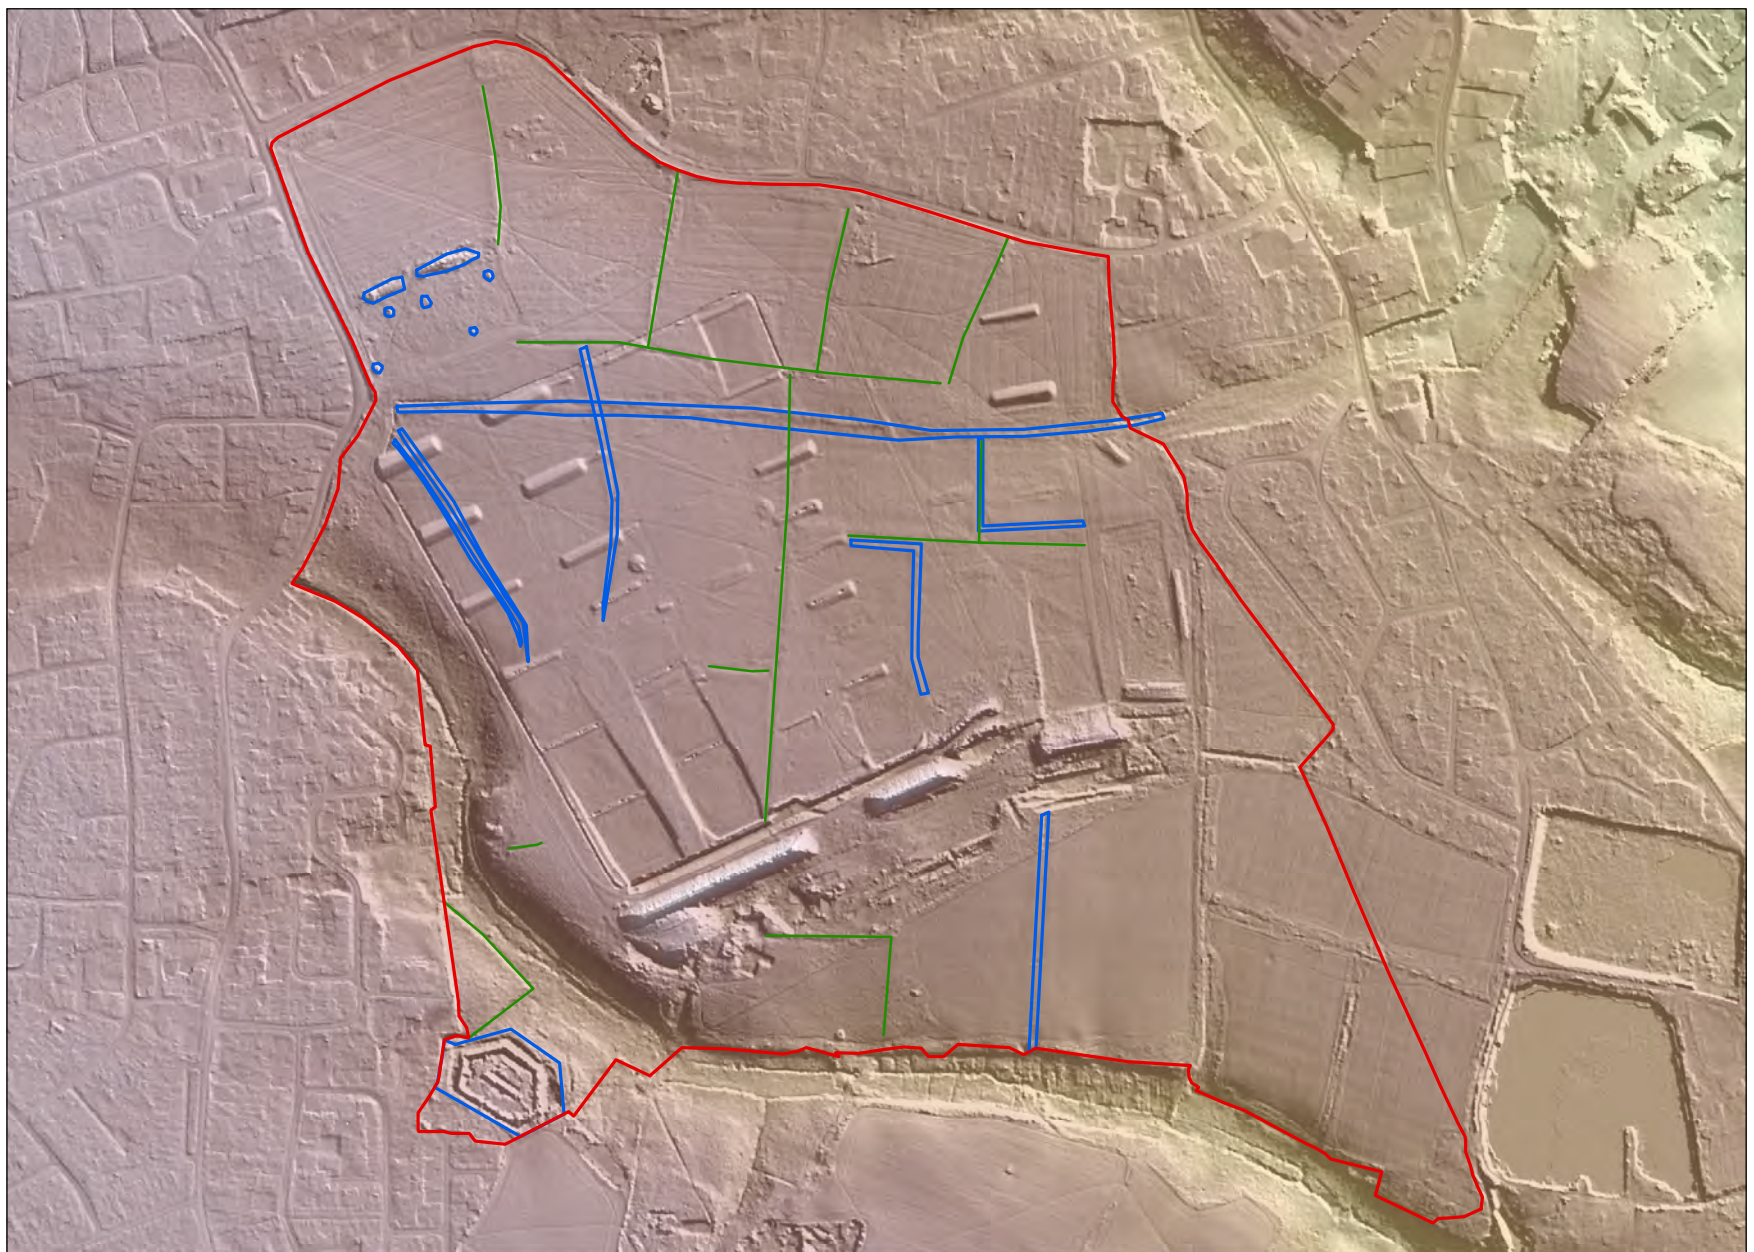
B) LiDAR data (2018 1m National LiDAR dataset) and topographic information covering the Site with interpretation

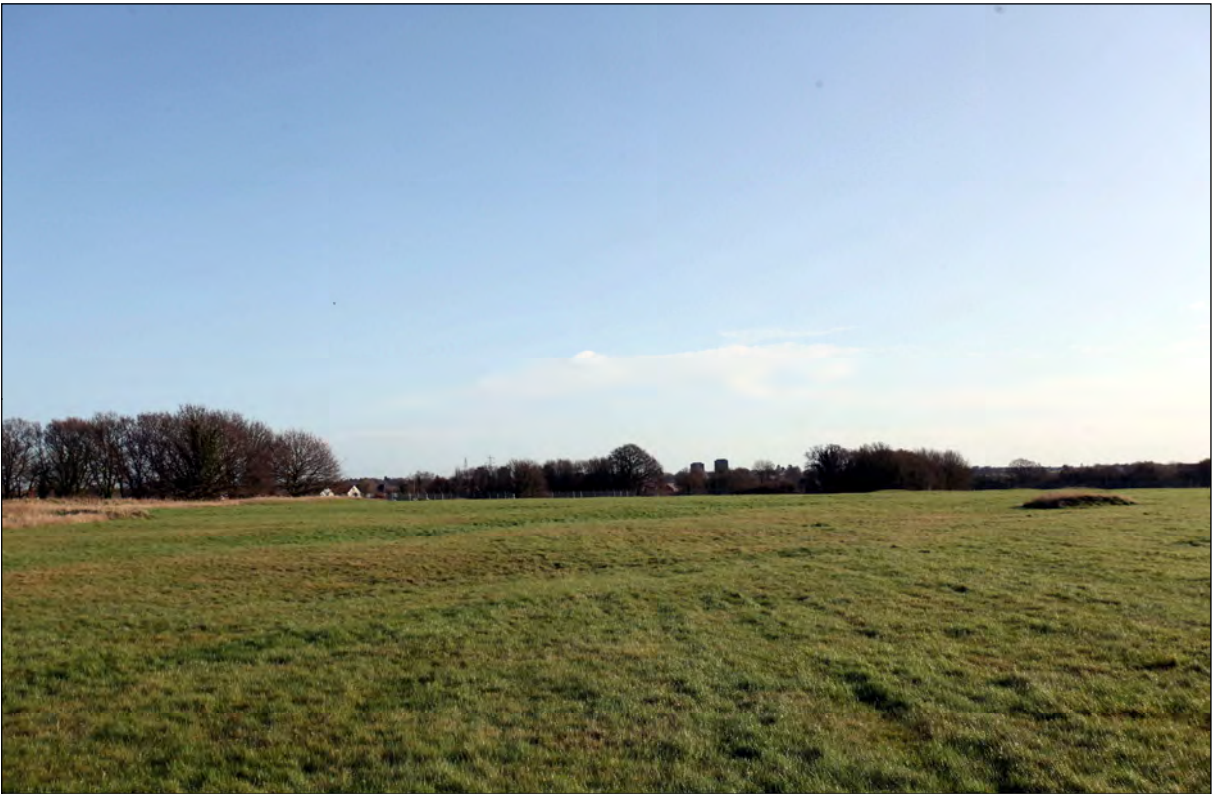
Plate 4) View looking south east across Middlewick Ranges, showing undulations in the grass

5.2.4 A number of areas have been deliberately scraped flat, presumably providing the material to create the Stop Butts, while removing any visual obstructions between the firer and the target. **Plates 4, 9, 10, 11 & 12** show examples of this as observed on the Site visit.

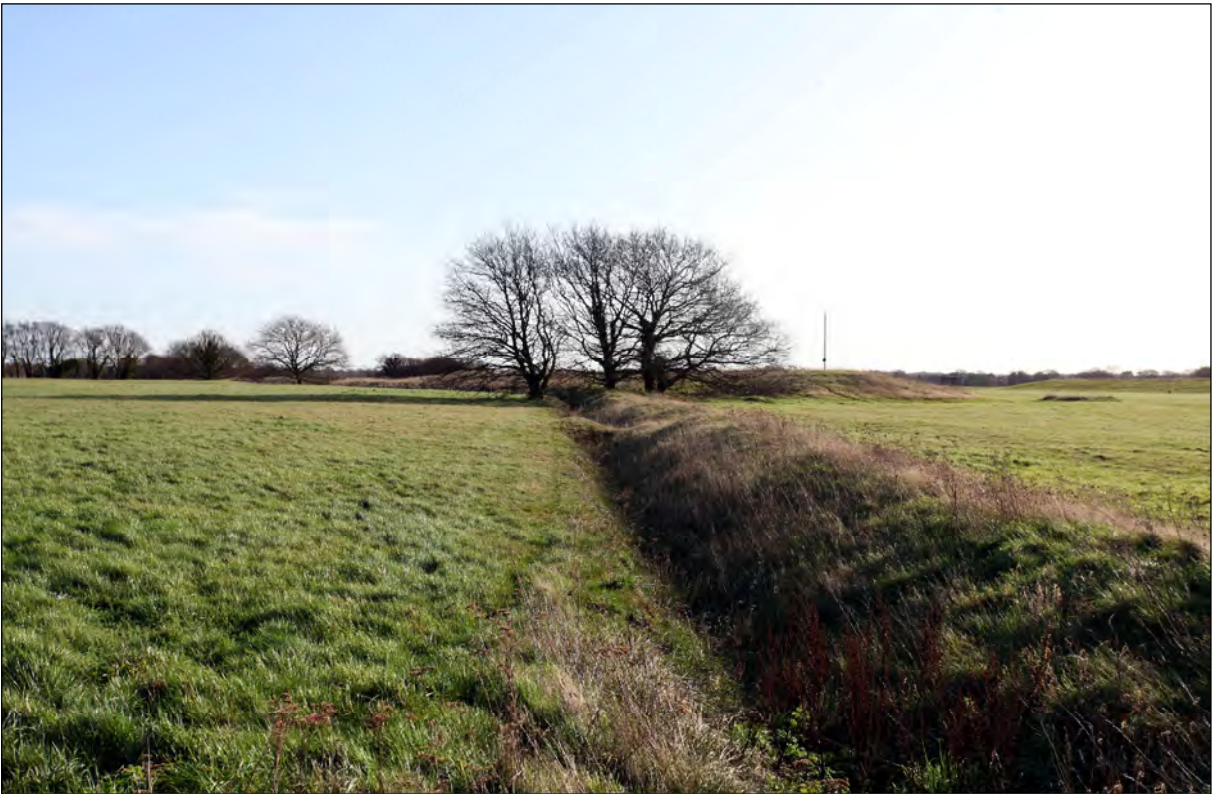
Plate 6) View of possible remaining section of anti-tank ditch looking east

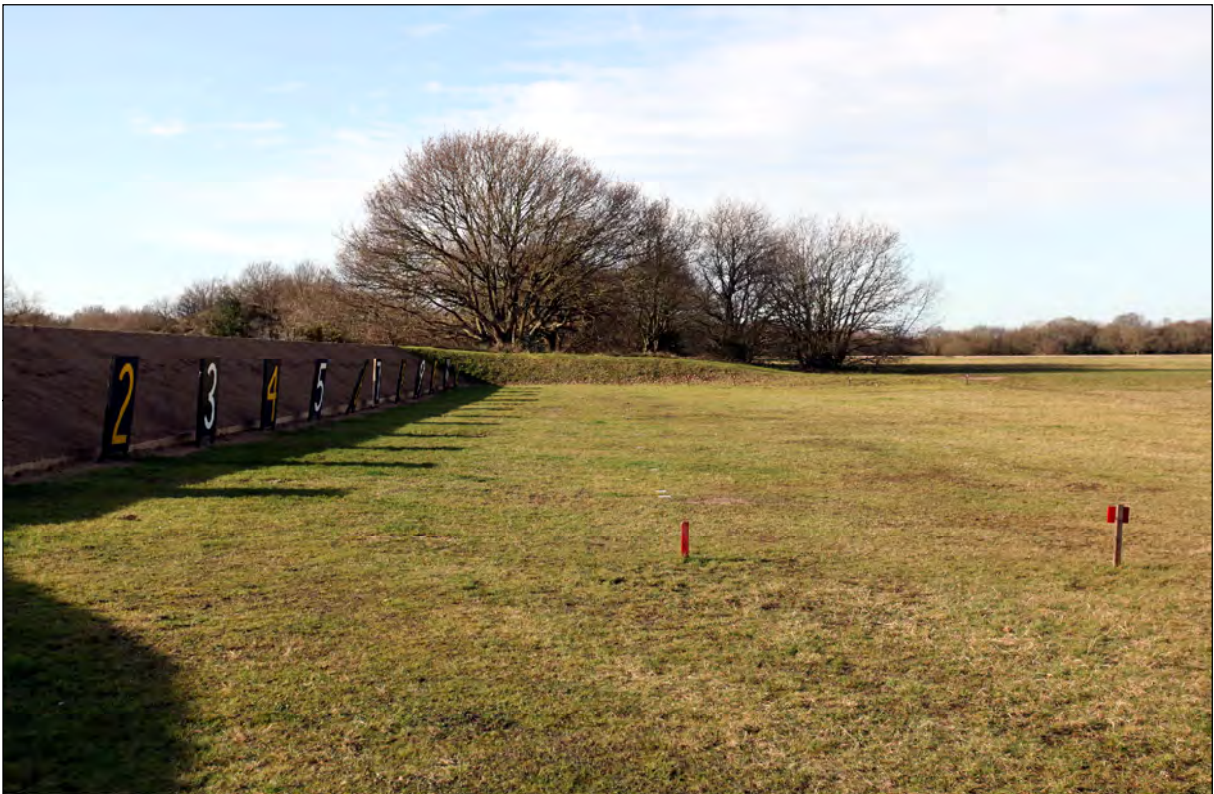
Plate 9) View of flattened area in front of shooting butts

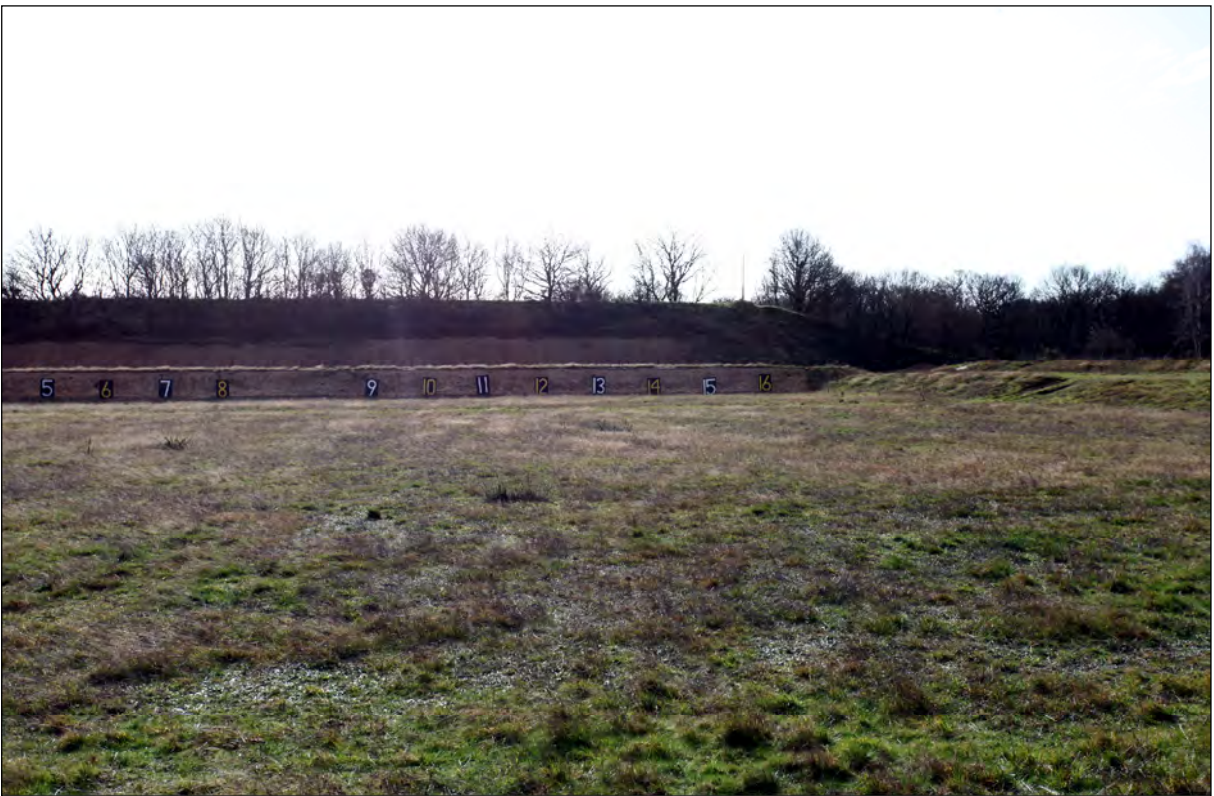
Plate 10) View of disused western training butt, demonstrating earth movement

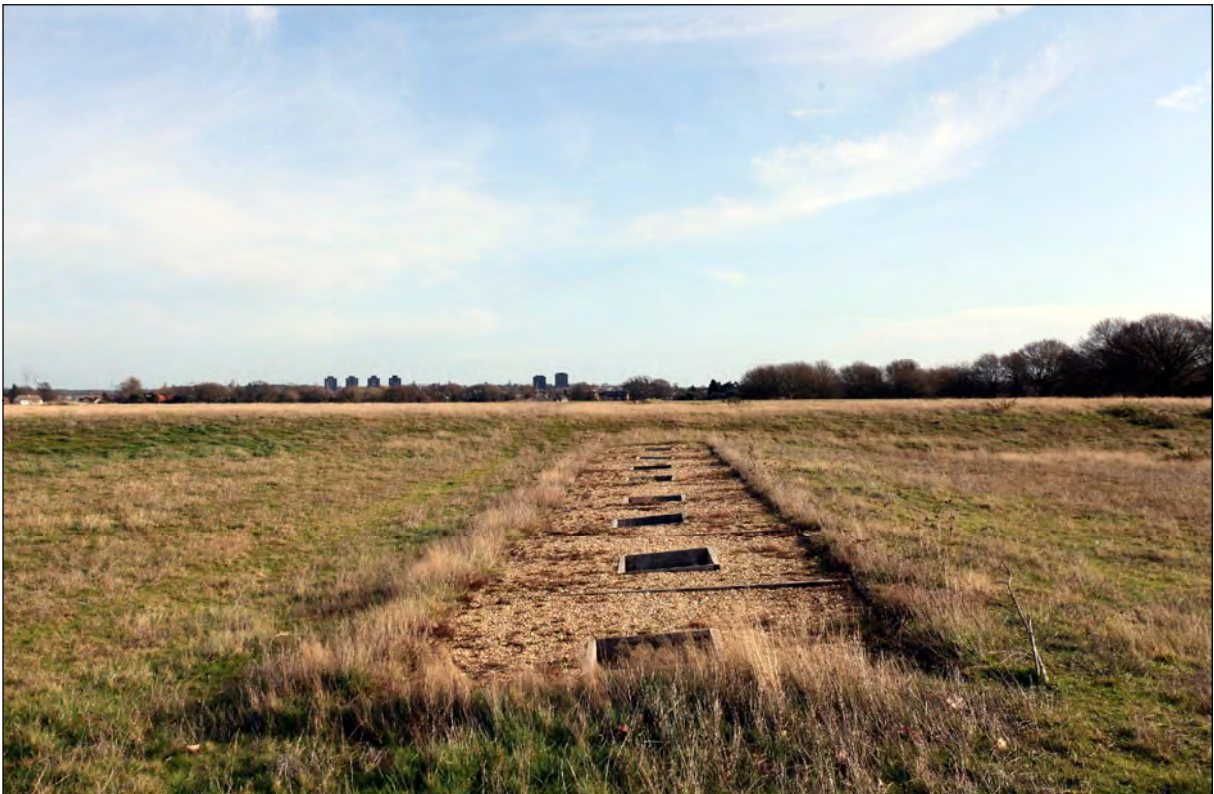
Plate 11) View of western rifle range showing earth movement

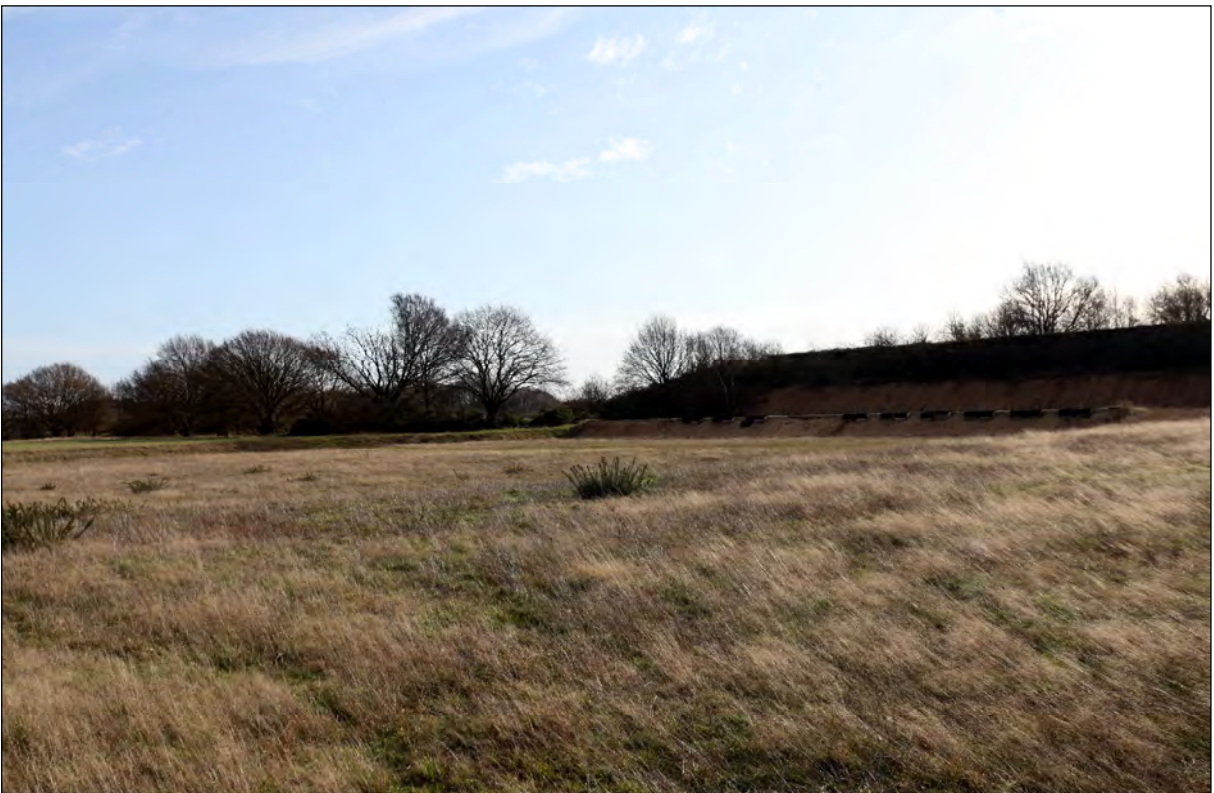
Plate 12) Disused rifle butt towards the centre of the Site

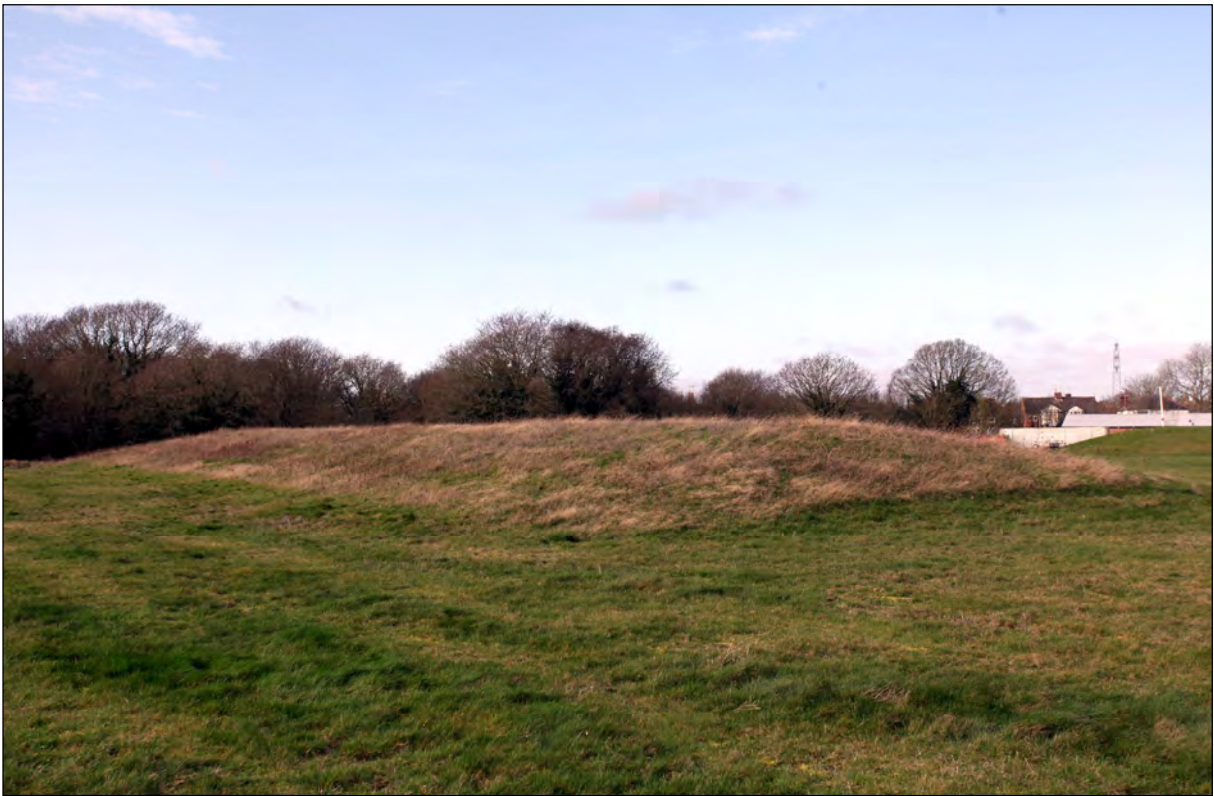
Plate 13) Earthwork associated with the rifle range

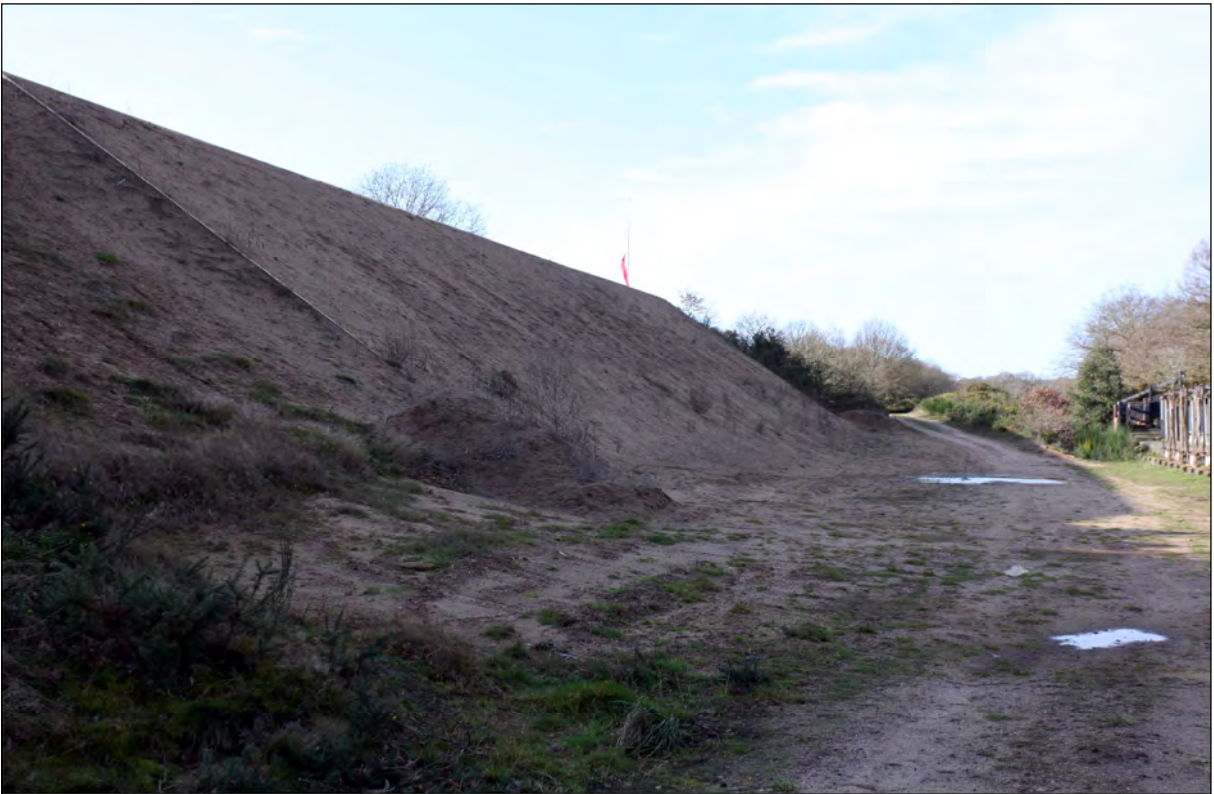
Plate 20) Sand bund to the south of the rifle butts

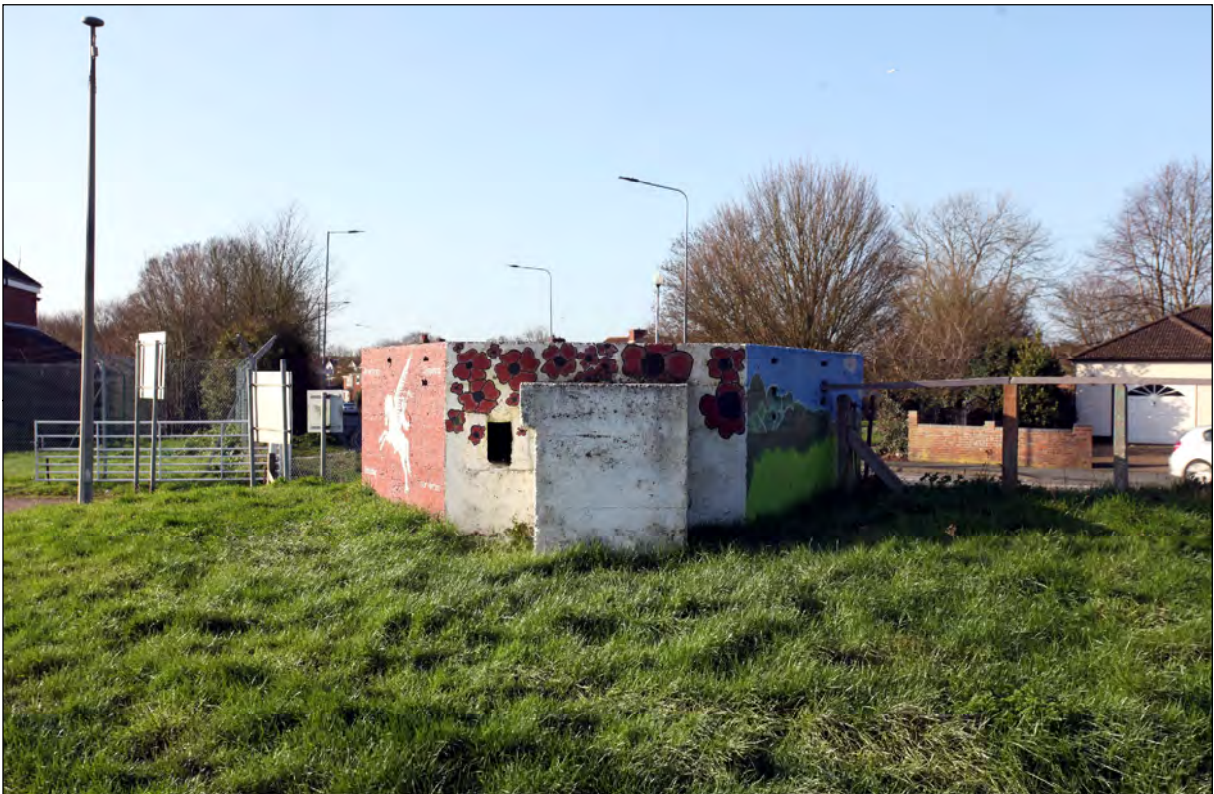
Plate 23) Pillbox (MCC5357) at western boundary of the Site

- Earthworks relating to the possible civil war redoubt (MCC8959);
- Anti-tank ditch (observed as a cropmark and visible as excavated on aerial photos) (MCC8706);
- Two Spigot Mortar's (MCC5358 & MCC5359);
- Two Pillboxes (MCC5357 & MCC5361); and
- Post-medieval to modern boundary stone (MCC5028);

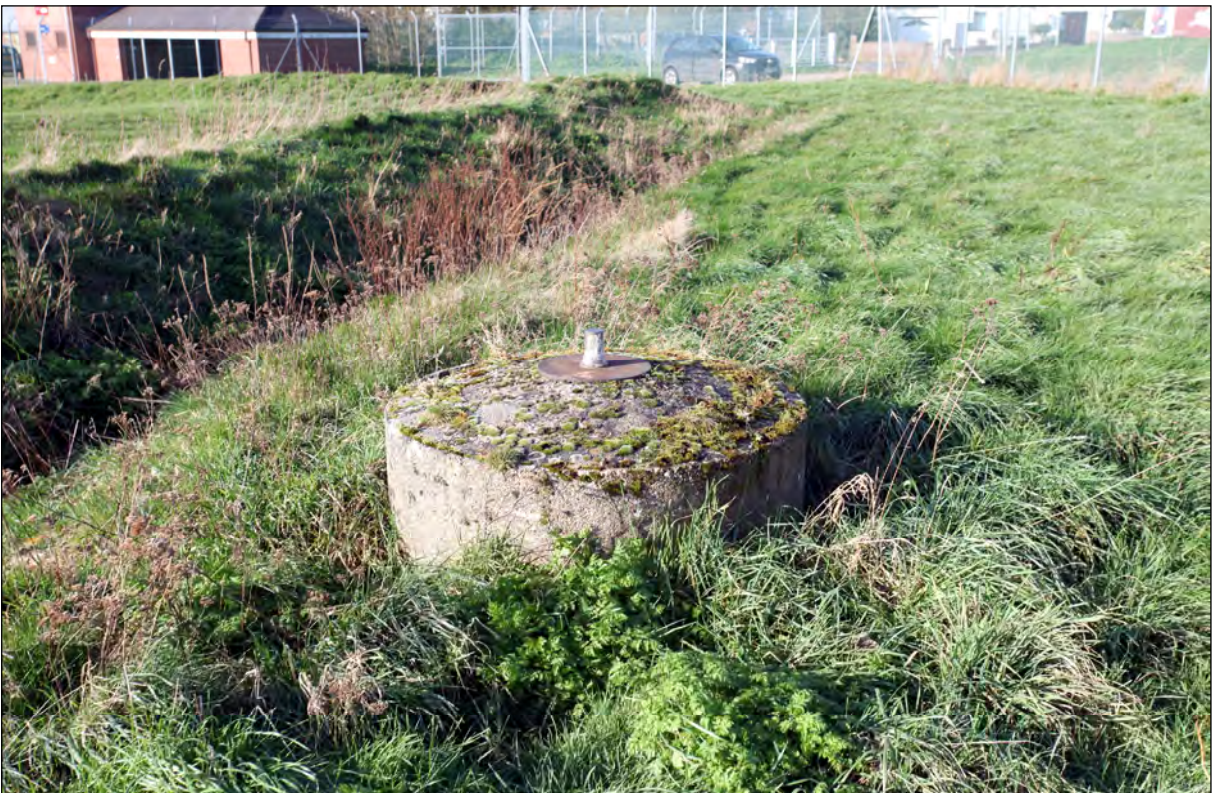
Plate 24) Spigot Mortar (MCC5359) located within the Site

- 4.4.63 MCC5359 lies to the east of MCC5357. An aerial photograph taken in April 1946 shows the pedestal within a typical spigot mortar pit with ammunition alcoves and the pedestal in the centre. The gun emplacement could be observed above ground at the Site (**Plate 24**) and the pit and alcoves probably survive below ground level. Both were placed to guard the anti-tank ditch MCC8706 and the route in from Mersea Road. Other spigot mortar gun emplacements and infantry posts lie within the Study Area (MCC5221, MCC5360, MCC5362, MCC5366).

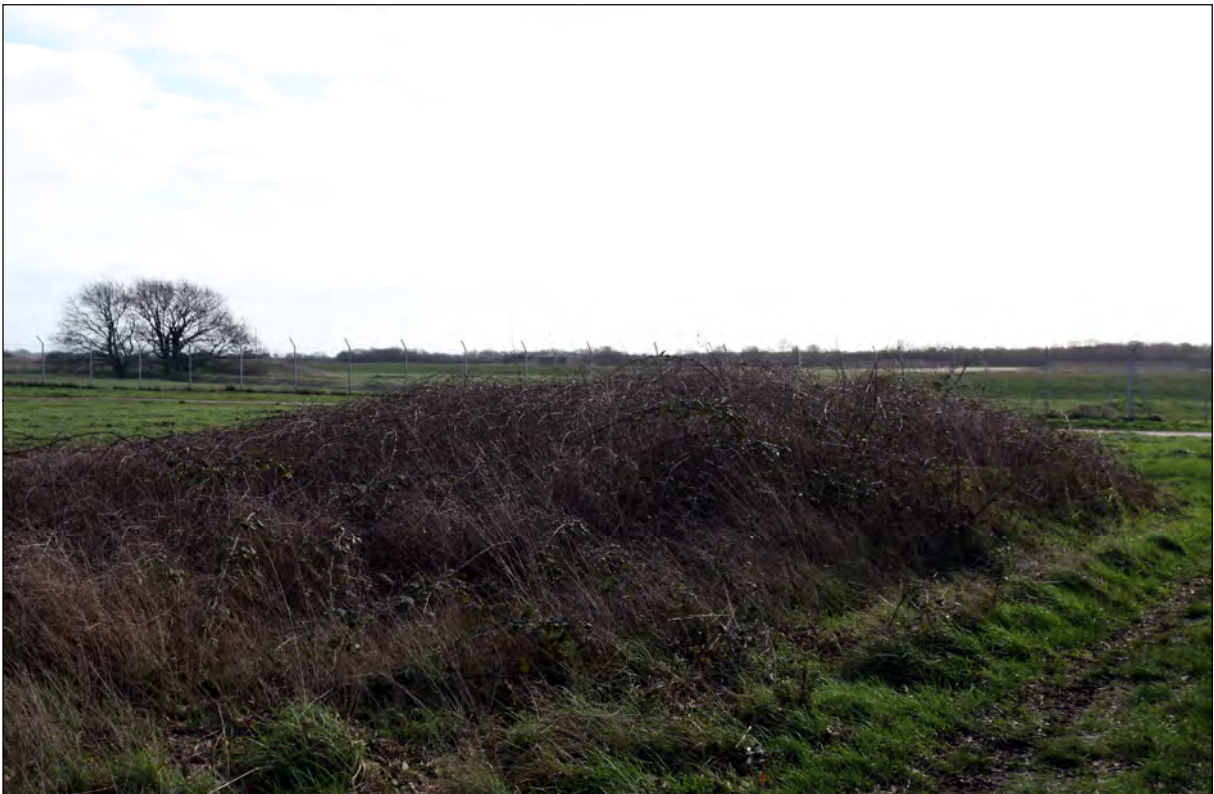
Plate 25) Brambles concealing Spigot Mortar (MCC5358) within the Site

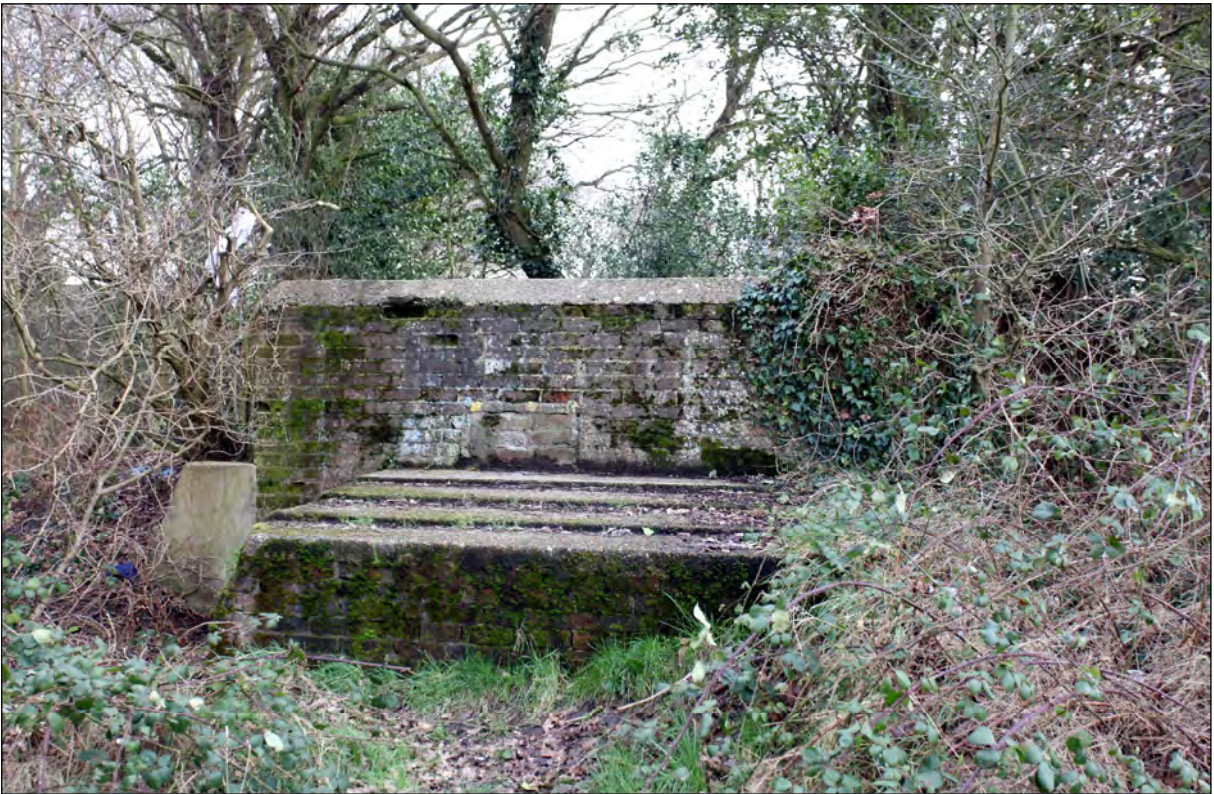
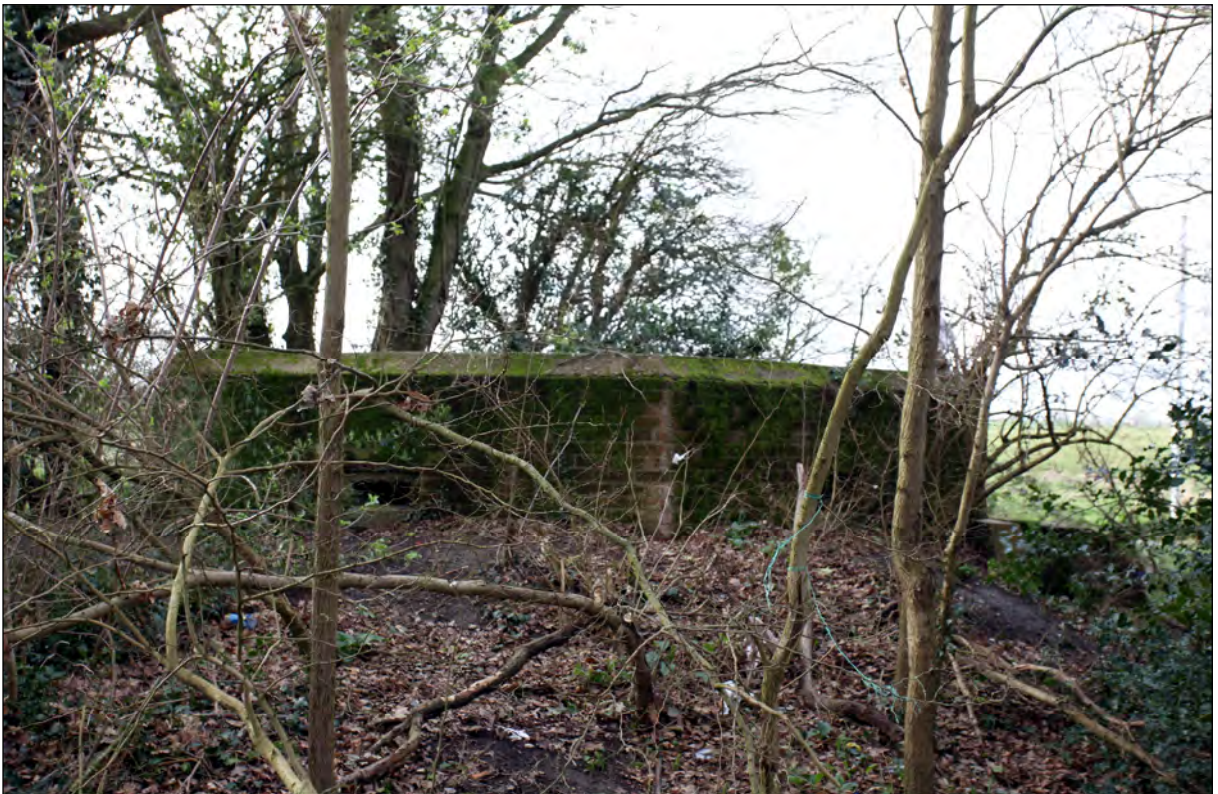
Plate 26) Pillbox (MCC5361) close to the eastern boundary of the Site

Plate 27) Pillbox (MCC5361) close to the eastern boundary of the Site

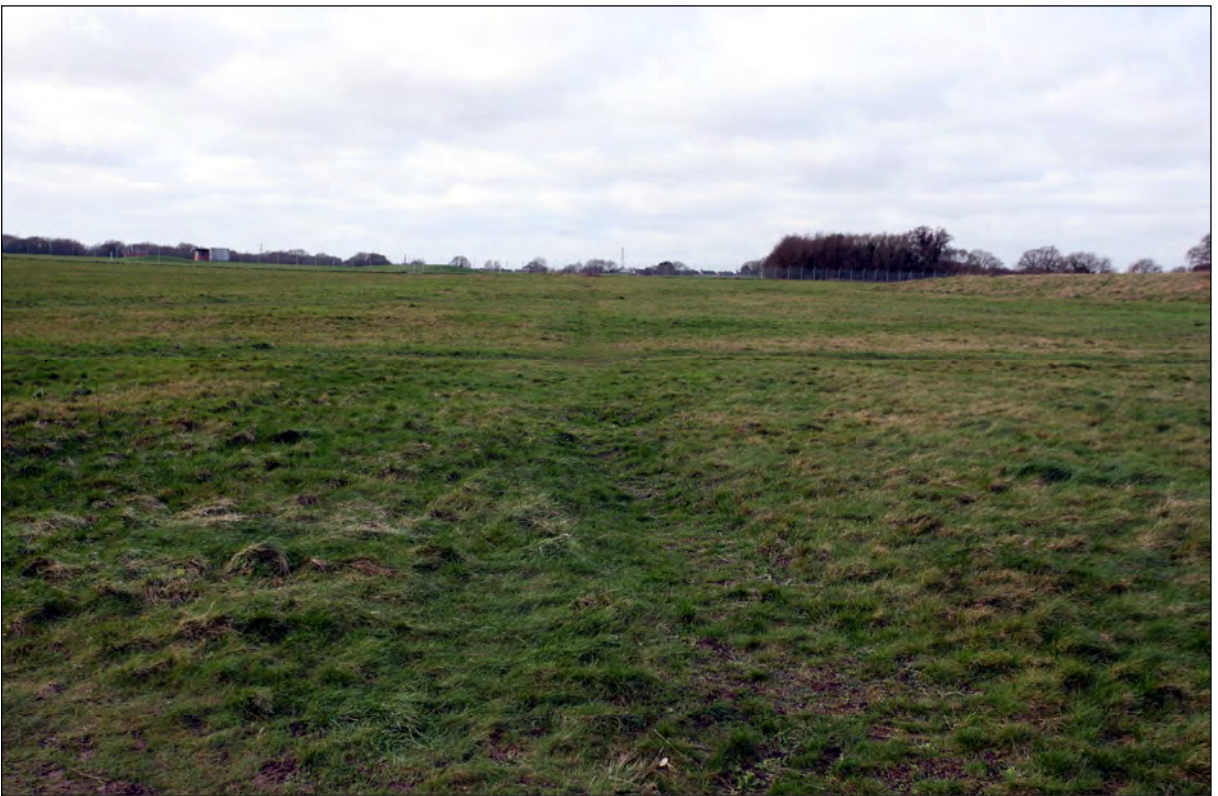
Plate 28) Depression at approximate route of anti-tank ditch (MCC8706) looking west from the eastern part of the Site

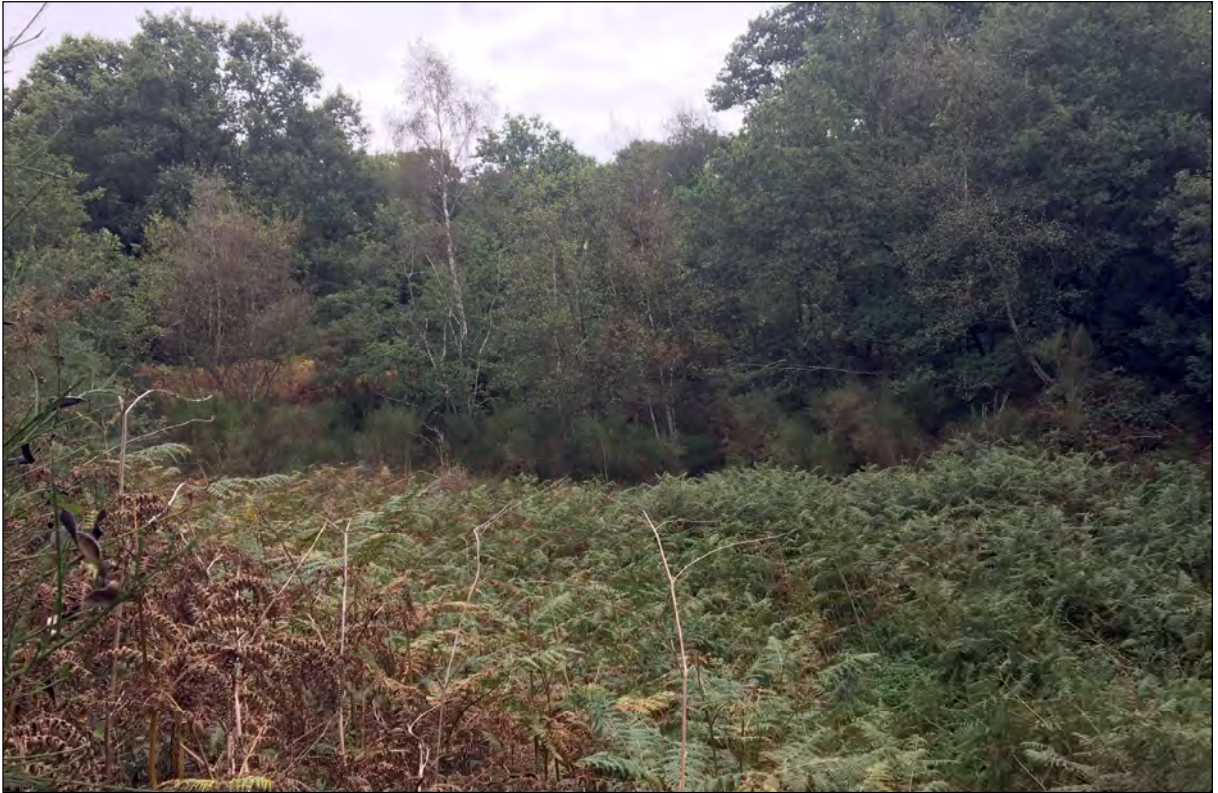
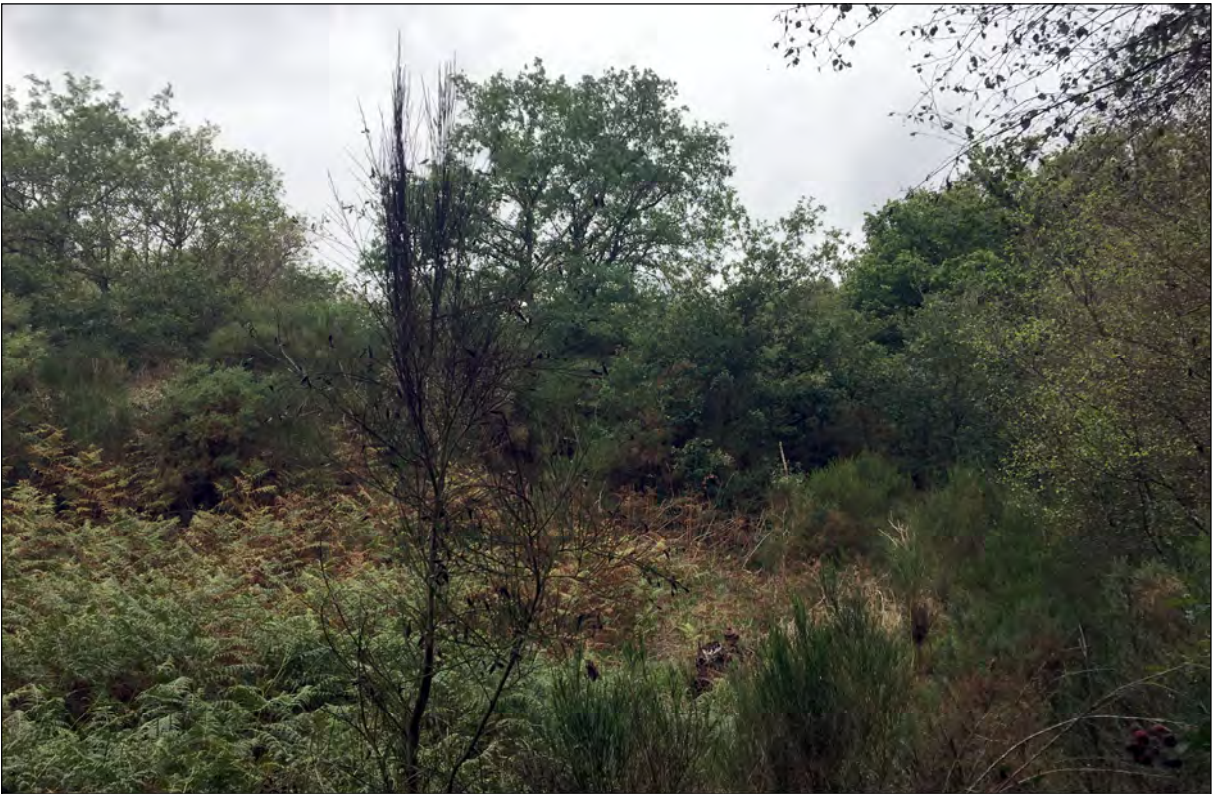
Plate 29) The Redoubt within the south western part of the Site looking north east across the monument

Plate 30) The Redoubt within the south western corner of the Site, looking west across the monument
