Construction noise and vibration Monthly Report – December 2020

Birmingham City

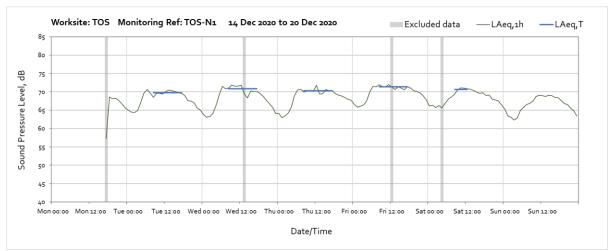
Worksite: Twisted Oak Stables (TOS) - Monitoring Ref: TOS-N1

The following graphs show the hourly measured ambient noise level $L_{Aeq,1h}$ and, where relevant, the averaged noise level $L_{Aeq,T}$ values, where the time period T is as specified in Table 1 of HS2 Information Paper E23. Periods with adversely weather affected noise levels are greyed out and have been excluded from the calculation of the $L_{Aeq,T}$ values in Table 3 of the main report.

Note: The noise monitor was installed at 17:00 on Monday 14th December 2020.

- 1.2.4 Noise and vibration monitors ref. TOS-N1 and TOS-V1 were installed to the north-west side of the Twisted Oak Stables worksite, at the boundary of the site, on Monday 14th December.

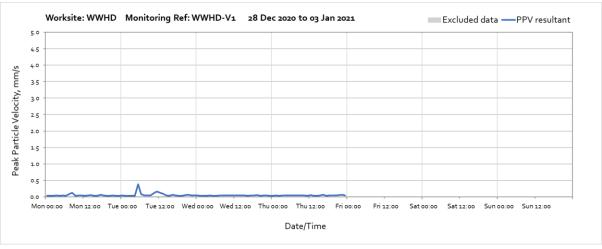
The following graphs show the hourly measured peak particle velocity PPV recorded during the monitoring period. The graphs show the resultant PPV due to vibration components on three orthogonal axis x, y and z. Where high values of PPV were caused by local interference with the vibration monitor, which are not representative of HS2 construction works, these values have been greyed out in the following charts and have been excluded to calculate values in Table 4 of the main report.

Note: The monitoring at this position was started at 13:00 on Tuesday 8th December.

- 1.2.3 Vibration monitor ref. WWHD-V1 was installed to the east side of the Washwood Heath Depot worksite on Tuesday 8th December and has been relocated at the same location as WWHD-N1, where more stable ground conditions are available, on Tuesday 15th December.

Worksite Reference	Measurement Reference	Monitor Address	Highest PPV measured in any axis, mm/s
MCC	MCC-V1	25 Dolman Street (Top Floor)	1.68 (Z-axis)
	MCC-V2	25 Dolman Street (Outside)	0.57 (Y-axis)
WWHD	WWHD-V1 (old)	Drews Lane, Birmingham	4.26 (X-axis)
	WWHD-V1	Drews Lane, Birmingham	1.95 (Z-axis)
TOS	TOS-V1	Along B4118- Birmingham Road, Water Orton, Birmingham	2.63 (X-axis)

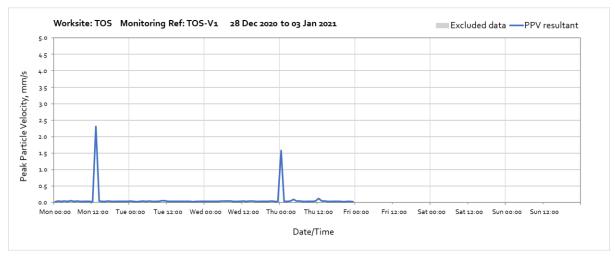
Worksite: Twisted Oak Stables (TOS) - Monitoring Ref: TOS-V1

Note: The monitor was installed at 17:00 on Monday 14th December 2020.
