Construction noise and vibration Monthly Report – December 2020

North Warwickshire Borough Council

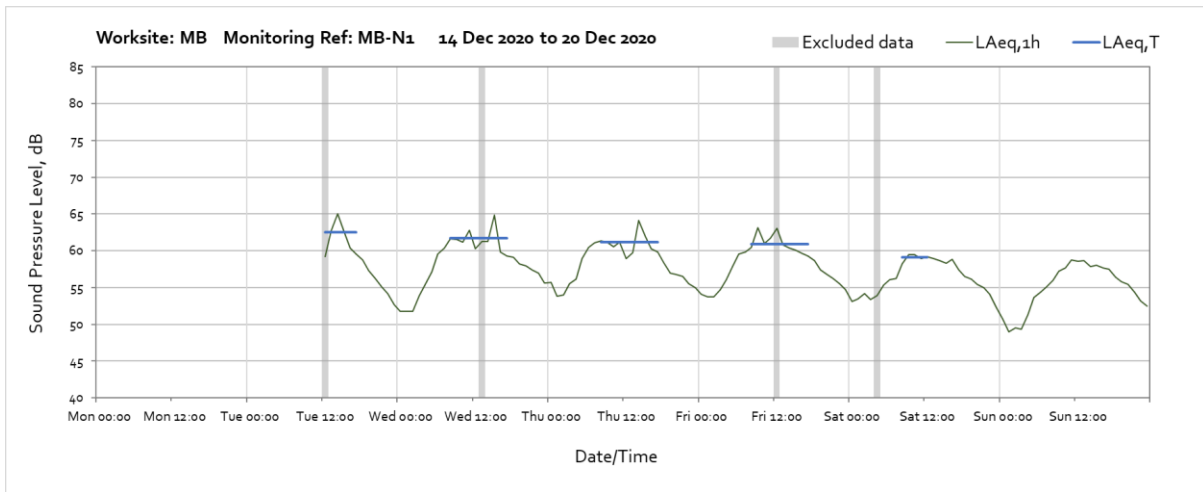
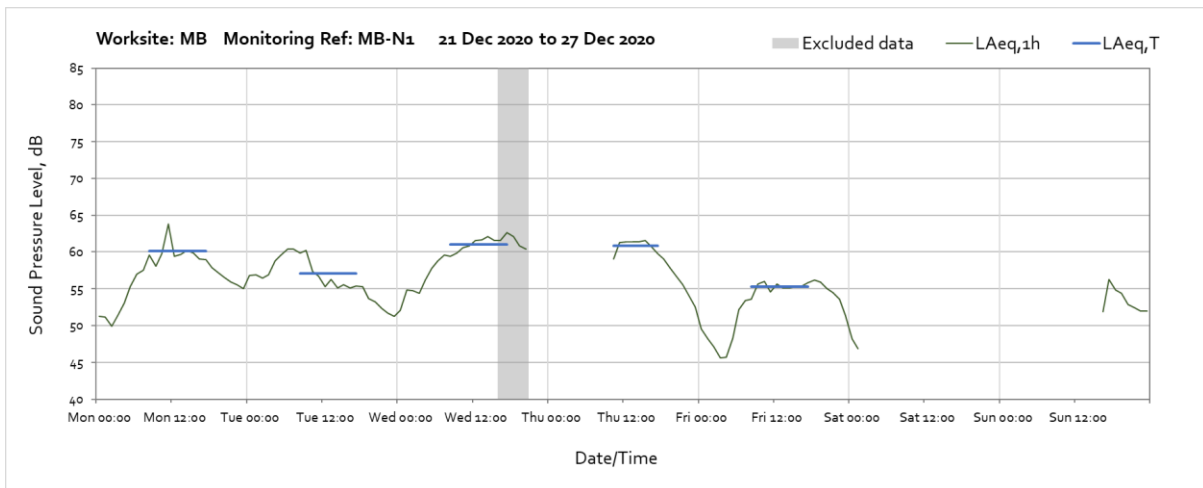
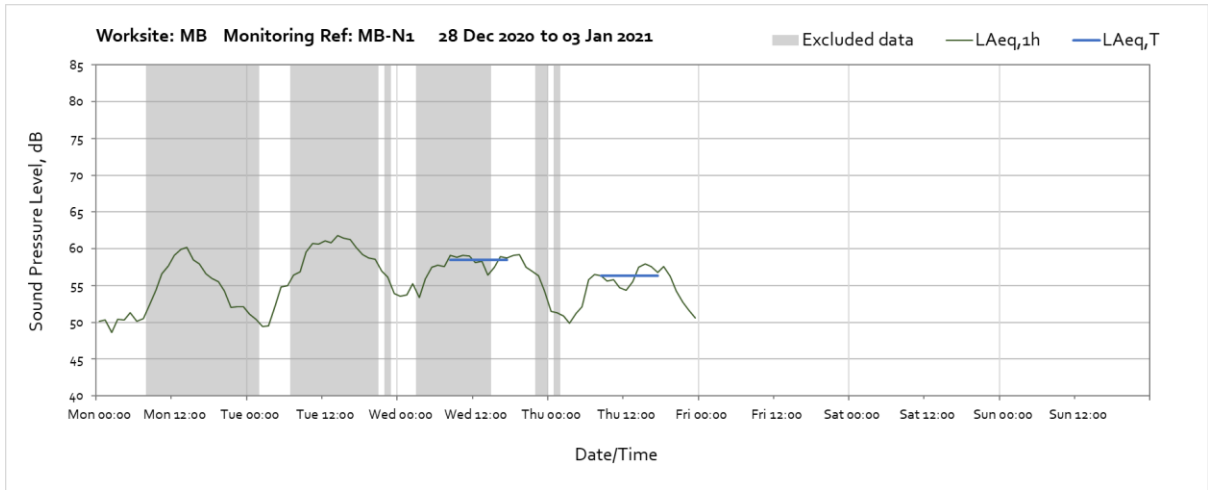
Worksite: MB – Monitoring Ref: MB-N1

Note: The monitor was installed at 12:00 on Tuesday 15th of December 2020.

Note: Missing data between 21:00 on Wednesday 23rd December and 10:00 on Thursday 24th December was due to temporary live data outage due to a firmware issue. Site was not operational between 02:00 on 26th Saturday December and Sunday 27th December due to Christmas.

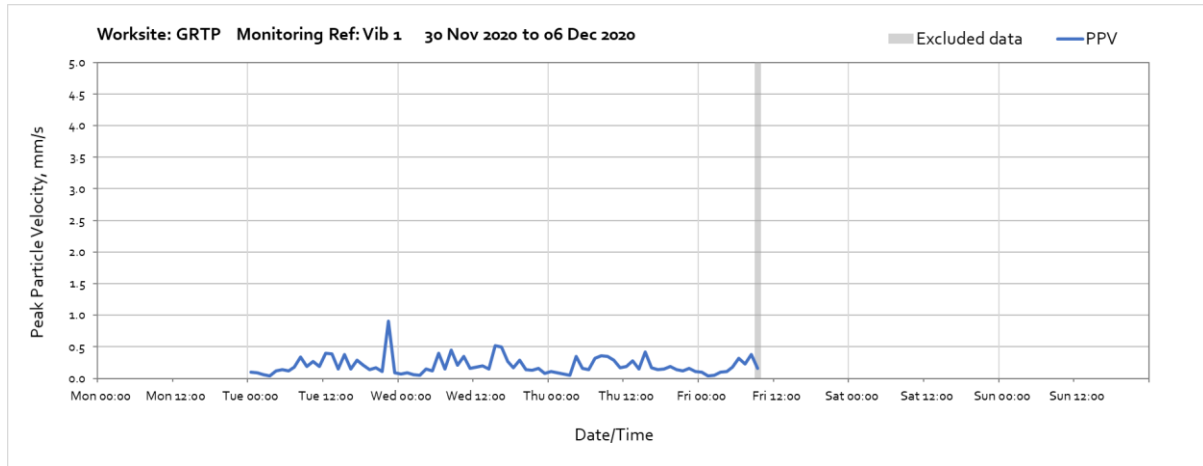
Worksite: Gilson Road Test Pile (GRTP) – Monitoring Ref: Vib 1

Note: The monitor was decommissioned at 08:00 on Friday 4th of December 2020 following completion of works at this site in September.

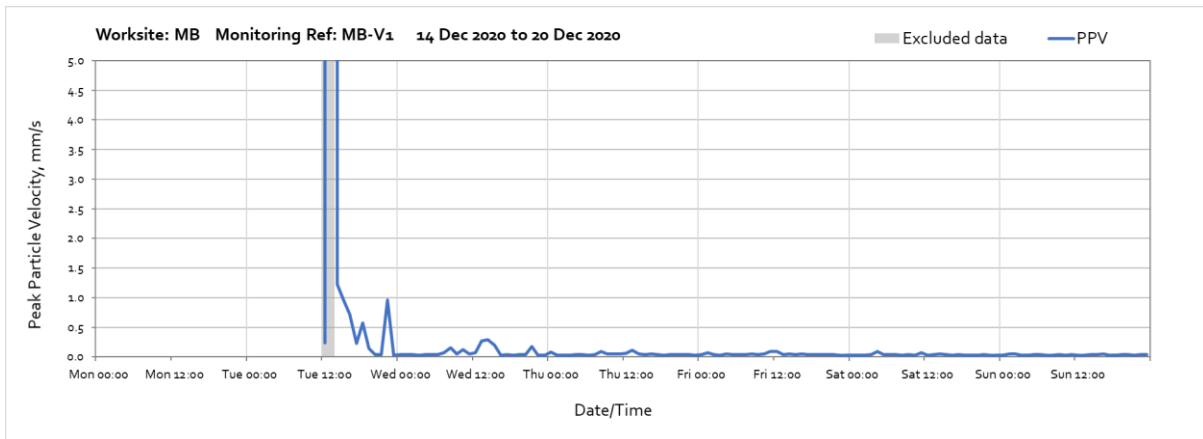
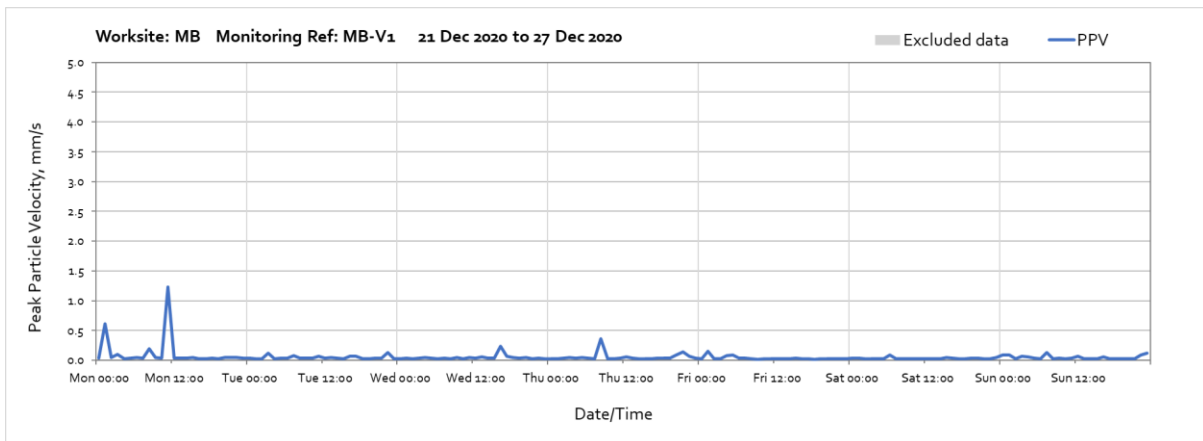
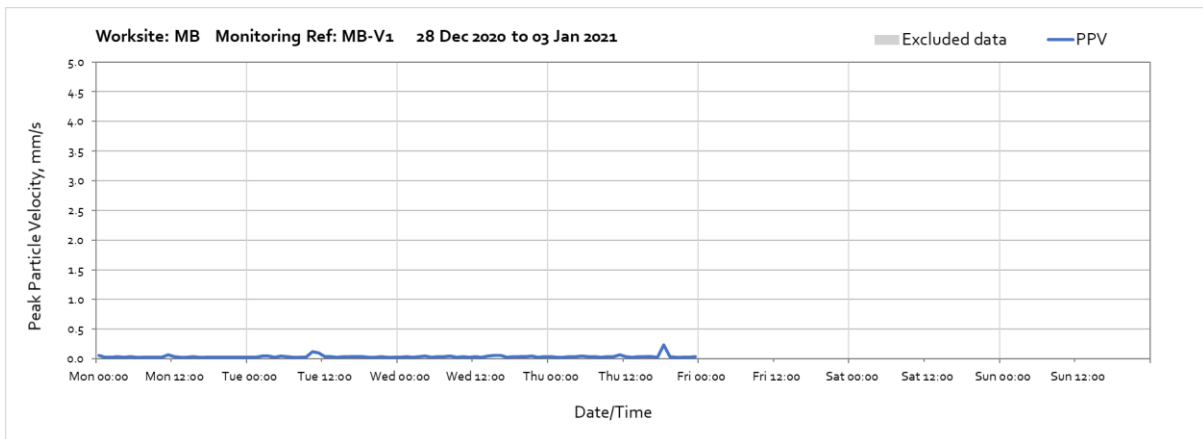
Worksite: MB – Monitoring Ref: MB-V1

Note: The monitor was installed at 12:00 on Tuesday 15th of December 2020.
