## **Construction noise and vibration Monthly Report – January 2021**

**London Borough of Hillingdon**

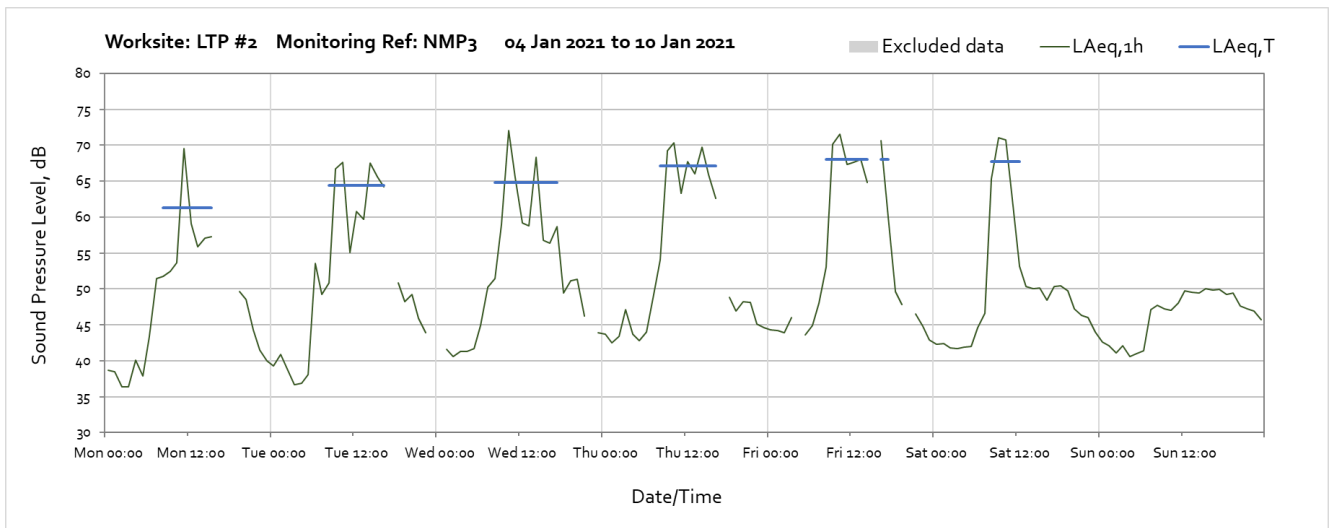
Note: Missing data between throughout the week was due to loss of power at the noise monitor and update and configuration issue of the noise monitor.

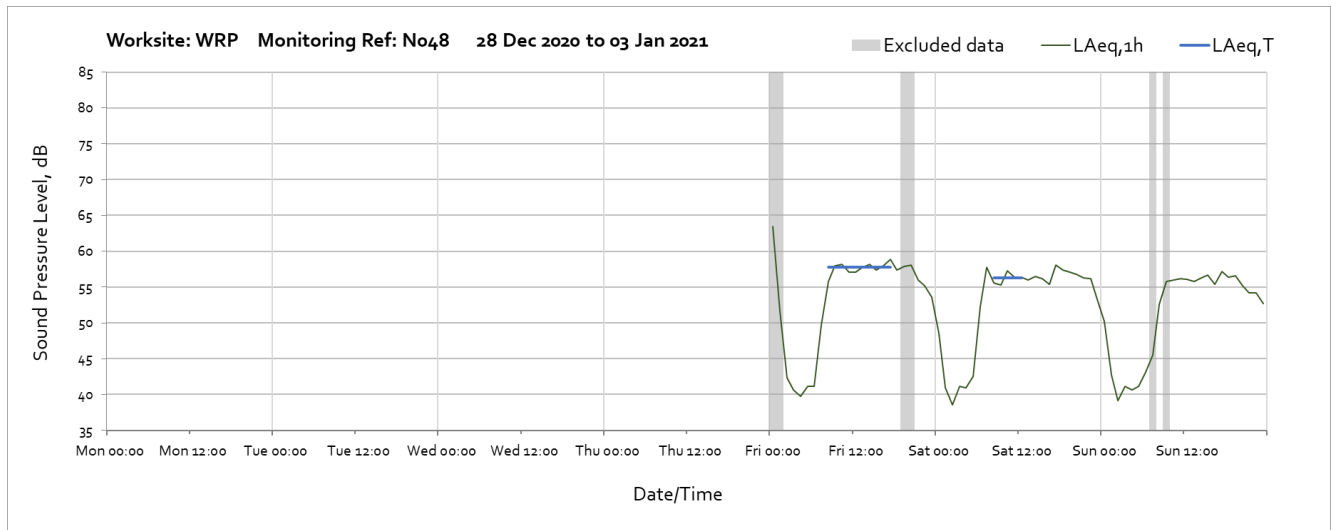
## Worksite: West Ruislip Portal (WRP) – Monitoring Ref: N048

Note: High noise levels on the early hours of the 1<sup>st</sup> January were due to New Year's Eve celebrations and have been excluded to calculate values in Table 3.

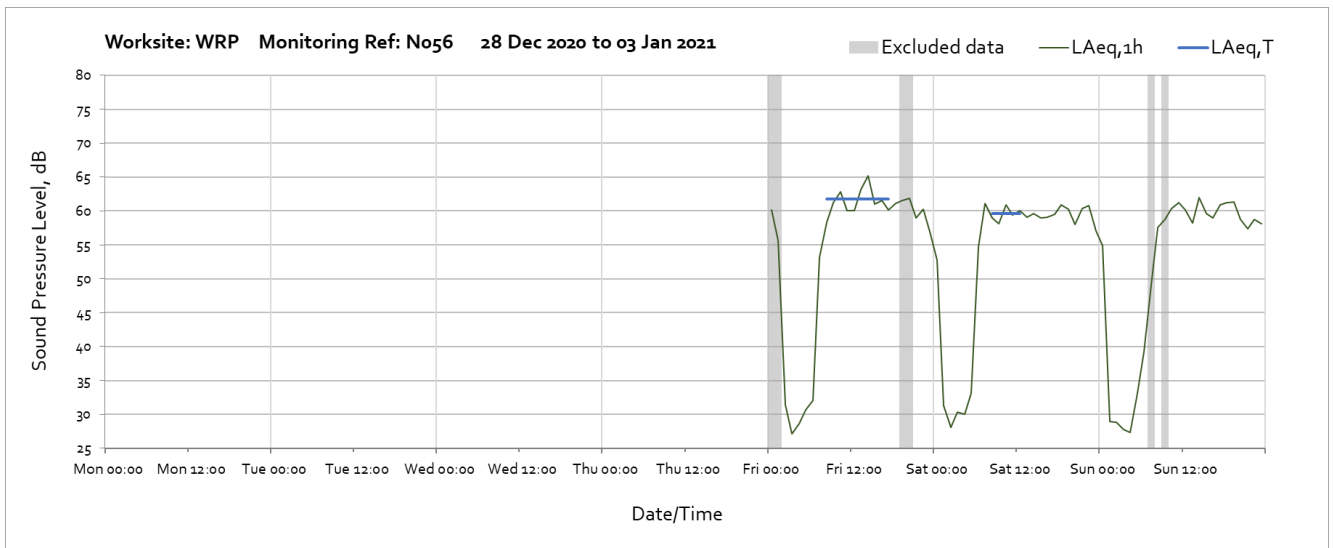
**Worksite: West Ruislip Portal (WRP) – Monitoring Ref: N056**

Note: High noise levels on the early hours of the 1<sup>st</sup> January were due to New Year's Eve celebrations and have been excluded to calculate values in Table 3.

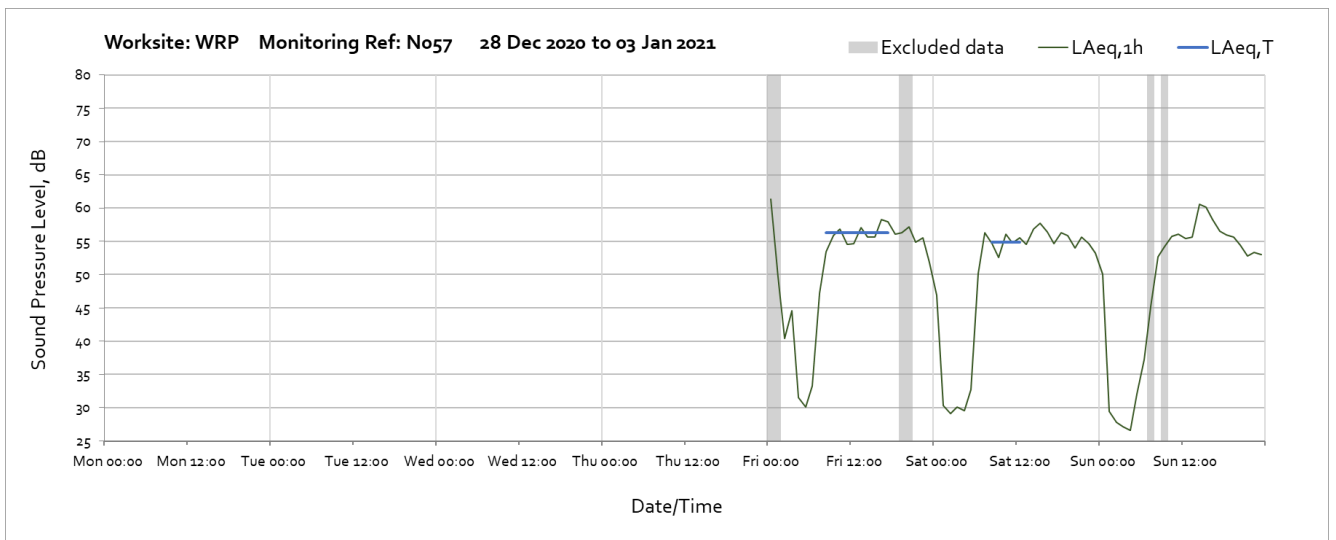
**Worksite: West Ruislip Portal (WRP) – Monitoring Ref: N057**

Note: High noise levels on the early hours of the 1<sup>st</sup> January were due to New Year's Eve celebrations and have been excluded to calculate values in Table 3.

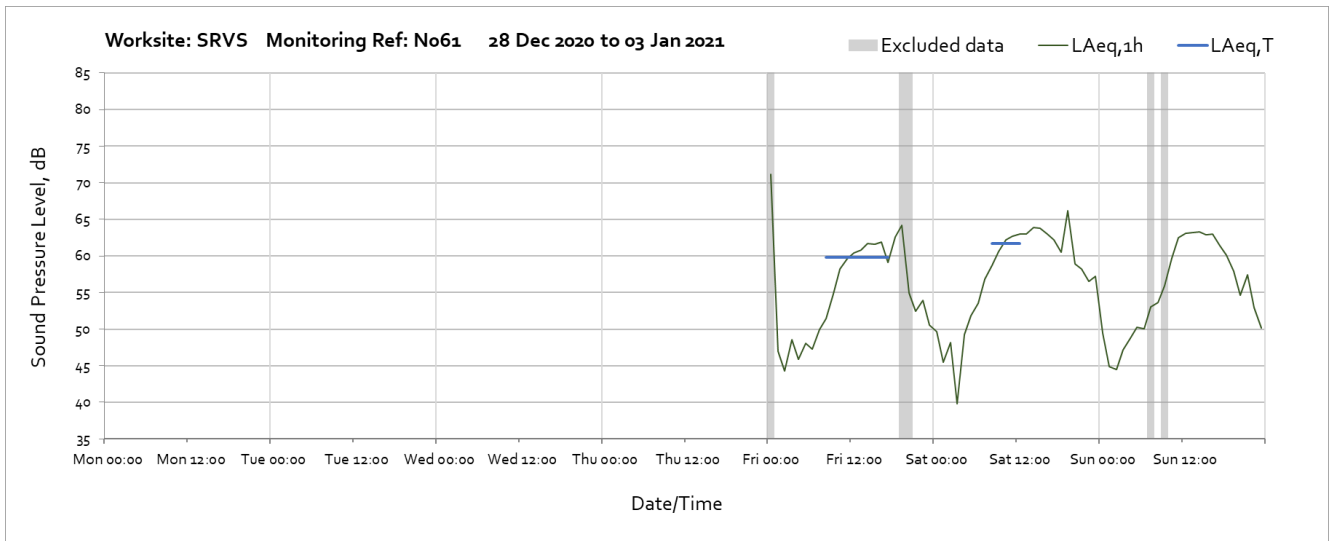
## Worksite: South Ruislip Ventilation Shaft (SRVS) – Monitoring Ref: N061

Note: High noise levels on the early hours of the 1<sup>st</sup> January were due to New Year's Eve celebrations and have been excluded to calculate values in Table 3.
