## Appendix E: WP6 – WDR testing

Prepared by UCL, CEGE

BEIS Research Paper Number: 2021/017

This report presents the analysis of the results obtained from the test campaigns developed in WP6: “*Wind Driven Rain (WDR) Simulation Tests on Real Size Cavity Walls Specimens*”.

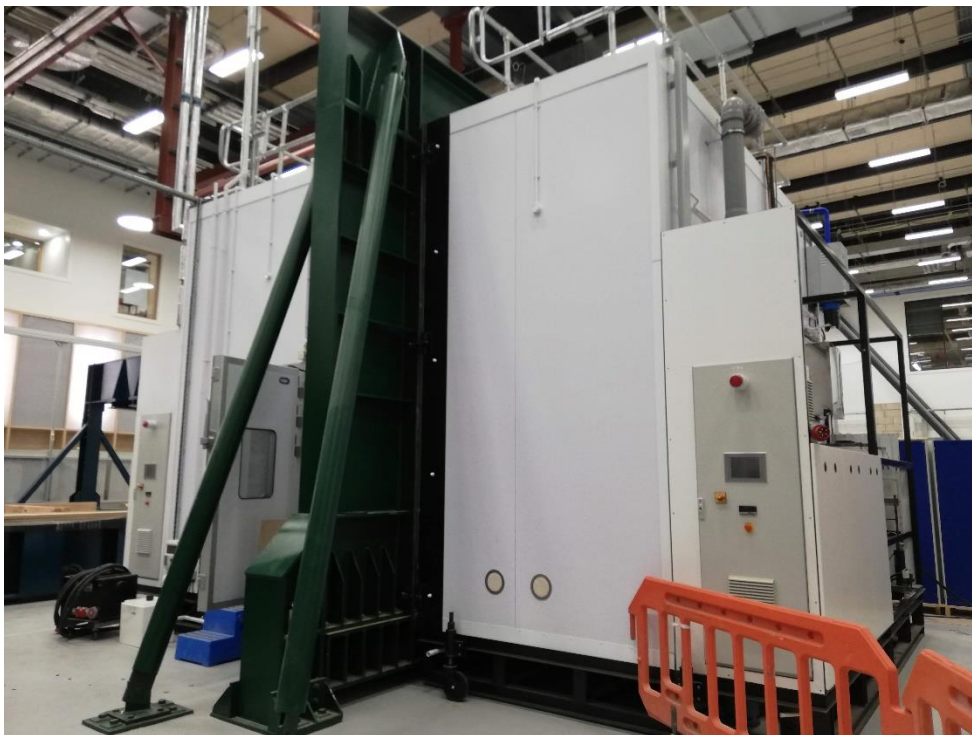
The coupled environmental chambers of UCL CEGE at Here East shown in Figure 2 were used in the WDR test to simulate indoor and outdoor environments simultaneously. The two chambers face each other and have a common mounting area interface of size 5m x 4m in elevation and 0.4m deep. To ensure the wall specimens can be fully and evenly impacted by the wind driven rain created by the rain simulator in the outdoor chamber, two wall specimens are tested simultaneously. In all, a repetition of three set of tests is conducted for insulated and uninsulated conditions, so as to expose six wall specimens. The first two tests consisted of a treated wall and an untreated reference wall, the third test compared directly the performance of treatments *B* and *C*.

Figure 2: UCL CEGE External-Internal coupled environmental Chambers at UCL-Here East

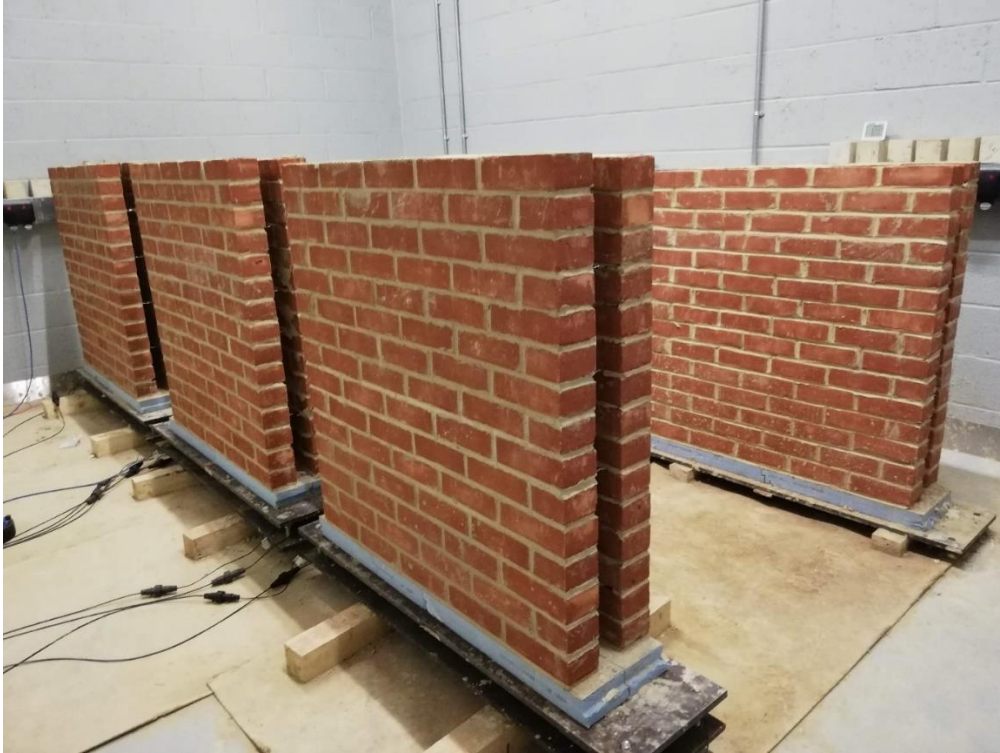
conducted in July 2019, providing a six-month curing period for the lime mortar. During this period the weight of the walls was monitored by placing load cells under each specimen. (see Figure 3)

Figure 3: Six wall specimens in the curing room, being cured for six months. The double set of plates with interposed loadcells can be seen under the first row of walls. Each specimen is built on insulating material to prevent temperature bridges from the plates

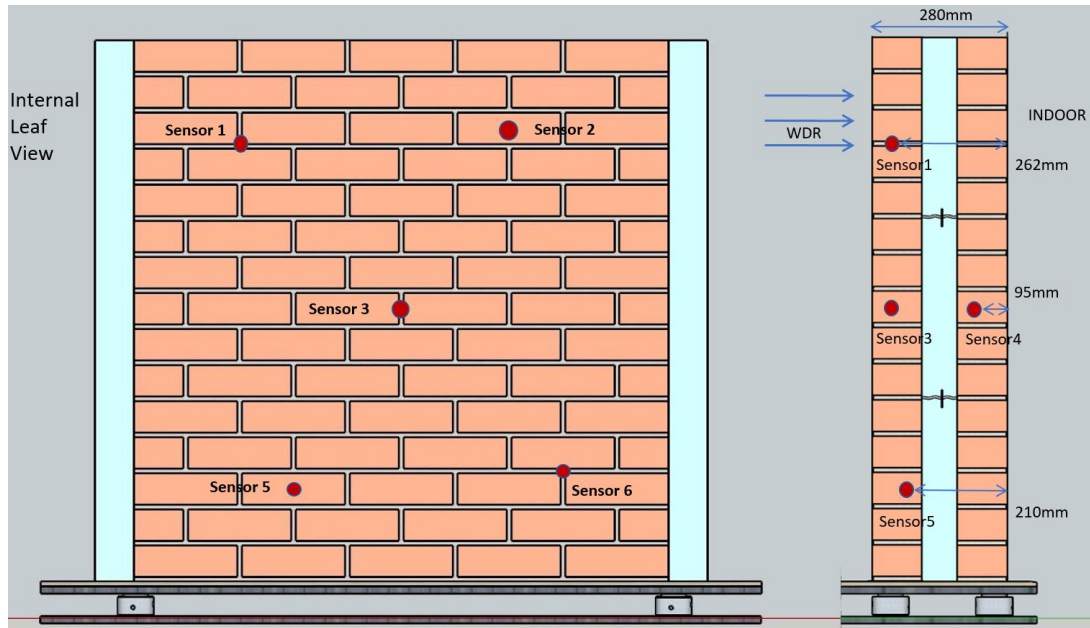
Sensor type	Position	Depth(mm)
T&RH 1	Mortar	262
T&RH 2	Brick	262
T&RH 3	Mortar	265
T&RH 4	Brick	95
T&RH 5	Brick	210
T&RH 6	Mortar	210

Figure 5: Layout of the in-wall T&RH sensors, and their depth into the panel with respect to the internal leaf. Sensor 3 is a high accuracy sensor.

For the purpose of determining the moisture uptake of the walls, each wall was monitored using 5 in-wall sensors with RH calibrated within  $\pm 2\%$  @55%RH and temperature measurement through NTC 10kOhms  $\pm 1\%$  direct output. Each wall was also equipped with one high accuracy sensor with humidity calibrated within  $\pm 0.5\%$  RH / 0.1 K at 10-90 %RH and 23 °C respectively. The detailed positioning of the in-wall sensors whose readings were logged using the CEGE NI LabView data acquisition system are shown in Figure 5 and Figure 6.

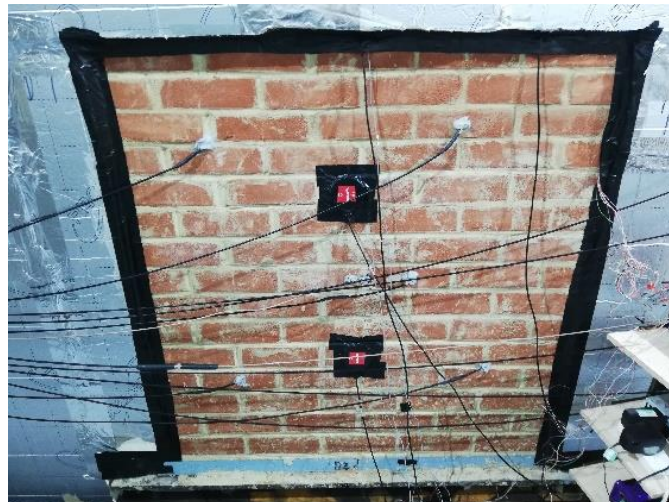
Figure 6: Position of the in-wall T&RH sensors seen from the internal leaf

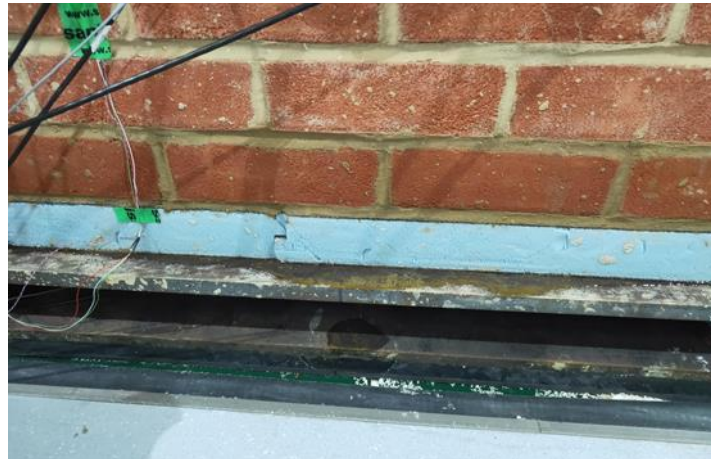
Figure 7: Example of water penetration to the interior surface of the interior leaf

On the first day of the test, 2 cycles were applied to the walls. This first day represents the wetting of the walls from dry conditions. The walls were then dried overnight for 14 hours at 20°C in both chambers. On the second day, up to 8 more cycles were applied or the test was concluded when water penetrated the walls' cavities and was observable on the interior surface of the interior leaf. Figure 7 shows that the bottom layers of brick and mortar were darker in colour compared to other layers due to water penetration. Liquid water can also be observed on the top surface of the upper steel plate.

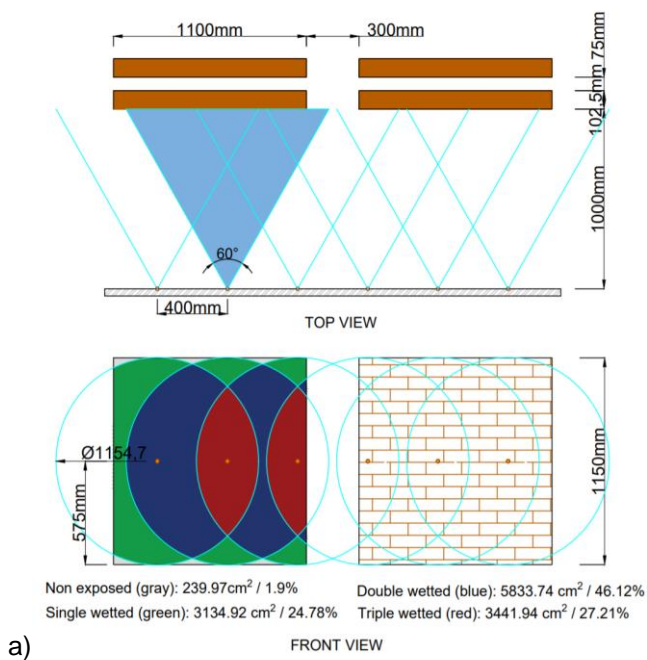
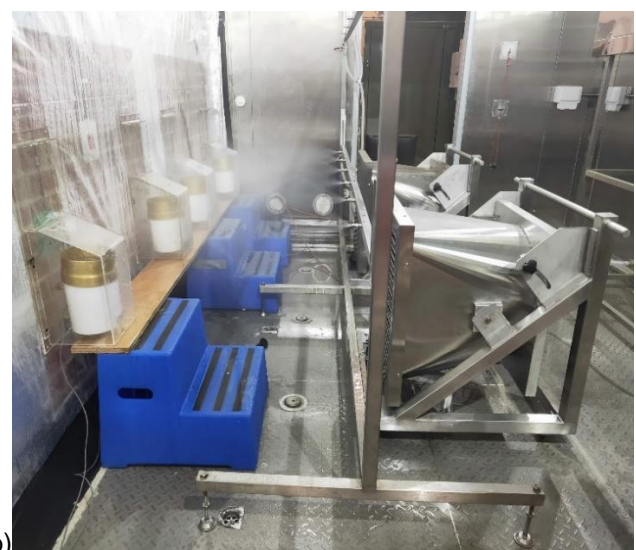
Figure 8: a) Theoretical patterns of wetting of walls during WDR tests    b) Calibration of water distribution with WDR gauges

During each wetting period, WDR gauges were placed in between the edges of the walls to confirm that a consistent amount of water was dispersed within the chamber and onto the external surfaces of the walls in each test. This confirmed repeatability of the test conditions throughout the testing programme.

Results of these measurements show that an average of 450ml of water was dispersed on 3 gauges over 400cm<sup>2</sup> surface area over 5 minutes. Based on this, the amount of rain dispersed on each wall can be calculated as 2.25 L/m<sup>2</sup>/min. (see Figure 8). This value compares well with the conditions specified in ASTM E 514/C1601 (2014) for masonry walls.

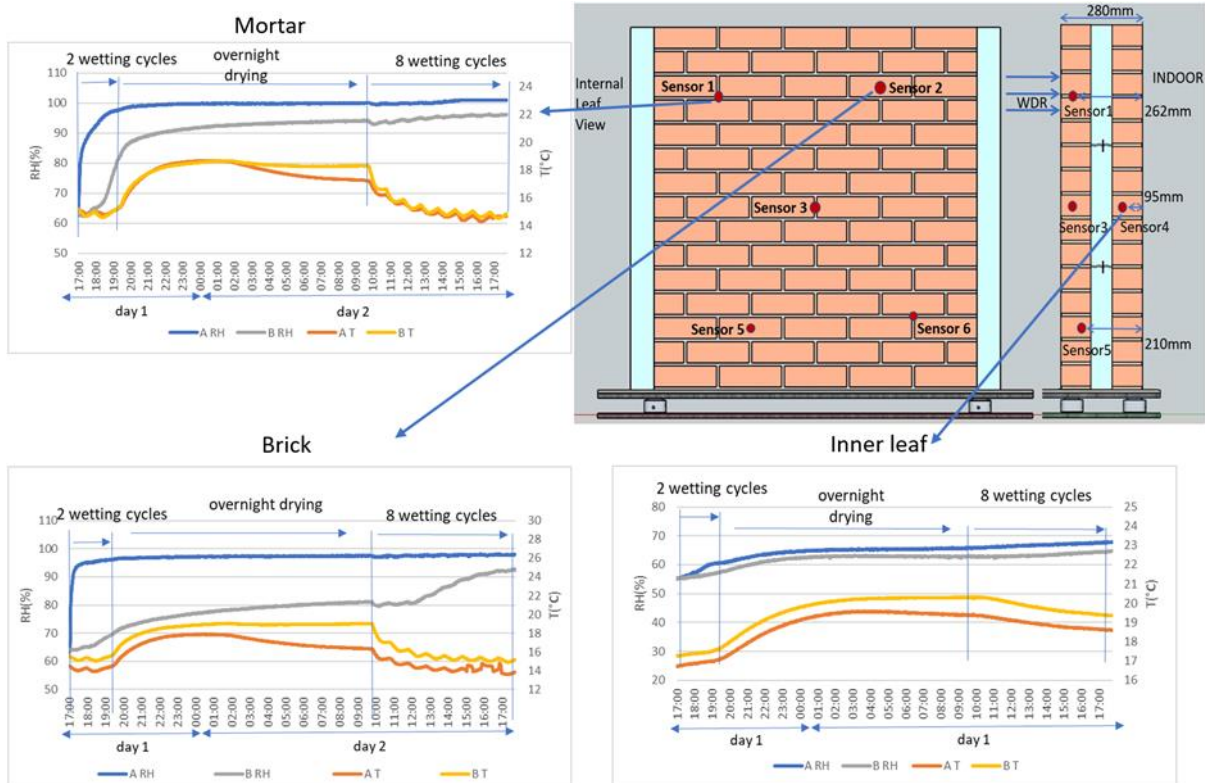
Figure 9: Variation of in wall temperature and RH for the untreated (A1) and B-treated1 (B1) walls in uninsulated test 1

As seen in Figure 9, for the wall treated with B product, the readings on S1 located in mortar show an increase in RH of 15% (ie from 65% to 80%) after the first two cycles, while the untreated wall had an increase of 23%. For S2 on the brick, the RH readings reached almost 100% after one cycle for the untreated wall, remaining then constant, while for the B-treated wall the increase was about 6% after two cycles. During the overnight drying, a further increase of 13% in the mortar and 10% in the brick RH sensors was observed for the B-treated wall. The eight cycles on the

The first test is to study the performance of treatment B by comparing the readings to an untreated wall. Two cycles of 20 min rain and 40 min drying at 15°C constant temperature were applied, and then the walls were left to dry overnight for 14 hours at 20°C, with no RH control. The indoor chamber was kept at 20°C constant through the entire test.

second day did not have much impact on the RH reading for the untreated one, while the B-treated mortar had a low increase of 1% from a starting value of 95%. S2 in brick showed no increase in the first three cycles and then an increase of 12% during the following five cycles, taking the total RH to 92%. This might be explained as a deterioration of the performance of the B product after a certain number of cycles of wetting and drying. However, the final total RH in the treated wall according to all instrument was still 5% lower than the untreated one.

The sensors S4 on the interior leaf of both walls had a gain of 13% RH over the whole test with a maximum difference of up to 5% in RH and 2°C in T between the untreated wall and the B-treated wall. The sensors on the outer leaf have shown temperature variations caused by the water dispersion on the walls. The reduction in temperature with the number of cycles reflects the uptake of moisture. The reduction in temperature due to the moisture absorption of the external leaf was recorded also at the internal leaf, notwithstanding the air cavity. However, the total reduction in temperature on the external leaf was about 4 to 5 °C while it was less than 2 °C on the internal leaf.

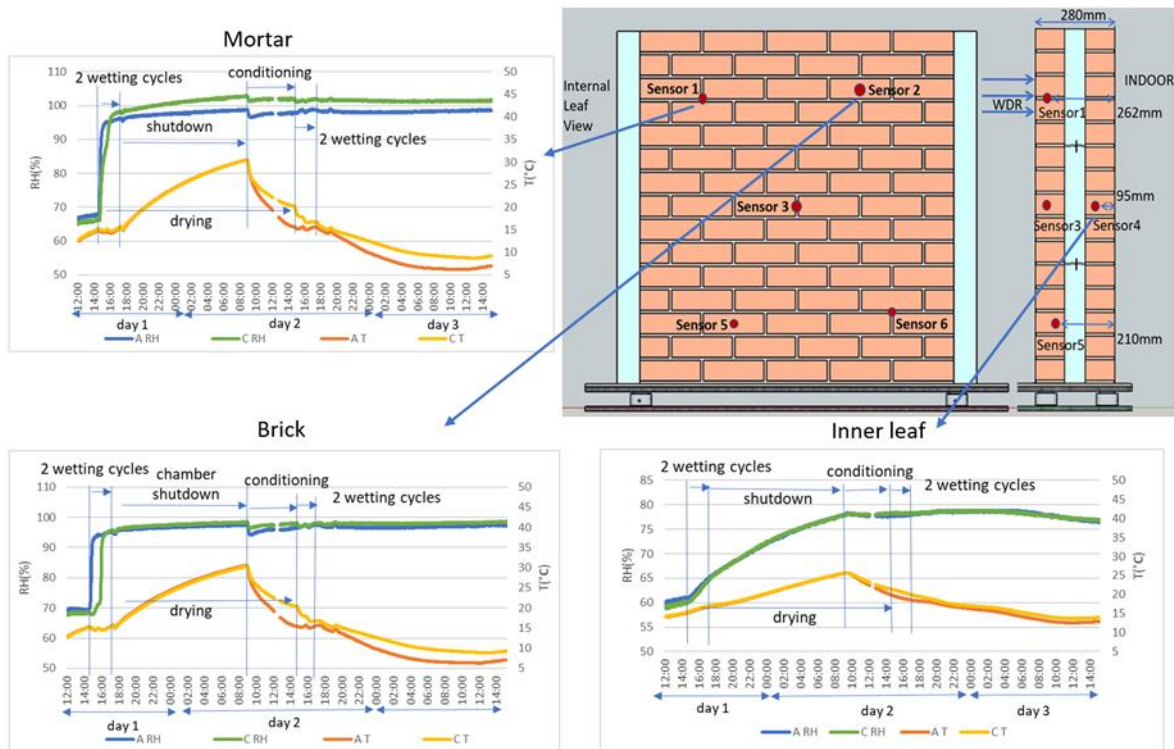
Figure 10: Variation of in wall temperature and RH for the untreated (A2) and C-treated (C1) walls in uninsulated test 2

The second test was to study the performance of C-treated wall in comparison to the performance of an untreated wall (Figure 10).

The initial testing protocol was as in the first test. During the first two cycles both sensors S1 and S2 reached values in the range of 100% RH for both walls with a slightly higher RH level in the case of C1.

The sensors on the internal leaf for both walls show an increase of about 18% of RH (12 percentage points) during the night period in correspondence with the shutdown, with a slight decrease following the conditioning and the cycles of wetting in the following day.

Overall the wall treated with C did not show much difference compared to the untreated wall. The RH gain was very similar over all sensors, however the temperature difference especially on the outer leaf shows that the C-treated wall has a better thermal performance than the untreated, with an overall 2°C higher T value.

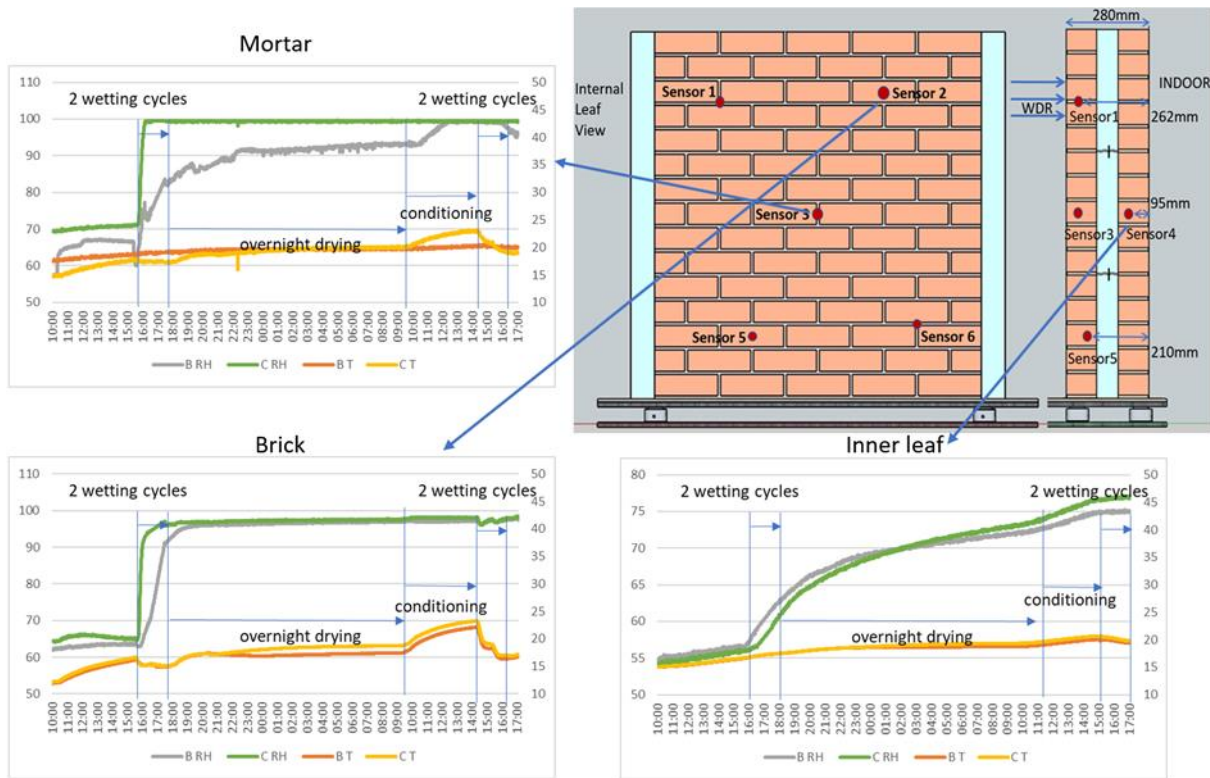
Figure 11: Variation of in wall temperature and RH for the C- (C2) and B-treated (B2) walls in uninsulated test 3

Two wetting cycles were applied to both walls on the first day and resulted in 100% RH readings of the C wall's external sensors and, for the B-treated wall, in substantial uptake of moisture during the 2 cycles up to 20% of RH increase at the mortar sensors S3, with a further increase of 11% RH during the dry period. The sensor S2 for the B-treated wall, reached 90% RH after the 2 cycles and 100% RH is attained during the drying period. After the overnight drying at 20°C, no humidity drop was observed on the in-wall sensors, so the outdoor chamber was conditioned at 25°C, 50% RH for 4.5 h. However, RH readings remained unchanged. During this period the RH sensor in mortar for the B-treated wall reached 100% RH. Two wetting cycles were then performed, which resulted in a slight loss of RH in the B-treated wall mortar sensor, while other sensor readings remained unchanged.

The inner leaf sensors showed an increase in RH overnight of about 15% during the dry period and then a further increase of 3% during the last two cycles. The B-treated wall showed a marginally better behaviour over the C-treated wall. However, the behaviour in temperature between the two walls was very similar, showing a constant behaviour overnight and loss of 3°C during the wetting cycles, as already observed in the previous tests.

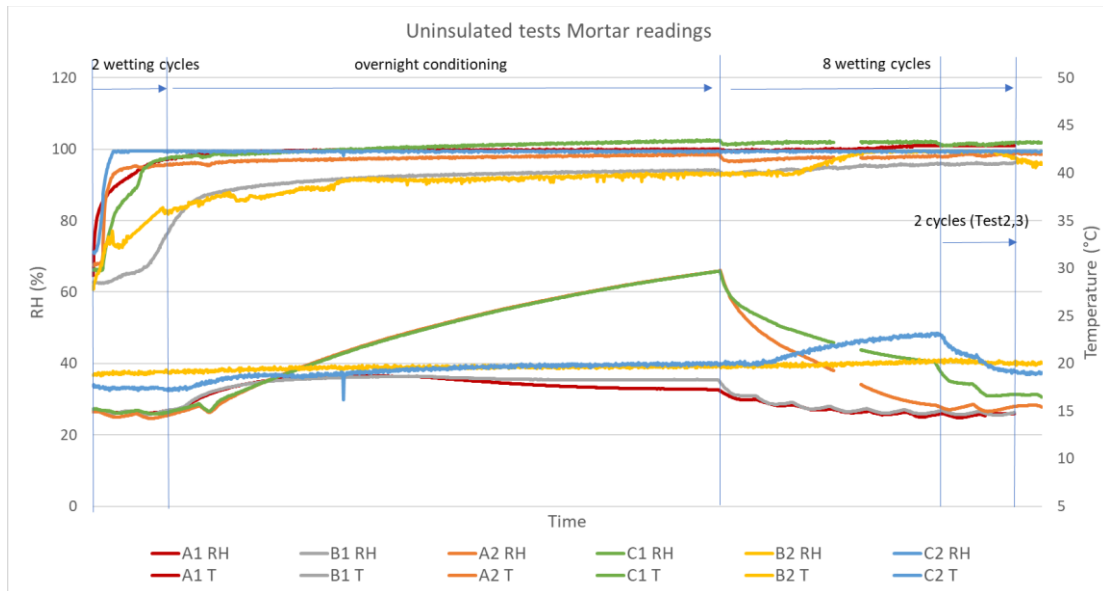
Figure 12: Variation in mortar T and RH for all walls in uninsulated tests

Figure 12 presents the RH and T readings of the sensors in mortar for each wall in the uninsulated tests. The total six walls contain two untreated walls, two B-treated walls and two C-treated walls. Both untreated walls reach 100% RH after the 2 wetting cycles on the first day with an increase of 35% RH, which remain unchanged to the end of the test. B1 and B2 started at same level of RH at around 60% but B1 has a slower and more stable RH gain compared to B2. RH increased by 8% at the end of 2 wetting cycles in day one and kept increasing after two hours into the overnight conditioning on B1. The 8 wetting cycles on the second day did not had much impact on B1 and only had a low increase of 1%. The performance of B2 was different from B1, in the first day, with an increase of RH by 22% during the first 2 cycles with spikes during wetting. The readings stabilized during the overnight conditioning but increased by 6% before the wettings on the second day, with no further increase during the 2 wetting cycles on the second day. C1 treated wall reached 100% RH by the end of the first 2 wetting cycles, on day one, while C2 sensor reached 100%RH within one wetting cycle.

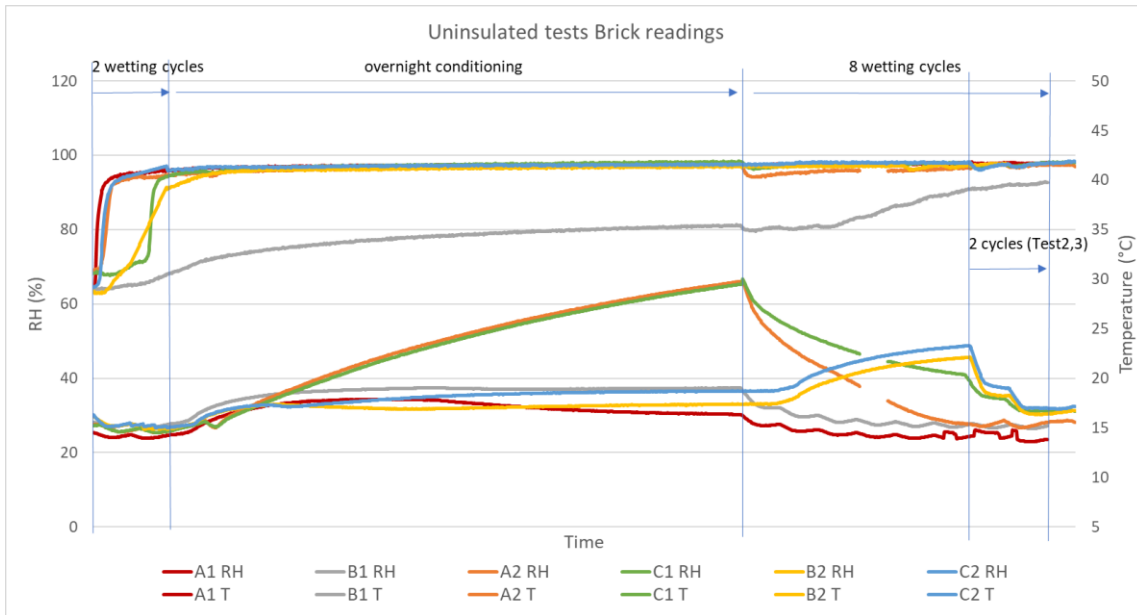
Figure 13: Variation of in brick T and RH for all walls in uninsulated tests

Figure 13 presents the RH and T readings of the S2 sensor in brick for each wall in the uninsulated tests. Both untreated walls maintained the consistency in the readings on mortar, both increased 35% in RH after the first cycle on day one and reached near 100% RH readings which remained to the end of the test. The performance between B1 and B2 was very different. B1 merely increased by 6% RH after two cycles and further gained 10% during the overnight conditioning. In the first three cycles of the 8 wetting cycles on the second day, B1 showed no obvious increase but increase by 12% in the following five cycles. This might be explained as a deterioration of the performance of the B product after repeated wetting and drying. B2 however, reached 100% RH readings after the first 2 wetting cycles on the first day and remained constant. C1 experienced a slow RH gain by 4% at the first wetting cycle but gained 25% in the second wetting cycle and reached nearly 100% RH. C2 did not show obvious differences compared to the untreated walls on brick.

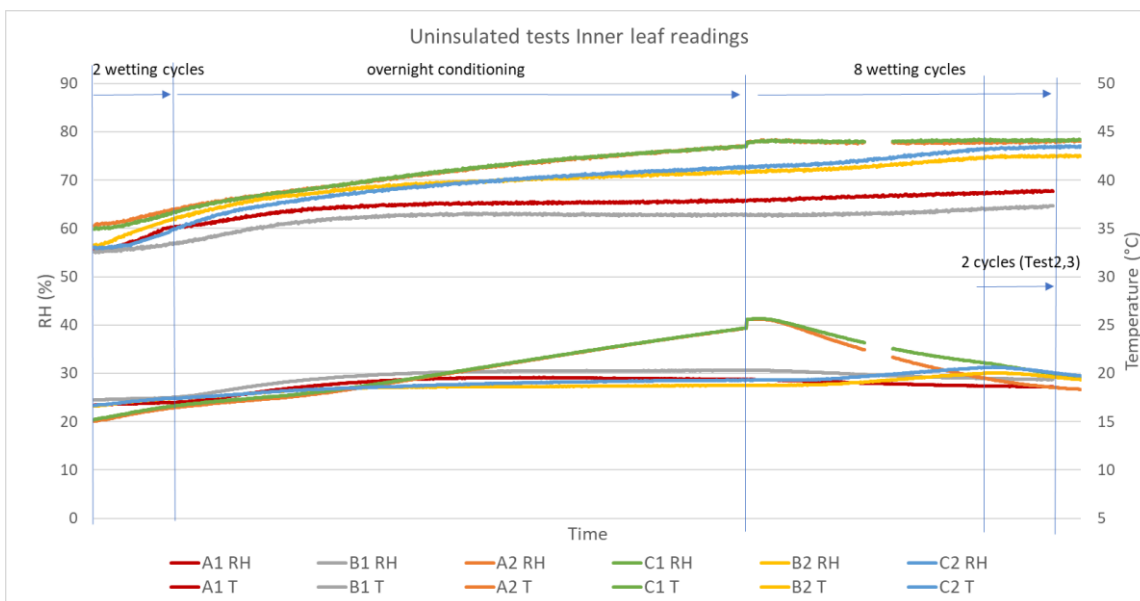
Figure 14: Variation of inner leaf T and RH for all walls in uninsulated tests

Figure 14 shows the RH and temperature readings of the sensors in the inner leaf of each wall in the uninsulated tests. Due to the inner leaf of the walls having no direct contact to the wind driven rain, the change in RH is considered a result of moisture vapour migrating across the air cavity. In test 1, after an initial increase in the first two cycles, A1

remained 5% higher in RH than B1 throughout the test. In test 2, the shutdown of the outdoor chamber raised the temperature to 30°C and this greatly accelerated the water transport. Both C1 and A2 have the same RH reading throughout the test but comparably higher than the other walls. In test 3, C2 was initially 2% lower than B2 but slowly increased overnight to a value of 2% higher than B2 by the end of the test.

The thermal performance difference was less obvious for the inner leaf than the outer leaf. The temperature on every two walls from each test was very close. Both B and C treated walls inner leaves maintained a T about 1°C higher than the untreated walls.

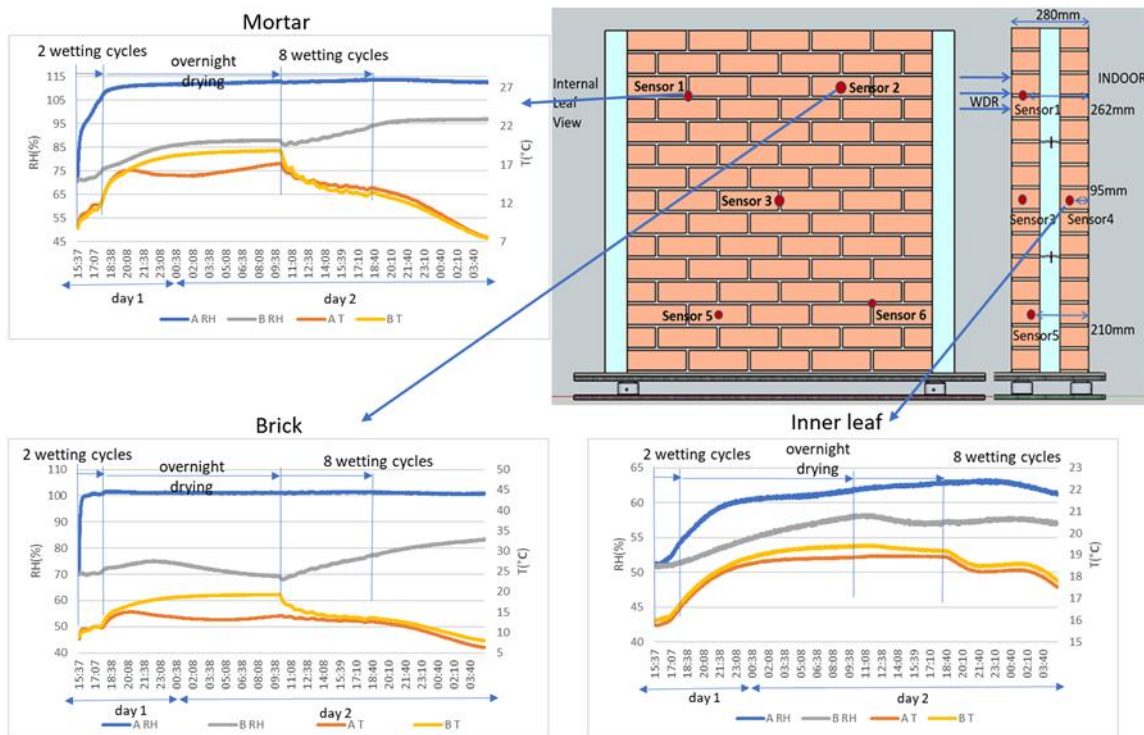
Figure 15: Variation of in wall temperature and RH for the untreated (A1) and B-treated (B1) walls in insulated test 1

Compared with the results from *uninsulated test 1*, better performance can be witnessed on all sensor readings on the *B1-treated* wall in Figure 15. Both sensors in mortar (S1) and brick (S2) have increased by 1-2% RH in the first 2 cycles while the sensors on untreated wall have shown readings corresponding to the saturation of the sensors in the range of 100% RH, similarly to the *uninsulated*. During the overnight dry conditions, a further increase of 11% was observed on the mortar RH sensor for *B1*. The brick sensor (S2), RH showed an increase of 5% in the first 5h and then decreased by 6%, resulting in a 1%RH decrease at the end of overnight drying. The temperature difference between *B1* and *A1* wall increased by up to 5 °C on both brick and mortar sensors during the overnight dry conditions. The 8 cycles on the second day did not have much impact on the total RH reading for the untreated one, while the *B-treated* mortar and brick show a steady increase of 10%.

The sensors on the interior leaf of *B1-treated* wall had a gain of 7% RH over the whole test while the untreated wall shows a 12% RH gain, resulting in a difference of up to 5% in RH and 1°C in T between the two walls.

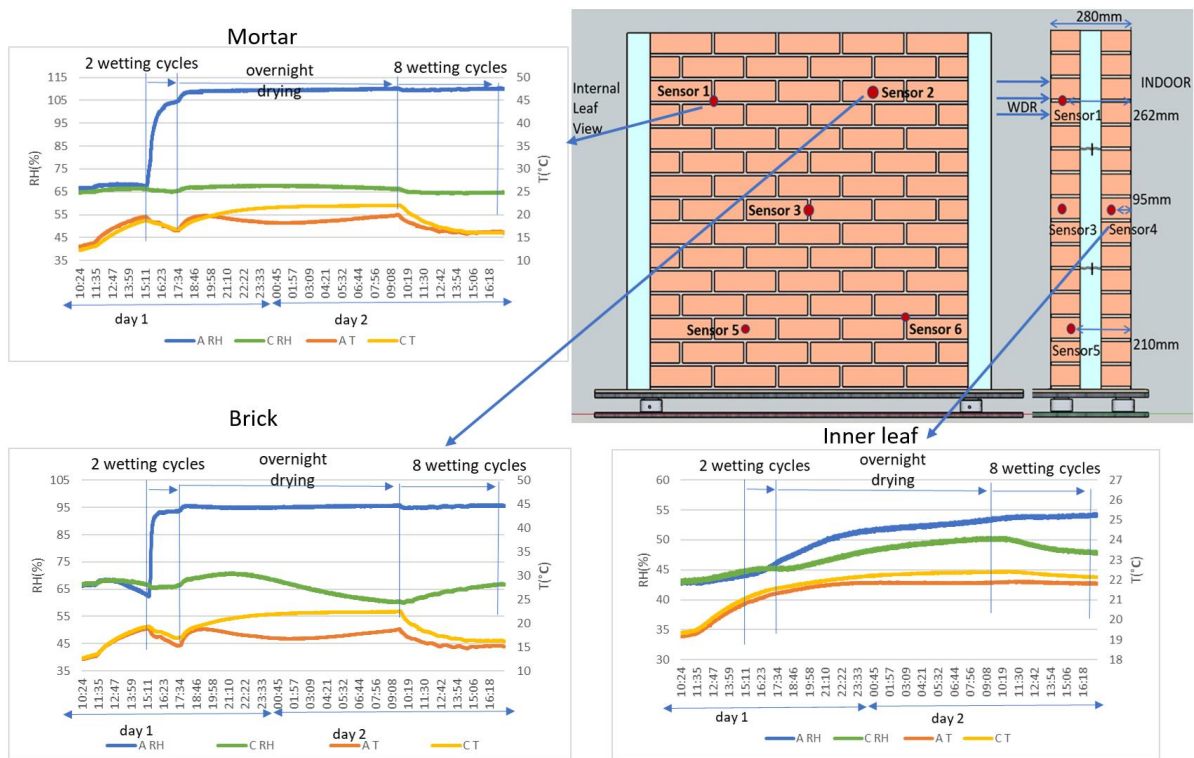
In Figure 16, the second insulated test studies the performance of C1 after installation of insulation in comparison to the A2 wall. A more substantial improvement in performance can be observed on all sensors in the C1 wall compared to the previous uninsulated test while the sensors on the untreated wall reached their RH saturation in the first 2 cycles as both in the previous test and in the A1 wall. Sensor S1 in mortar on C1 showed no obvious RH gain throughout the whole test, while the sensor in brick showed no gain in RH in the first two cycles, then during the overnight dry conditions it first increased by 6%RH in 7h and then dropped by 10%. During the 8 cycles on the second day the RH increased again by 6% more.

Figure 16: Variation of in wall temperature and RH for the untreated (A2) and C-treated (C1) walls in insulated test 2

The sensors on the interior leaf of C1 wall had a gain of 7% RH over the whole test while the A2 wall gained 11% RH resulting in up to 4% difference in RH and 1°C in temperature between walls A2 and C1. Compared to the uninsulated test, wall C1 has shown substantial performance improvement in this test on both brick and mortar with significantly reduced RH gain.

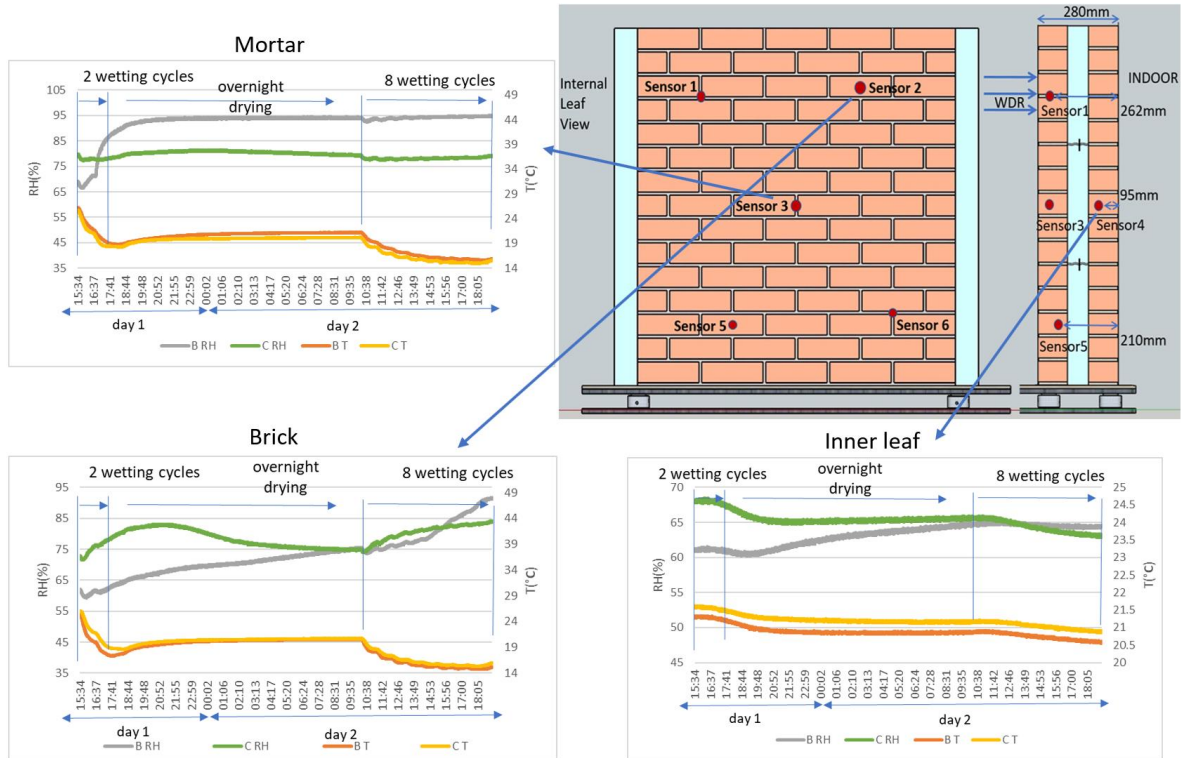
To compare the performance between the two different products B and C directly and to confirm the findings from the previous 2 insulated tests, the readings of the sensors in the two walls B2 and C2 are compared in Figure 17. The two wetting cycles on the first day resulted in a 20% RH gain on S3 located in the B2 mortar, and further increase during the drying period to reach 95% RH, while the mortar sensor in C2 although starting at a higher RH of 75%, had no obvious gain throughout the test.

Figure 17: Variation of in wall temperature and RH for the *B2* and *C2* walls in insulated test 3

For the brick sensor S2, a fluctuation of 3% occurred on the B2 wall during the first two wetting cycles but resulted in no obvious difference in RH compared to the starting condition. A 15% increase in RH was later observed during the overnight dry conditions. During the 8 cycles on the second day, wall B2 first gradually gained 4% RH in the first 4 cycles, then the RH started to climb during the last 4 cycles resulting in 13% RH increase.

On the other hand, the readings of S2 on wall C2 shows an increase by 5% in RH in the 2 cycles on the first day. Then in the overnight dry conditions, the RH first rose by 5% then dropped by 7%. A further 10% RH gain was recorded after the 8 cycles on the second day. On inspection of the graph in Figure 17 it can be seen that, the overall gain for wall C2 was 20% lower than for wall B2. The temperature behaviour is very similar for the two walls, with differences in the range of sensitivity of the sensors.

The inner leaf sensors showed an increase in RH of about 5% throughout the test on *B2* wall and 5% decrease on the *C2* wall. The steady dry conditions in the indoor chamber during the test have accelerated the RH decrease on the interior leaf. The temperature of two walls remained very close throughout the test while *C2* remained about 0.5°C higher than *B2* wall in the interior leaf.

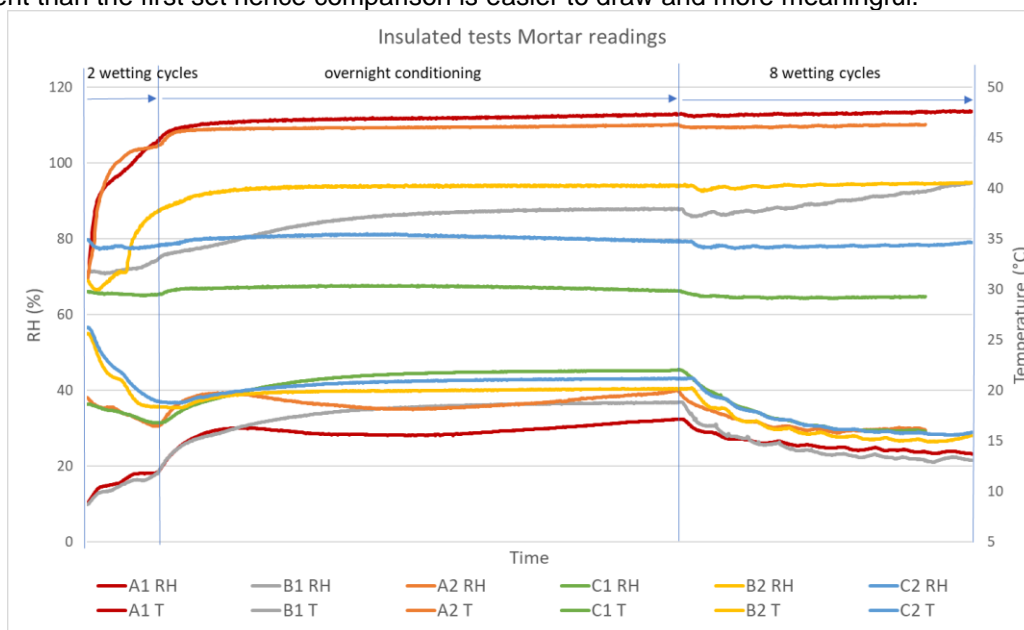
Figure 18: Variation in mortar *T* and RH (sensor 3 readings) for all walls in insulated tests

Figure 18 presents the RH and temperature readings of the sensors in mortar for each wall in the insulated tests. The total six walls contain two untreated walls, two B-treated walls and two C-treated walls. The *untreated walls* have maintained good consistency, both reached 100% RH readings after the 2 wetting cycles on the first day. RH on both untreated walls have increased by 40% in the first 2 wetting cycles over initial RH readings, then maintained the same level to the end of the test. The two *B-treated walls* performed differently although reaching the same ultimate 95% RH. B1 increased 5% in RH during the first 2 wetting cycles while B2 increased by 20%. While the RH of B2 maintained the same level to the end of the test, B1 gained 11% in RH during the overnight conditioning and steadily increased by 10% during the 8 wetting cycles on the second day, resulting in the same final value of RH as B2. On the C-treated walls, though the level of RH at beginning had a difference of 15%, both walls had no obvious RH gain throughout the test.

Although the temperature reading was different at the beginning of each batch of tests, due to slightly different periods of conditioning, the temperature differences between treated walls and untreated ones were very close between tests. The differences in temperature start to appear at the beginning of the overnight conditioning and reached a maximum during the middle of the conditioning. Both B and C treated walls were up to 5°C warmer than the untreated walls. For all walls, the temperature dropped during the 8 cycles test on the second day by 4°C degrees on average.

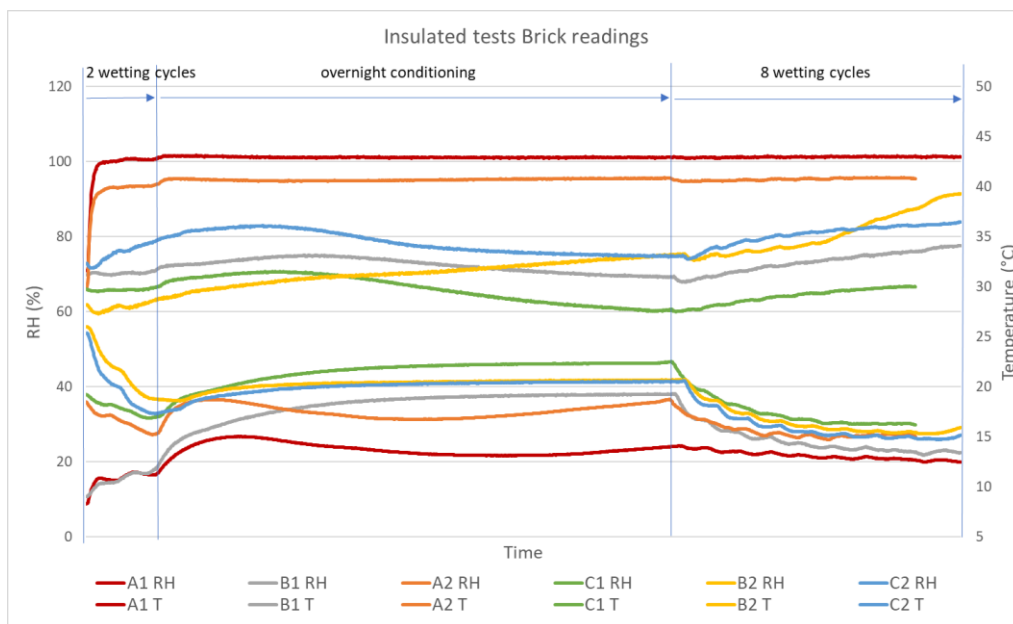
Figure 19 presents the RH and temperature readings of the sensors S2 in brick for each wall in the insulated tests. Similar to the behaviours in mortar, bricks on both untreated walls have shown the same pattern in RH gain with a difference of 5% RH between the two. B1 shows no obvious RH gain in the 2 cycles on the first day while a fluctuation of 3% occurred on B2. During the overnight conditioning, B1 first increased 5%RH in the first 5h, then decreased by 6%, resulting in 1%RH decrease at the end of overnight drying while B2 experienced a 15% increase. The 8 cycles on the second day produced a steady increase of 10% on B1, but on B2 it gradually gained 4% RH in the first 4 cycles, then the RH gain accelerated during the second 4 cycles resulting in 13% RH increase. C1 maintained a good performance in brick during the first 2 cycles, showing no obvious RH gain while RH on C2 increased by 10%. In the rest of the test, the two C-treated walls have shown very similar performance regardless of the difference in RH before start. They both increased by 5%RH in the first 4h and decreased by 10% during the rest of the conditioning period, resulting in circa 5%RH decrease at the end of overnight drying. During the 8 wetting cycles on the second day, RH on C1 increased by 6% while C2 increased by 10%.

Figure 19: Variation in brick T and RH (S2 readings) for all walls in insulated tests

The temperature difference was very close to the performance of the S1 in mortar. Regardless of the difference in temperature at the start of each batch of tests, the thermal performance between B and C treated walls were very close and were up to 5°C higher than the untreated walls.

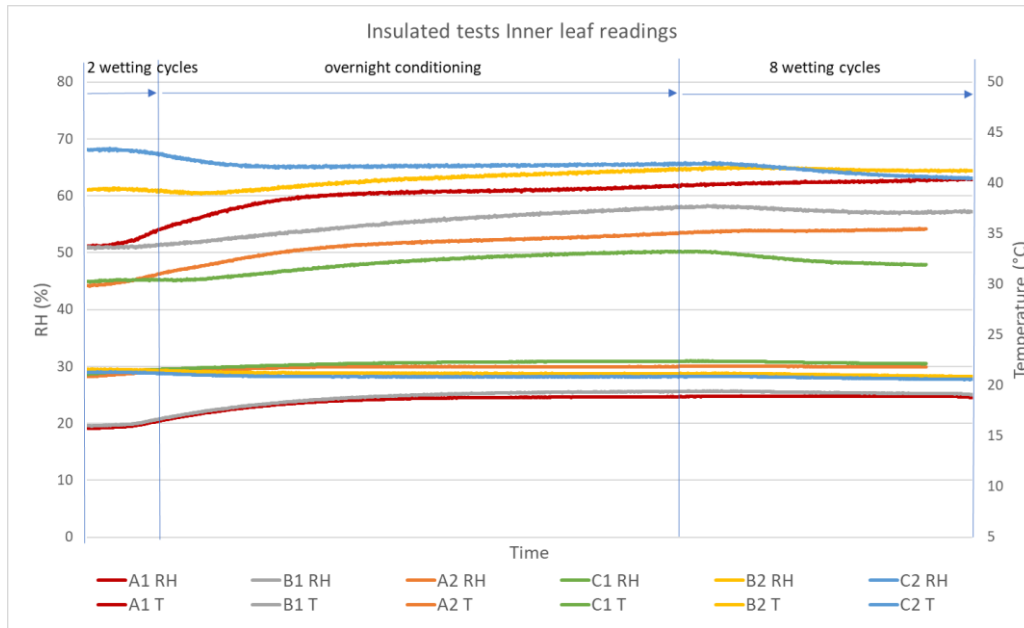
Figure 20 presents the RH and T readings of the sensors in the inner leaf of each wall in the insulated tests. Differently from the mortar and brick on the outer leaf, the inner leaf of the walls has no direct contact to the wind driven rain, so the changes in both RH and temperature were less obvious. Except for the difference in RH at the start of the tests, both untreated walls have a 10% increase in RH throughout the test. The increase was not immediate, it started at

Figure 20: Variation in inner leaf T and RH (sensor 4 readings) for all walls in insulated tests

the end of the first cycle and lasted about 5 hours, then the increase slowed down towards the end of the test. The 8 wetting cycles on the second day made no obvious impact on all test walls. The performances of both B-treated walls were very similar on the inner leaf, with a gradual increase by 5% from the end of the second cycle until the end of the overnight conditioning. No obvious changes during the 8 cycles on the second day. Due to the shorter drying time on wall B2 and C2, their RH were higher at the beginning of the test, the RH on C2 dropped by 3% in four hours and remained constant until the start of the 8 cycles. C1 had 5% increase during the overnight conditioning, then the RH of both C-treated walls dropped by 2% during the 8 wetting cycles.

The thermal performance difference was more obvious on brick and mortar on the outer leaf than on the inner leaf. The temperatures on every two walls from the same batch were very close; both B and C-treated walls were 1°C higher than the untreated walls.

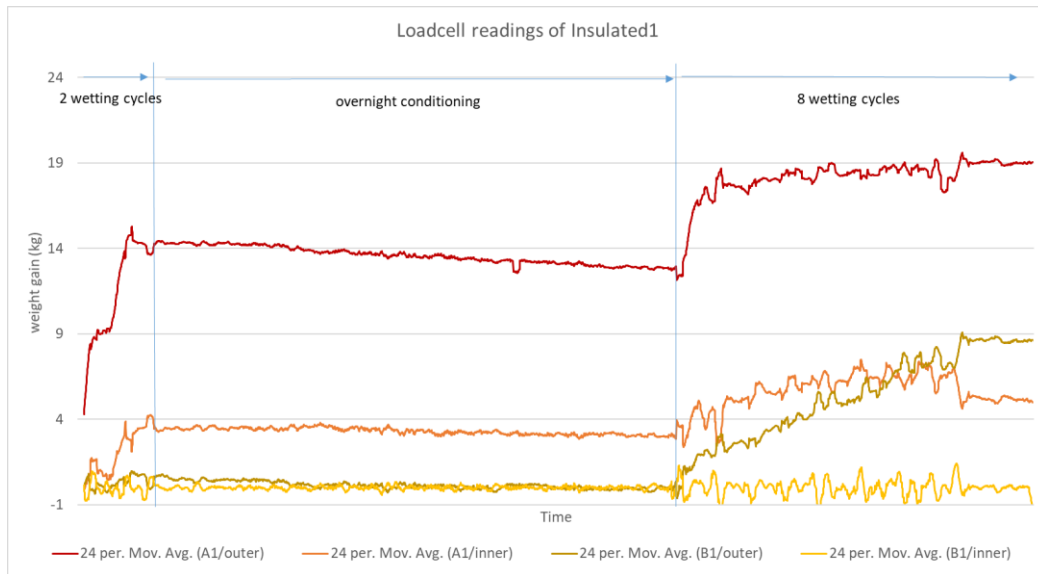
Figure 21: Loadcell readings of inner and outer leaves of walls in insulated test 1 A1 and B1

Figure 21 presents the loadcell readings of inner and outer leaves of *A1* and *B1* walls, respectively. An obvious weight gain can be observed during the first 2 cycles on both the inner and outer leaves of the *A1* wall. The outer leaf gained about 10kg of water while the inner leaf gained 4 kg. During the overnight conditioning, the outer leaf of the *A1* wall lost 2 kg of water while the inner leaf remained constant. On the following 8 wetting cycles on the second day, the outer leaf increased by 6kg while the inner leaf increased by 3 kg. The total change in weight by the end of the test is 16.5 kg gain on the outer leaf and 7 kg on the inner leaf of *A1*. Conversely, wall *B1* shows very modest weight gain, with the outer leaf fluctuating about 1 kg during the first 2 wetting cycles but had no change during the overnight conditioning. During the 8 wetting cycles on the second day, the outer leaf of *B1* absorbed 7 kg of water. The impact has remained on the outer leaf of *B1* while the inner leaf had some fluctuation during wetting cycles but recorded no obvious weight gain. The total gain for the outer leaf of the untreated wall is 1.5% of its weight, while for the inner leaf the gain is just 0.65 %. The gain of the *B1* wall's outer leaf at the end of test is 0.75%.

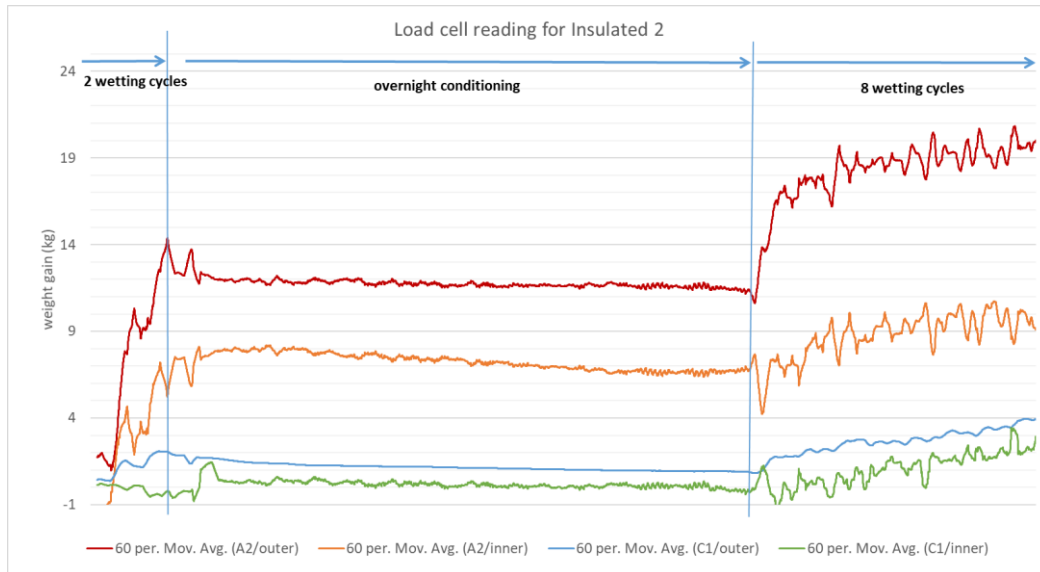
Figure 22: Loadcell readings of inner and outer leaves of walls in insulated test 2, A2 and C1

Figure 22 presents the loadcell readings of A2 and C1 walls of insulated test 2. The outer leaf of A2 received 12.5 kg of weight gain after the first 2 wetting cycles, the inner gained 7.5 kg. The overnight conditioning reduced the weight by 1.5 kg on the outer leaf and 0.5 kg on the inner leaf. After 8 cycles on the second day a further 9 kg were gained by the outer leaf and 3 kg by the inner leaf, with total of 20 kg weight gain on the outer leaf and 10 kg on inner leaf of A2. On the wall C1, a slight gaining trend can be identified by looking at the 8 wetting cycles of the second day, the readings on the outer leaf marking an increase by 3 kg while the inner leaf remained flat with some noise. The total gain for the outer leaf of the untreated wall is 1.9% of its weight, while for the inner leaf the gain is 0.93 %. The gain of the C1 wall outer leaf after the whole test is 0.28%.

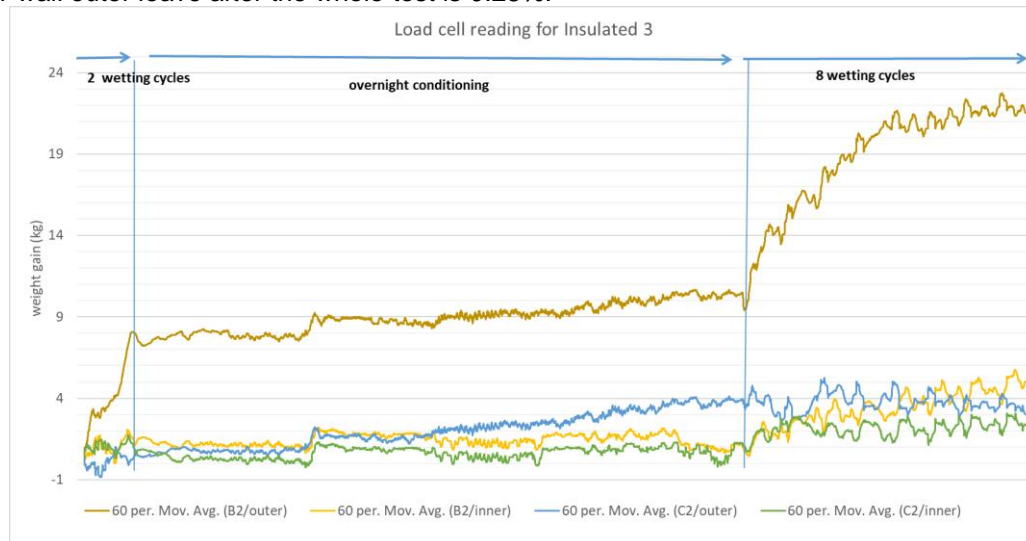
Figure 23: Loadcell readings of inner and outer leaves of walls in insulated test 3

Figure 23 shows the loadcell readings of B2 and C2 walls of insulated test 3. The outer leaf of B2 gained 7.5 kg of weight in the first 2 wetting cycles, lost 0.5 kg during overnight conditioning and gained another 11 kg in the 8 wetting cycles, for a total gain of 18 kg . The inner leaf of B2 had around 2 kg of fluctuation during the 2 wetting cycles and gained 5 kg in total at the end of the test. By comparing the trend between inner leaf and outer leaf of the C2 *outerleaf* shows a slight gain in weight overnight and fluctuation over the 8 cycles during the second day, while the inner leaf records no increase overnight but a slight increase of about 2 Kg during the second day. The total gain for the outer leaf of the B2 wall was 1.7% of its weight, while for the inner leaf the gain is just 0.47 %. No gain in weight for the C2 wall can be computed with confidence as the trend is not clear.
