Air Quality and Dust Monitoring Monthly Report - April 2021

London Borough of Brent

Monthly Summary

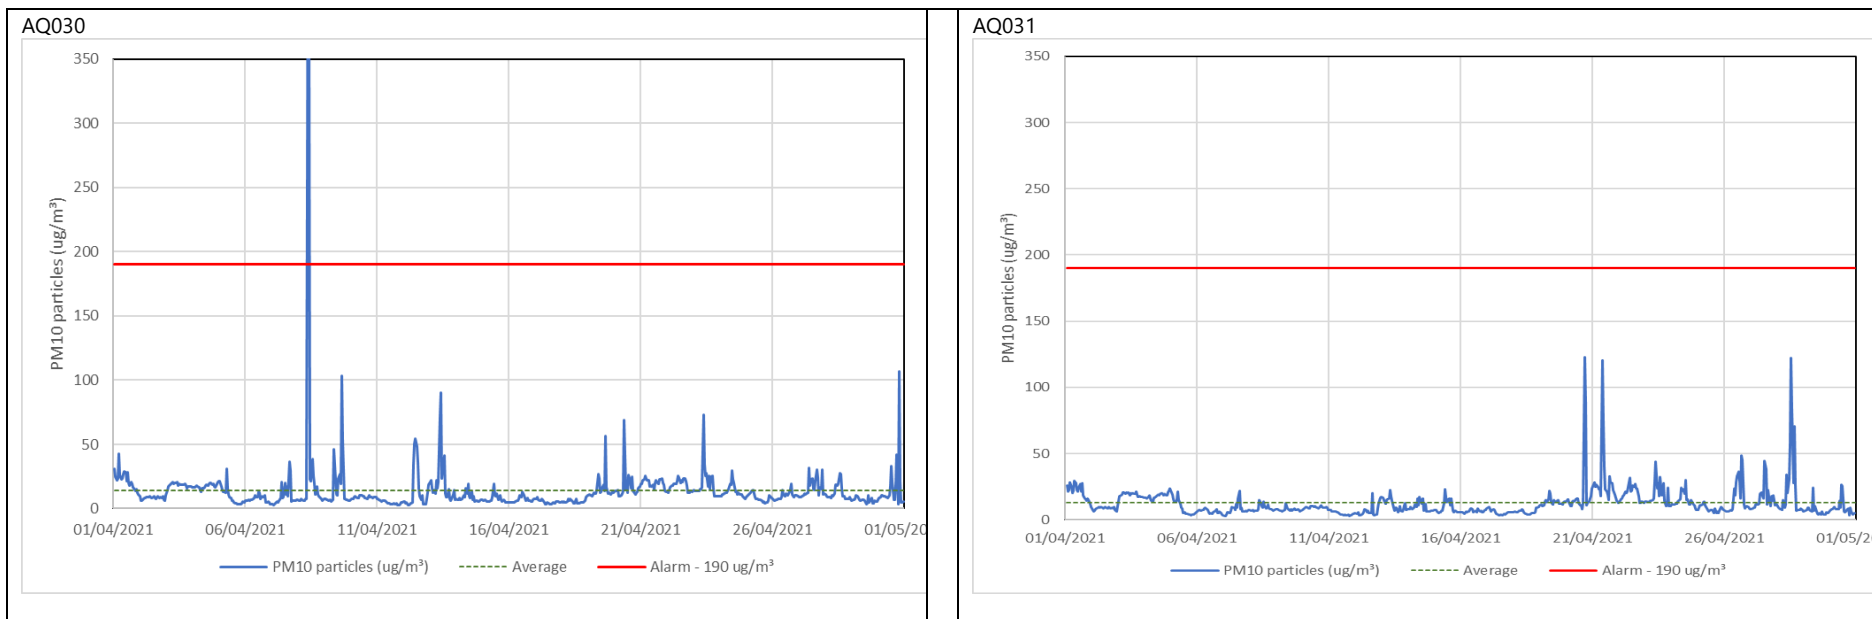
Figure 2: Construction dust 1-hour mean indicative PM₁₀ concentration for dust monitors

- 1.1.6 Dust monitoring location and results are presented in Appendix B, Table 1, together with line chart of monthly data from the dust monitor in Figure 2. The continuous dust monitoring is undertaken using indicative monitors. Despite being Environment Agency (MCERTS) certified, indicative monitors carry a higher level of uncertainty than reference monitors, and therefore cannot be strictly compared with Air Quality Standards for human health and the environment. The purpose of the monitoring undertaken is to ensure the effectiveness of the on-site mitigation.

- 1.1.7 The trigger level for PM₁₀ concentrations of 190 µg/m³, over a 1-hour period, in accordance with the updated guidance document '*Guidance on Monitoring in the Vicinity of Demolition and Construction Sites – (October 2018)*' has been applied.

- 1.1.8 Two (2) exceedances of the dust trigger level were recorded during the monitoring period (April 2021). Exceedances are presented in Appendix B, Table 2. All other results were in line with the expected ranges.

Monitoring site ID	Period exceeding trigger alert and concentration recorded	Investigation	Outcomes / Resolution / Remedial measures implemented
AQ030	08/04/2021 08:00 – 09:00: 504.4 µg/m ³ 08/04/2021 09:00 – 10:00: 371.9 µg/m ³	<p>At the time of the first trigger alert from dust monitor (AQ030), which is located on the western boundary of the Canterbury Road Vent Shaft site, concrete floor cutting using a hand-held saw was being undertaken directly beneath the monitor. Albeit dust suppression was being used on the cutter and visually successful the proximity of the monitor to the works meant it picked up the elevated levels in the immediate vicinity.</p> <p>Works subsequently continued, with dust suppression in place, but a further trigger was received.</p> <p>It is considered the elevated levels were confined to the immediate vicinity of works area (and the monitor).</p>	<p>On receipt of the trigger, works were stopped, a bowser was immediately deployed, and the area damped down before groundwork recommenced.</p> <p>Subsequent monitored readings dropped to expected levels once again.</p> <p>The site team will take a more precautionary approach in future and ensure dust suppression is available and deployed where required on site.</p>
