April 2021

## Air Quality and Dust Monitoring Monthly Report - April 2021

Cherwell District Council

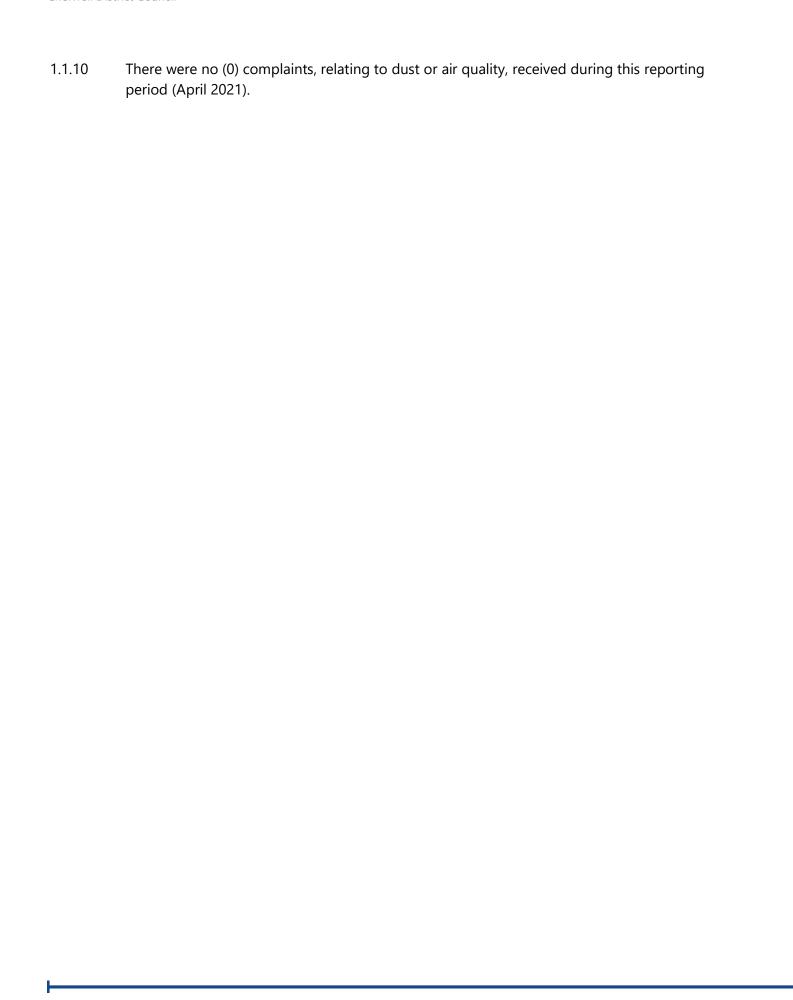
Figure 1: Worksite and monitoring locations during April 2021

- 1.1.4 The current phase of works at the A4421 Overbridge worksite, within the administrative boundary of CDC, commenced in January 2021 and is expected to be completed by August 2021. The current A4421 Overbridge worksite, as presented in Appendix A, Figure 1, included: temporary compound, trial holes surveys, trial embankment, vegetation clearance and Finmere bridge preliminary works.

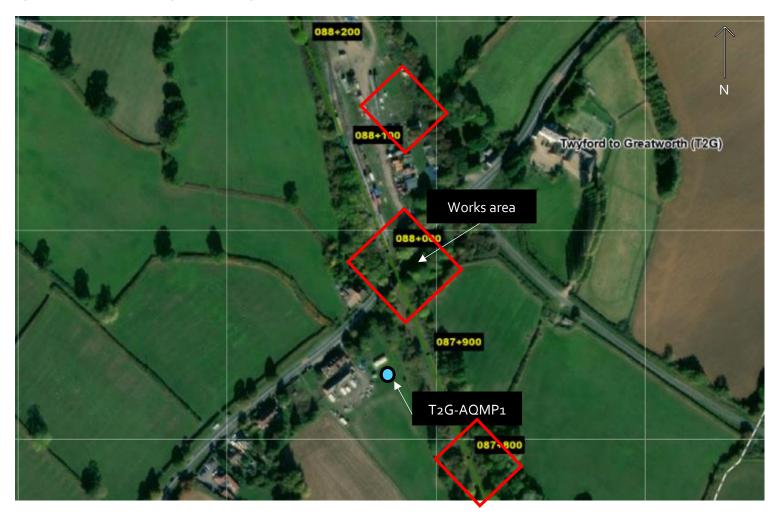
- 1.1.5 One (1) dust monitor is installed at the worksite, where preparation for concrete using hand tools and a small excavator, and concreting activities are underway. Dust Risk Assessments for each worksite returned a medium dust risk rating.

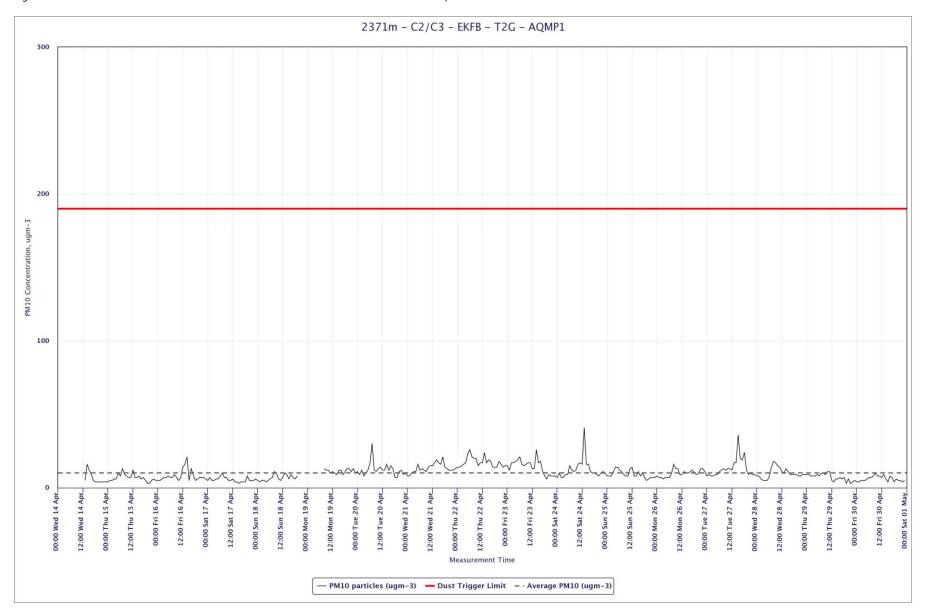
Figure 2: Continuous dust 1-hour mean indicative PM<sub>10</sub> concentration for T2G-AQMP1 for April 2021

- 1.1.6 Dust monitoring locations and results are presented in Appendix B, Table 1, together with a line chart of monthly data from the dust monitor presented in Figure 2. All continuous dust monitoring is undertaken using indicative monitors. Despite being Environment Agency (MCERTS) certified, indicative monitors carry a higher level of uncertainty than reference monitors, and therefore cannot be strictly compared with Air Quality Standards for human health and the environment. The purpose of the monitoring undertaken is to ensure the effectiveness of the on-site mitigation.

- 1.1.7 The trigger level for  $PM_{10}$  concentrations of 190  $\mu$ g/m³, over a 1-hour period, in accordance with the updated guidance document 'Guidance on Monitoring in the Vicinity of Demolition and Construction Sites (October 2018)' has been applied.

- 1.1.8 There were no (0) dust trigger alerts recorded during the monitoring period (April 2021).
- 1.1.9 Data capture for monitor T2G-AQMP1 was below 90% for the month of April 2021. This was due to the monitor being installed on Friday 14/06/21, and a temporary loss of power, which has since been resolved.
