# **Construction noise and vibration Monthly Report – May 2021**

**Lichfield City Council**

This Noise and Vibration Monitoring Report fulfils HS2 Limited's commitment detailed in the Environmental Minimum Requirements (EMRs), Annex 1, Code of Construction Practice, to present the results of noise monitoring carried out within the Lichfield City Council (LCC) area during the month of May 2021.

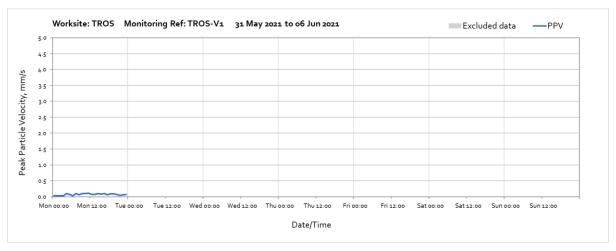
#### **Worksite: TROS - Monitoring Ref: TROS-V1**

The following graphs show the hourly measured peak particle velocity PPV recorded during the monitoring period. The graphs show the resultant PPV due to vibration components on three orthogonal axis x, y and z. Where high values of PPV were caused by local interference with the vibration monitor, which are not representative of HS2 construction works, these values have been greyed out in the following charts and have been excluded to calculate values in **Error! Reference source not found.** of the main report.

Note: Vibration monitor installed on the 25th May 2021
