Defence
Safety Authority

Service Inquiry

Death of a Royal Marine
Recruit following a Beach
Landing Exercise, Tregantle
Beach

21 January 2020

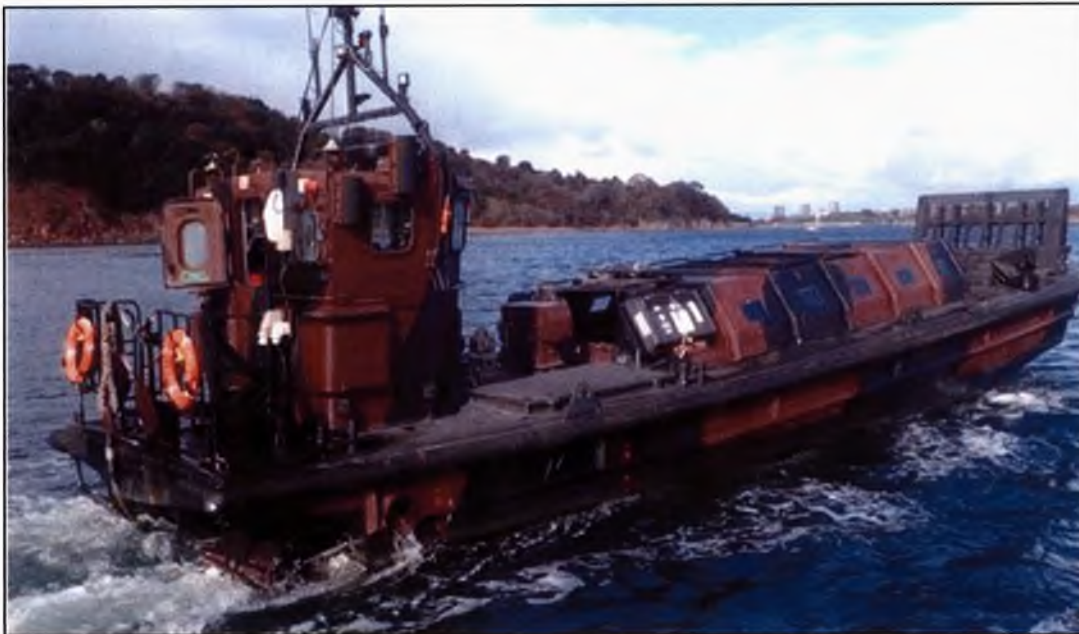
Figure 1.3.1 – Landing Craft Vehicle and Personnel Mk5 (Library picture).

1.3.9. **LCVP Mk5B.** The LCVP Mk 5B was principally employed to land troops and equipment from ship to shore and was designed for beaching on either rocky or sandy beaches with a minimum gradient of 1 in 120, leaving a maximum of 0.6 m of water at the bow. It was crewed by three RM personnel: a coxswain, who was a Landing Craftsman Class Two (LC2), in command of the craft, and two Landing Craftsman Class Three (LC3) crewmen.

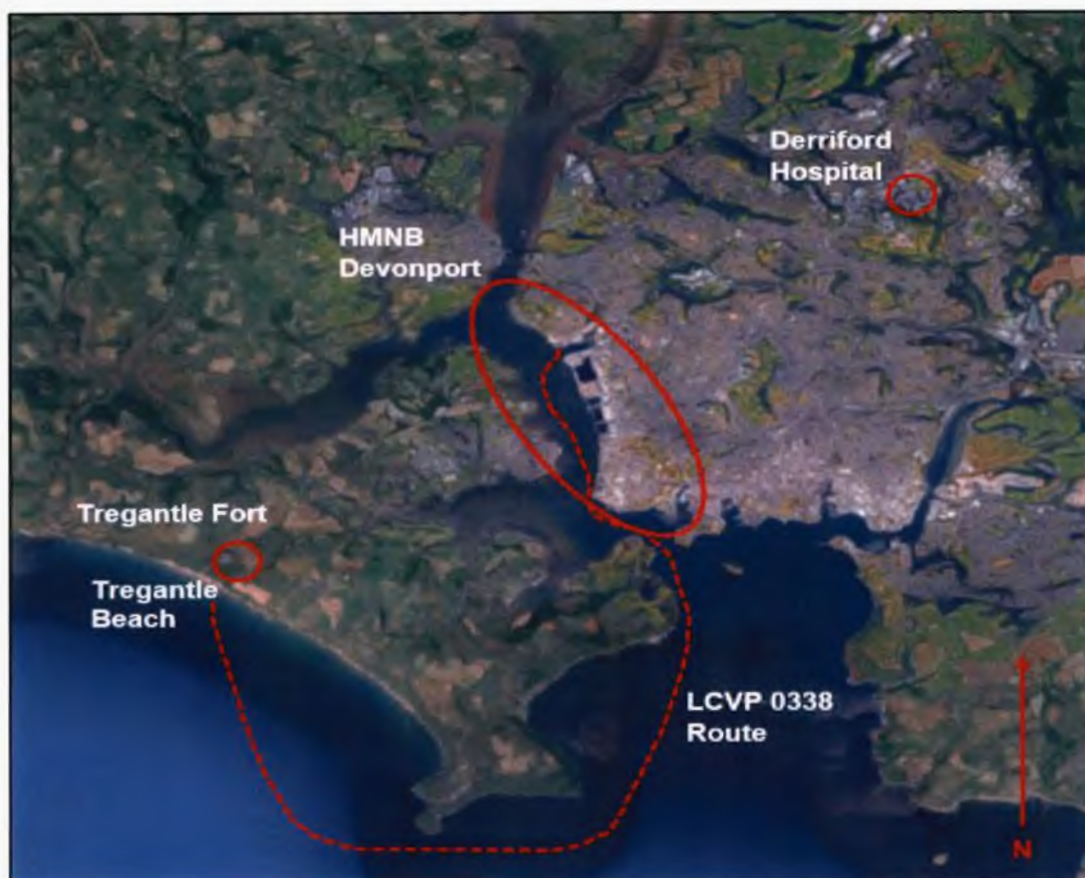
Figure 1.3.3 – Area of Interest.

1.3.3. During the disembarkation the depth of water increased from approximately 0.77 m and the last 8 of the 26 individuals to leave the craft found themselves in water above their heads (>1.85 m). Three recruits were recovered from the water to the craft including Recruit Ethan Jones, who was unconscious and unresponsive. First aid was given on the craft initially by the crew, some members of 282 Tp Training Team (282 Tp Trg Team), a Royal Navy (RN) Medic and then the South West Ambulance Service paramedics. Recruit Jones was transferred to the beach and then transported by air to Derriford Hospital, Plymouth where he subsequently died on 24 January 2020.
