## Air Quality and Dust Monitoring Monthly Report – July 2021

London Borough of Ealing

# Monthly Summary

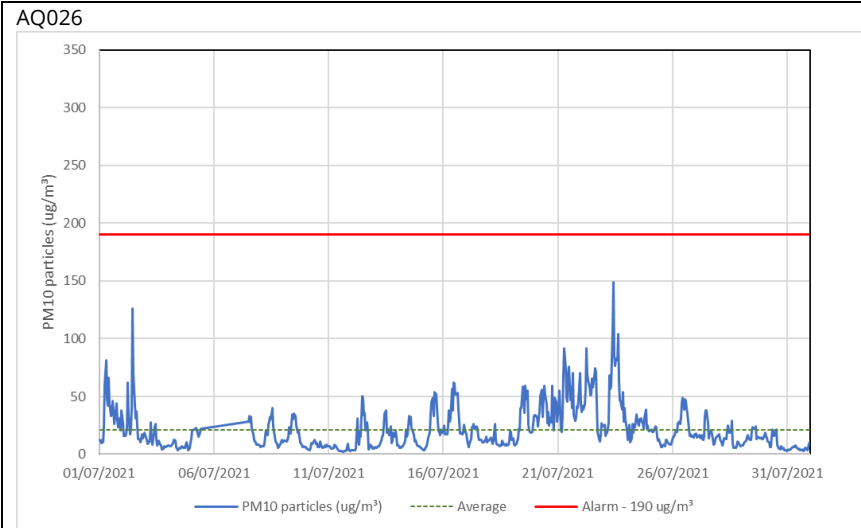
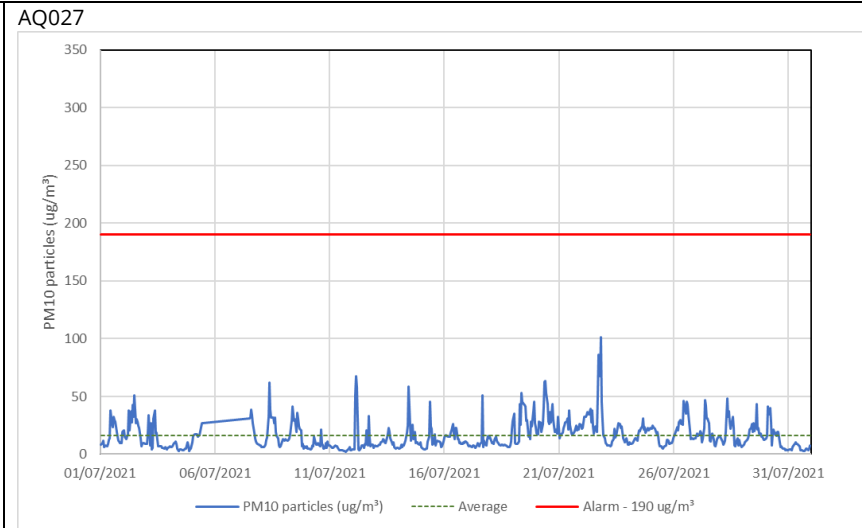
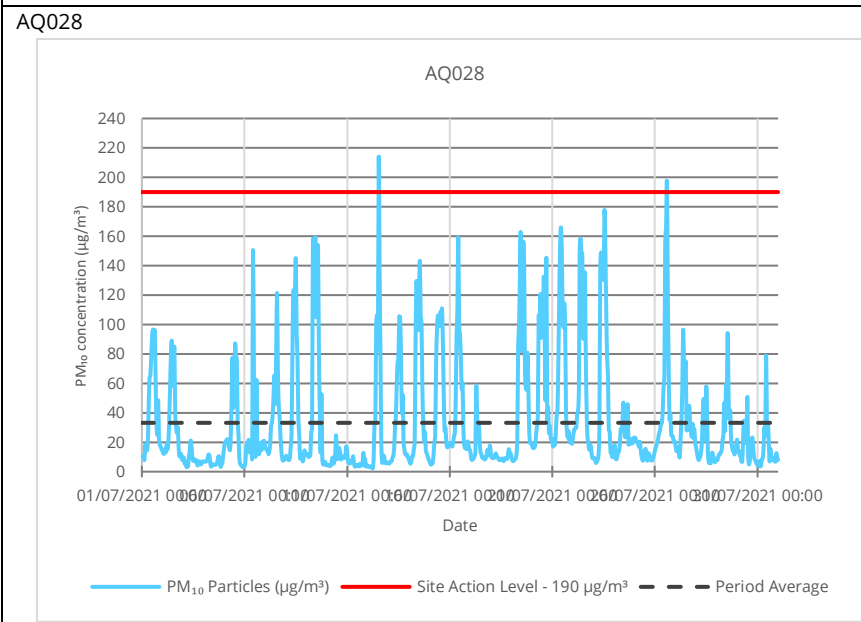
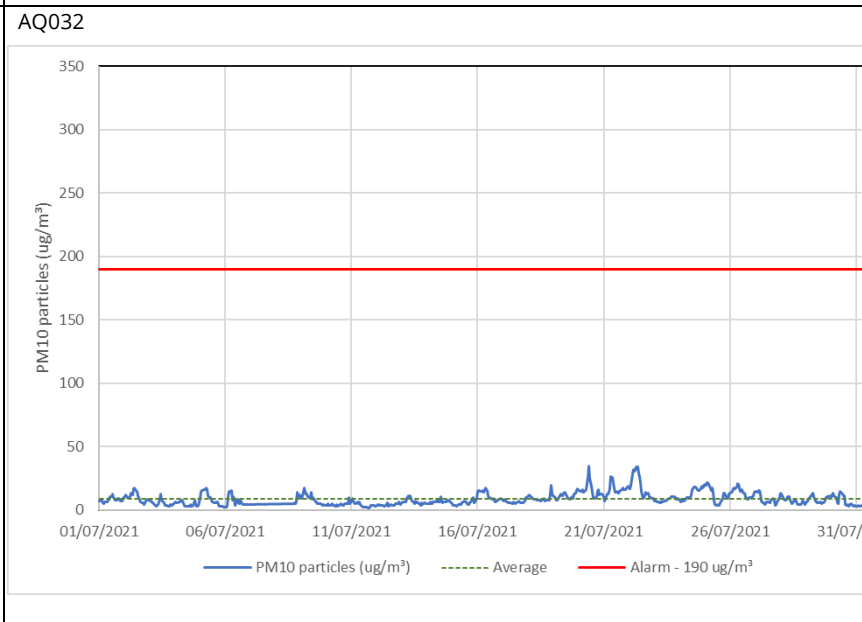
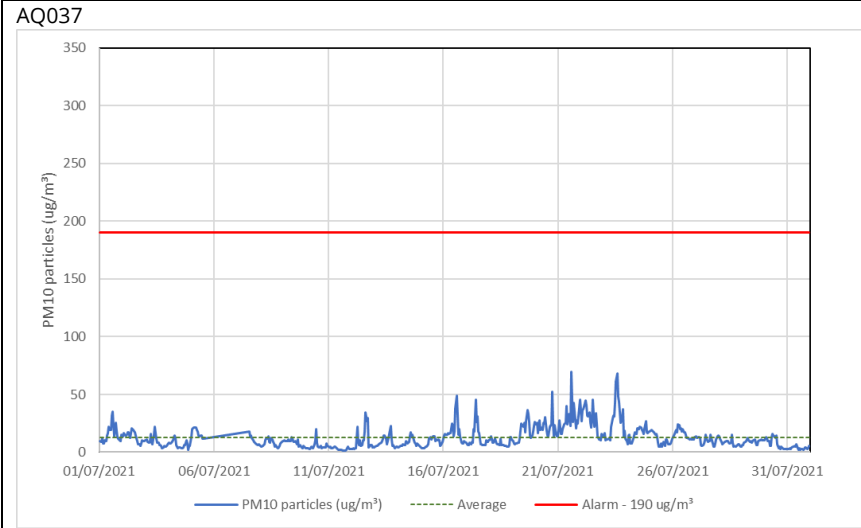
Figure 3: Construction dust 1-hour mean indicative PM<sub>10</sub> concentration for dust monitors

- 1.1.6 Dust monitoring locations and results are presented in Appendix B, Table 2, together with line charts of monthly data from each dust monitor, in Figure 4. All continuous dust monitoring is undertaken using indicative monitors. Despite being Environment Agency (MCERTS) certified, indicative monitors carry a higher level of uncertainty than reference monitors, and therefore cannot be strictly compared with Air Quality Standards for human health and the environment. The purpose of the monitoring undertaken is to ensure the effectiveness of the on-site mitigation.

- 1.1.7 The trigger level for PM<sub>10</sub> concentrations of 190 µg/m<sup>3</sup>, over a 1-hour period, in accordance with the updated guidance document '*Guidance on Monitoring in the Vicinity of Demolition and Construction Sites – (October 2018)*' has been applied.

- 1.1.8 There was one (1) dust trigger alert recorded during the monitoring period (July 2021). Triggers are presented in Appendix B, Table 3. All other results were in line with expected ranges.

Monitoring site ID	Period exceeding trigger level	Investigation	Outcomes / Resolution / Remedial measures implemented
AQ038	20/07/2021 22:00 – 23:00; 212.2 µg/m <sup>3</sup>	At the time of the trigger there were no works associated with the HS2 site as the site was shut. It is considered the trigger was due to moisture and loose debris in the inlet during the late night giving a false reading.	Good housekeeping practices, and regular monitor maintenance.
