# **Construction noise and vibration Monthly Report – July 2021**

**London Borough of Brent**

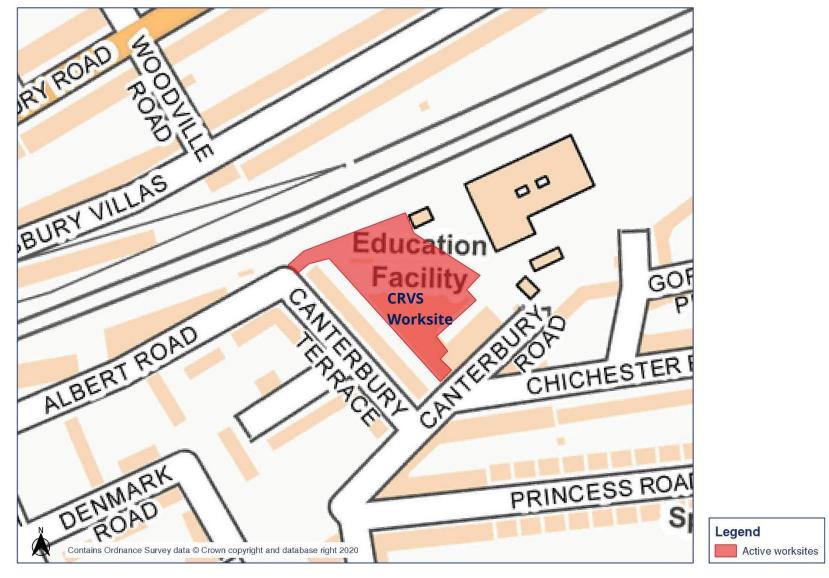
### Worksite identification plan - 1

- 1.1.3 There was one active construction site in the local authority area, where monitoring was undertaken, during this period:
  - Canterbury Road Vent Shaft worksite ref.: CRVS (see plan 1 in Appendix A), where work activities included:

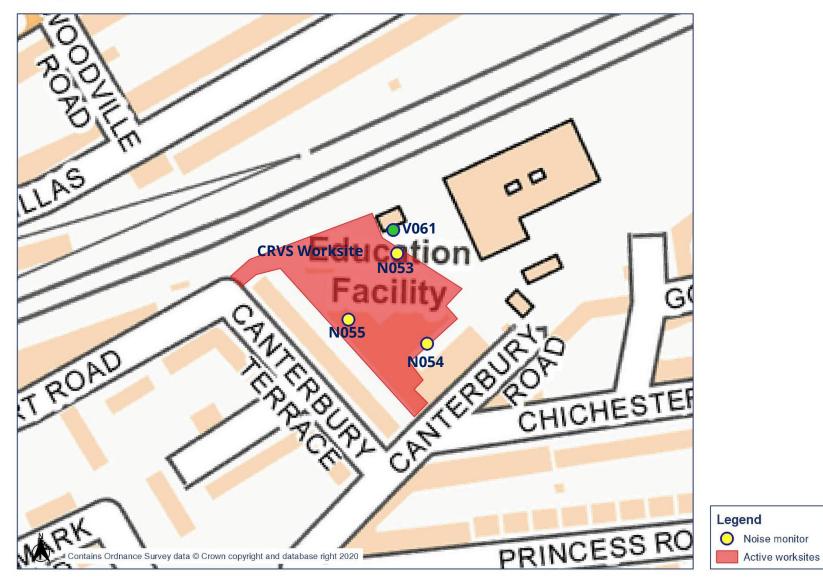
### Noise monitoring plan - 1

- 1.2.1 Three noise and one vibration monitoring installation were active in July in the LBB area. Table 2 summarises the positions of the noise monitoring installations within the LBB area in July 2021.
- 1.2.2 A map showing the positions of the noise monitoring installations is presented in Appendix B.

Worksite Reference	Measurement Reference	Address
CRVS	N053	St Mary's Catholic Primary School, Canterbury Road, London
	N054	Canterbury House, Canterbury Road, London
	N055	Carlton House, Canterbury Terrace, London
	V061	St Mary's Catholic Primary School, Canterbury Road, London

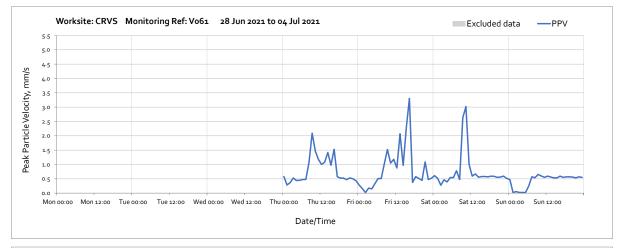
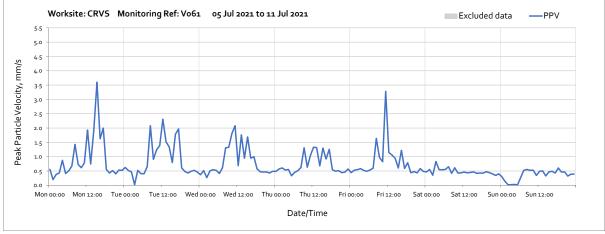
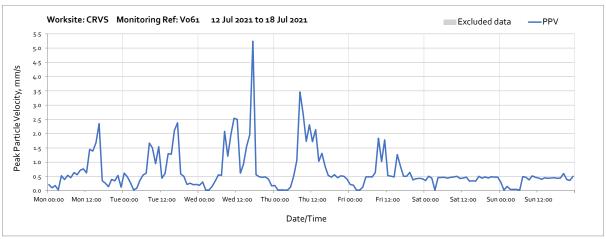
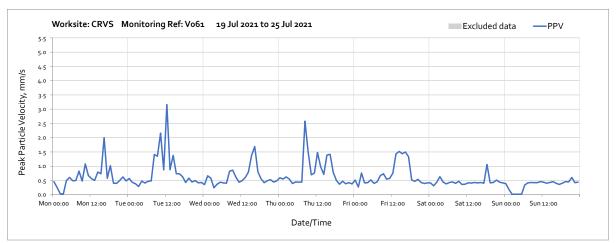
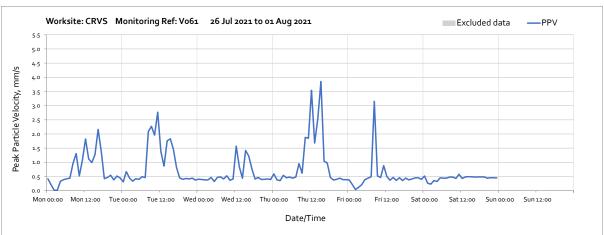
#### **Vibration**

Worksite	Measurement	Monitor	Highest PPV measured in any axis, mm/s
Reference	Reference	Address	
CRVS	V061	St Mary's Catholic Primary School, Canterbury Road, London	5.24 (Z-axis)

The following graphs show the hourly measured peak particle velocity PPV recorded during the monitoring period. The graphs show the highest PPV of the three orthogonal axis x, y and z. Where high values of PPV were caused by local interference with the vibration monitor, which are not representative of HS2 construction works, these values have been greyed out in the following charts and have been excluded to calculate values in Table 4 of the main report.
