Construction noise and vibration Monthly Report – August 2021

London Borough of Brent

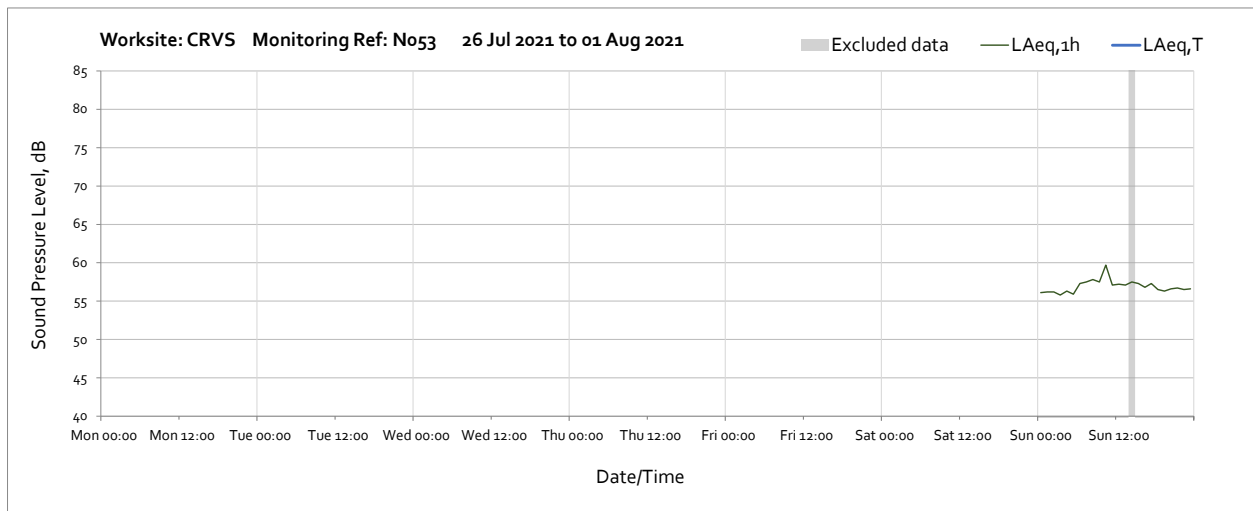
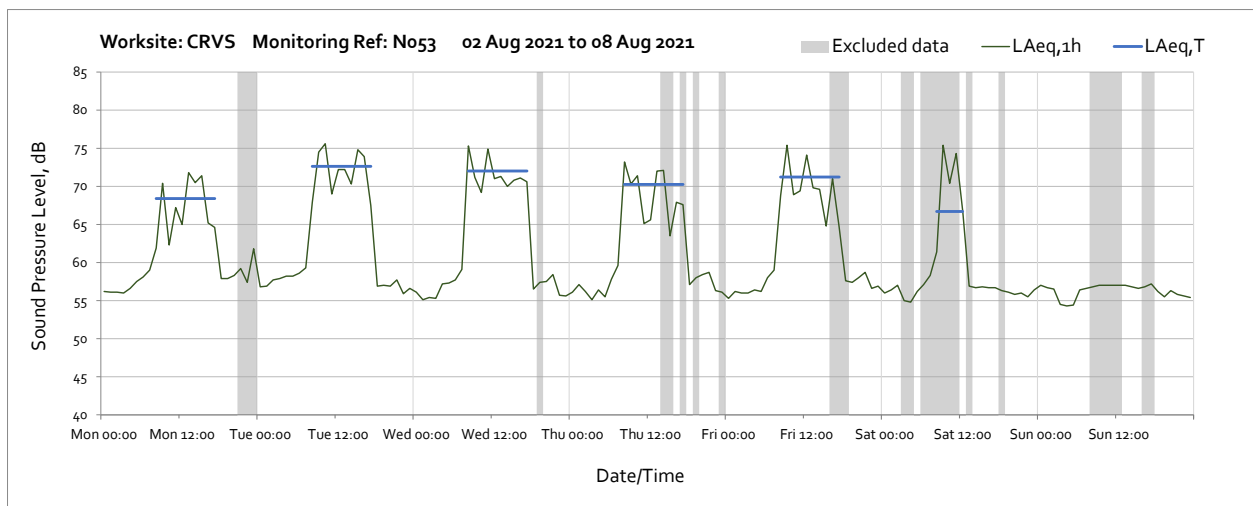
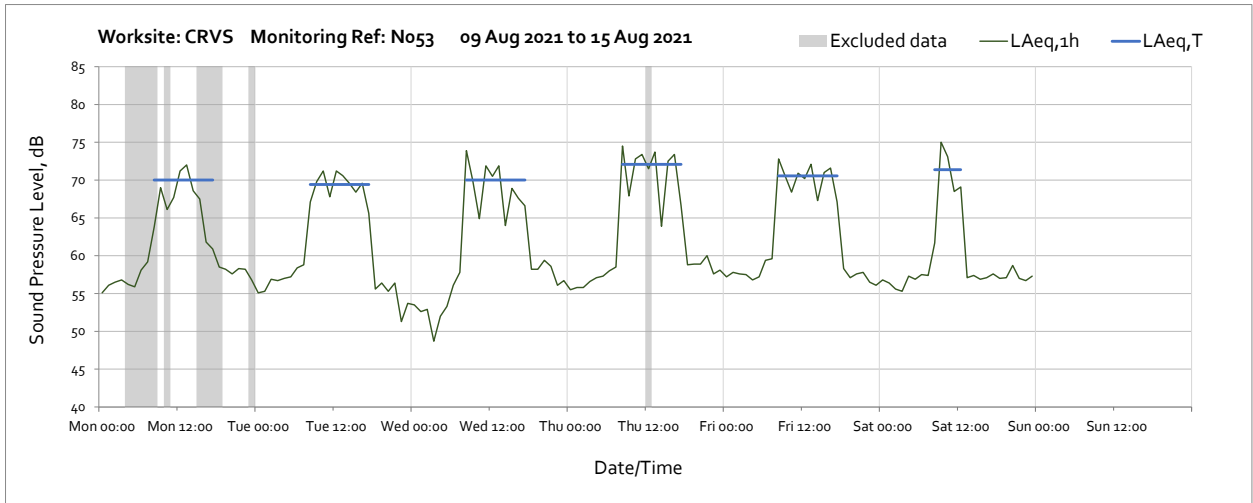
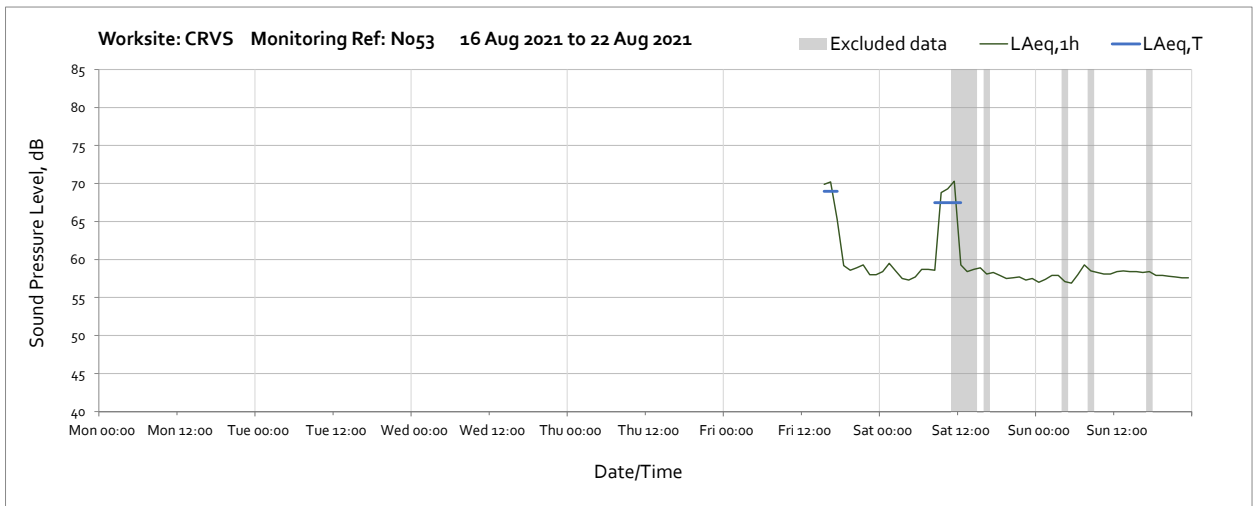
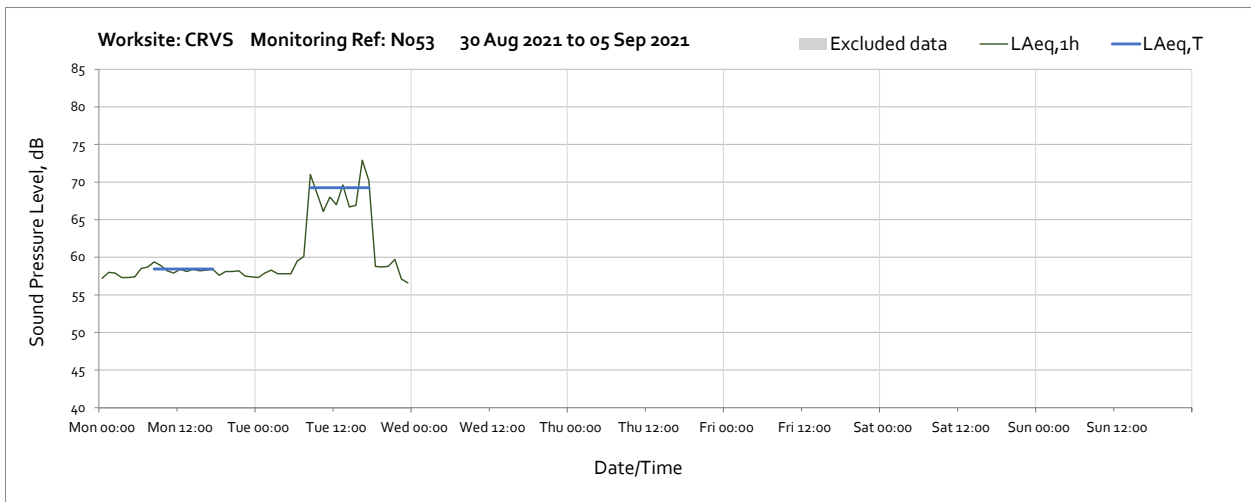
Worksite: CRVS – Monitoring Ref: N053

The following graphs show the hourly measured ambient noise level $L_{Aeq,1h}$ and, where relevant, the averaged noise level $L_{Aeq,T}$ values, where the time period T is as specified in Table 1 of HS2 Information Paper E23. Periods with adversely weather affected noise levels are greyed out and have been excluded from the calculation of the $L_{Aeq,T}$ values in Table 3 of the main report.

Note: Missing data from 00:00 on Sunday 15th August until 15:00 on Friday 20th August was due to equipment failure during software update and an error with the SD card. The unit was replaced to prevent further loss of data.

Note: Missing data from 00:00 on Sunday 15th August until 15:00 on Friday 20th August was due to equipment failure during software upgrade and error with the SD card. The unit was replaced to prevent further loss of data.

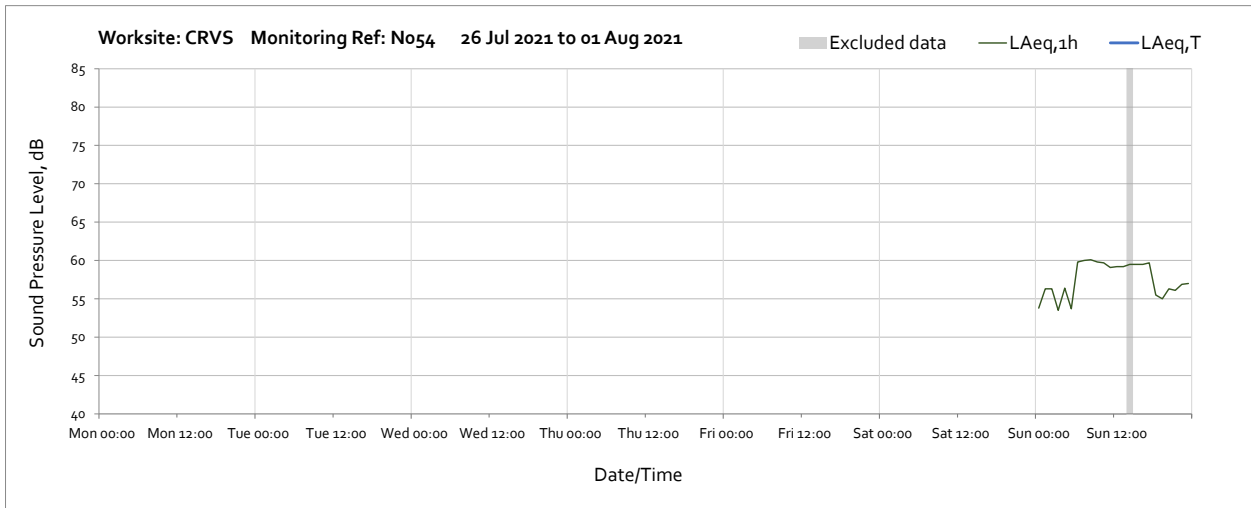
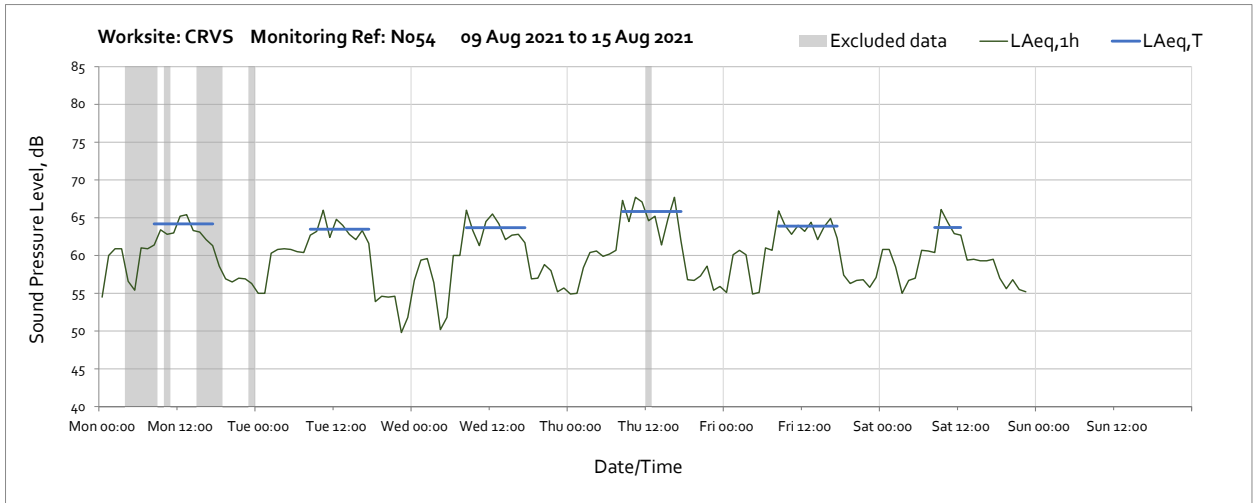
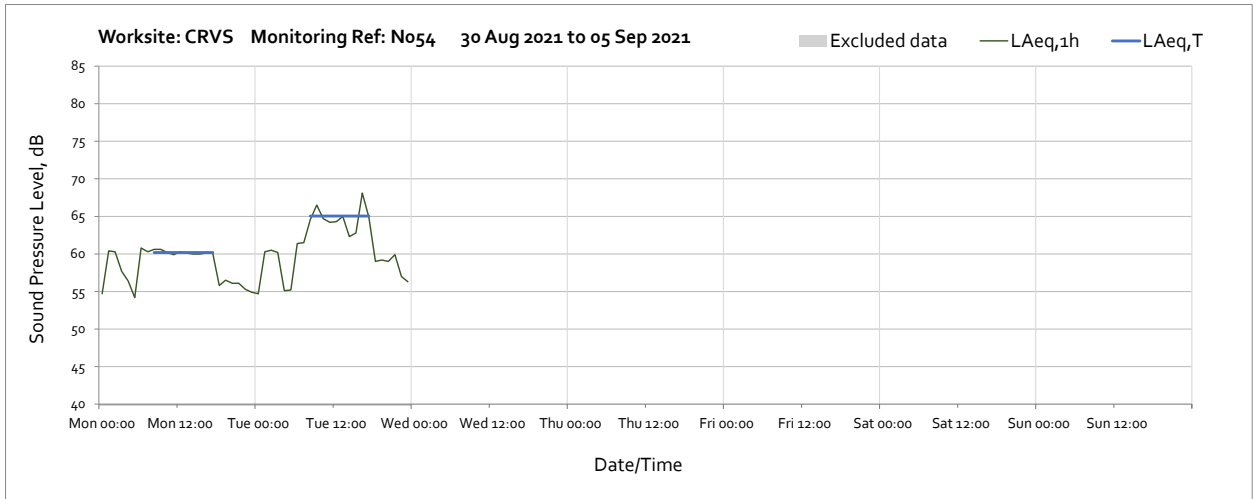
Worksite: CRVS - Monitoring Ref: N054

Note: Missing data from 23:00 on Saturday 14th August until 10:00 on Monday 16th August was due to equipment failure during software update.

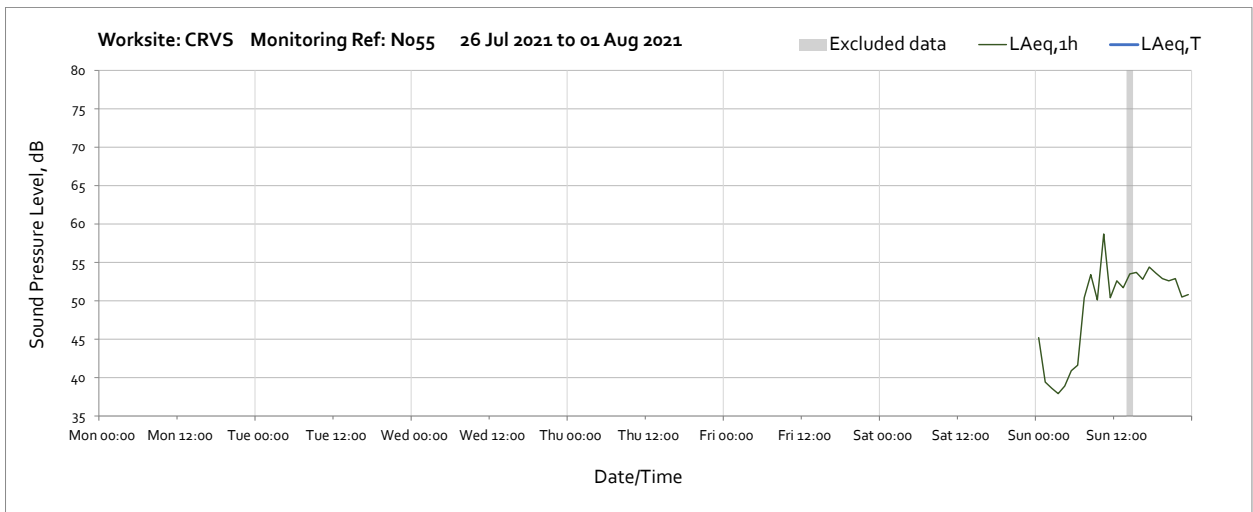
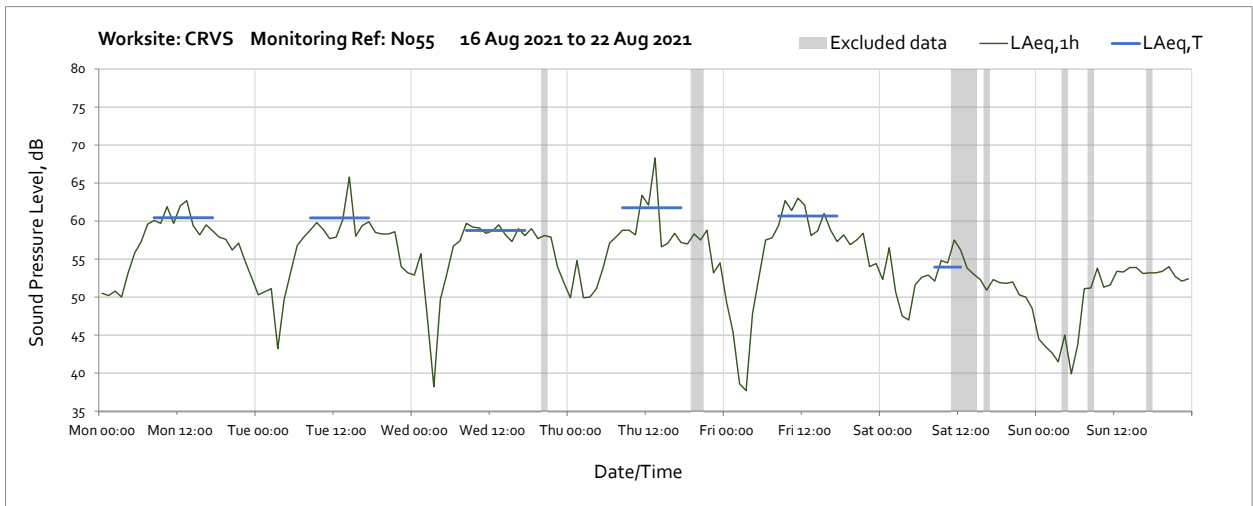
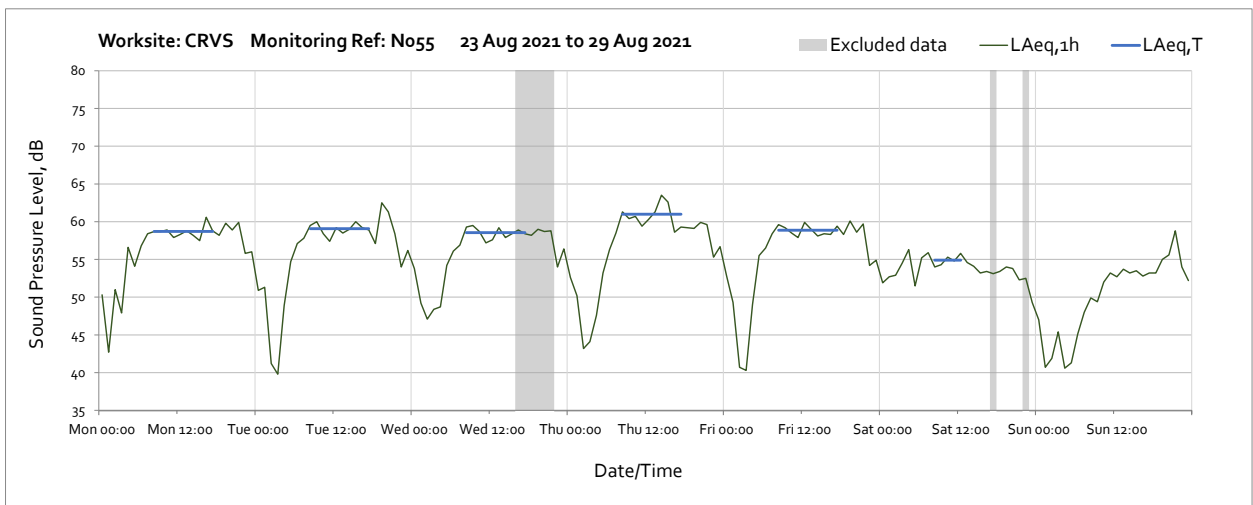
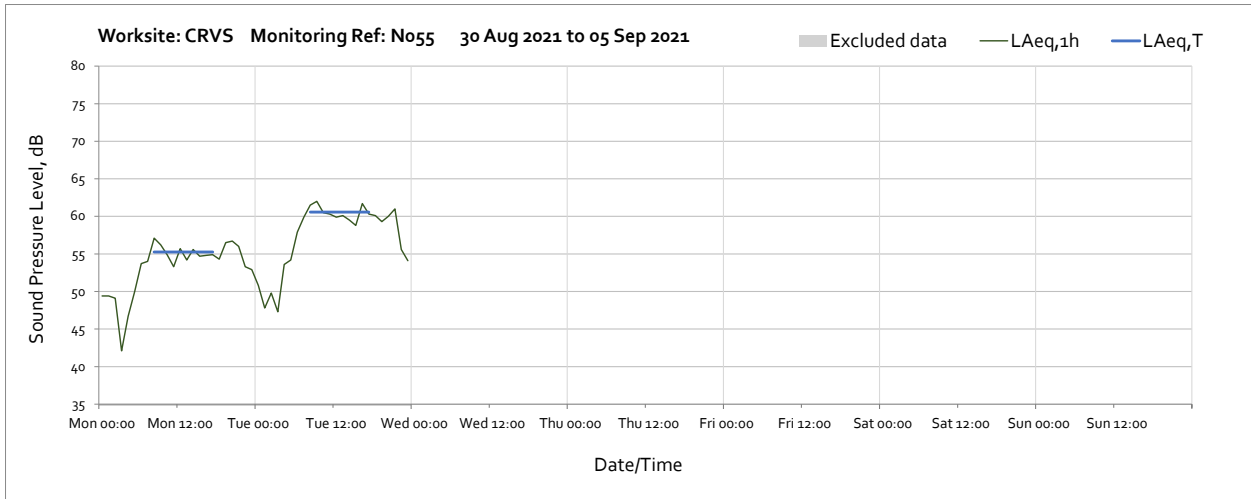
Worksite: CRVS – Monitoring Ref: N055

Note: Missing data from 10:00 to 11:00 on Saturday 14th August was due equipment failure during software update.

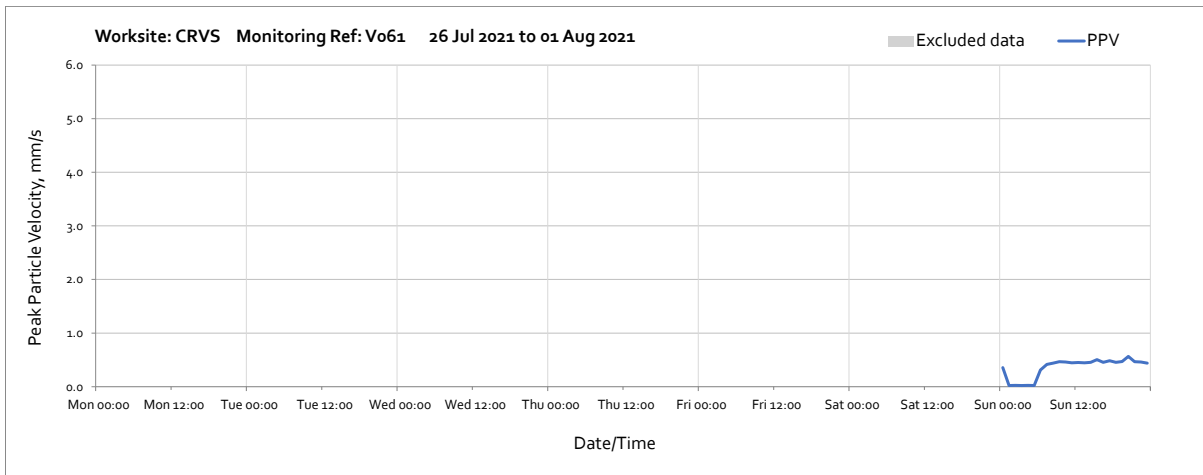
Worksite: CRVS – Monitoring Ref: V061

The following graphs show the hourly measured peak particle velocity PPV recorded during the monitoring period. The graphs show the highest PPV of the three orthogonal axis x, y and z. Where high values of PPV were caused by local interference with the vibration monitor, which are not representative of HS2 construction works, these values have been greyed out in the following charts and have been excluded to calculate values in Table 4 of the main report.

Note: Missing data from 16:00 on Friday 6th August until 18:00 on Tuesday 10th August was due to depleted batteries and difficulty in obtaining access to change the batteries due to the school holidays. A temporary additional vibration monitor V061 (temp) was installed within CRVS worksite 4 metres from vibration monitor V061 on Tuesday 10th August to provide cover for vibration monitor V061.

1.2.3 A temporary additional vibration monitor V061 (temp) was installed within CRVS worksite 4 metres from vibration monitor V061 at St Mary's Catholic Primary School, Canterbury Road, London, on the 10th of August. This action was taken to provide cover for vibration monitor V061 which ran out of battery power on the 6th of August and due to the school holidays, there was difficulty in obtaining access to change the batteries.

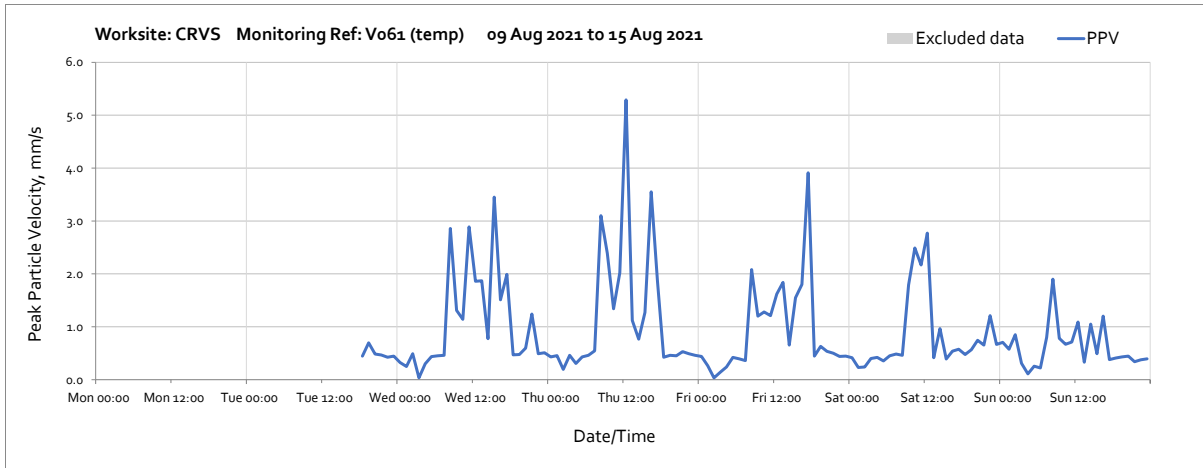
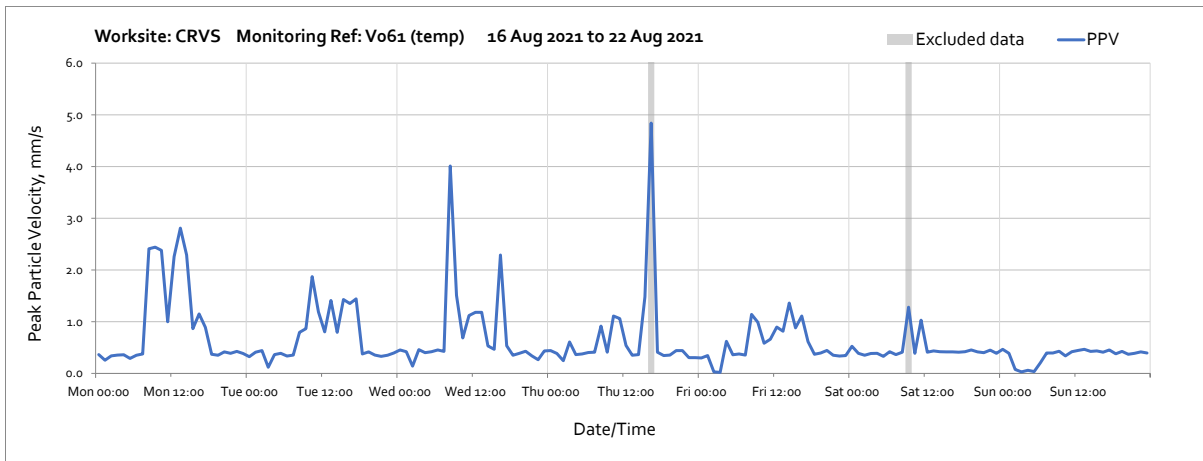
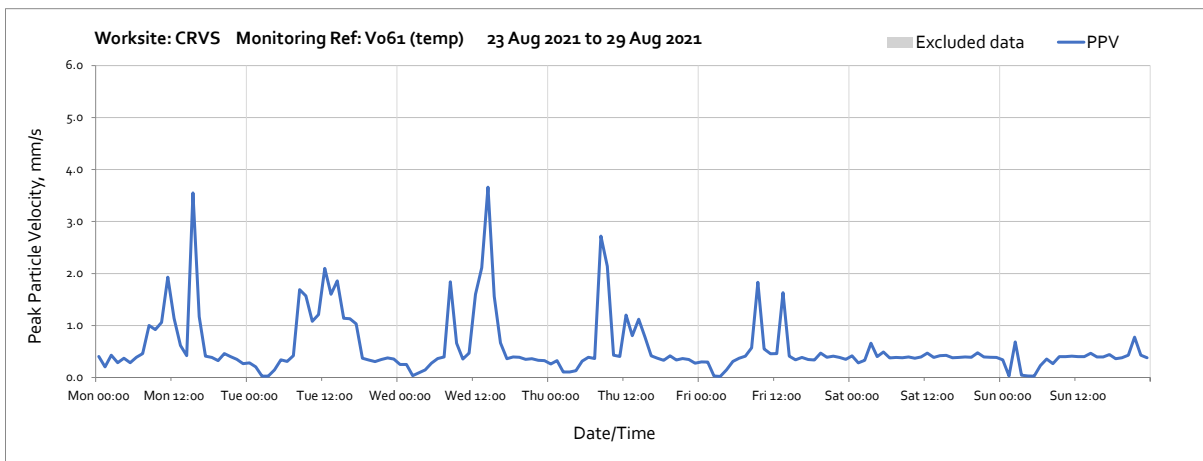
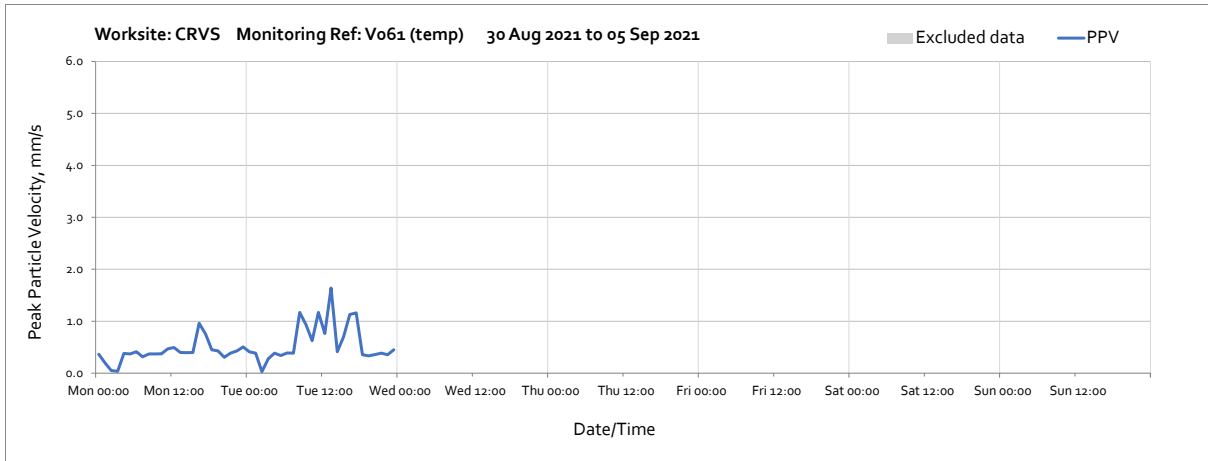
Worksite: CRVS – Monitoring Ref: V061 (temp)

Note: A temporary additional vibration monitor V061 (temp) was installed within CRVS worksite 4 metres from vibration monitor V061 on Tuesday 10th August. It was installed to provide cover for vibration monitor V061 because it ran out of battery on the 6th of August and there was difficulty in obtaining access to change the batteries due to the school holidays.
