Construction noise and vibration Monthly Report – August 2021

London Borough of Hillingdon

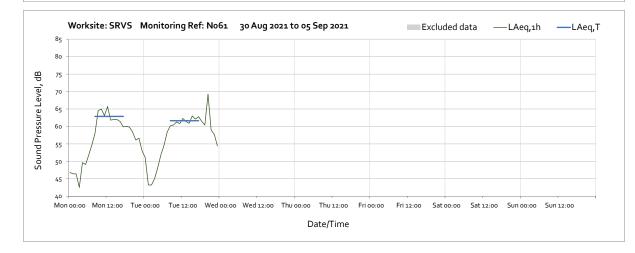
Worksite: South Ruislip Ventilation Shaft (SRVS) – Monitoring Ref: N061

Note: missing data between 00:00 and 05:00 on Sunday 1st August 2021 was due to an error with the memory card of the monitoring station.

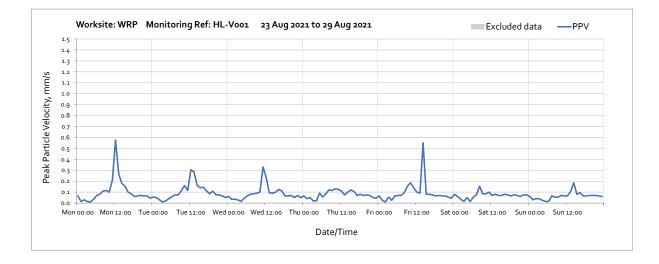
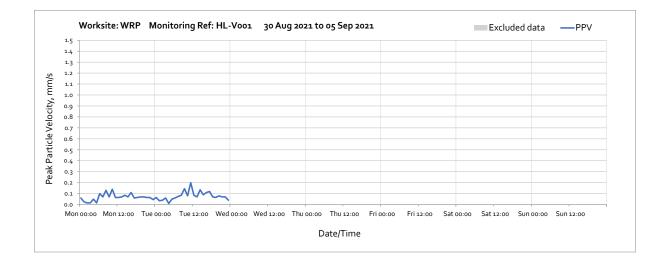
Worksite: West Ruislip Retained Embankment (WRRE) - Monitoring Ref: HL-V001

The following graphs show the hourly measured peak particle velocity PPV recorded during the monitoring period. The graphs show the highest PPV of the three orthogonal axis x, y and z. Where high values of PPV were caused by local interference with the vibration monitor, which are not representative of HS2 construction works, these values have been greyed out in the following charts and have been excluded to calculate values in Table 4 of the main report.

Note: the vibration monitor (ref.: HL-V001) has been installed on Thursday 19th of August at 13:00.
