October 2021

# HS2

# **Construction noise and vibration Monthly Report – August 2021**

**North Warwickshire Borough Council**

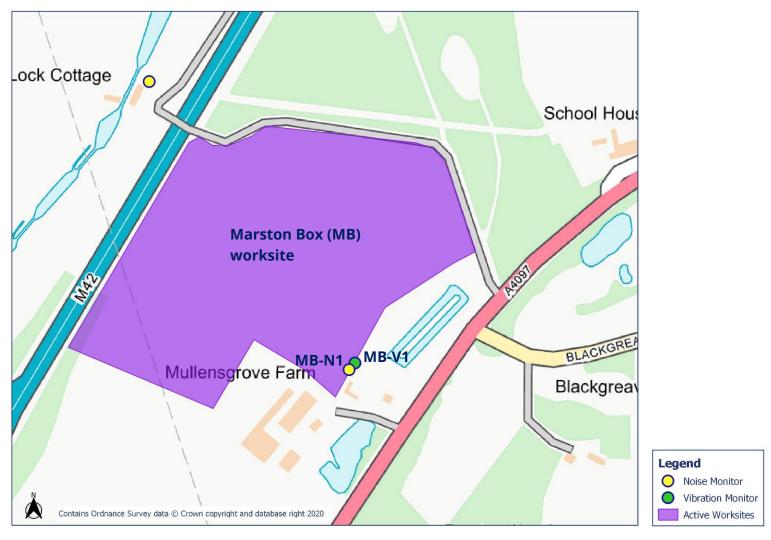
## **HS2** Noise and Vibration Monitoring Plan - 1

- 1.2.1 Four noise monitoring installations and one vibration monitoring installation were active in August in the NWBC area. Table 2 summarises the position of noise and vibration monitoring installations within the NWBC area in August 2021.
- 1.2.2 Maps showing the position of noise and vibration monitoring installations are presented in Appendix B.
