HS2

Air Quality and Dust Monitoring Monthly Report – September 2021

City of Westminster

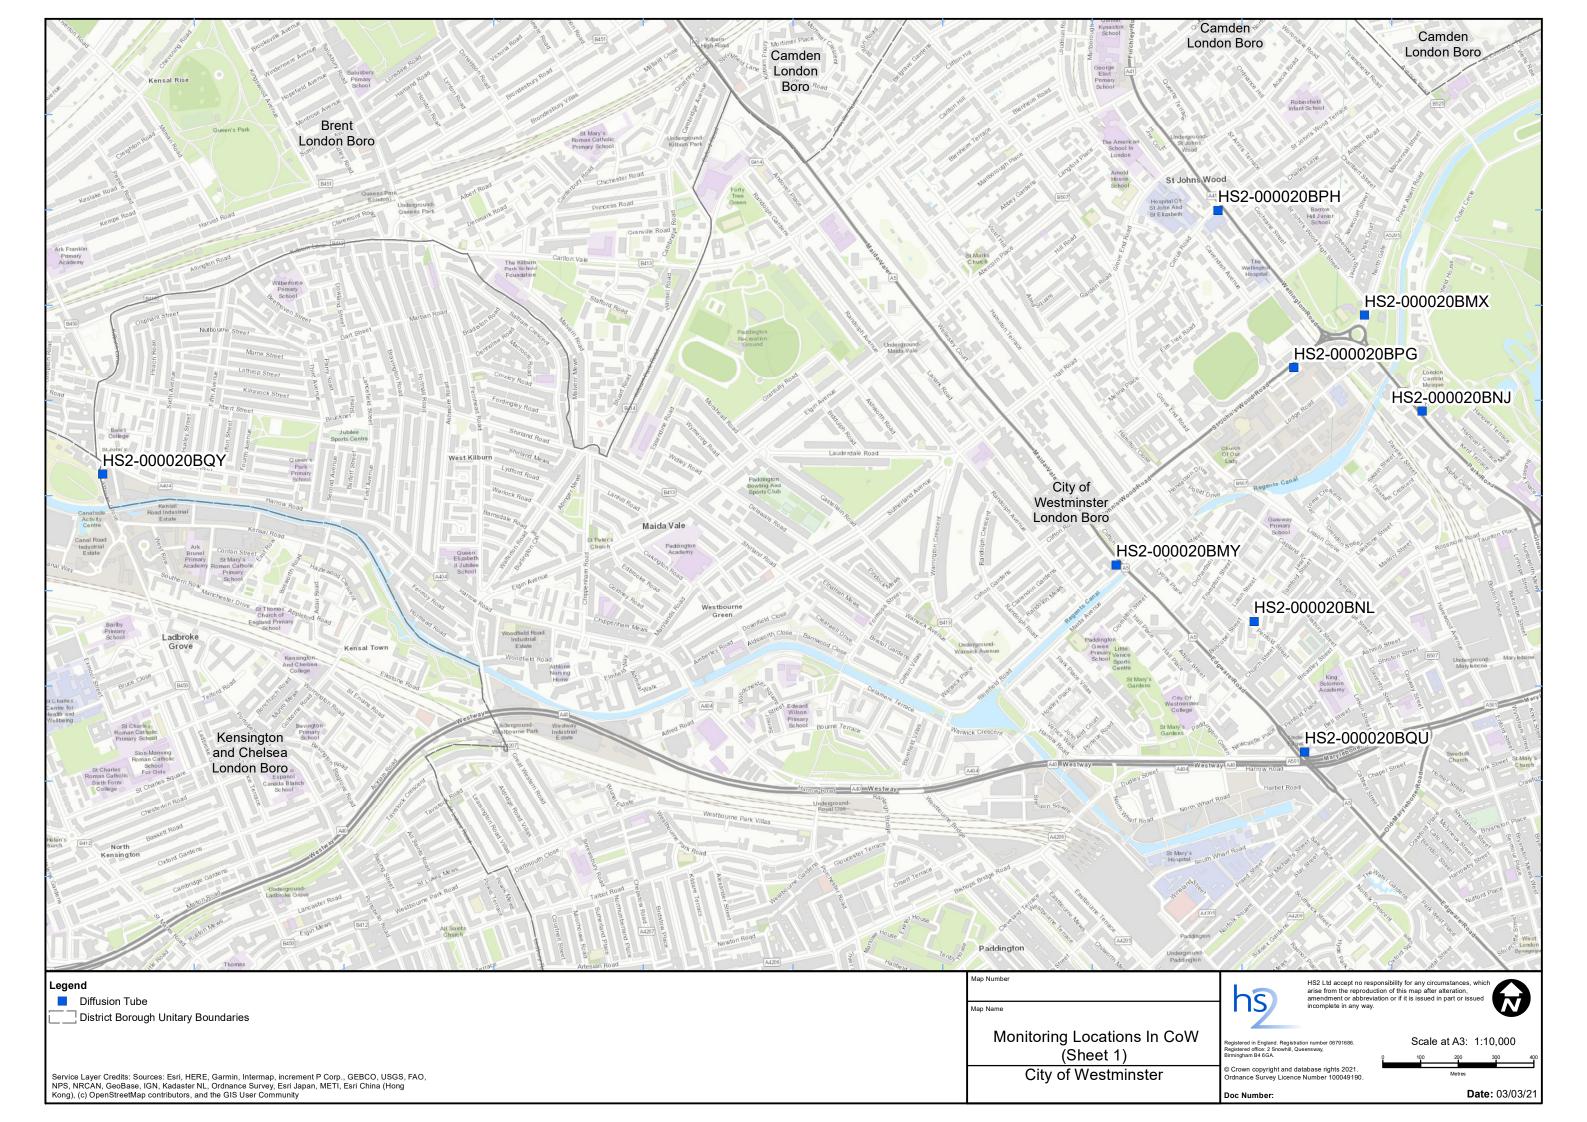
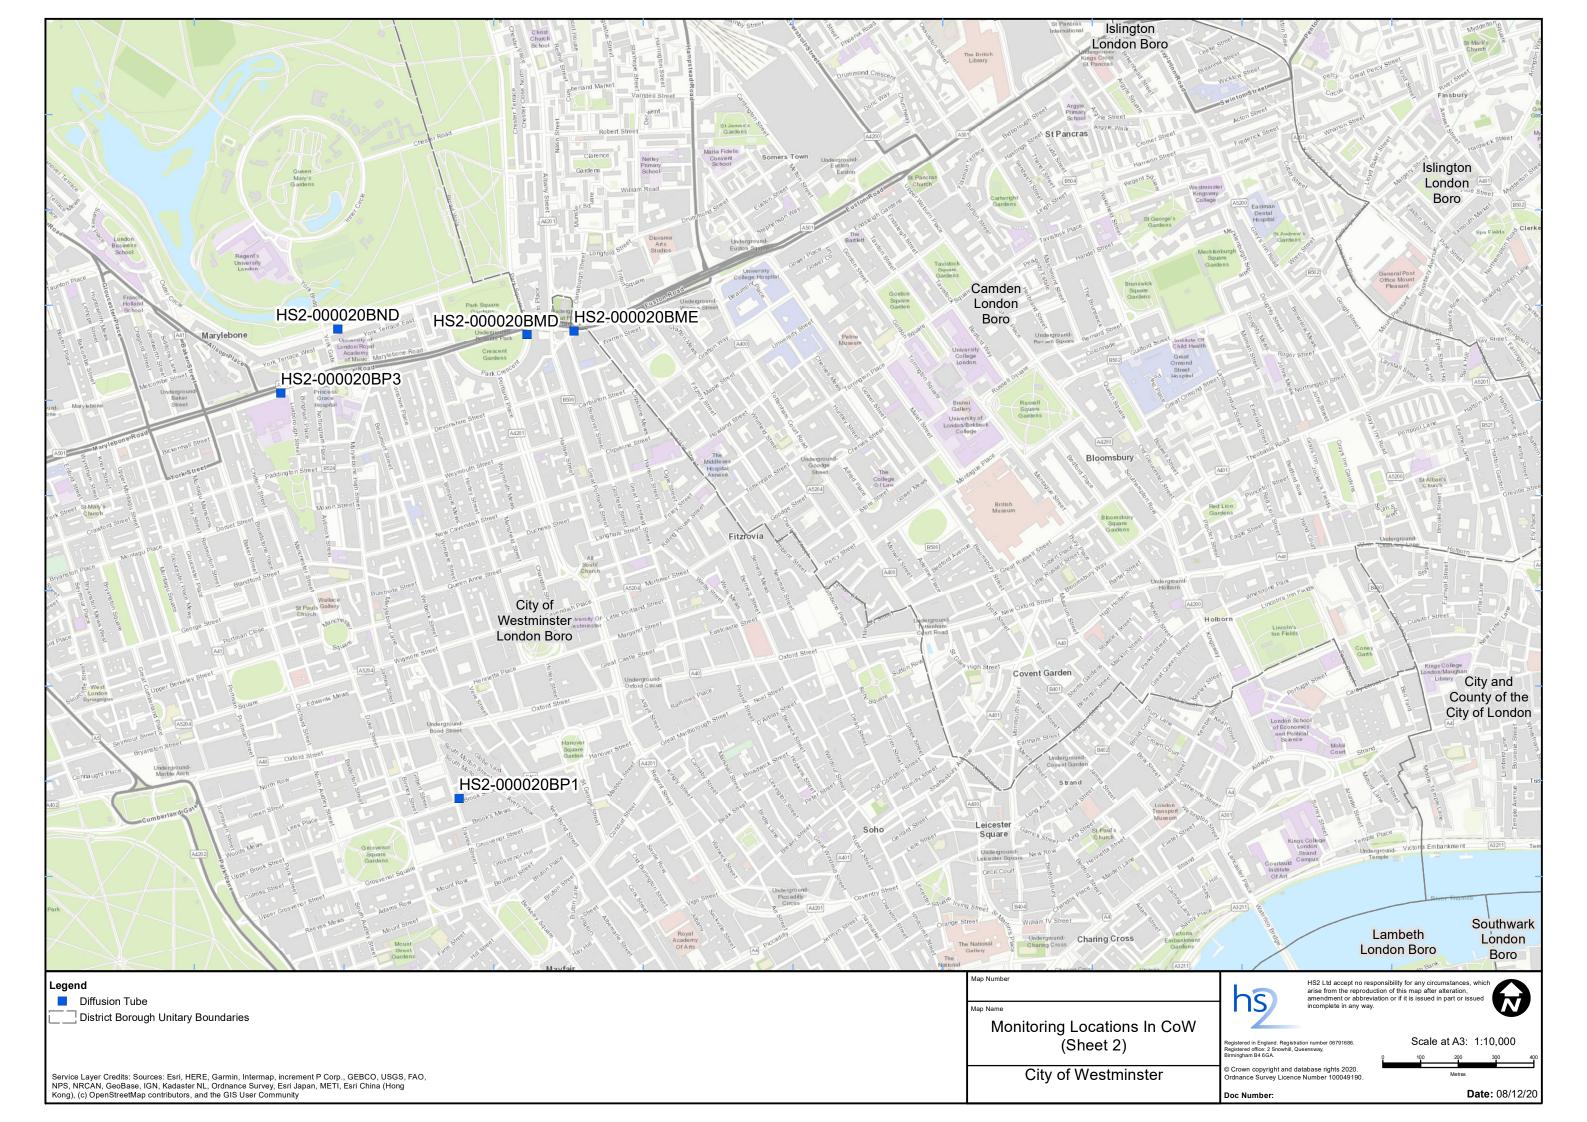
Figure 1 and 2: Current monitoring locations within the COW

- 1.1.2 Figure 1 and Figure 2 in Appendix A indicate the current air quality monitoring locations within CoW.
- 1.1.3 This summary should be read in conjunction with the overview monitoring report available from www.gov.uk/government/collections/monitoring-the-environmental-effects-of-hs2, which highlights: the applicable standards and guidance, as well as the air quality and dust monitoring methodologies to be implemented by nominated undertakers throughout construction.

- 1.1.4 There are no current worksites located within the CoW. Therefore, no dust monitoring has been carried out.
- 1.1.5 Diffusion tube monitoring of Nitrogen Dioxide (NO₂) was undertaken at thirteen (13) locations around highways within the CoW as part of the management of air quality where significant effects may occur as a result of the scheme.
