## **Construction noise and vibration Monthly Report – October 2021**

**Lichfield City Council**

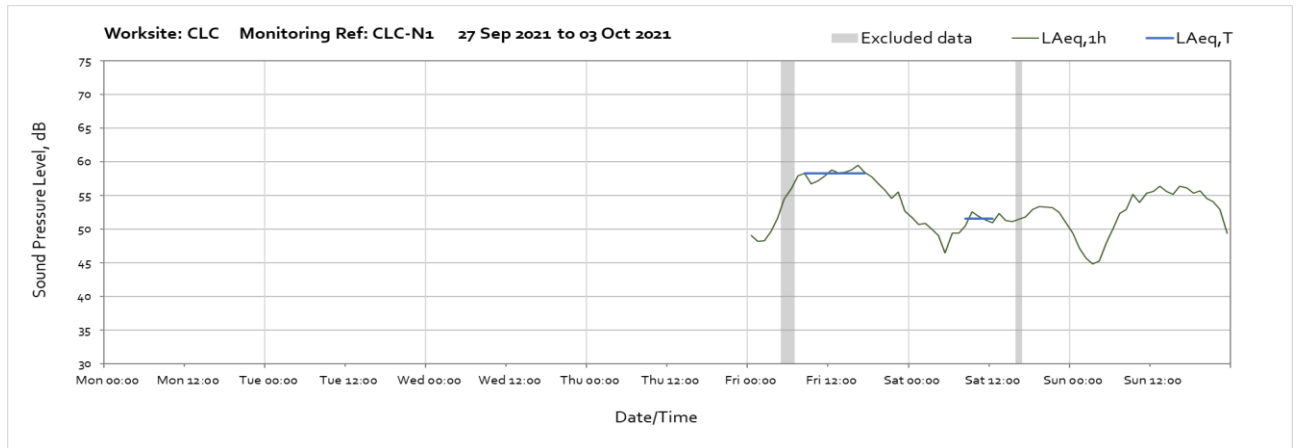
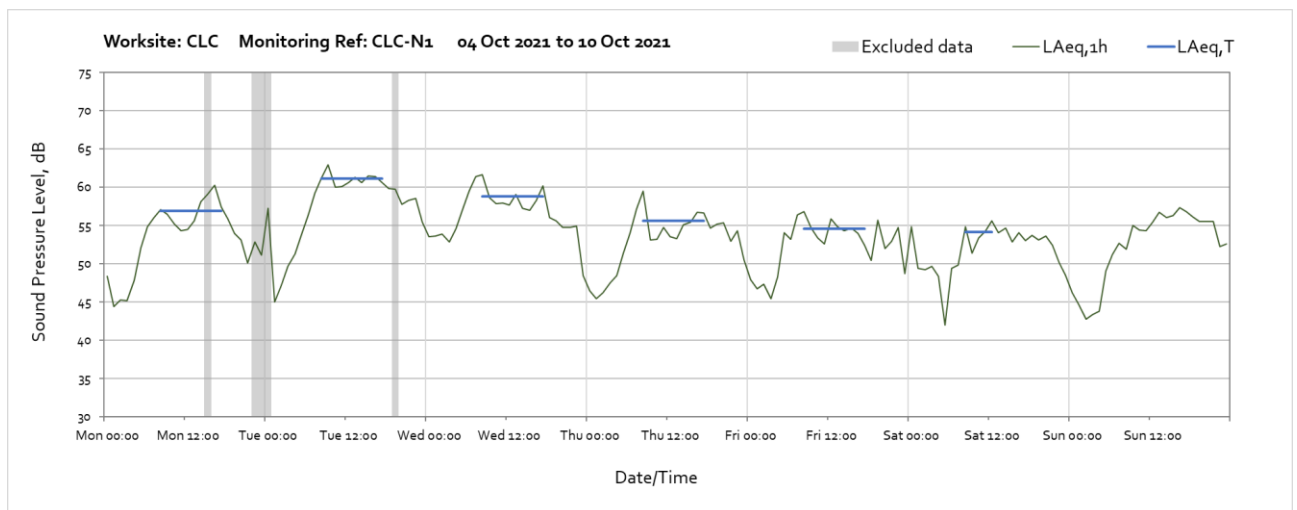
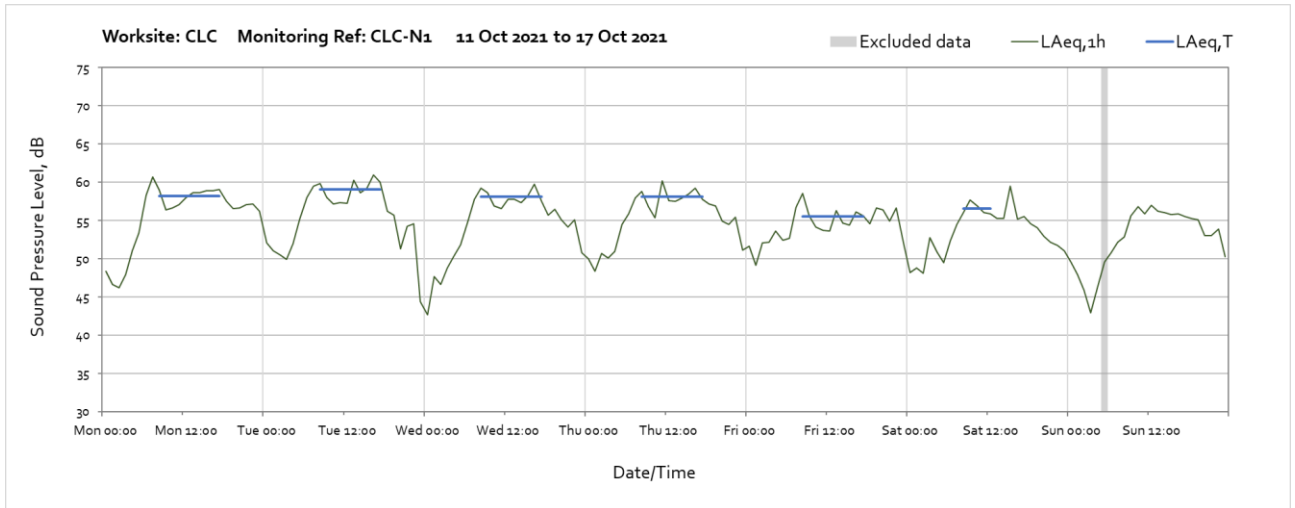
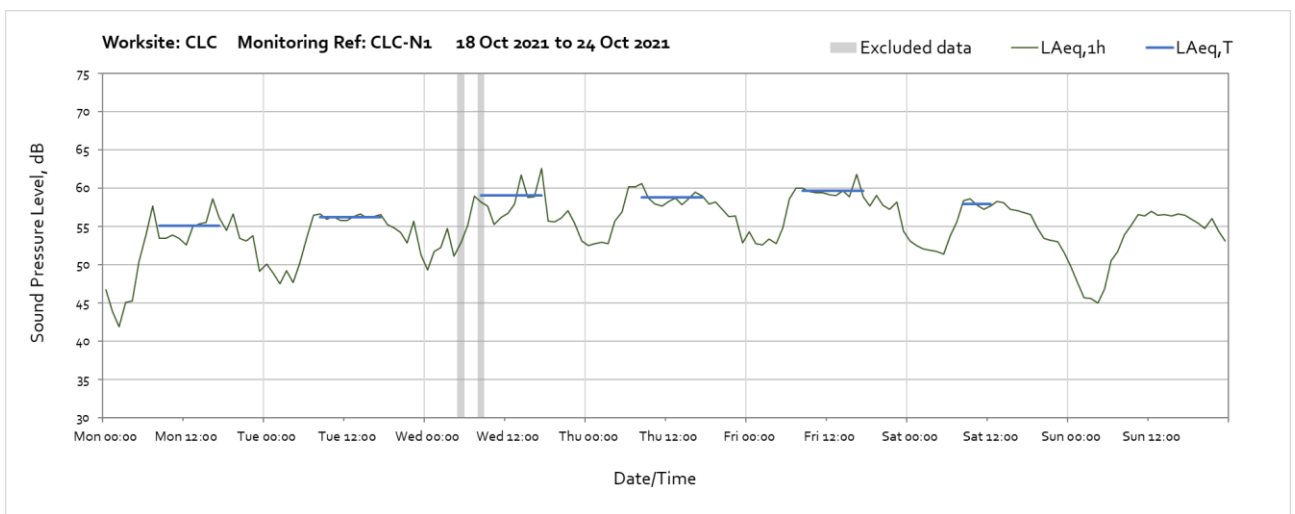
## Worksite: CLC – Monitoring Ref: CLC-N1

The following graphs show the hourly measured ambient noise level  $L_{Aeq,1h}$  and, where relevant, the averaged noise level  $L_{Aeq,T}$  values, where the time period T is as specified in Table 1 of HS2 Information Paper E23. Periods with adversely weather affected noise levels are greyed out and have been excluded from the calculation of the  $L_{Aeq,T}$  values in Table 3 of the main report.

Note: Unusually low levels between 00:00 and 01:00 on the 31<sup>st</sup> October have been excluded due to a daylight saving adjustment.

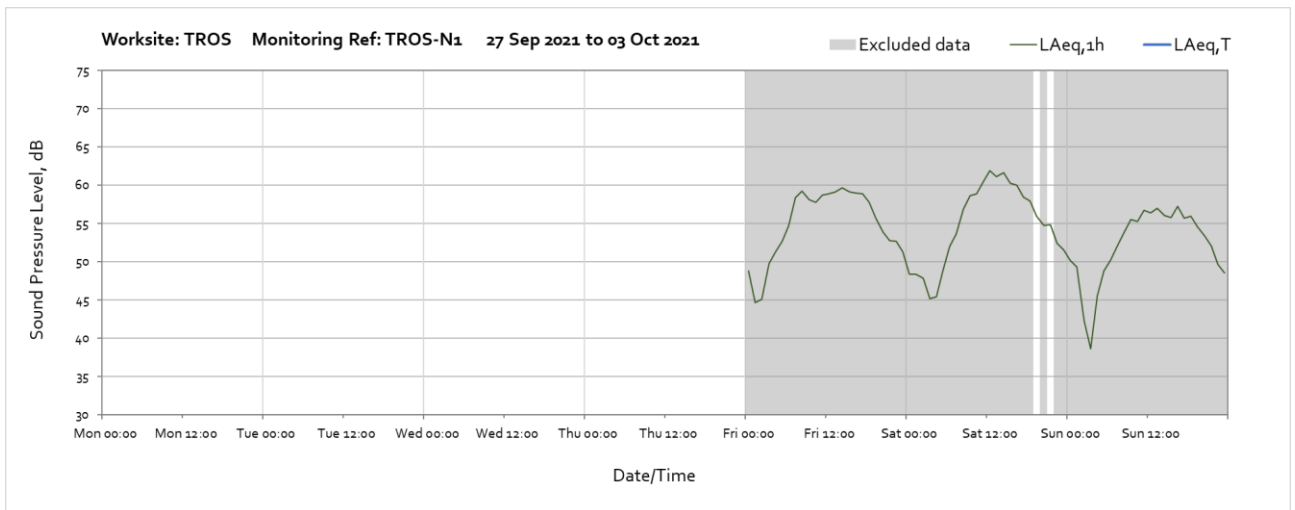
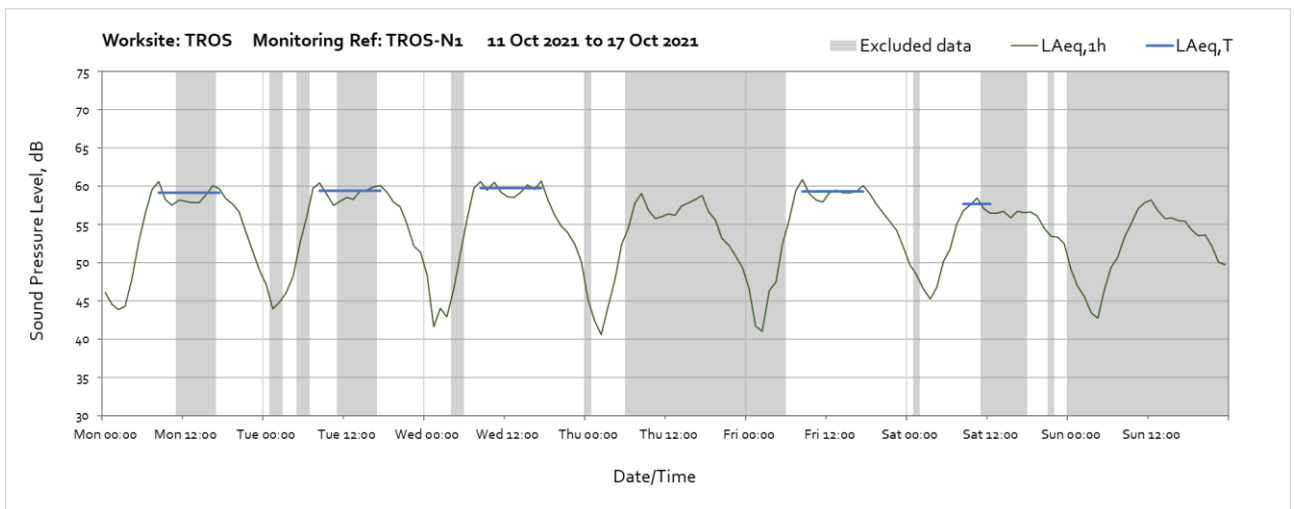
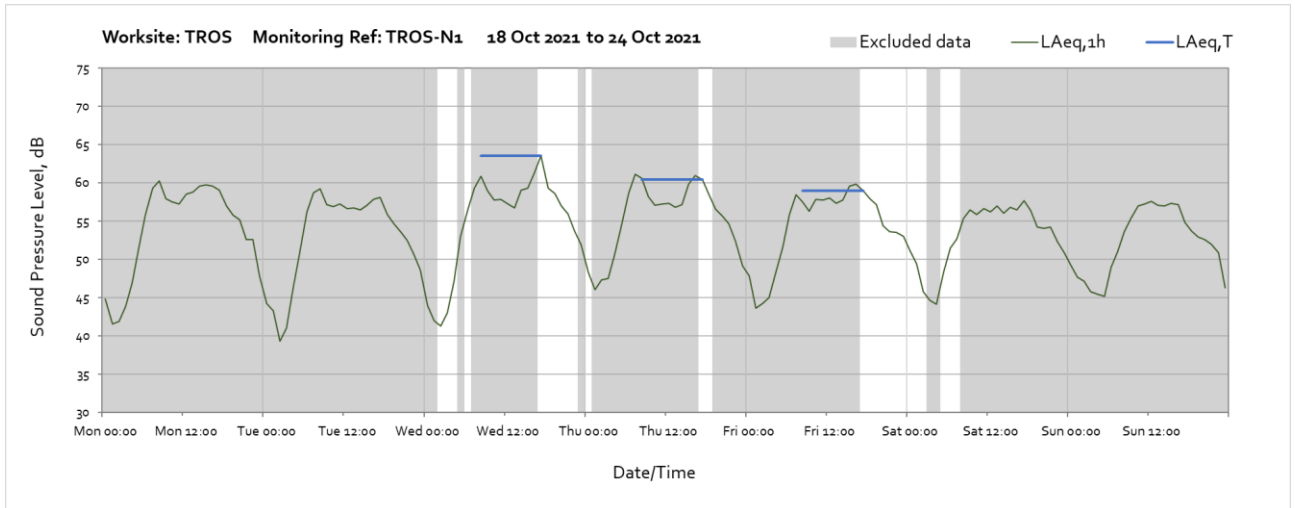
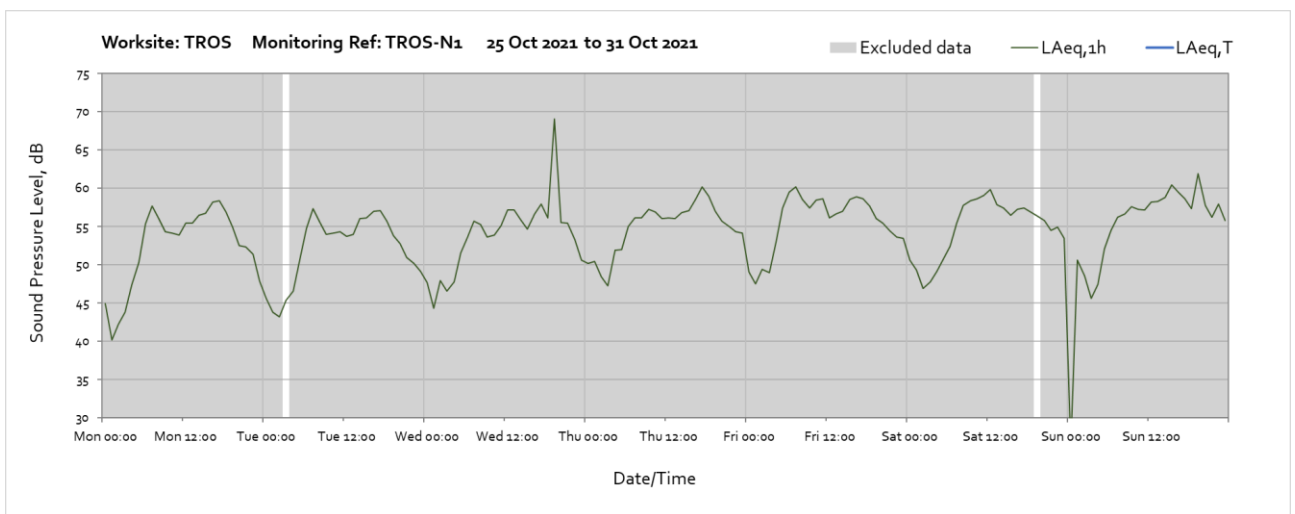
## Worksite:TROS – Monitoring Ref: TROS-N1

Note: Unusually low levels between 00:00 and 01:00 on the 31<sup>st</sup> October have been excluded due to a daylight saving adjustment.

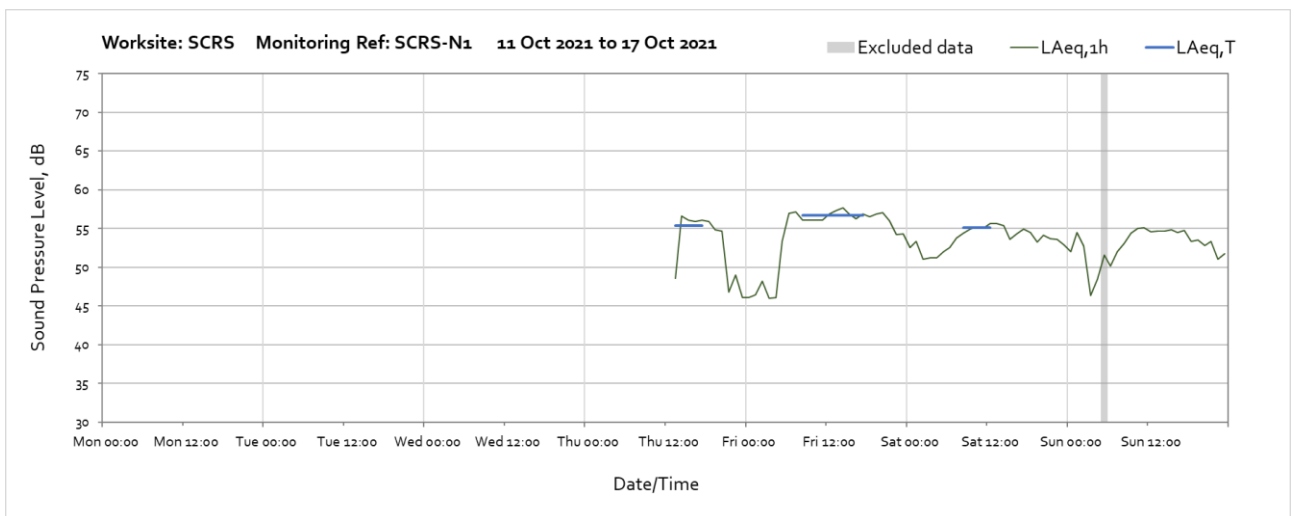
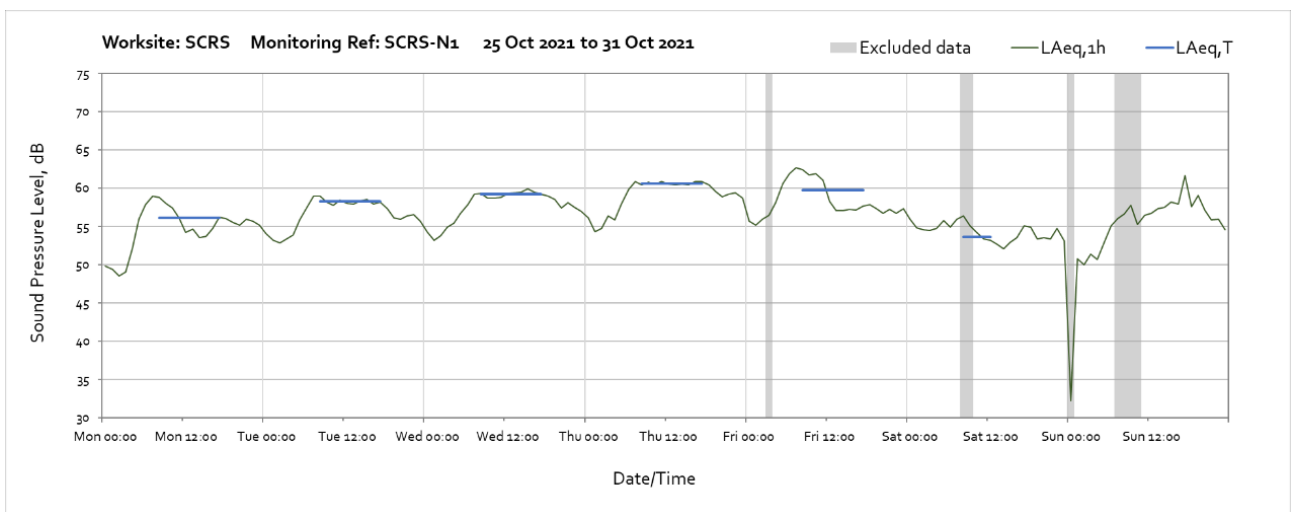
### Worksite: SCRS – Monitoring Re f: SCRS-N1

Note: The noise monitor was installed on Wednesday 14<sup>th</sup> October.

Note: Unusually low levels between 00:00 and 01:00 on the 31<sup>st</sup> October have been excluded due to a daylight saving adjustment.

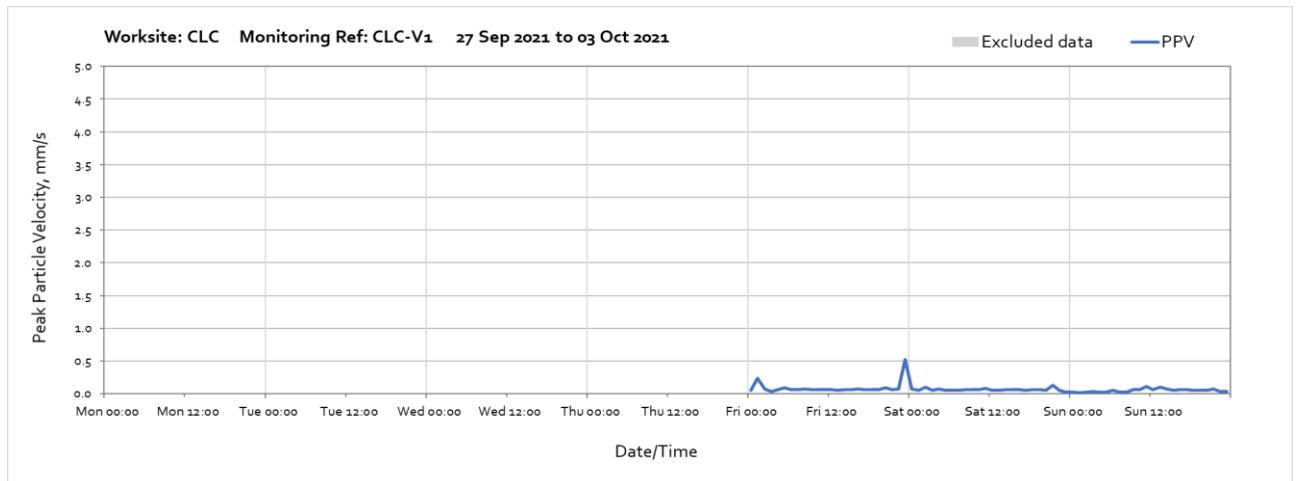
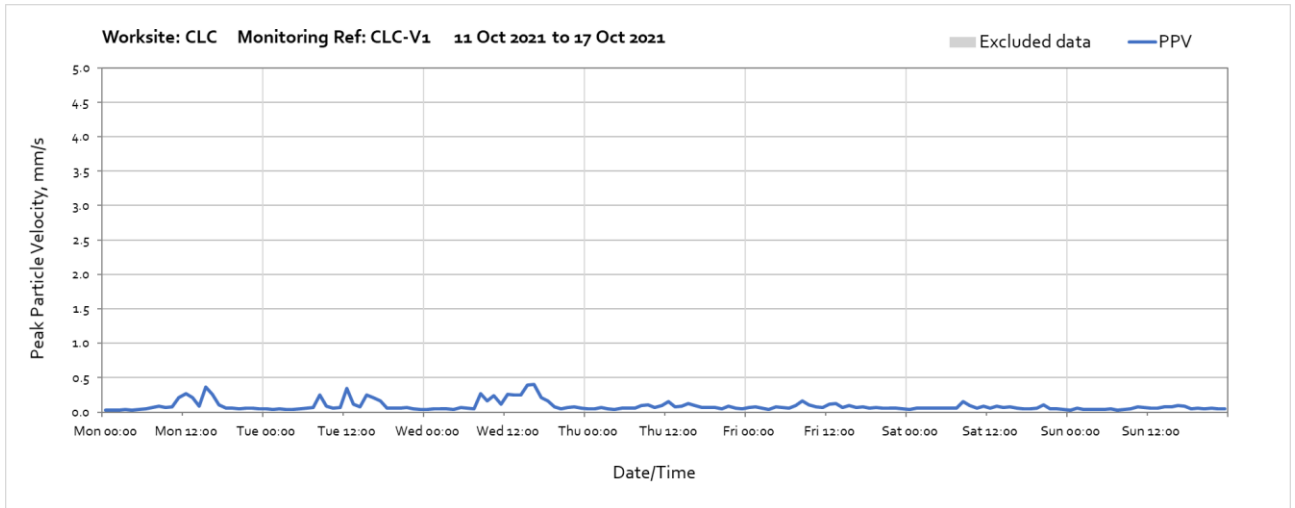
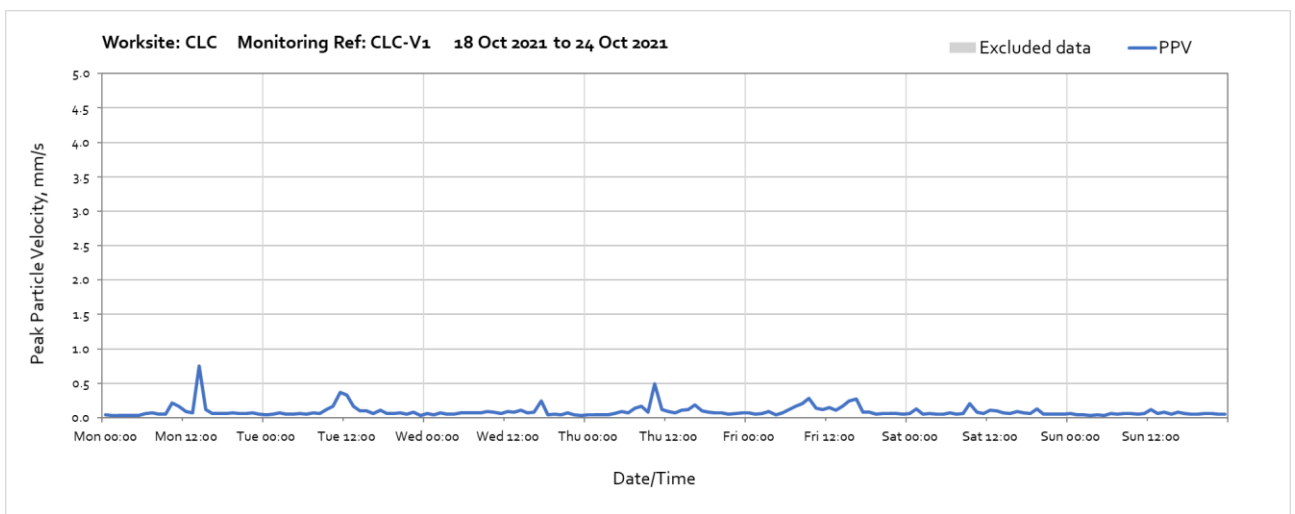
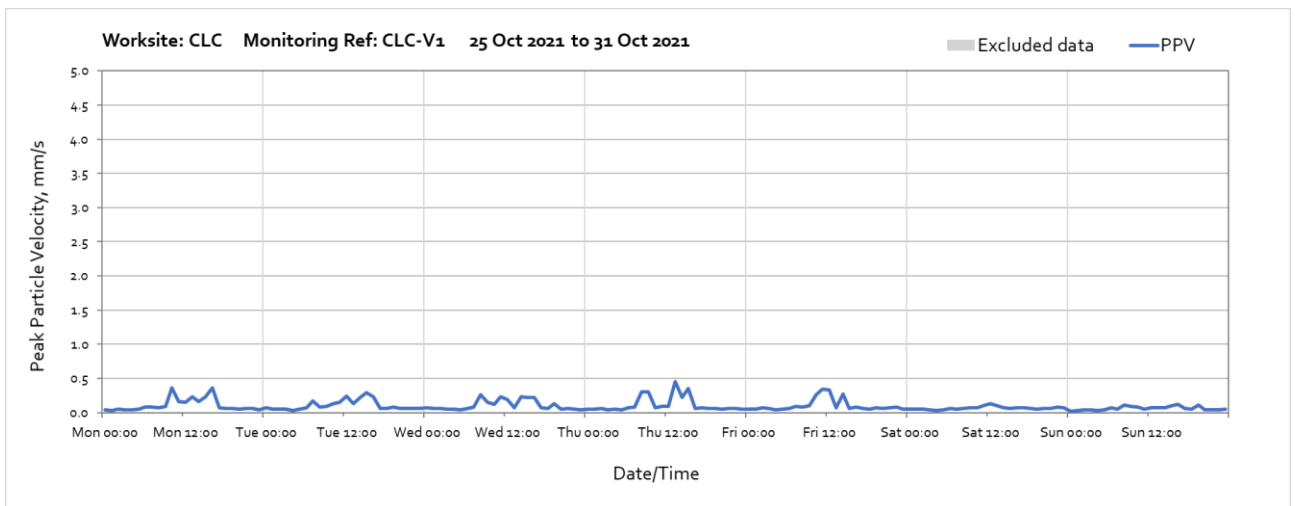
### Worksite: CLC – Monitoring Ref: CLC-V1

The following graphs show the hourly measured peak particle velocity PPV recorded during the monitoring period. The graphs show the resultant PPV due to vibration components on three orthogonal axis x, y and z. Where high values of PPV were caused by local interference with the vibration monitor, which are not representative of HS2 construction works, these values have been greyed out in the following charts and have been excluded to calculate values in Table 4 of the main report.

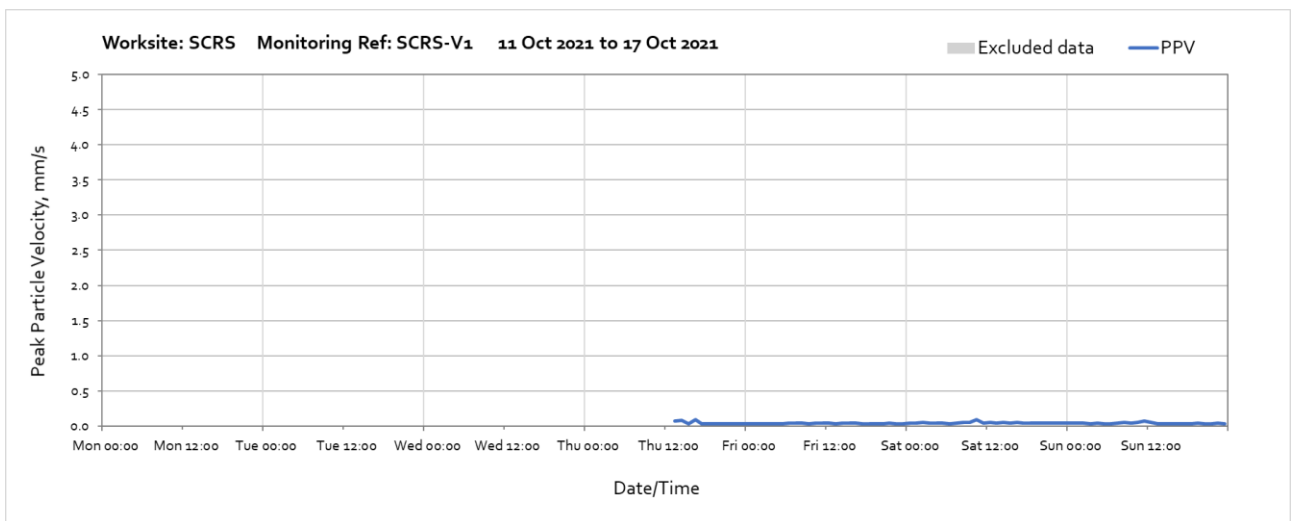
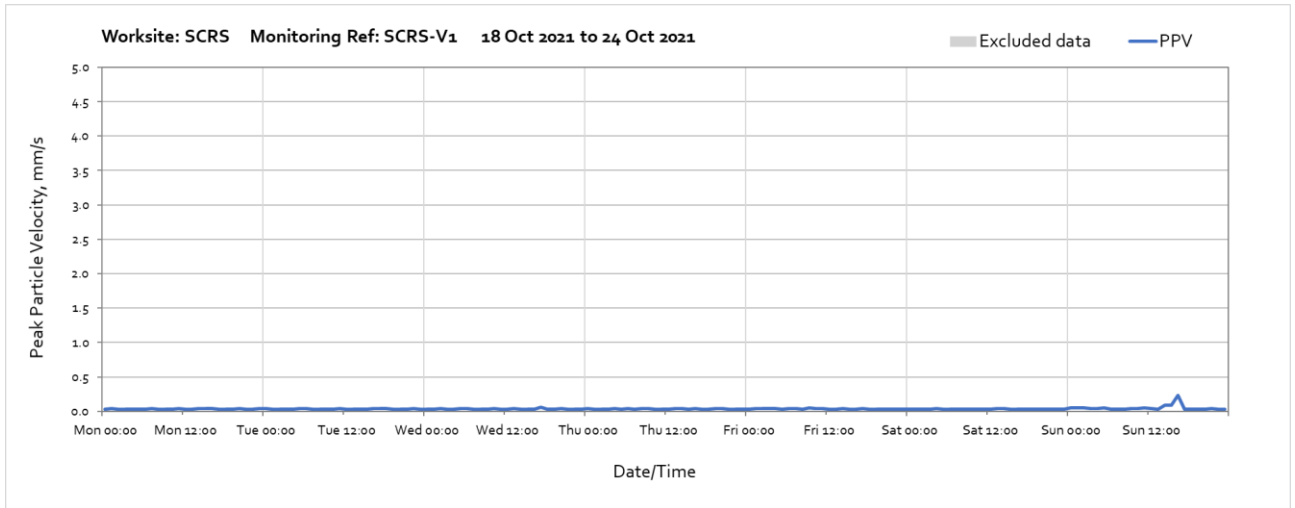
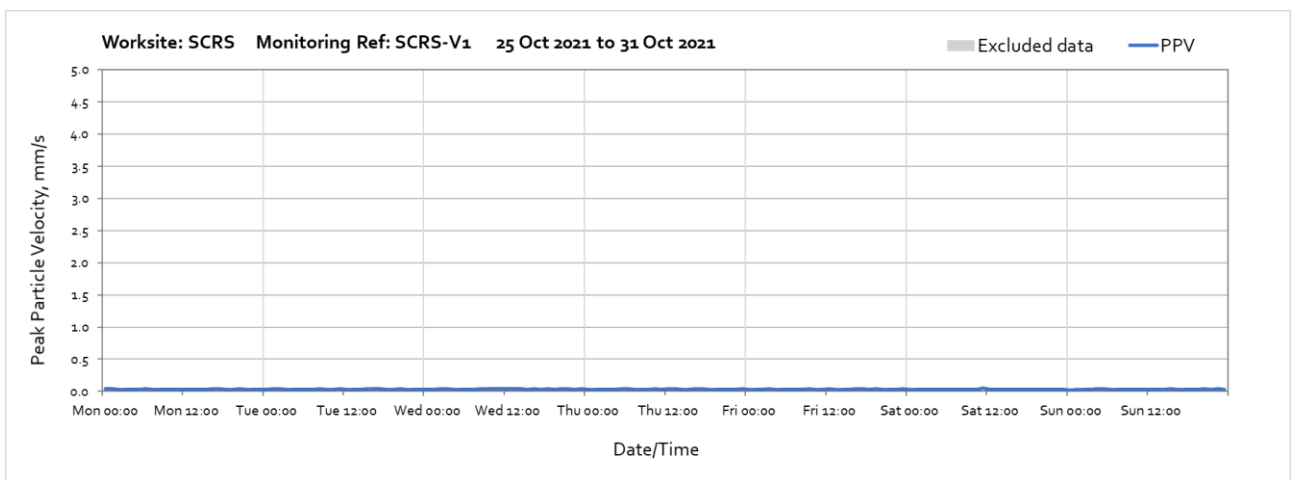
**Worksite: SCRS – Monitoring Ref: SCRS-V1**

Note: The vibration monitor was installed on Wednesday 14<sup>th</sup> October.
