## **Construction noise and vibration Monthly Report – November 2021**

**Birmingham City**

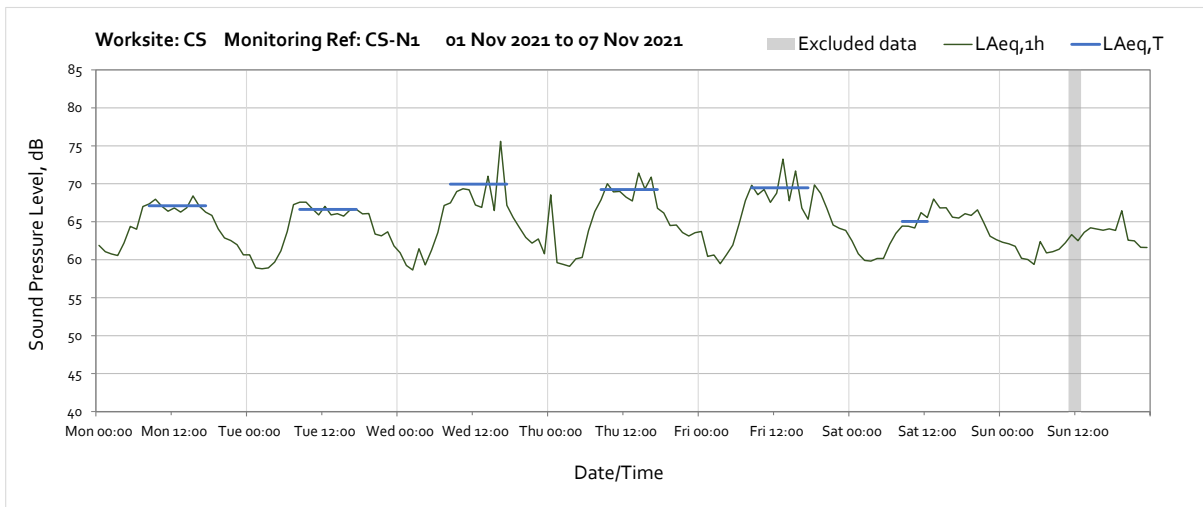
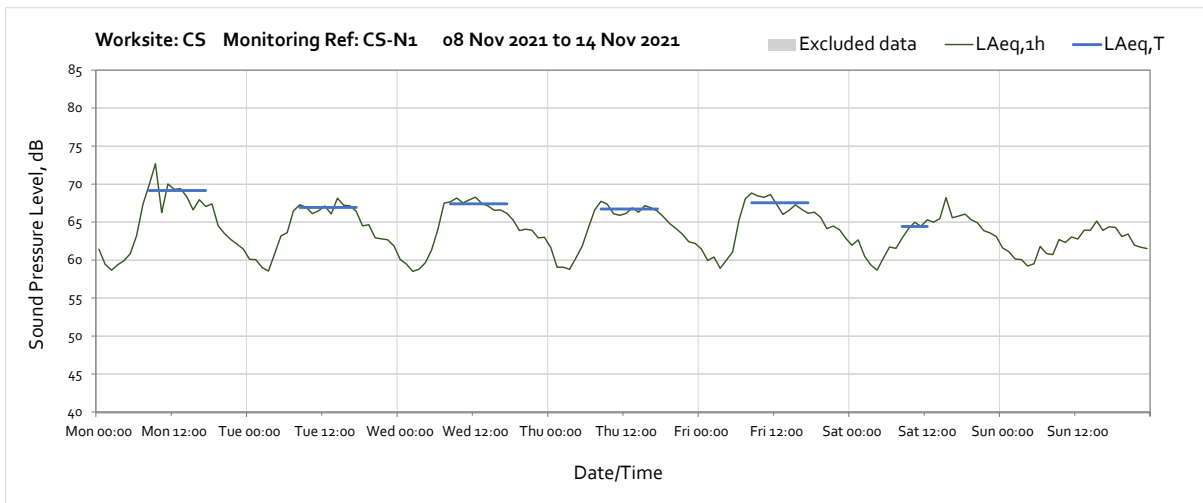
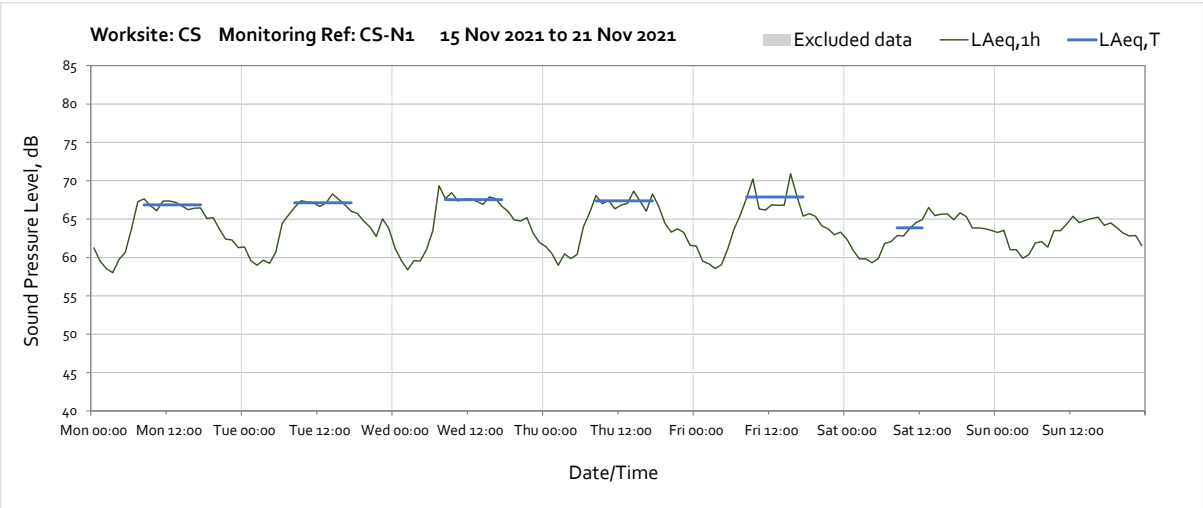
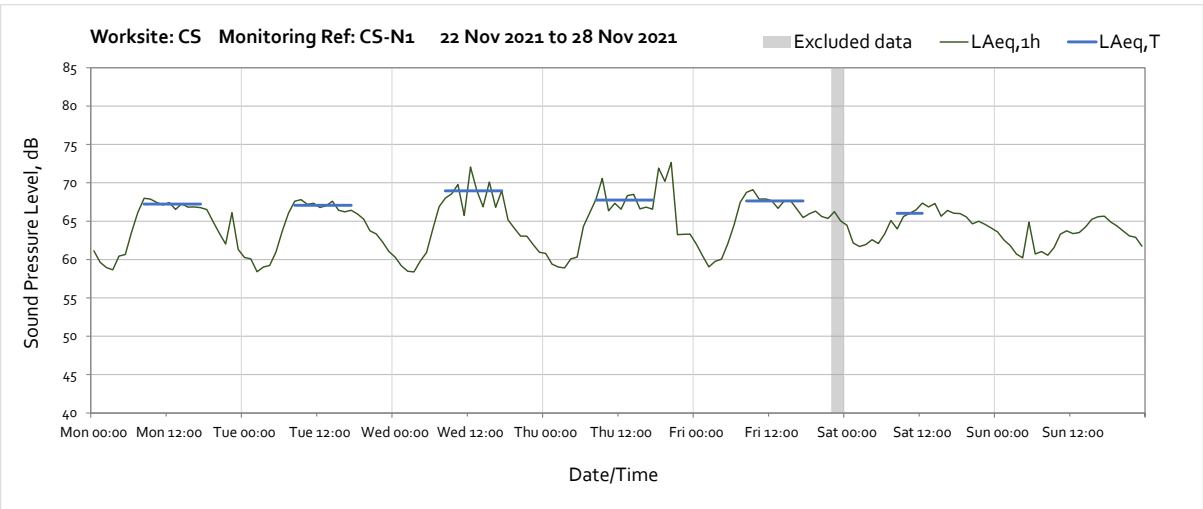
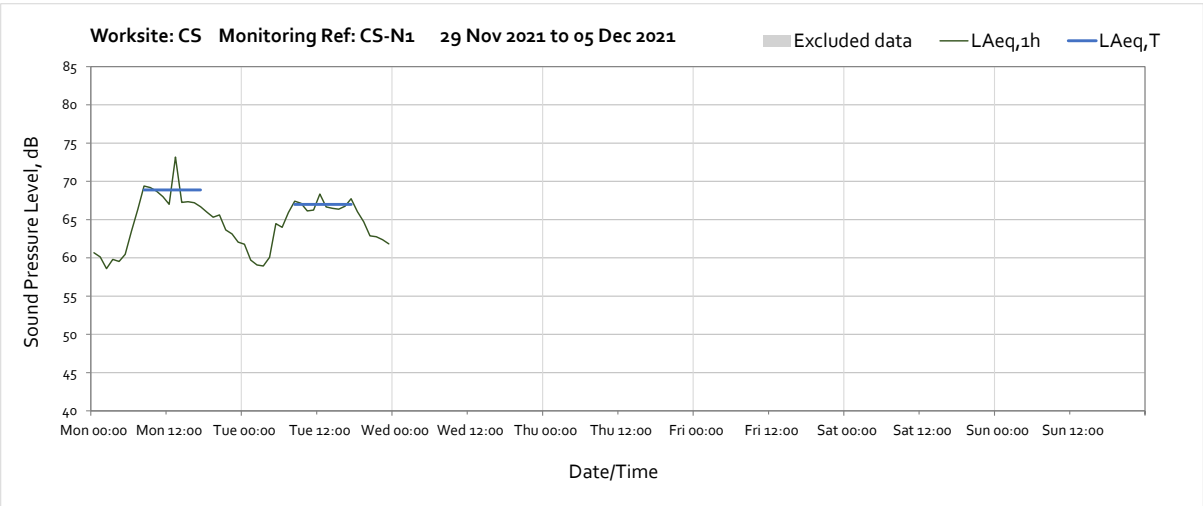
### Worksite: Curzon Street (CS) – Monitoring Ref: CS-N1

The following graphs show the hourly measured ambient noise level  $L_{Aeq,1h}$  and, where relevant, the averaged noise level  $L_{Aeq,T}$  values, where the time period T is as specified in Table 1 of HS2 Information Paper E23. Periods with adversely weather affected noise levels are greyed out and have been excluded from the calculation of the  $L_{Aeq,T}$  values in Table 3 of the main report.

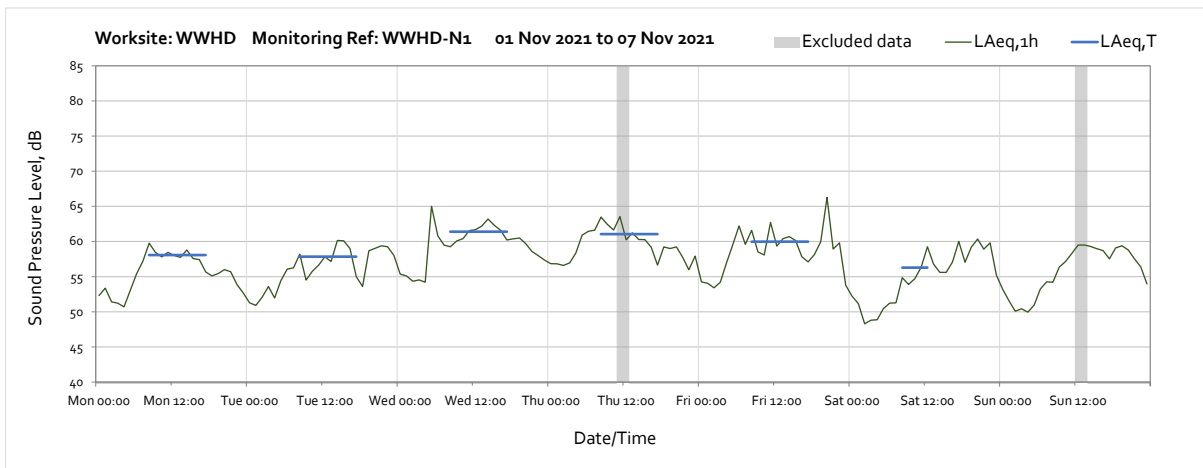
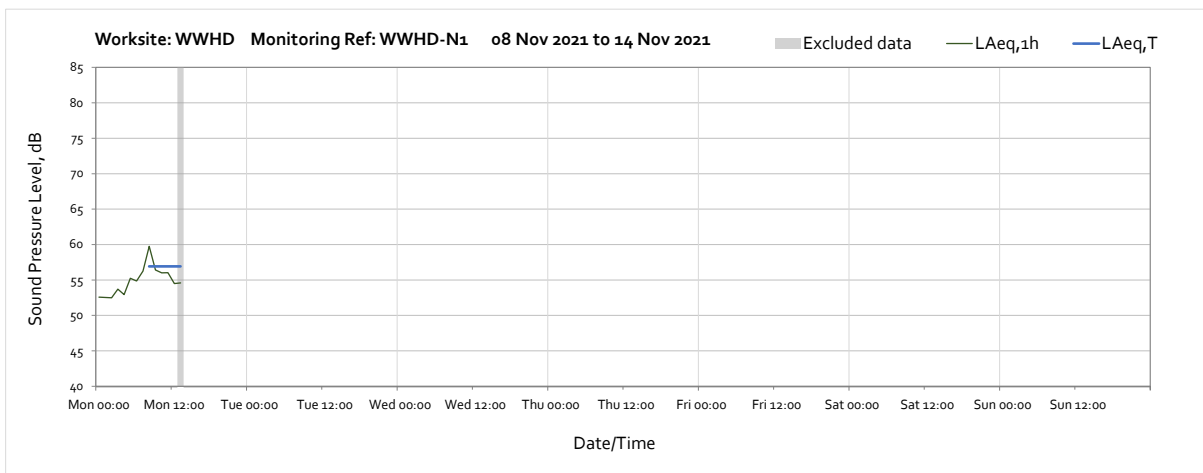
## Worksite: Washwood Heath Depot (WWHD) – Monitoring Ref: WWHD-N1

Note: Missing data between 14:00 on Monday 8<sup>th</sup> November and 09:00 on Monday 22<sup>nd</sup> November was due to weather station being added to the noise monitoring station for panel reconfiguration, the blank out periods were expected.

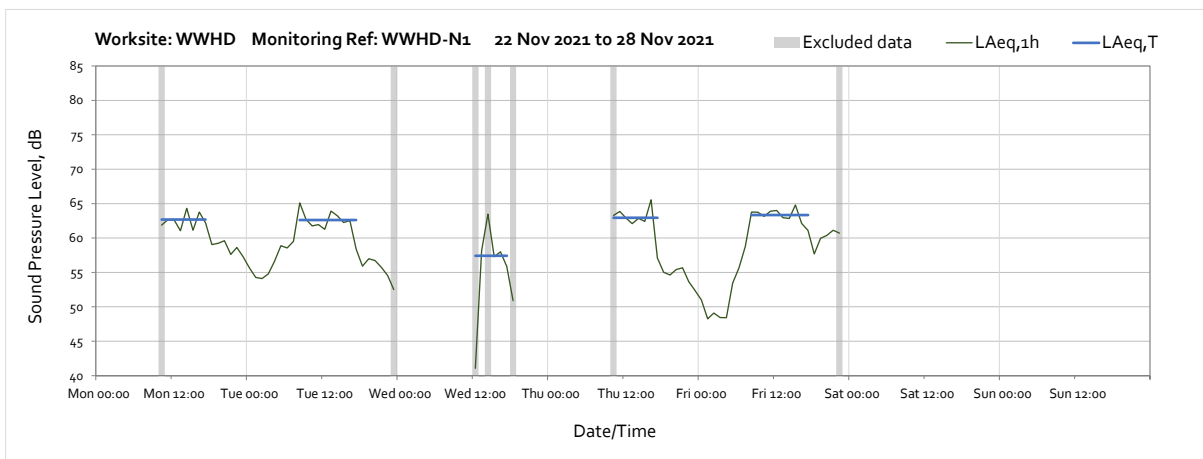
Note: Missing data across the week was due to weather station being added to the noise monitoring station for panel reconfiguration, the blank out periods were expected.

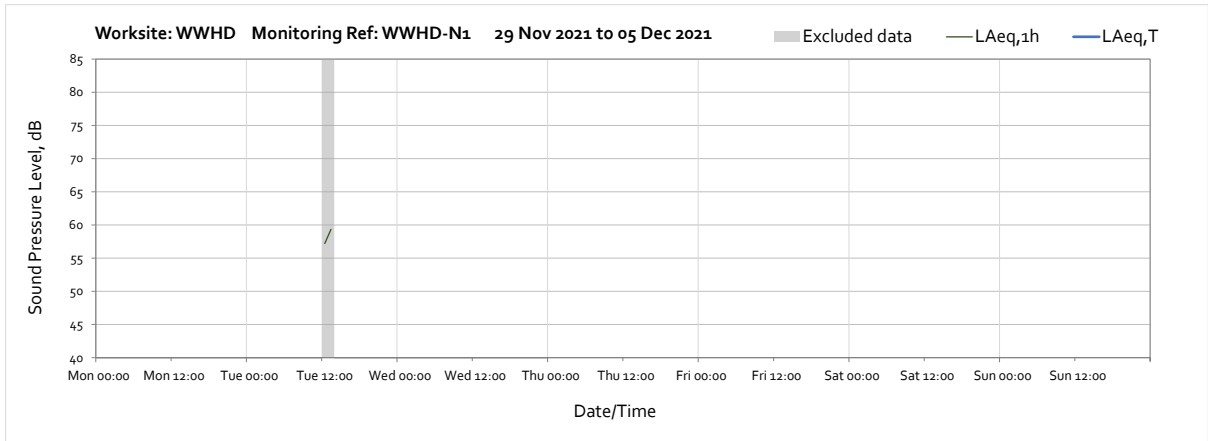
Note: Missing data across the week was due to weather station being added to the noise monitoring station for panel reconfiguration, the blank out periods were expected.

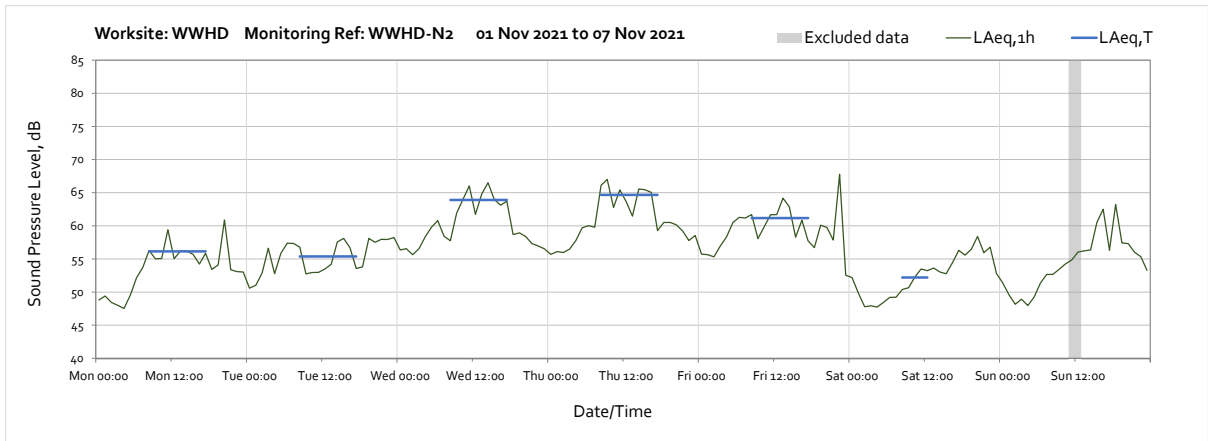
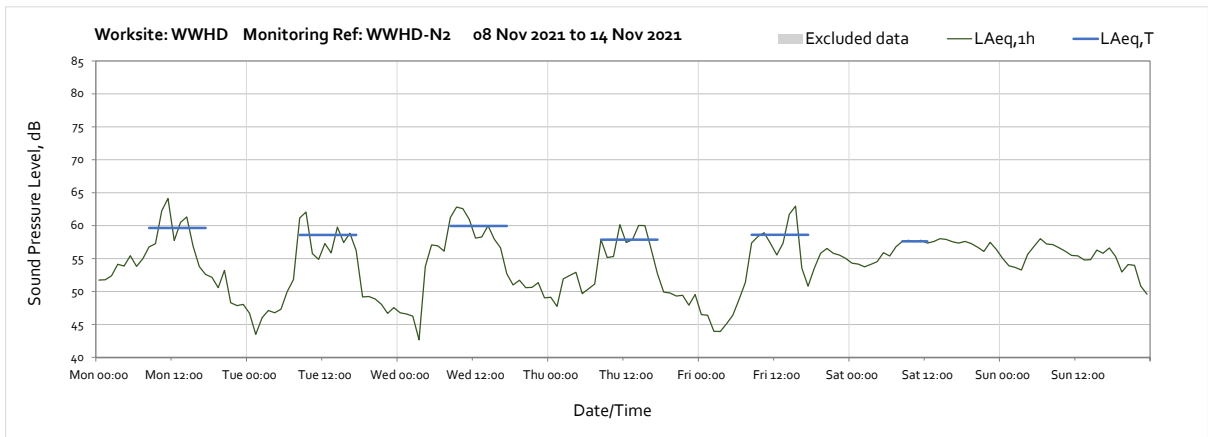
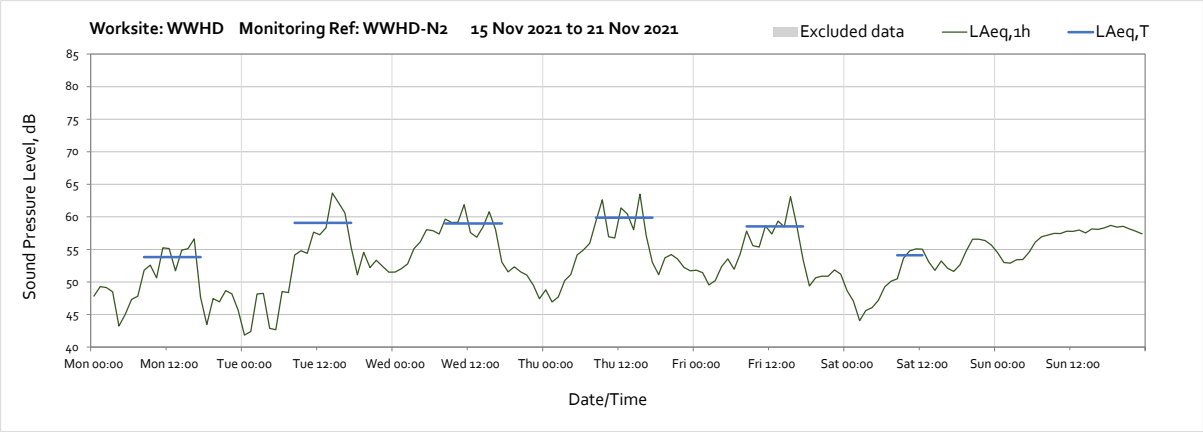
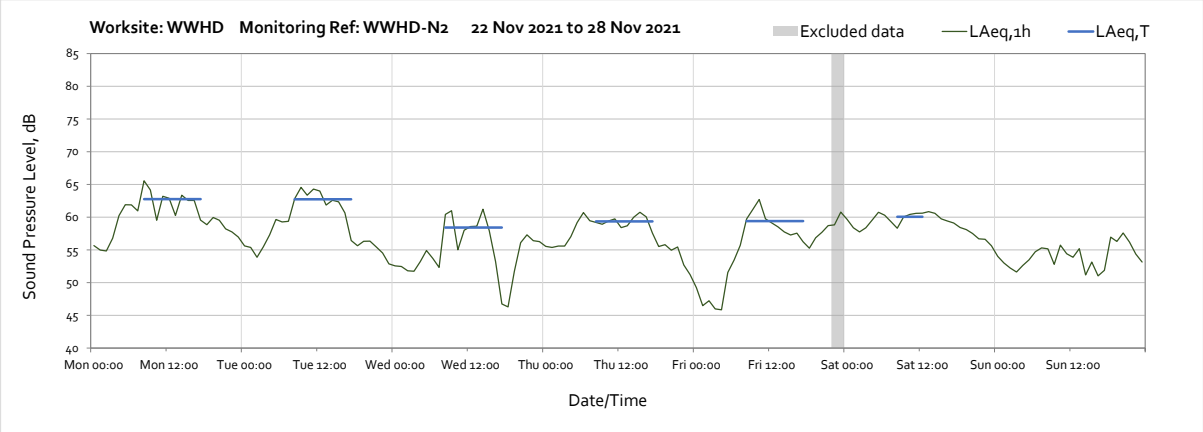
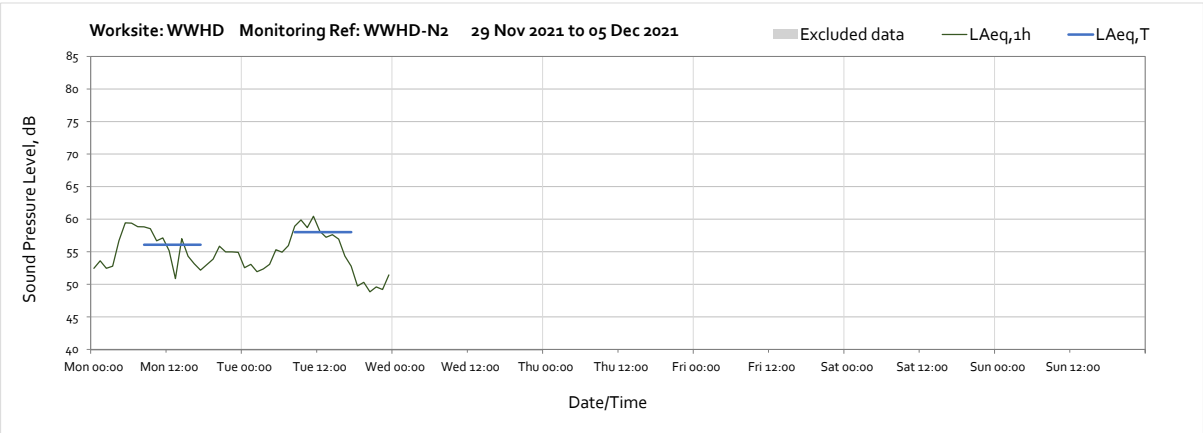
### Worksite: Washwood Heath Depot (WWHD) - Monitoring Ref: WWHD-N2

- 2.2.6 No exceedance of the SOAEL was recorded due to HS2 construction works during November 2021. Five LOAEL exceedance were recorded at noise monitoring location ref.: WWHD-N2 during normal core hours.

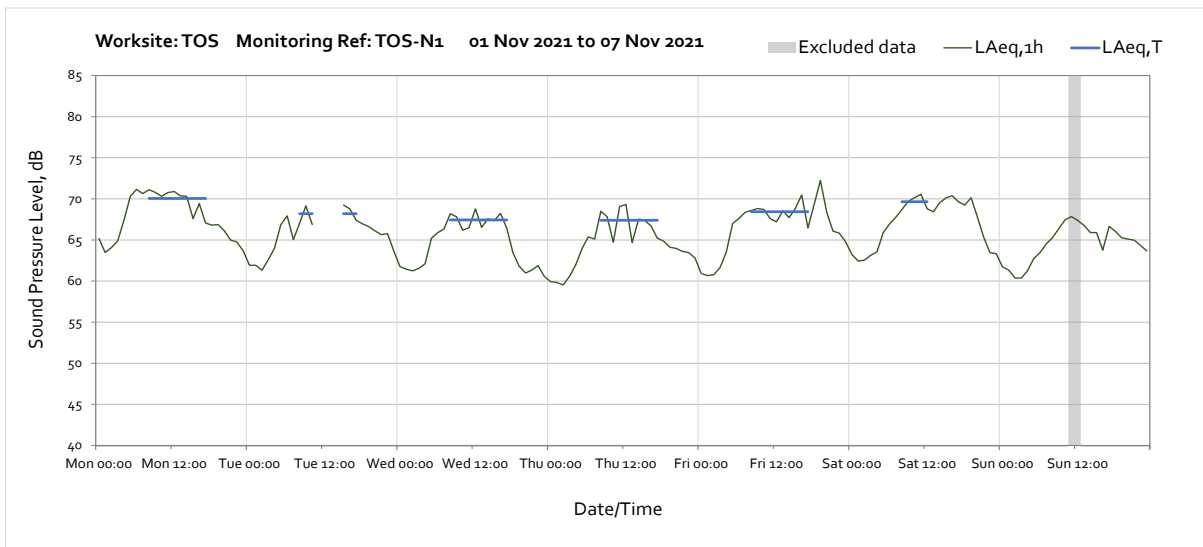
## Worksite: Twisted Oak Stables (TOS) – Monitoring Ref: TOS-N1

Note: Missing data between 11:00 and 14:00 on Tuesday 2<sup>nd</sup> November was due to loss of connection between the monitoring station and data server.

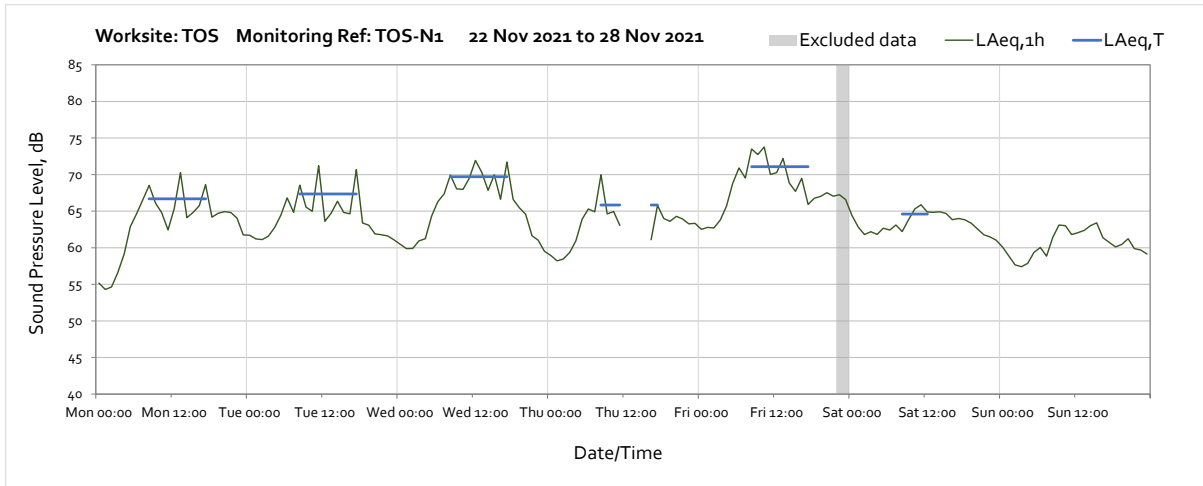
Note: Missing data between 12:00 and 15:00 on Thursday 2<sup>nd</sup> November was due to loss of connection between the monitoring station and data server.

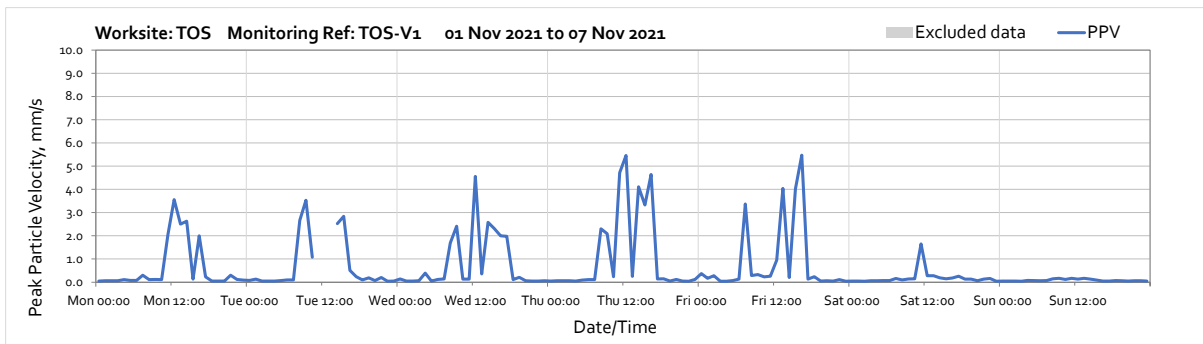
### Worksite: Twisted Oak Stables (TOS) – Monitoring Ref: TOS-V1

Note: High vibration levels across the week were due to backfilling and levelling work activities around the Slurry Treatment Plant (STP) platform area for the concrete blinding extension over duct runs taking place near to the monitoring equipment.

Note: Missing data between 11:00 and 13:00 on Tuesday 2<sup>nd</sup> November was due to loss of connection between the monitoring station and data server.

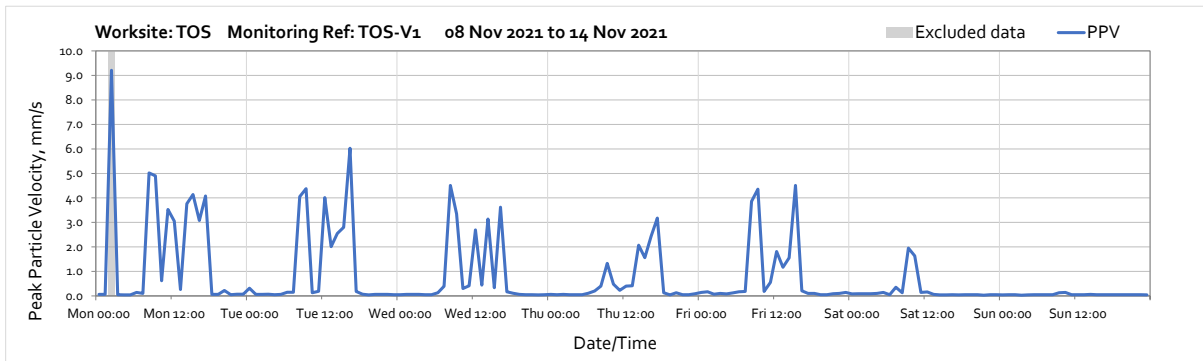
Note: High vibration levels across the week were due to backfilling and levelling work activities around the Slurry Treatment Plant (STP) platform area for the concrete blinding extension over duct runs taking place near to the monitoring equipment.

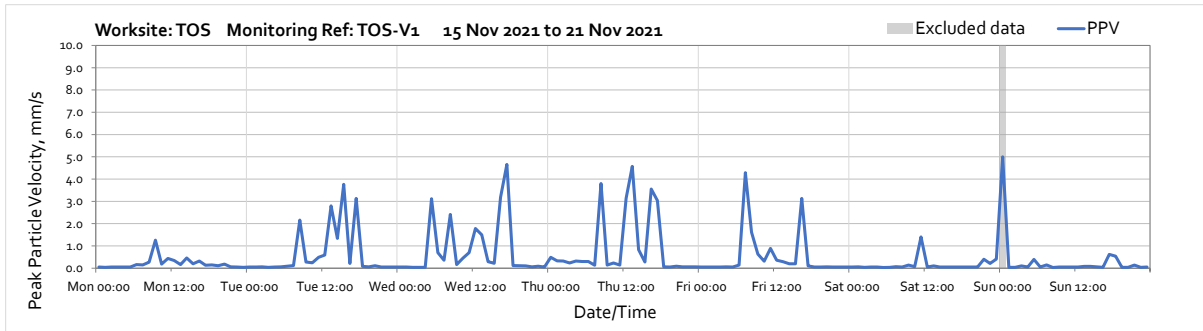
Note: High vibration levels across the week were due to backfilling and levelling work activities around the Slurry Treatment Plant (STP) platform area for the concrete blinding extension over duct runs taking place near to the monitoring equipment.

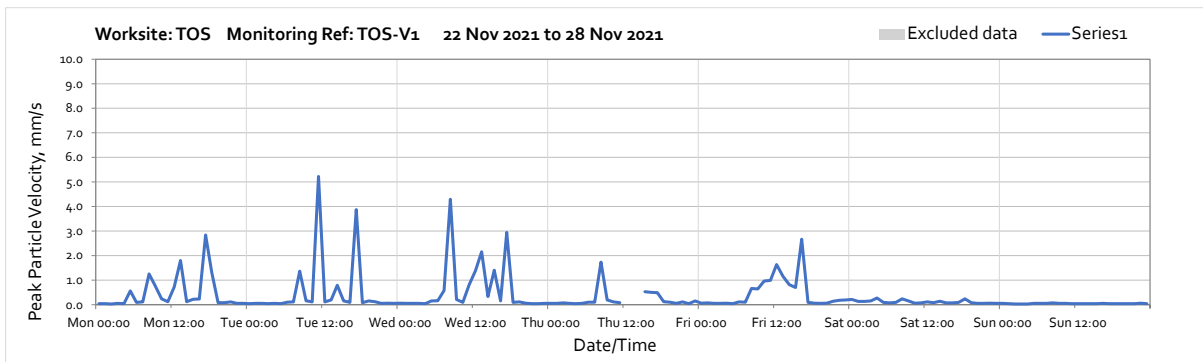
Note: High vibration levels across the week were due to backfilling and levelling work activities around the Slurry Treatment Plant (STP) platform area for the concrete blinding extension over duct runs taking place near to the monitoring equipment.

Note: Missing data between 12:00 and 12:00 on Thursday 25<sup>th</sup> November was due to loss of connection between the monitoring station and data server.

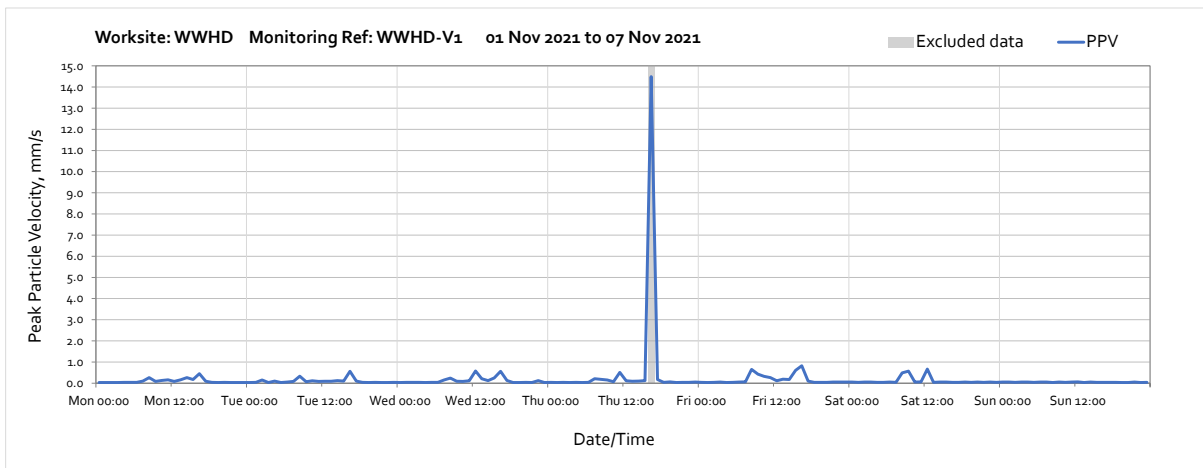
## Worksite: Washwood Heath Depot (WWHD) – Monitoring Ref: WWHD-V1

Note: High Vibration levels measured at 16:00 on Thursday 4<sup>th</sup> November was due to machinery passing closely by the monitoring equipment and not representative of vibration at the nearest receptor.

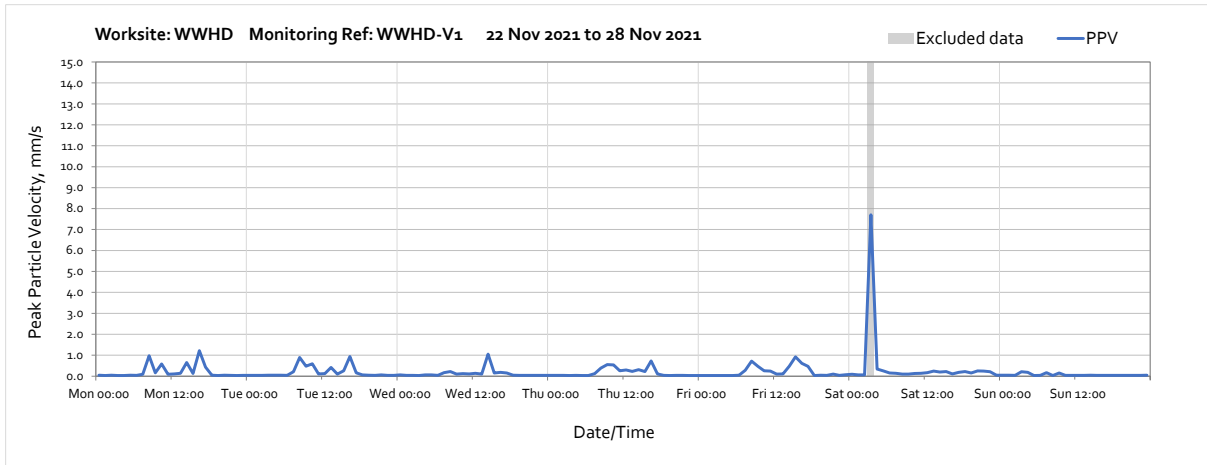
Note: High vibration levels measured at 03:00 on Saturday 27<sup>th</sup> November were due to local disturbance and not due to HS2 related works.
