## **Construction noise and vibration Monthly Report – December 2021**

**Lichfield City Council**

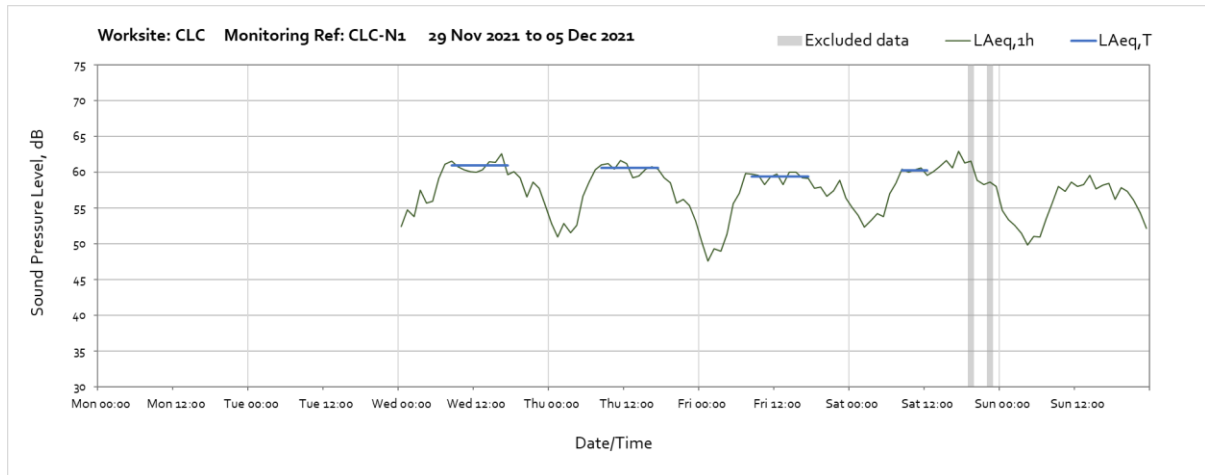
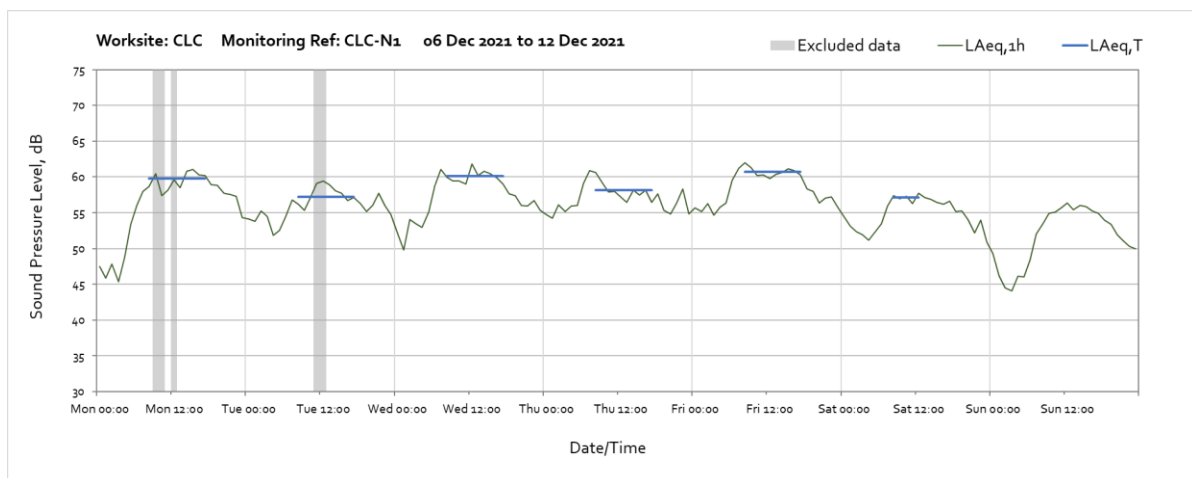
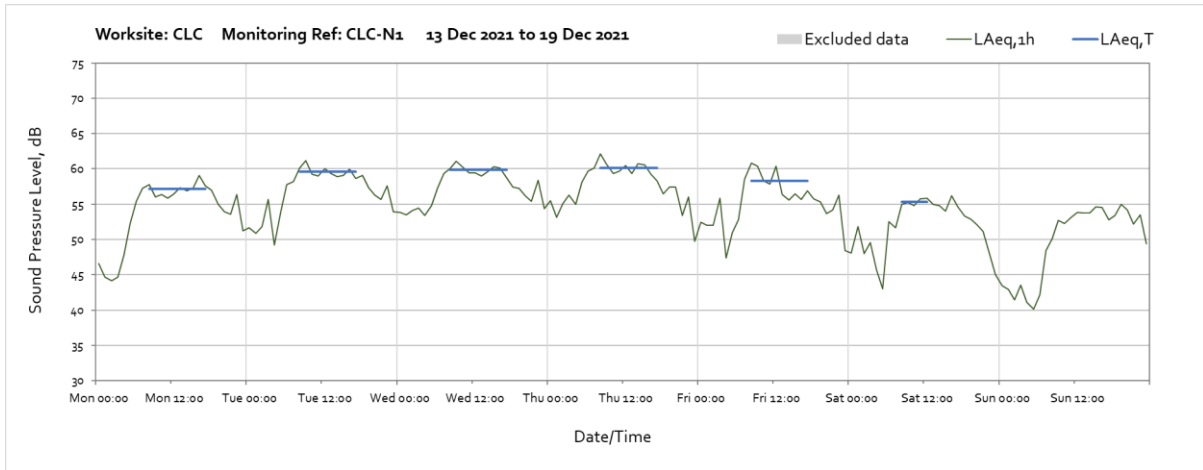
## Worksite: CLC – Monitoring Ref: CLC-N1

The following graphs show the hourly measured ambient noise level  $L_{Aeq,1h}$  and, where relevant, the averaged noise level  $L_{Aeq,T}$  values, where the time period T is as specified in Table 1 of HS2 Information Paper E23. Periods with adversely weather affected noise levels are greyed out and have been excluded from the calculation of the  $L_{Aeq,T}$  values in Table 3 of the main report.

Note: Equipment power problems arising from weak sunlight caused the above missing data.

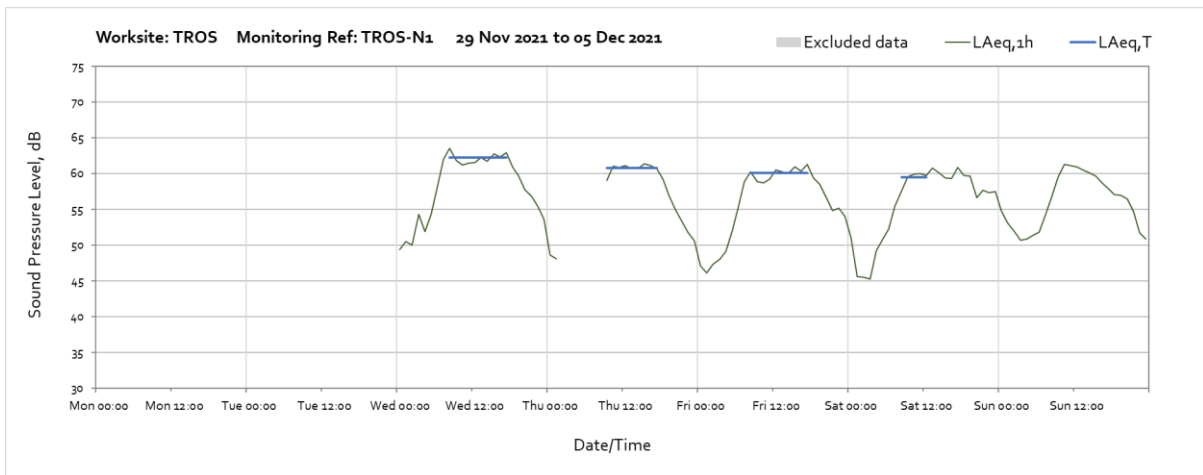
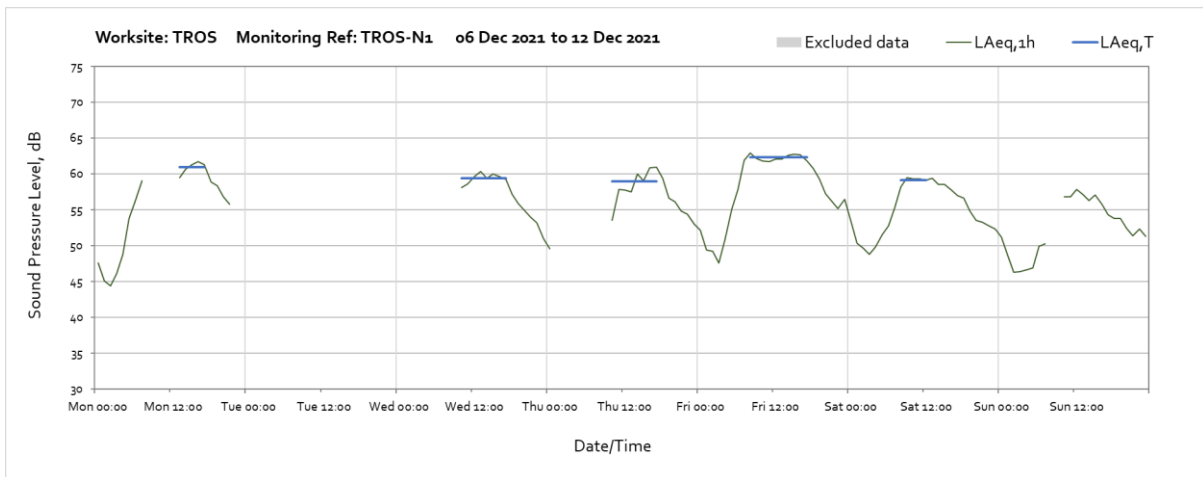
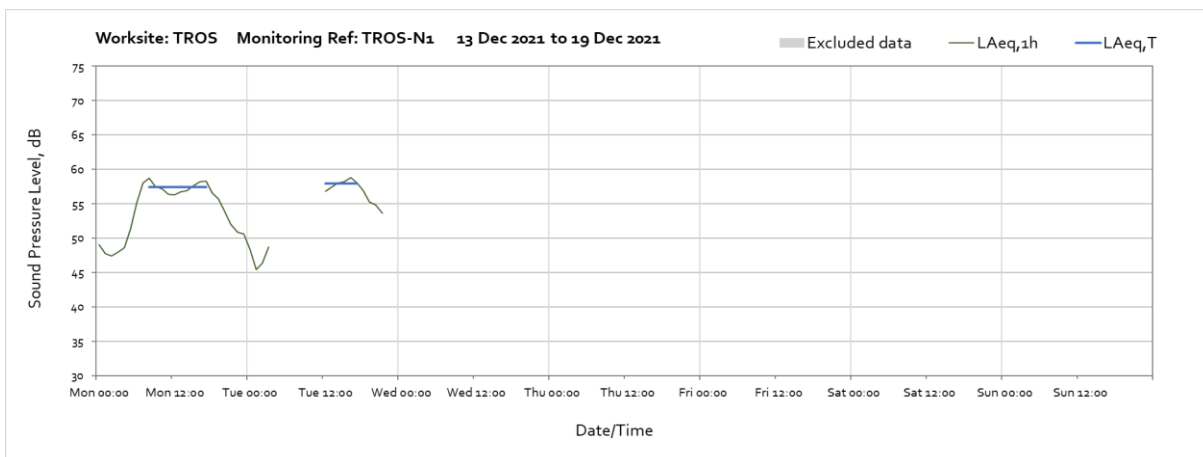
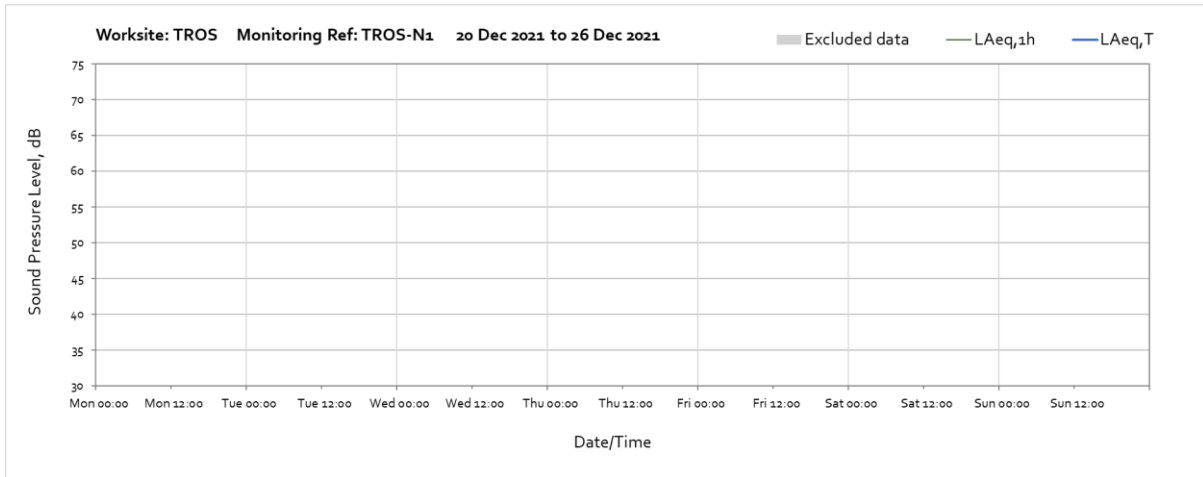
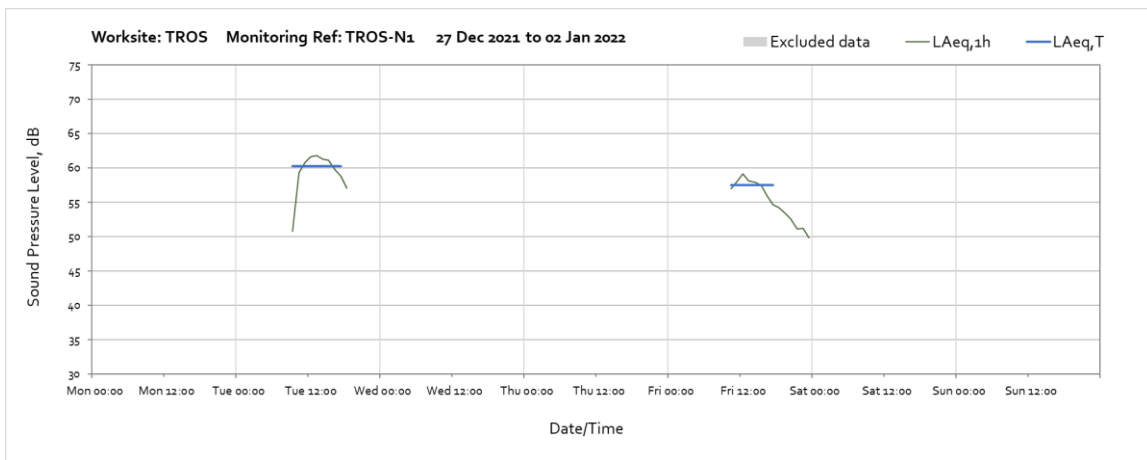
## Worksite:TROS – Monitoring Ref: TROS-N1

Note: Equipment power problems arising from weak sunlight caused the above missing data.

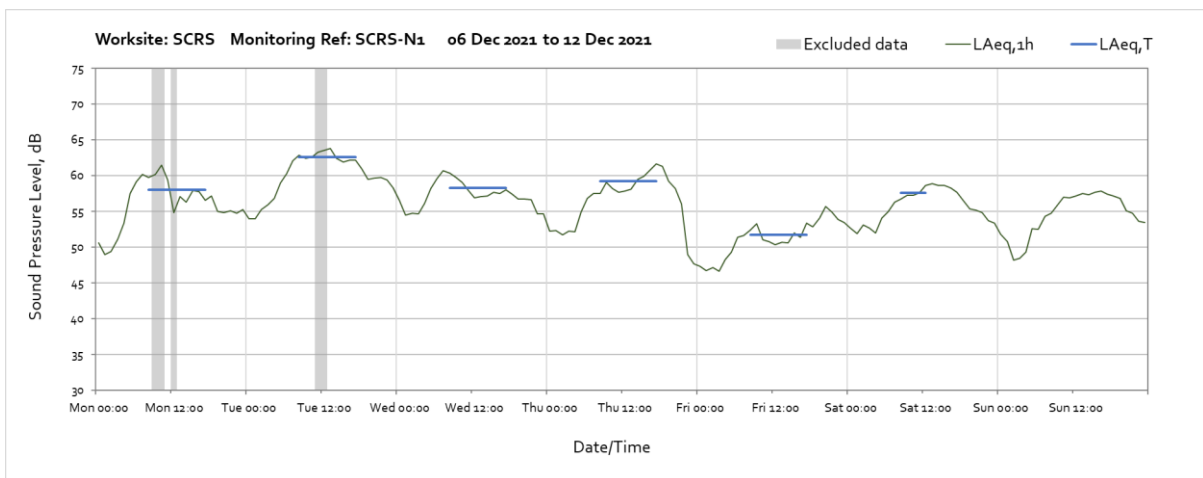
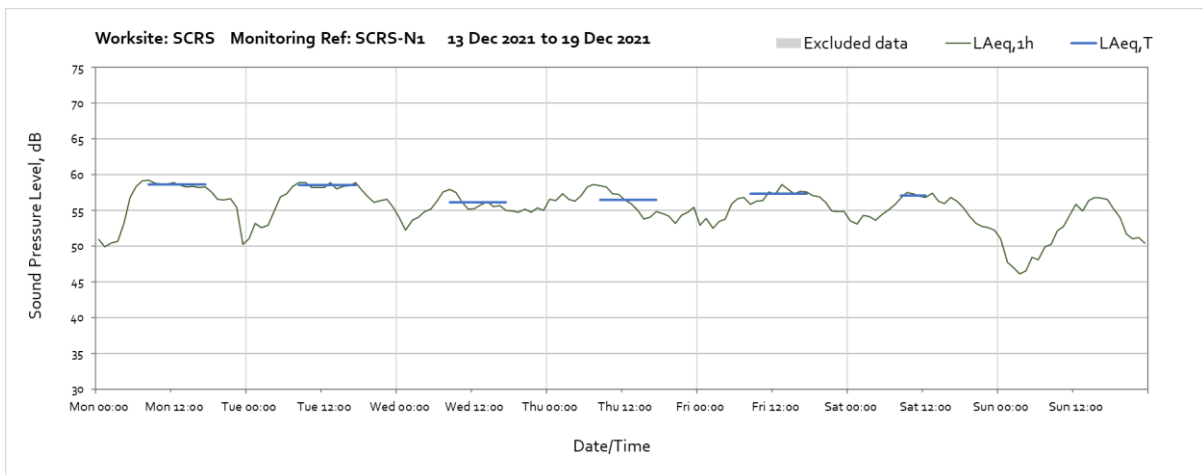
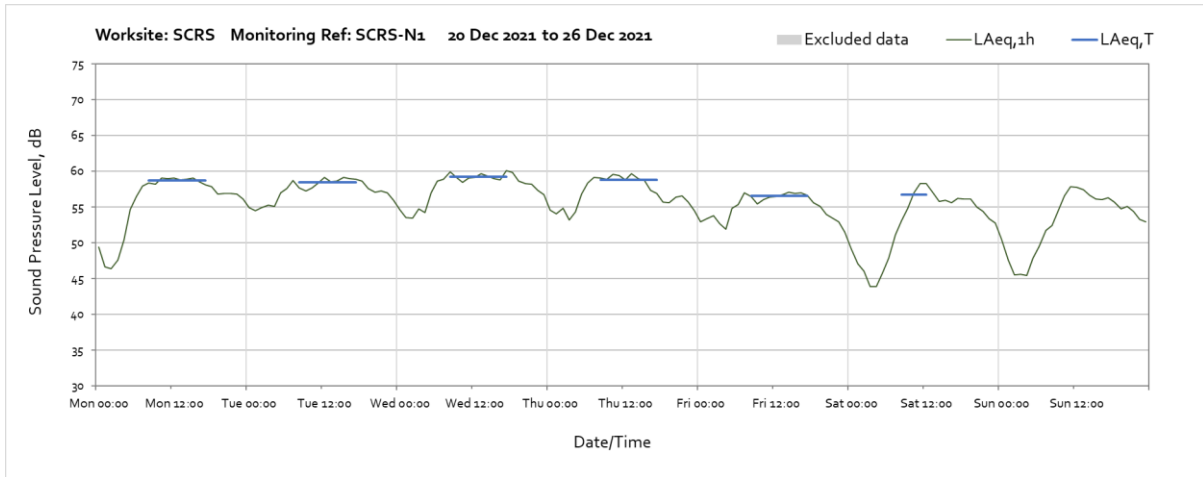
## Worksite: SCRS – Monitoring Ref: SCRS-N1

Note: Equipment power problems arising from weak sunlight caused the above missing data.

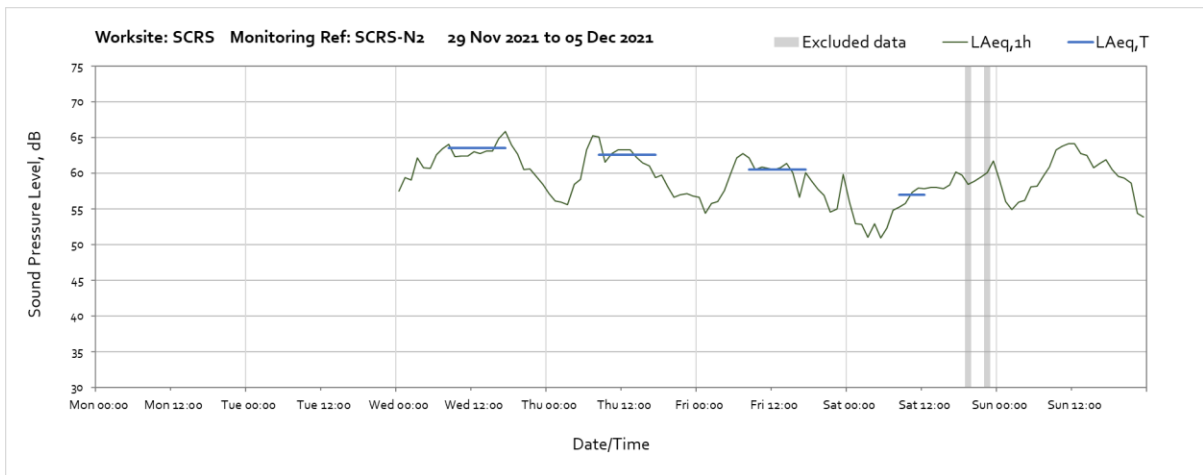
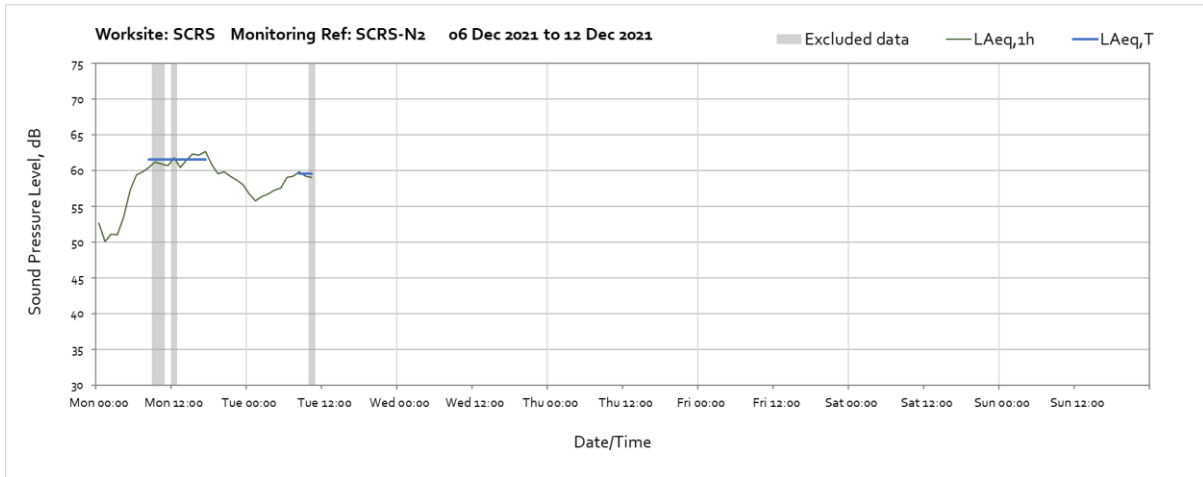
### Worksite:SCRS – Monitoring Ref: SCRS-N2

Note: The SCRS-N2 monitoring equipment was decommissioned on the morning of 7th December.

2.2.8 Two (2) exceedances of the SOAEL at one monitoring location were recorded due to HS2 construction works during December 2021. The exceedances occurred at:

- Monitoring location SCRS-N2 during two night-time periods due to road works undertaken during weekend possession works.

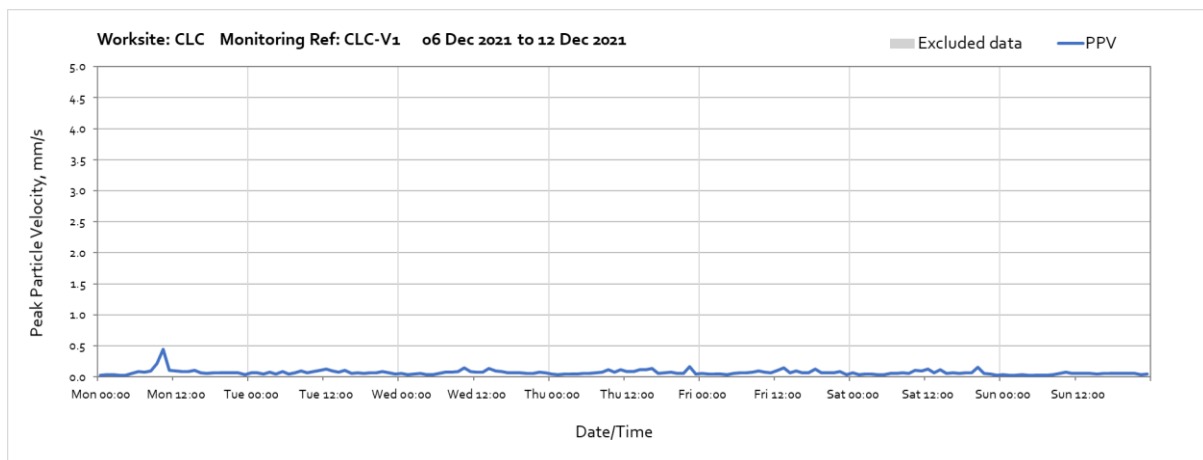
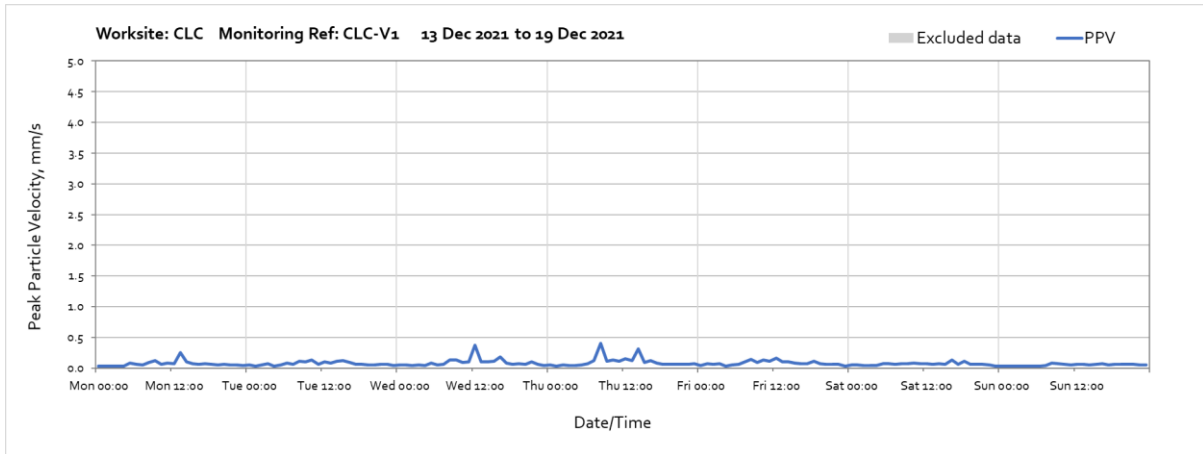
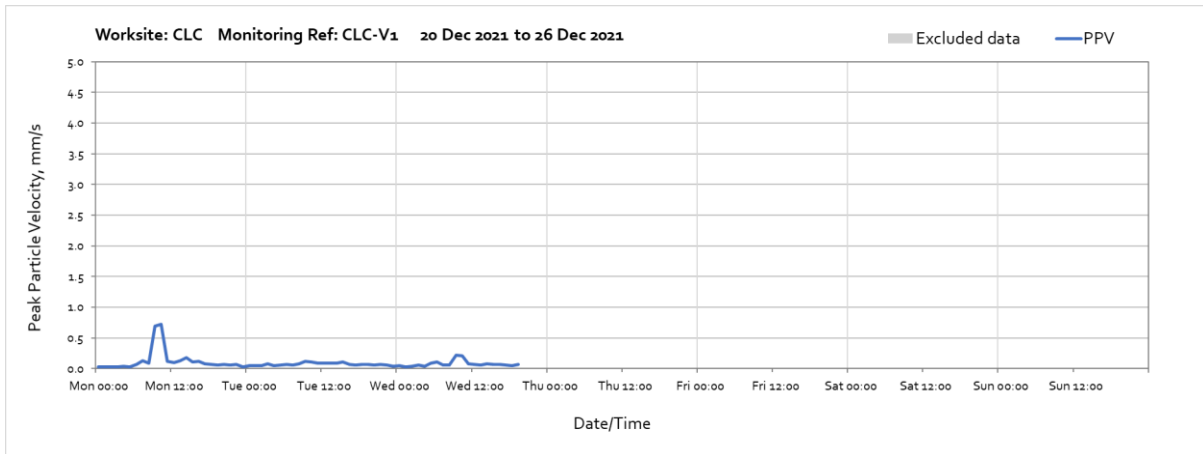
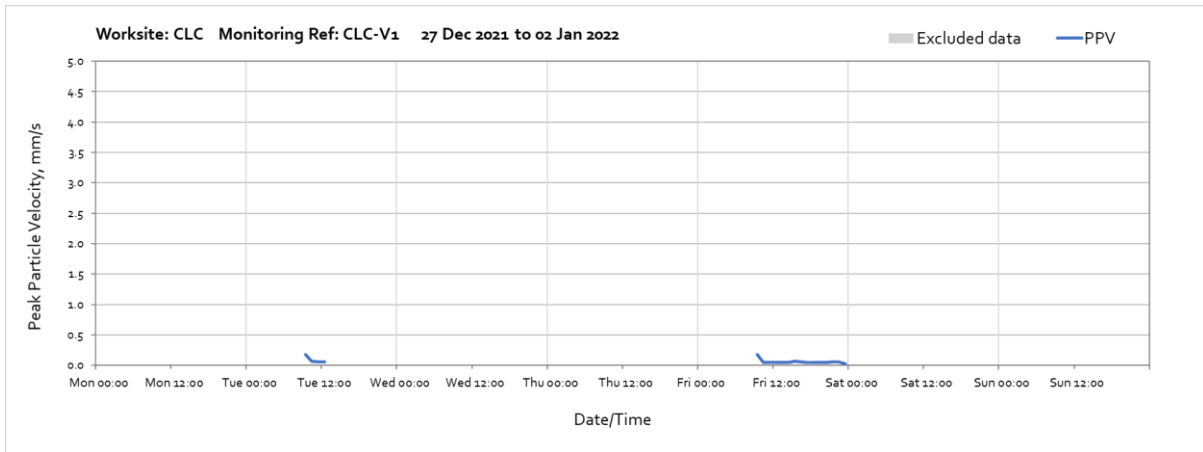
### Worksite: CLC – Monitoring Ref: CLC-V1

The following graphs show the hourly measured peak particle velocity PPV recorded during the monitoring period. The graphs show the resultant PPV due to vibration components on three orthogonal axis x, y and z. Where high values of PPV were caused by local interference with the vibration monitor, which are not representative of HS2 construction works, these values have been greyed out in the following charts and have been excluded to calculate values in Table 4 of the main report.

Note: Equipment power problems arising from weak sunlight caused the above missing data.

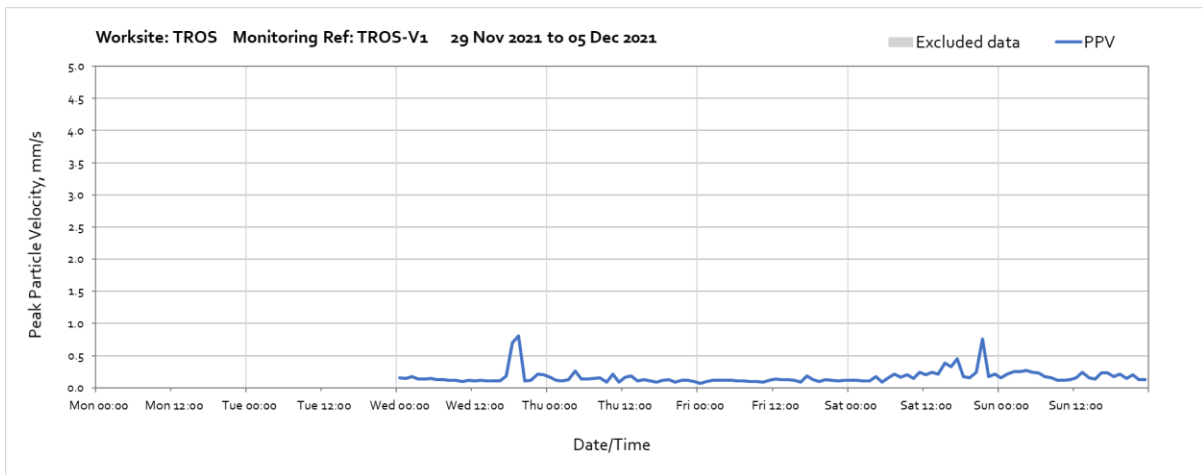
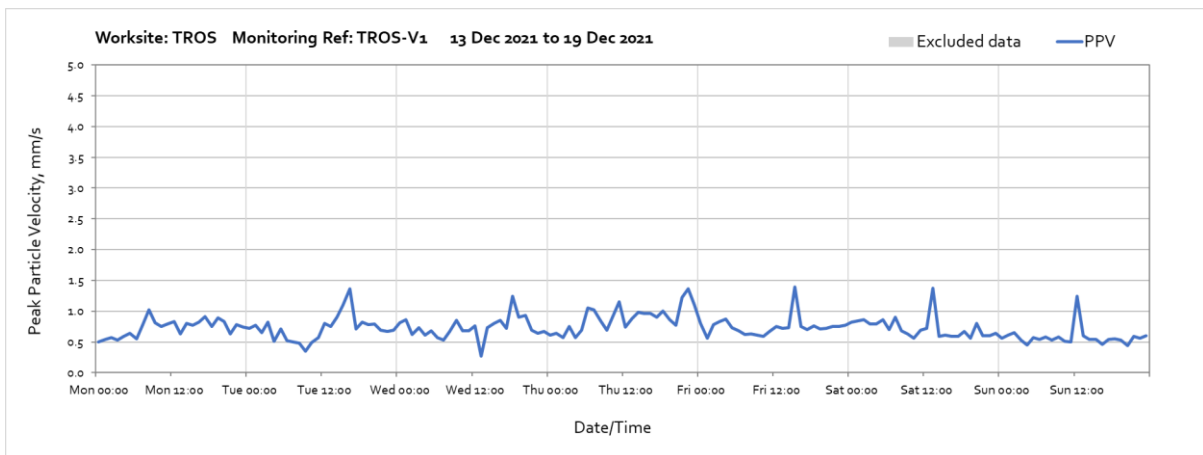
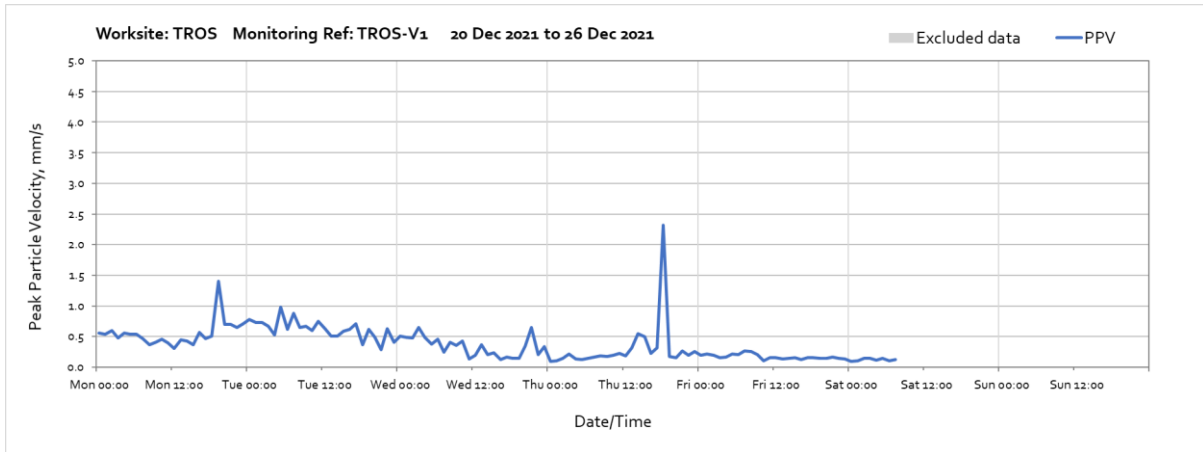
## Worksite: TROS – Monitoring Ref: TROS-V1

Note: Equipment power problems arising from weak sunlight caused the above missing data.

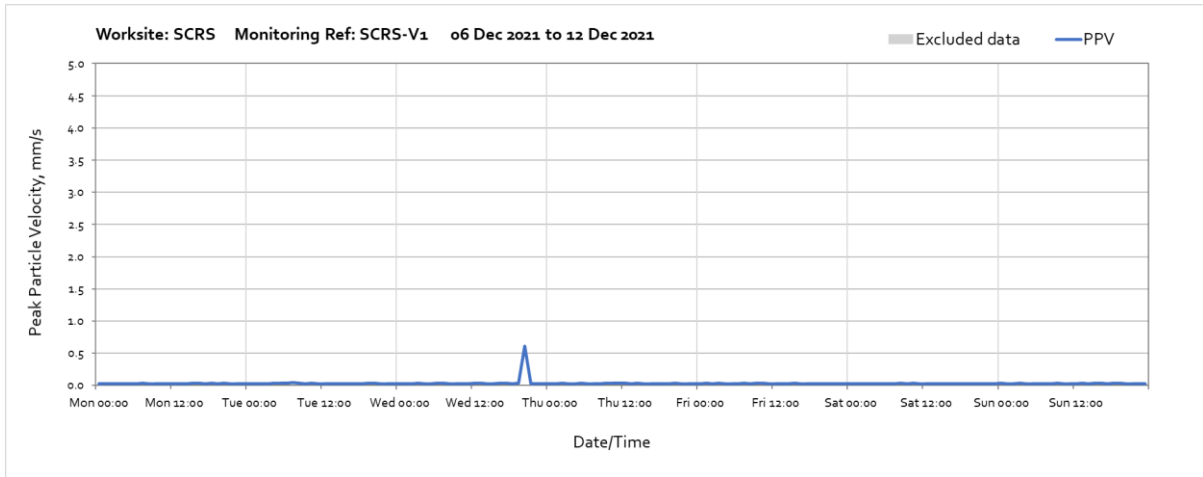
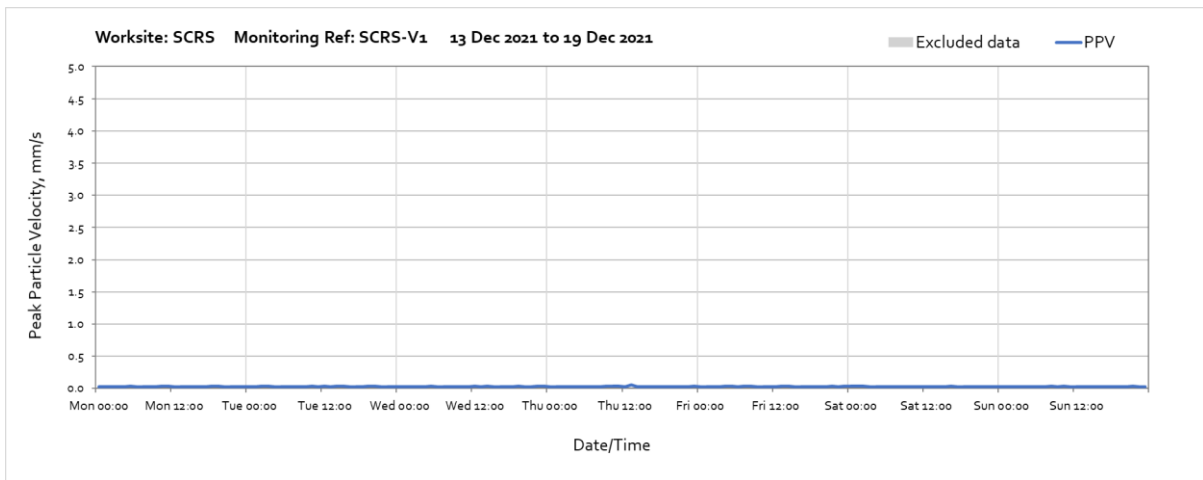
### Worksite: SCRS - Monitoring Ref: SCRS-V1

Note: Equipment power problems arising from weak sunlight caused the above missing data.
