Construction noise and vibration Monthly Report – December 2021

Solihull Metropolitan District

Non-Technical Summary

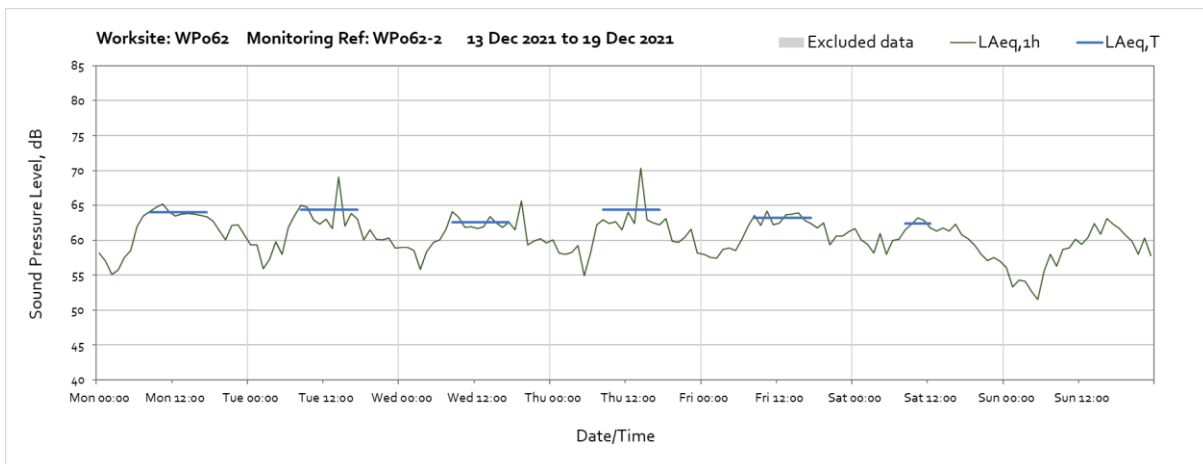
Worksite: WP062 – Monitoring Ref: WP062-2

The following graphs show the hourly measured ambient noise level $L_{Aeq,1h}$ and, where relevant, the averaged noise level $L_{Aeq,T}$ values, where the time period T is as specified in Table 1 of HS2 Information Paper E23. Periods with adversely weather affected noise levels are greyed out and have been excluded from the calculation of the $L_{Aeq,T}$ values in Table 3 of the main report.

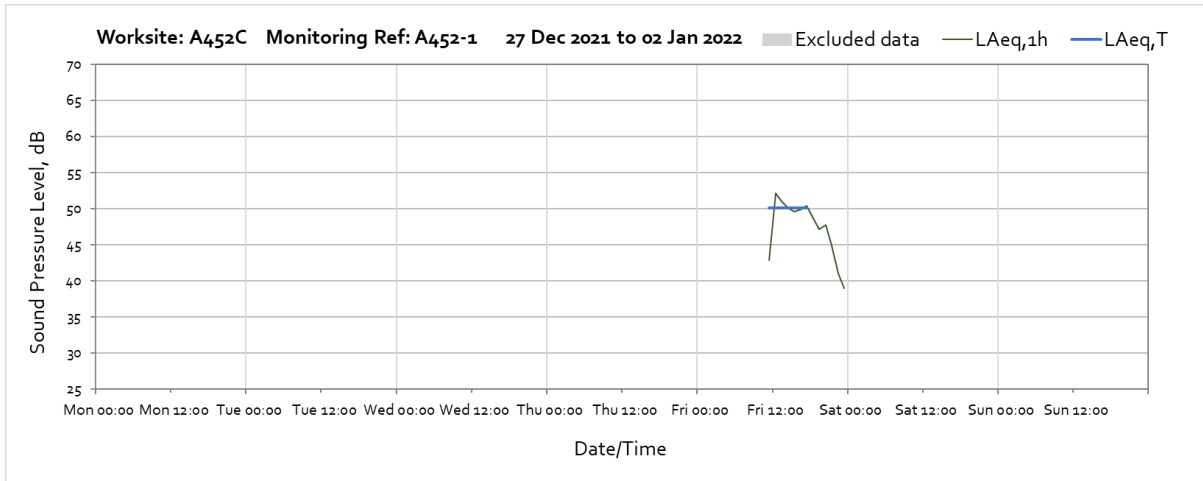
Note: Missing data throughout the week were due to loss of power to the monitor caused by insufficient solar energy to charge ancillary batteries.
