Construction noise and vibration Monthly Report – December 2021

Warwick District Council

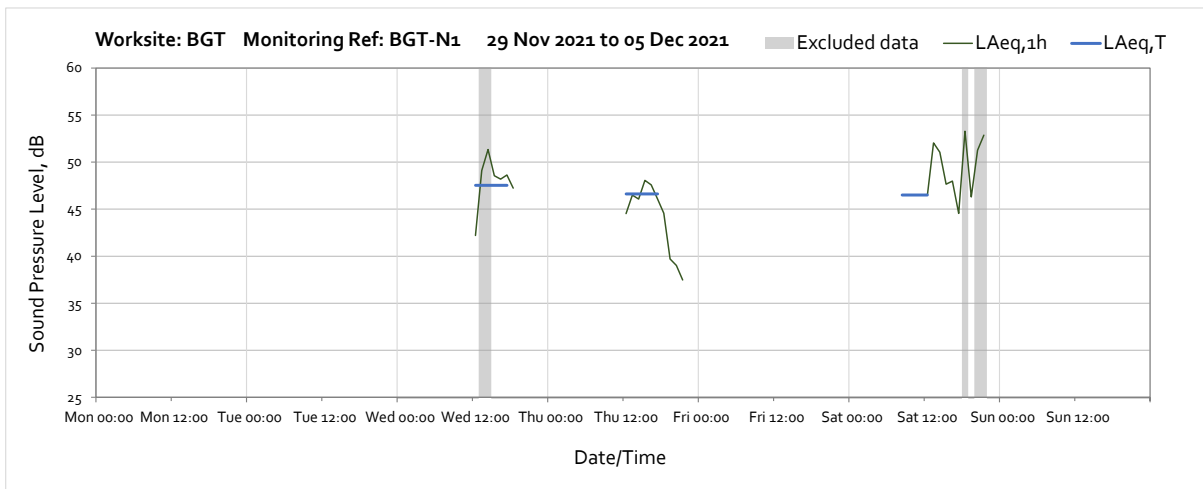
Worksite: BGT - Monitoring Ref: BGT-N1

Note: Missing data throughout the week were due to prolonged insufficient solar power to the equipment.

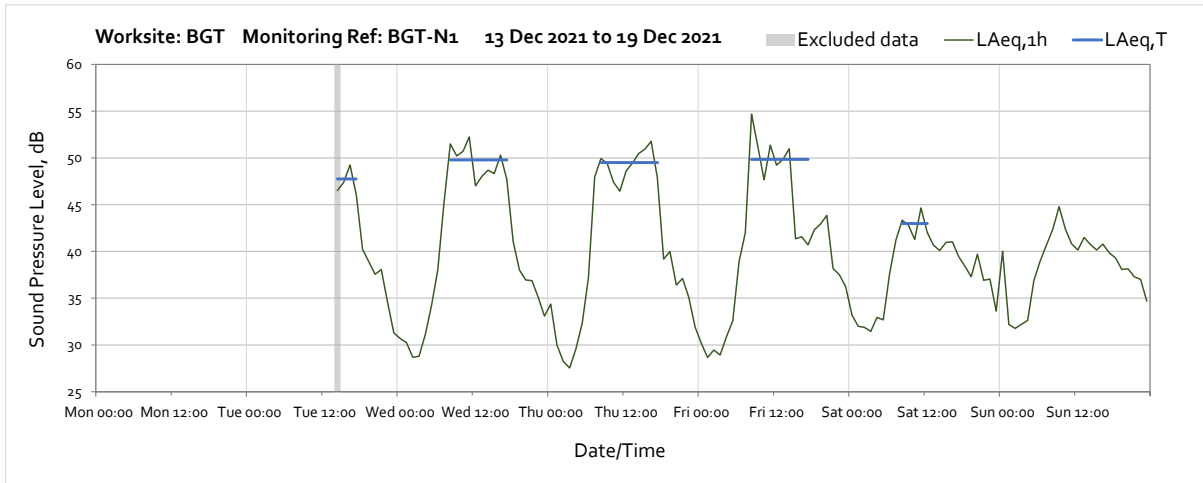
Note: Missing data between 00:00 on Monday 13th December and 13:00 on Tuesday 14th December was due to prolonged insufficient solar power to the equipment.

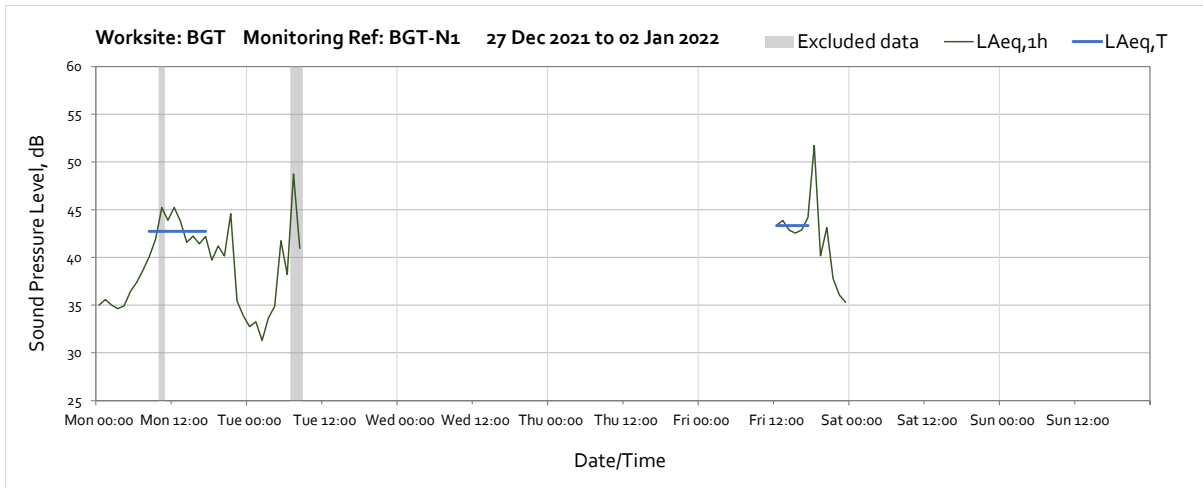
Note: Missing data between 09:00 on Tuesday 28th December and 11:00 on Friday 31st of December was due to prolonged insufficient solar power to the equipment. To ensure there is no loss of power again solar maintenance is being conducted.

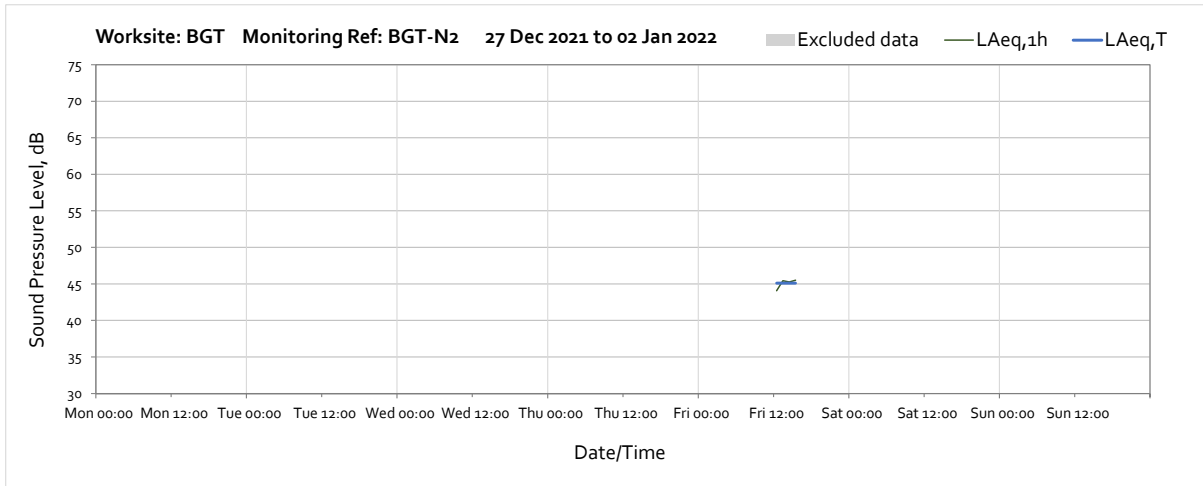
Note: Missing data between 16:00 and 23:00 on Friday 31st of December was due to prolonged insufficient solar power to the equipment. To ensure there is no loss of power again solar maintenance is being conducted.

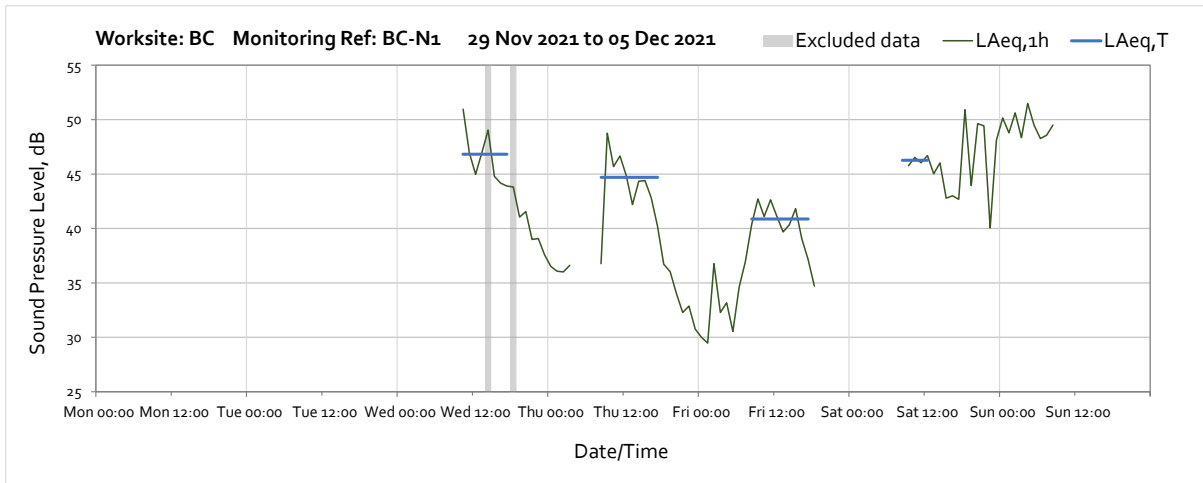
Worksite: BC – Monitoring Ref: BC-N1

Note: Missing data throughout the week were due to prolonged insufficient solar power to the equipment.

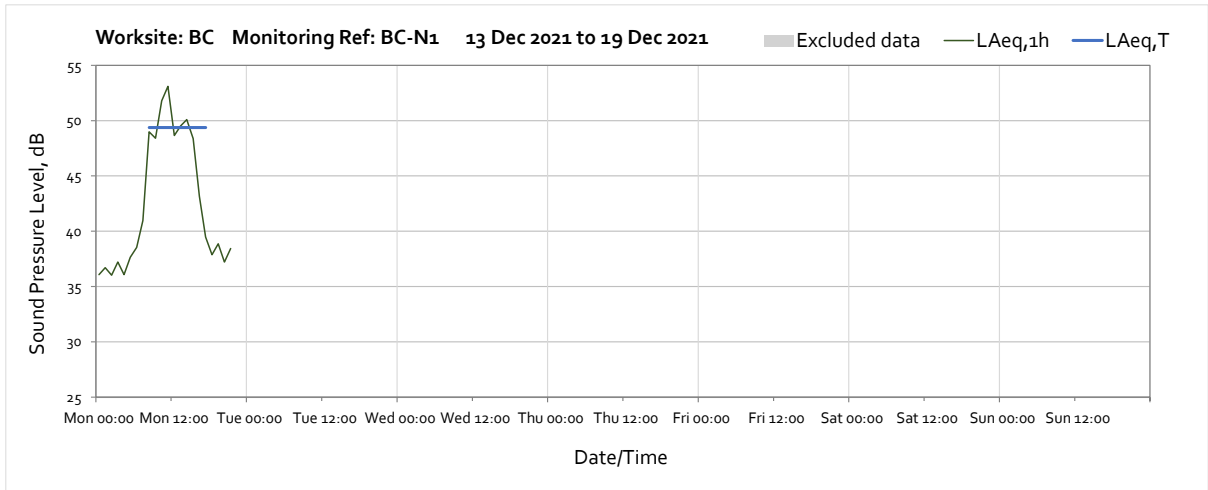
Note: Missing data between 22:00 on Monday 13th December and 23:00 on Friday 31st of December was due to prolonged insufficient solar power to the equipment. To ensure there is no loss of power again solar maintenance is being conducted.

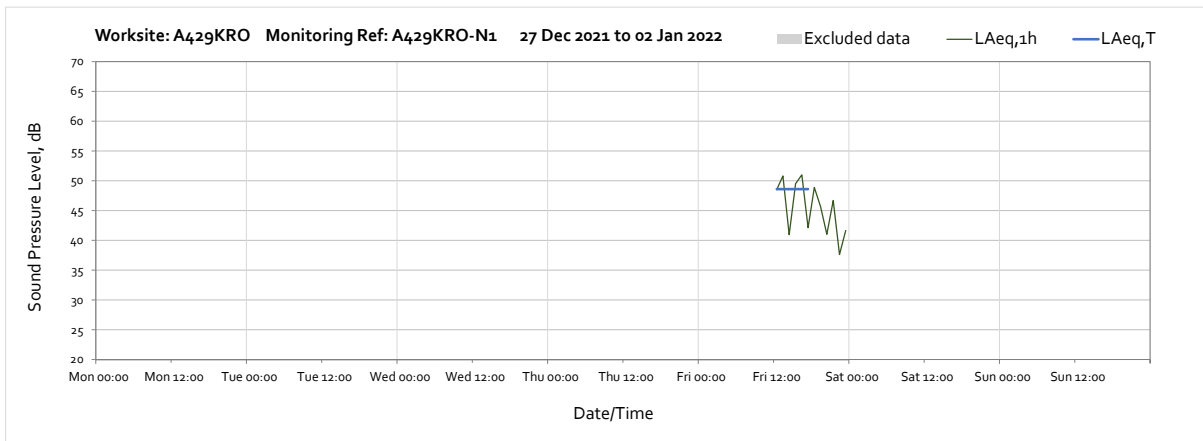
Worksite: A429KRO – Monitoring Ref: A429KRO-N1

Note: Missing data between 00:00 on Monday 20th December and 11:00 on Friday 31st of December was due to prolonged insufficient solar power to the equipment. To ensure there is no loss of power again solar maintenance is being conducted.

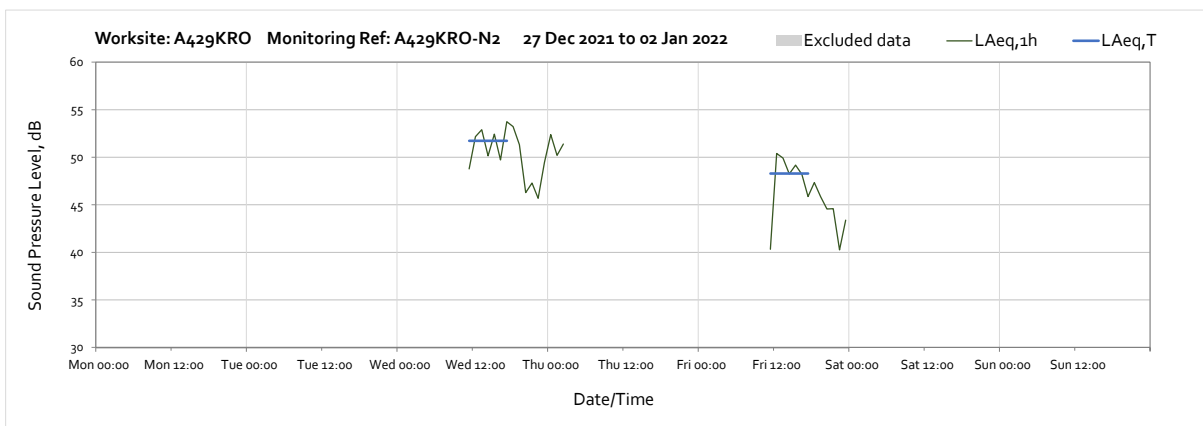
Worksite: A429KRO – Monitoring Ref: A429KRO-N2

Note: Missing data in between 03:00 on Thursday 30th December and 10:00 on Friday 31st December were due to prolonged insufficient solar power to the equipment. To ensure there is no loss of power again solar maintenance is being conducted.
