HS2

March 2022

Construction Noise and Vibration Monthly Report – January 2022

North Warwickshire Borough Council

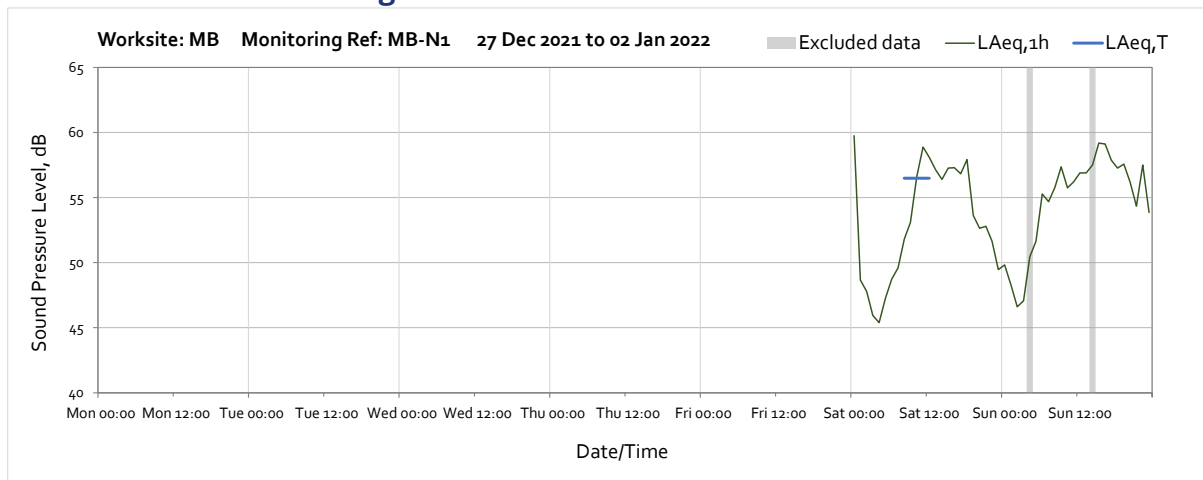
Worksite: MB – Monitoring Ref: MB-N1

Note: High noise levels measured at 00:00 on Saturday 1st January were due to New Year Night celebration

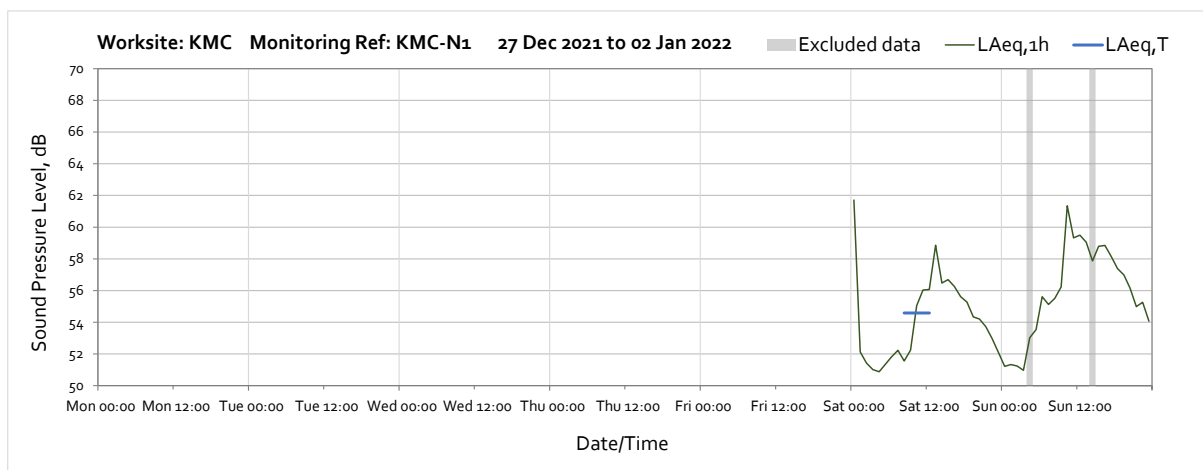
Worksite: KMC – Monitoring Ref: KMC-N1

Note: High noise levels measured at 00:00 on Saturday 1st January were due to New Year Night celebration

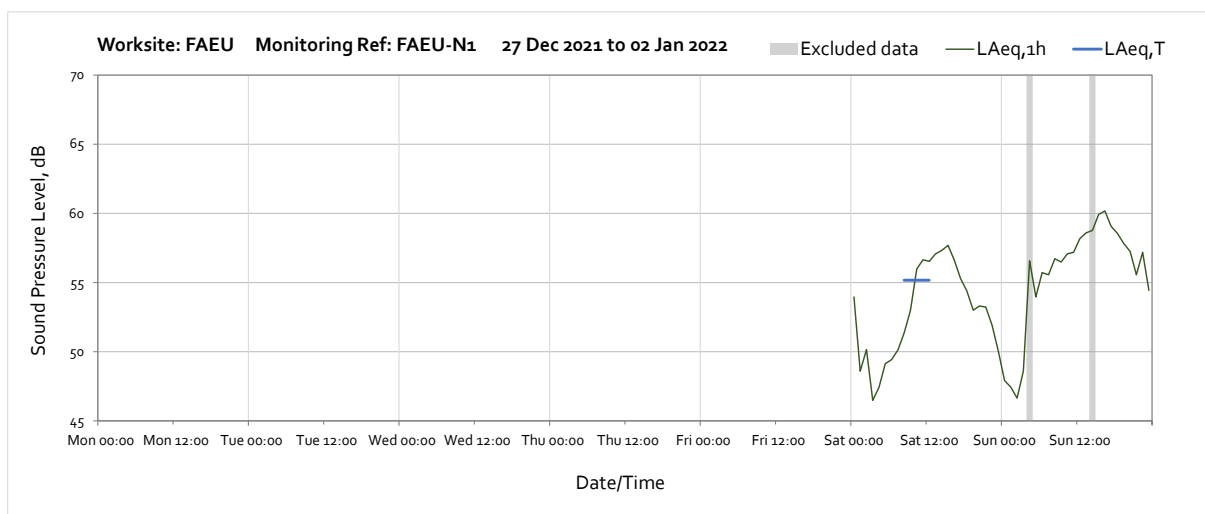
Worksite: FAEU – Monitoring Ref: FAEU-N1

Note: High noise levels measured at 00:00 on Saturday 1st January were due to New Year Night celebration
