## ACCIDENT

<b>Gyroplane Type and Registration:</b>	Rotorsport UK Calidus, G-TGLG	
<b>No &amp; Type of Engines:</b>	1 Rotax 914-UL piston engine	
<b>Year of Manufacture:</b>	2015 (Serial no: RSUK/CALS/028)	
<b>Date &amp; Time (UTC):</b>	18 March 2022 at 1251 hrs	
<b>Location:</b>	Shobdon Airfield, Herefordshire	
<b>Type of Flight:</b>	Training	
<b>Persons on Board:</b>	Crew - 2	Passengers - None
<b>Injuries:</b>	Crew - 1 (Serious) 1 (None)	Passengers - N/A
<b>Nature of Damage:</b>	Damage to the left side of the fuselage pod, wheels, propeller, left vertical stabiliser and rotor blades	
<b>Commander's Licence:</b>	Private Pilot's Licence (Gyroplane)	
<b>Commander's Age:</b>	70 years	
<b>Commander's Flying Experience:</b>	1,253 hours (of which 1,251 were on type) Last 90 days - 19 hours Last 28 days - 8 hours	
<b>Information Source:</b>	Aircraft Accident Report Form submitted by the pilot and further enquiries by the AAIB

## Synopsis

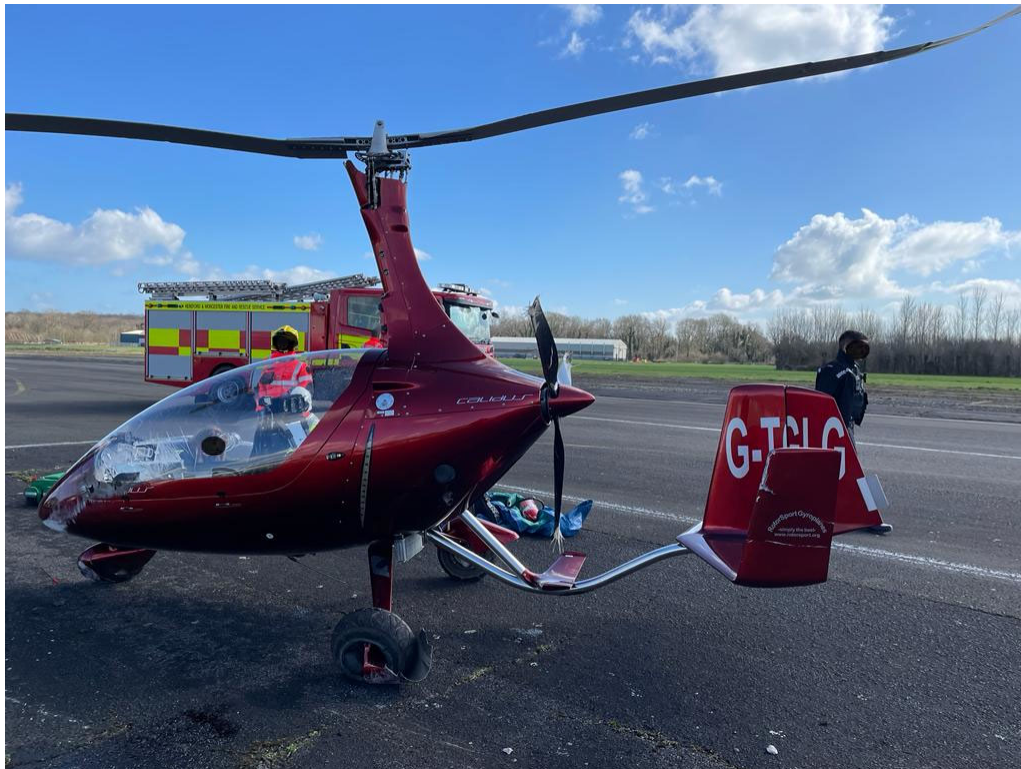
**Figure 2**

G-TGLG after righting by emergency services

The gyroplane fell onto its side and slid along the runway, coming to a stop on the left side of the runway (Figure 1 and 2). The occupants were trapped and could smell fuel. Airfield personnel were on scene quickly and were able to right the gyroplane and extract the occupants. The instructor was uninjured; the student had chest pains and later discovered he had broken a bone in his back.
