February 2022

## HS2

# Air Quality and Dust Monitoring Monthly Report – February 2022 **Buckinghamshire** Council

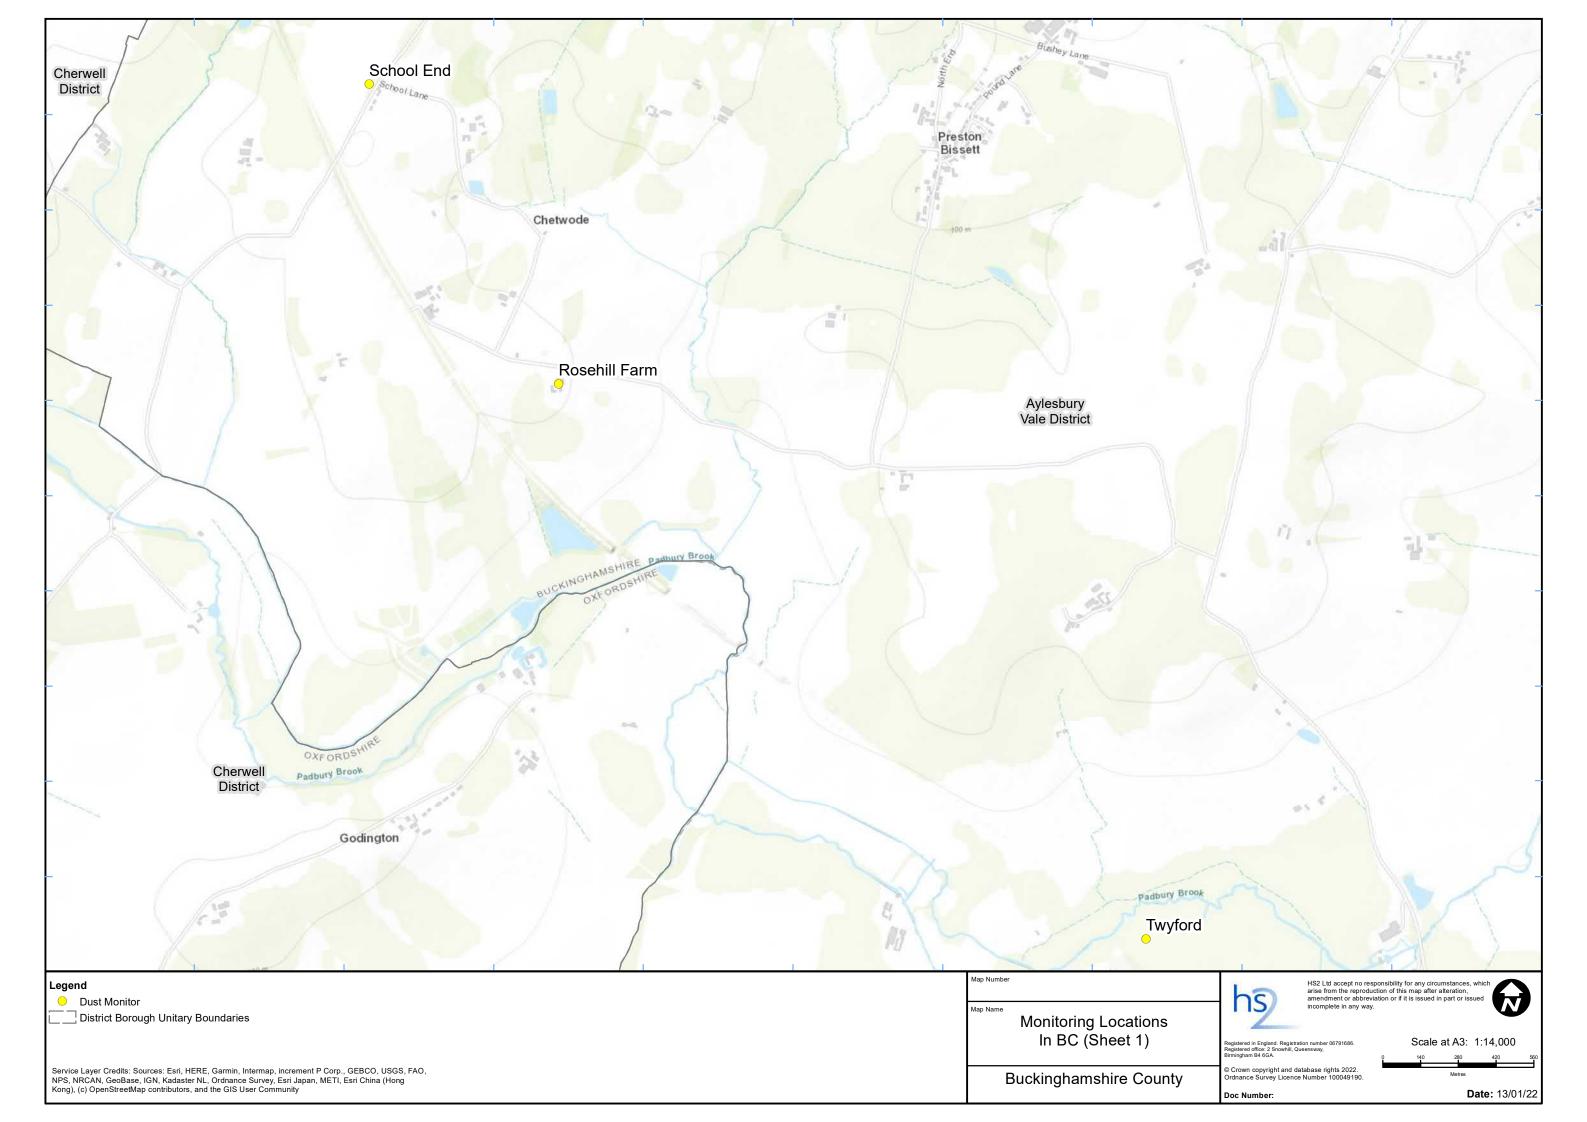
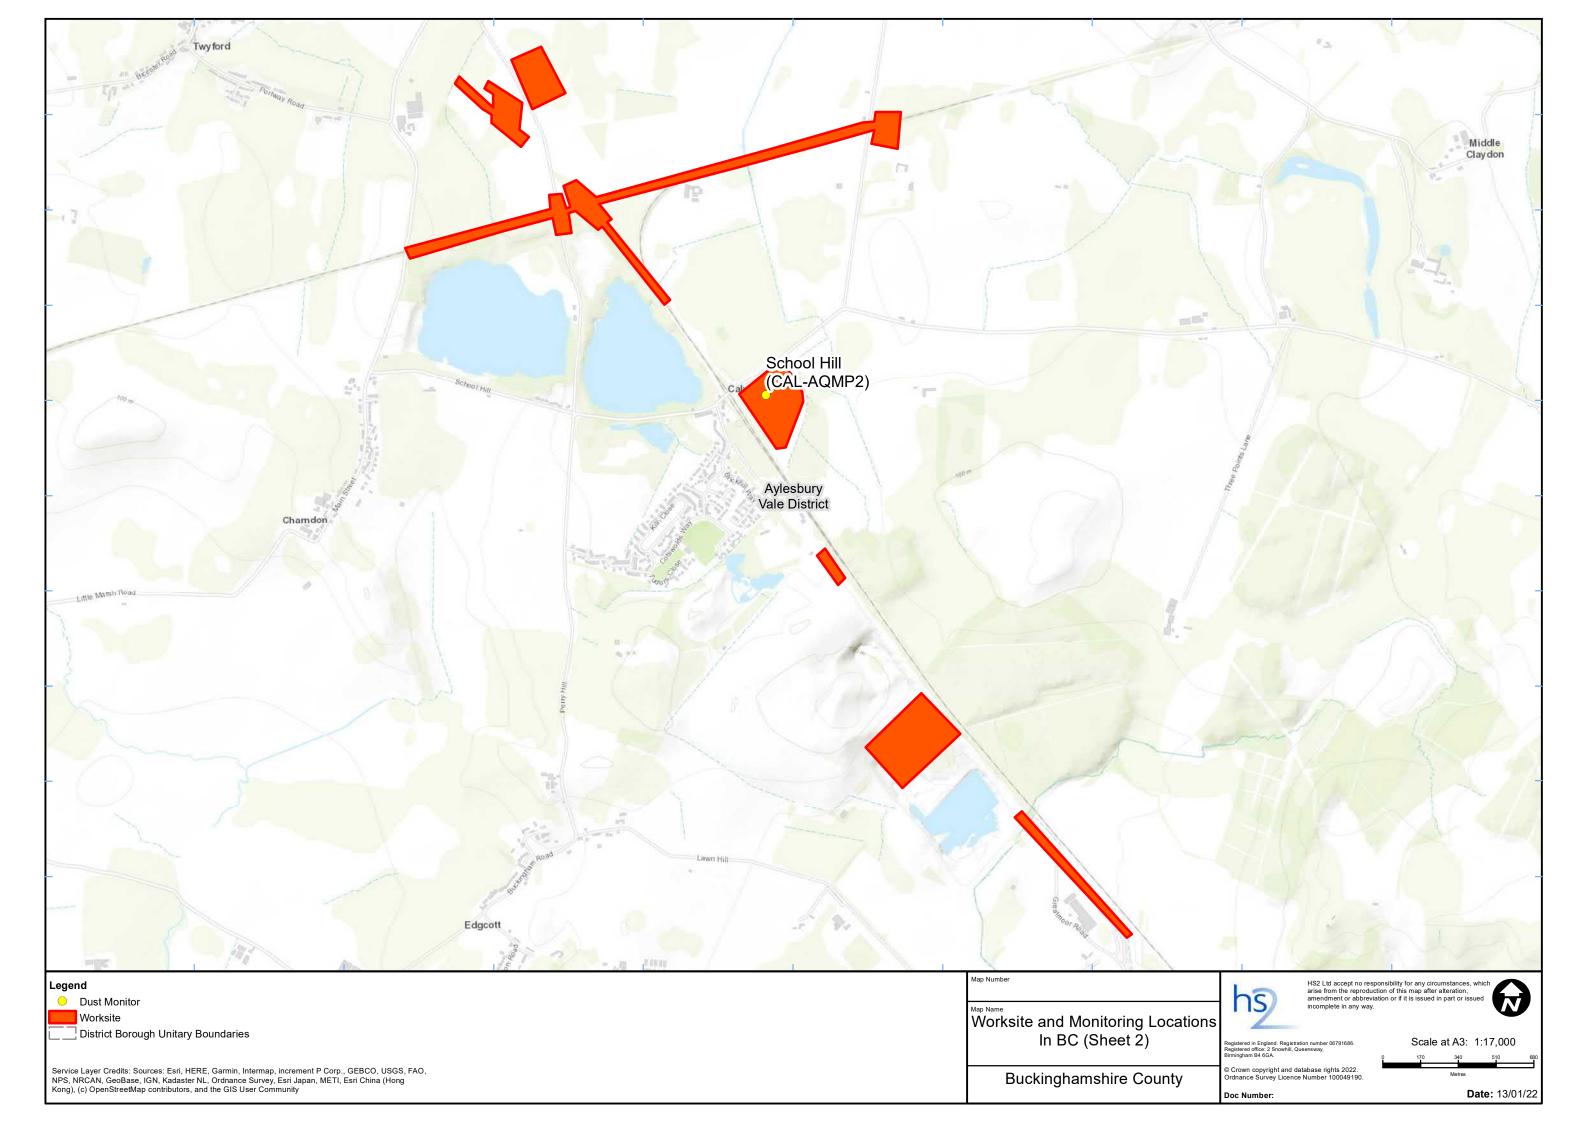
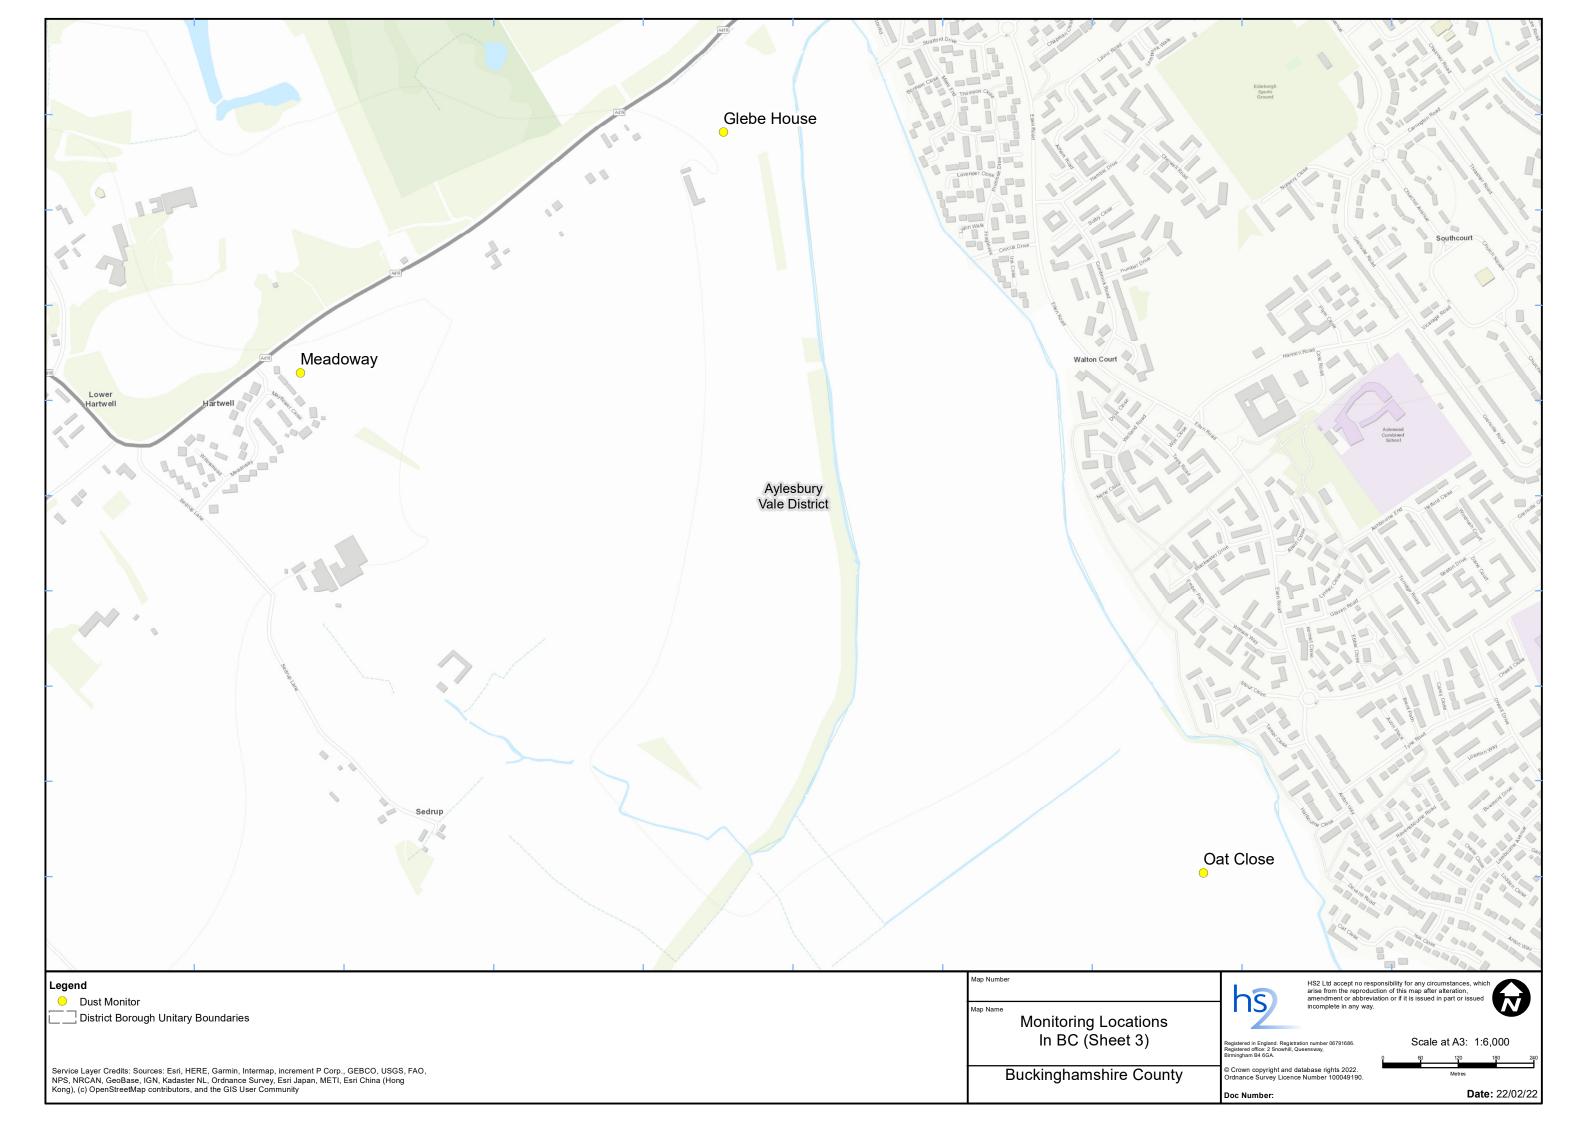
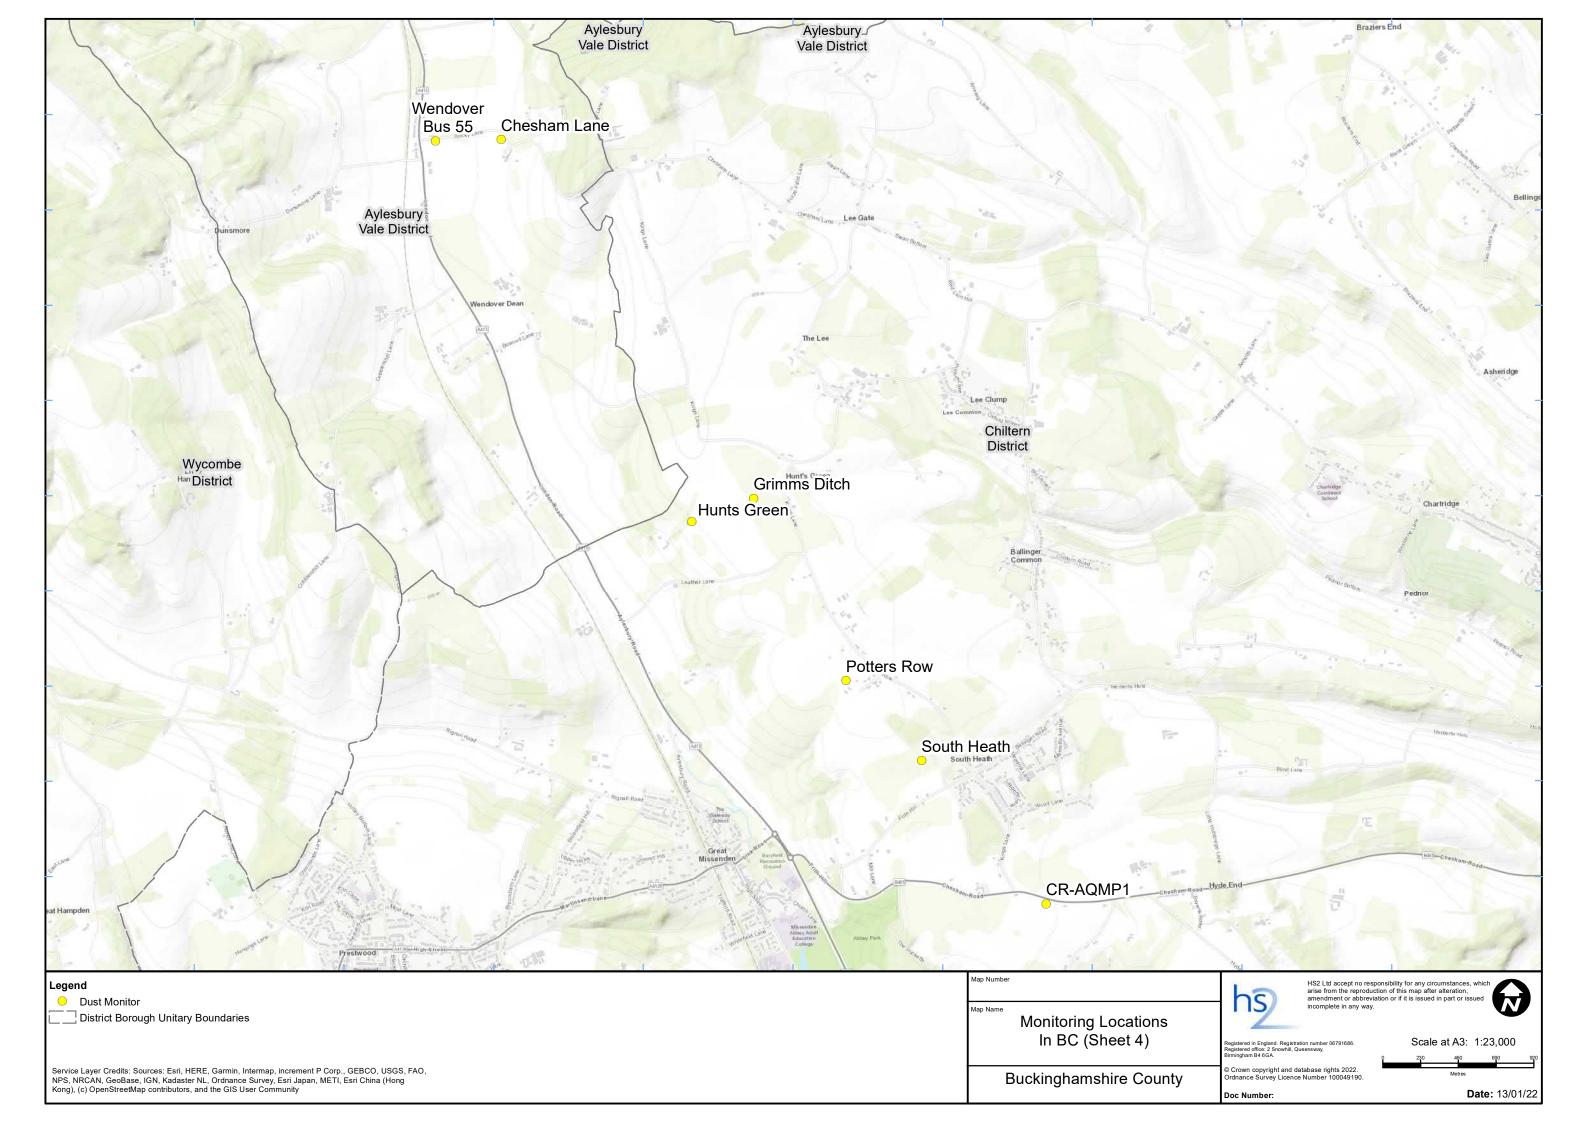
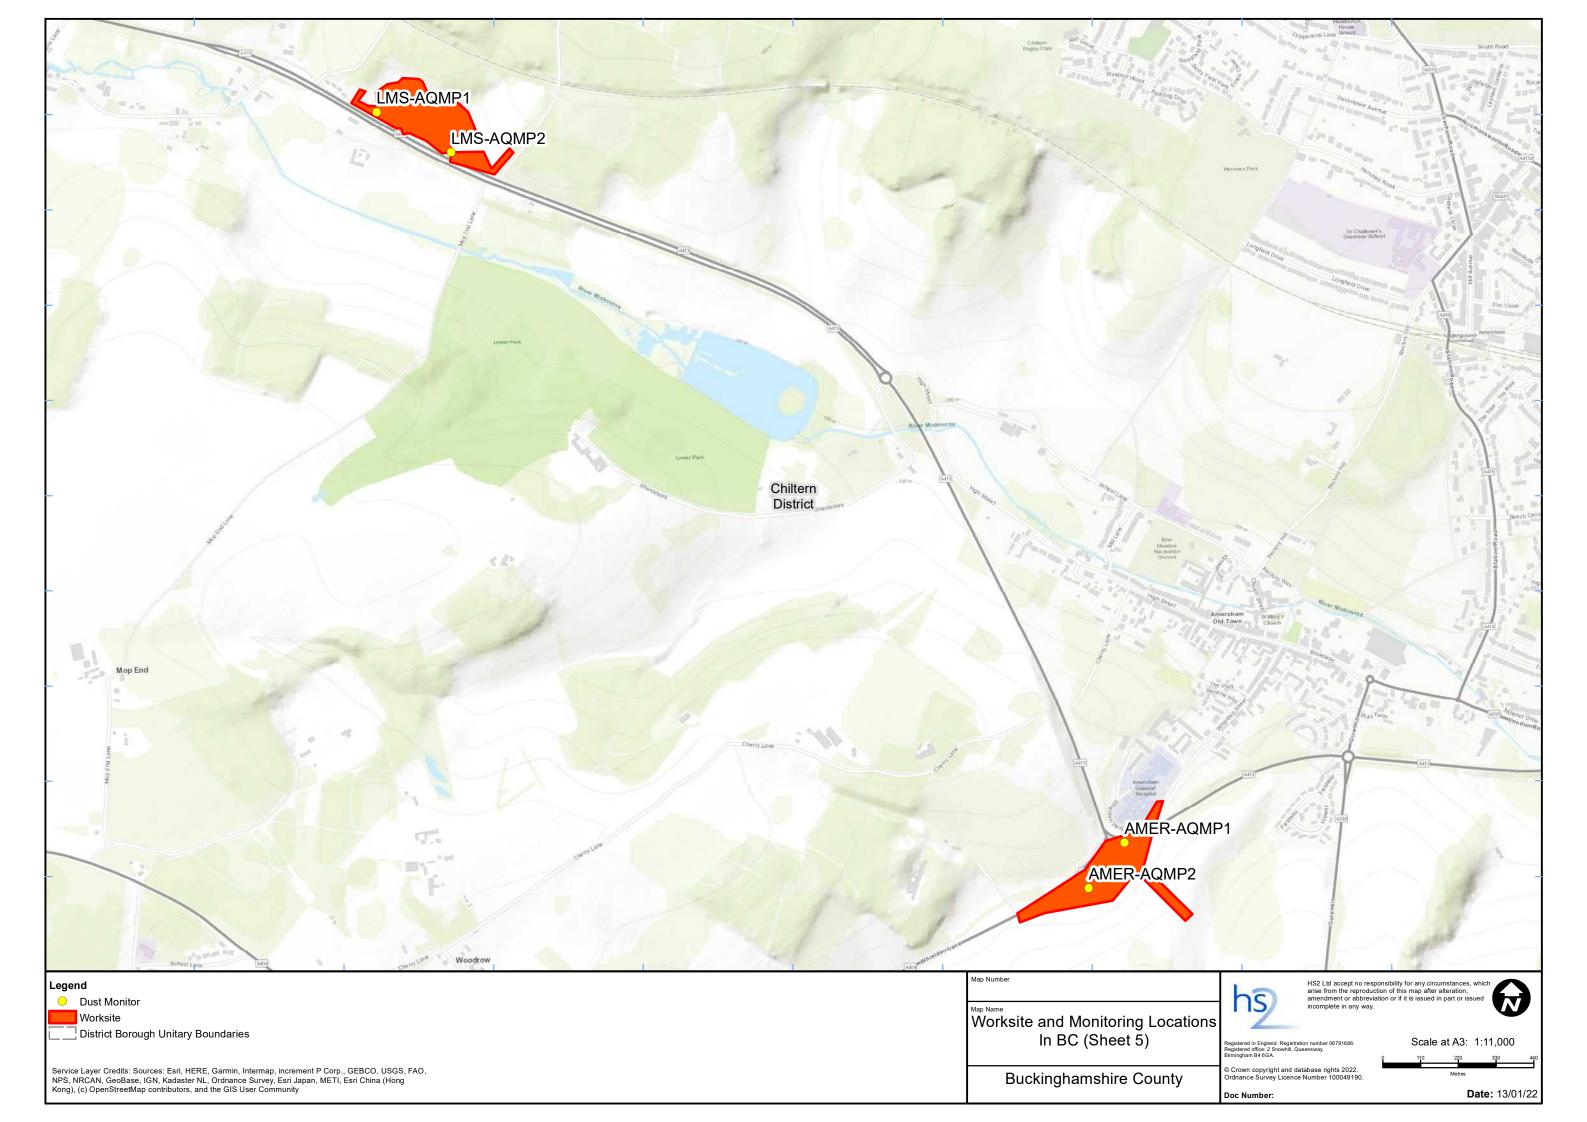
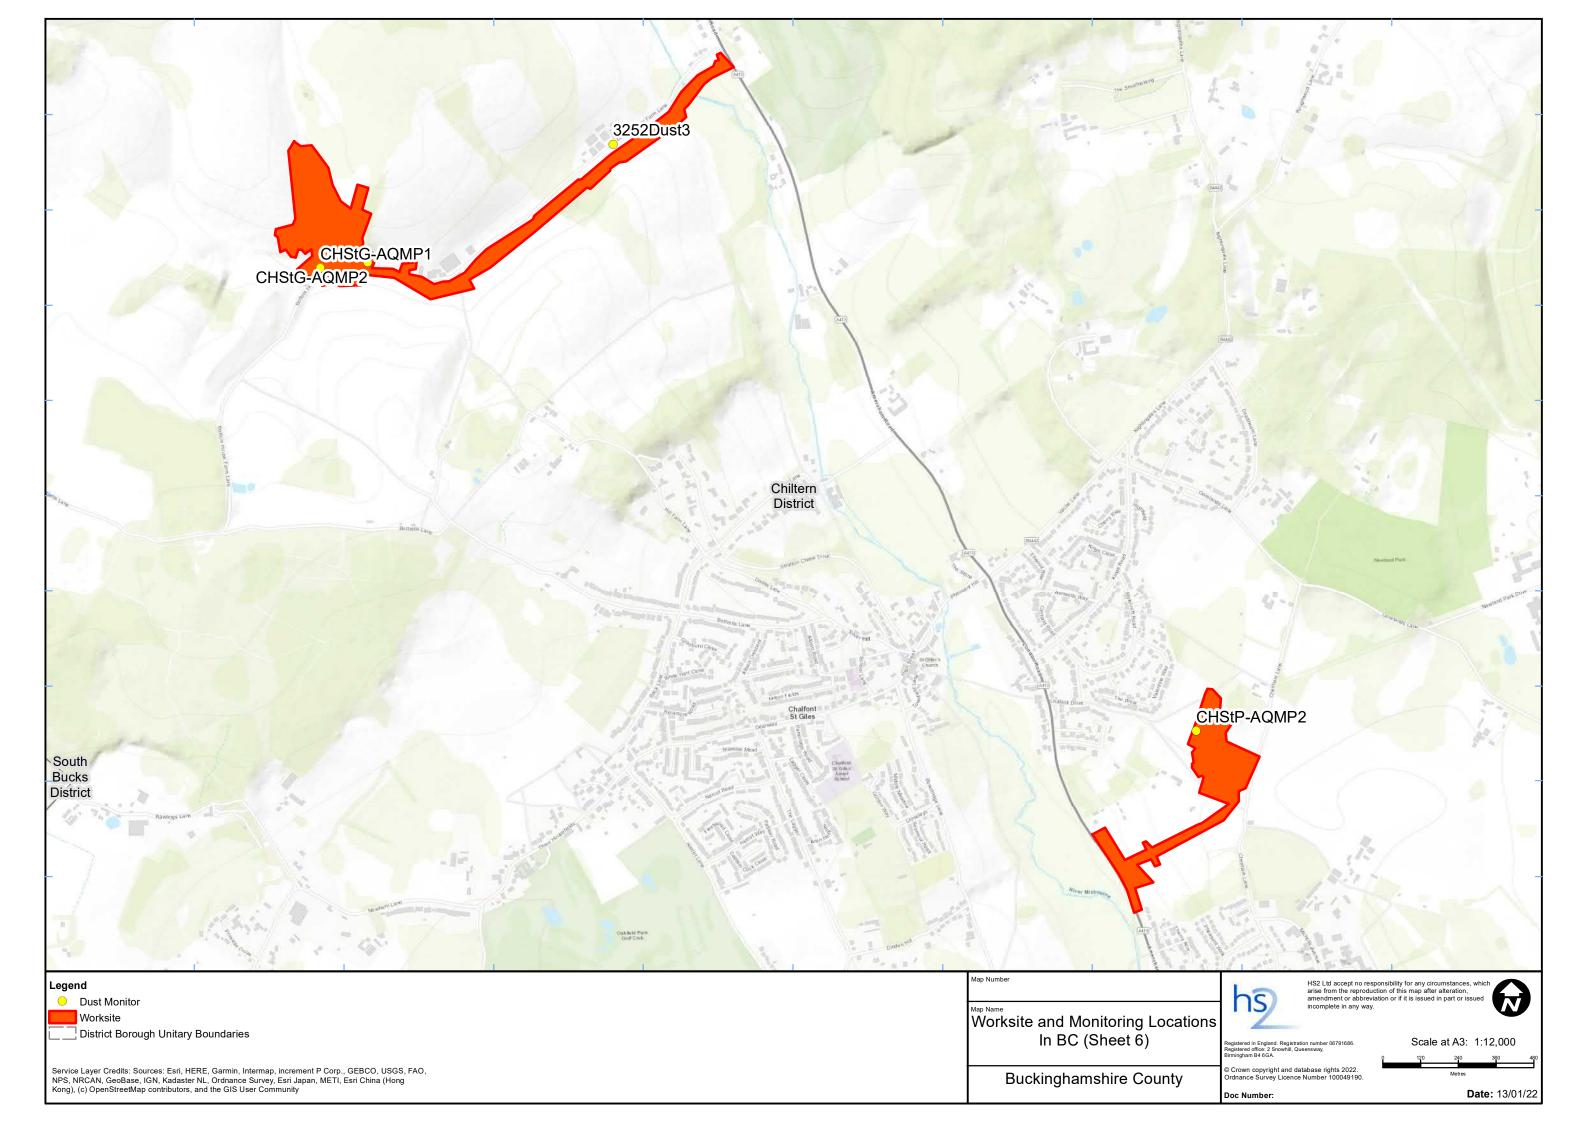
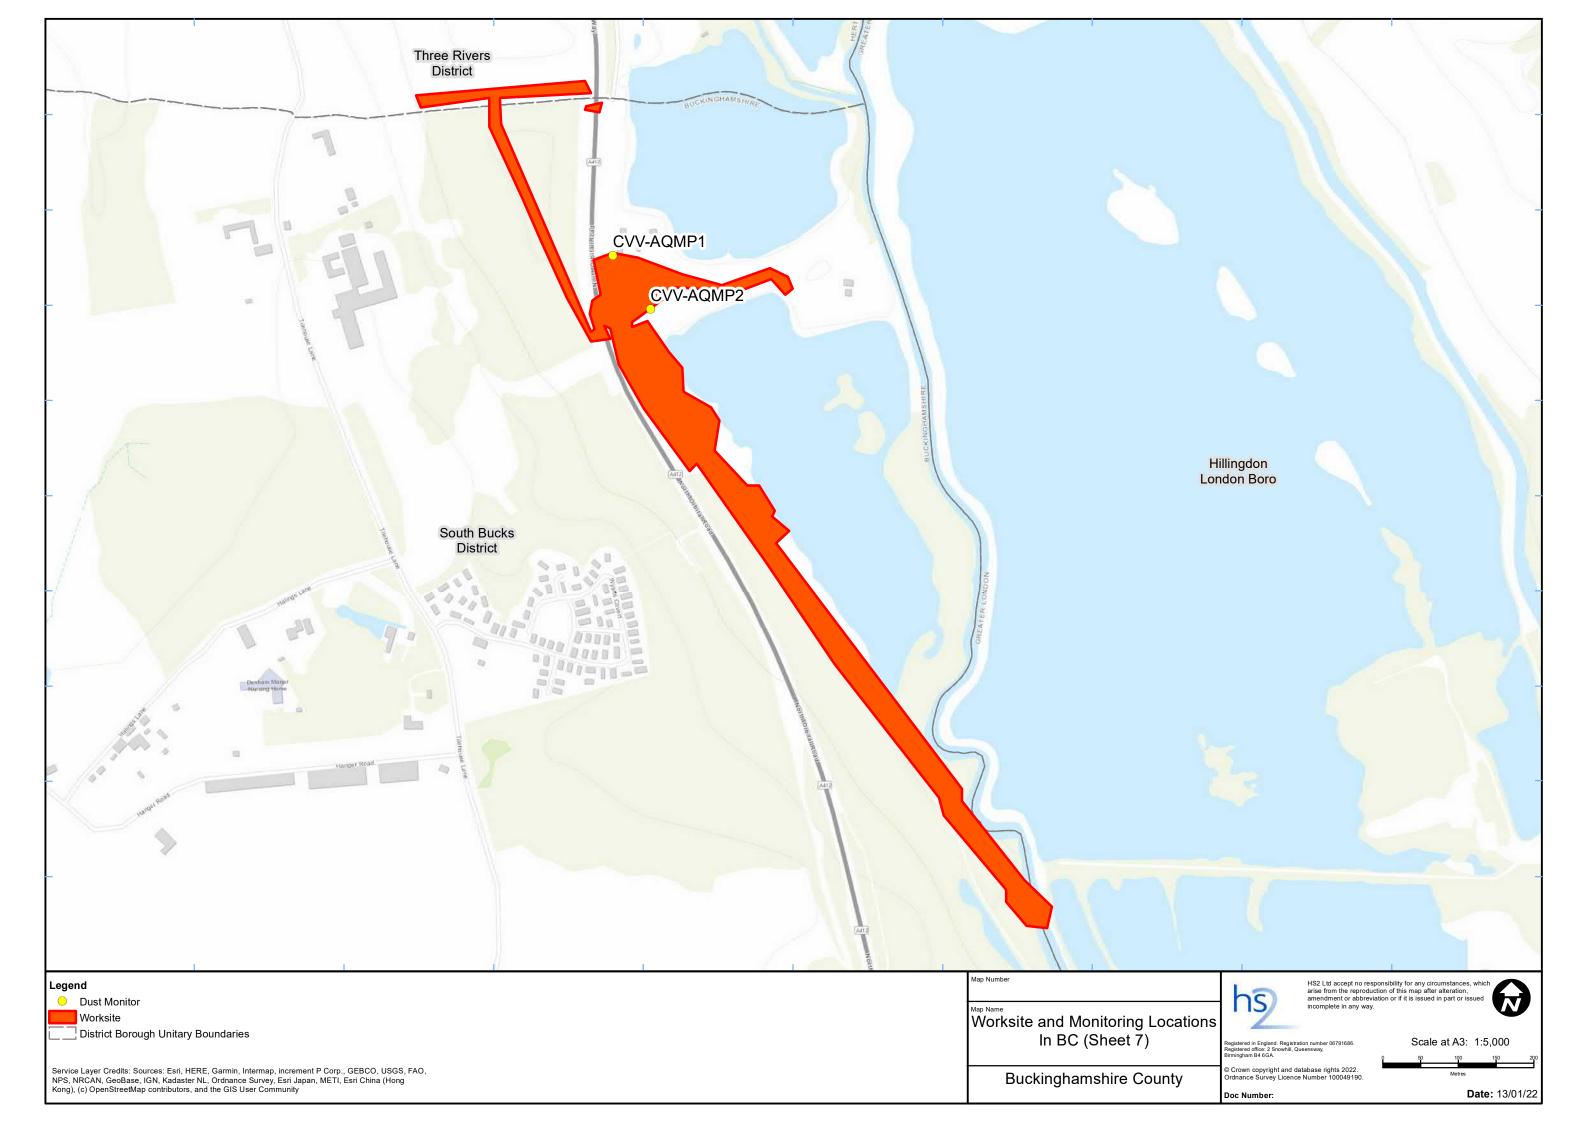
Figure 1-7: Worksite and monitoring locations within the BC

- 1.1.2 Figure 1-7 in Appendix A indicate the current worksites together with the dust monitoring locations.
- 1.1.3 This summary should be read in conjunction with the overview monitoring report available from <a href="www.gov.uk/government/collections/monitoring-the-environmental-effects-of-hs2">www.gov.uk/government/collections/monitoring-the-environmental-effects-of-hs2</a>, which highlights the applicable standards and guidance, as well as the air quality and dust monitoring methodologies to be implemented by nominated undertakers throughout construction.

- 1.1.4 The current phase of works commenced in March 2020. The current worksites, as presented in Appendix A, Figures 1-7, include:

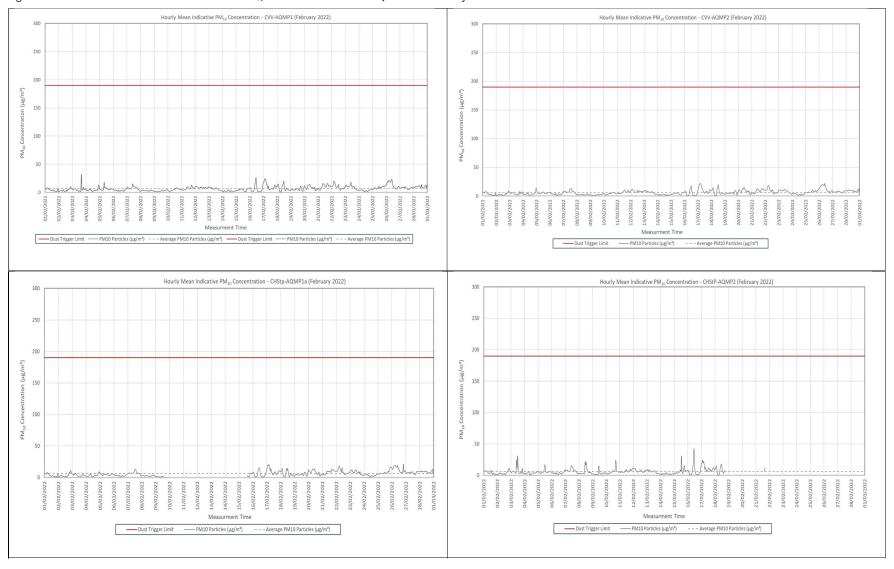
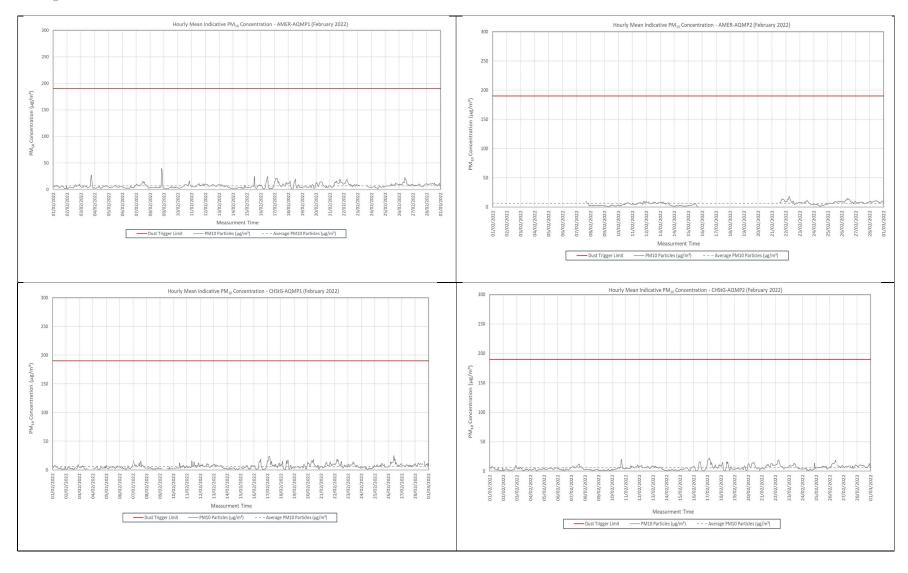
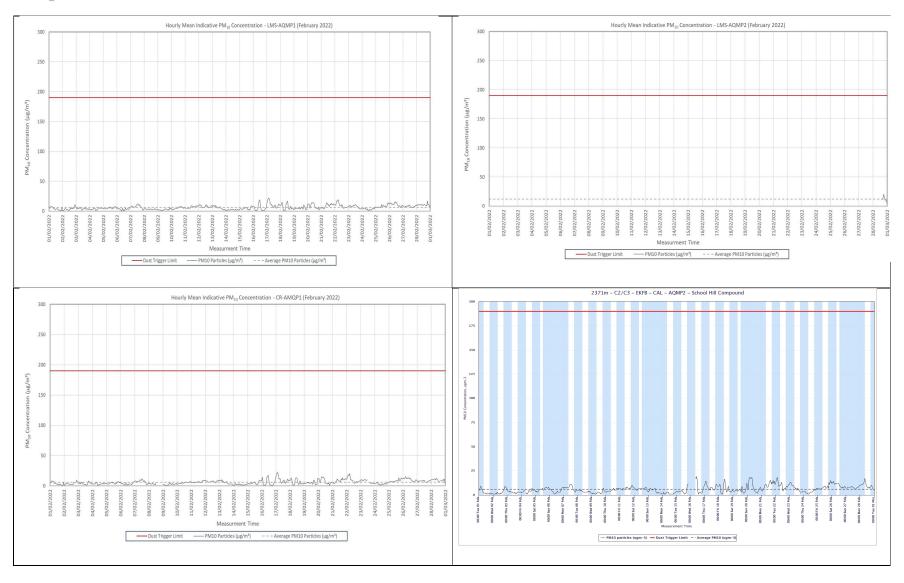
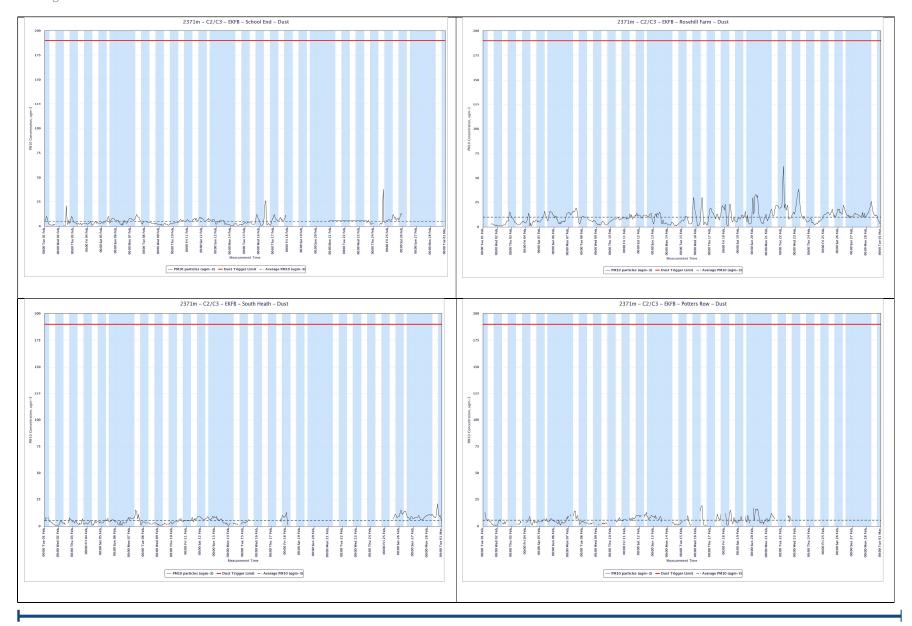
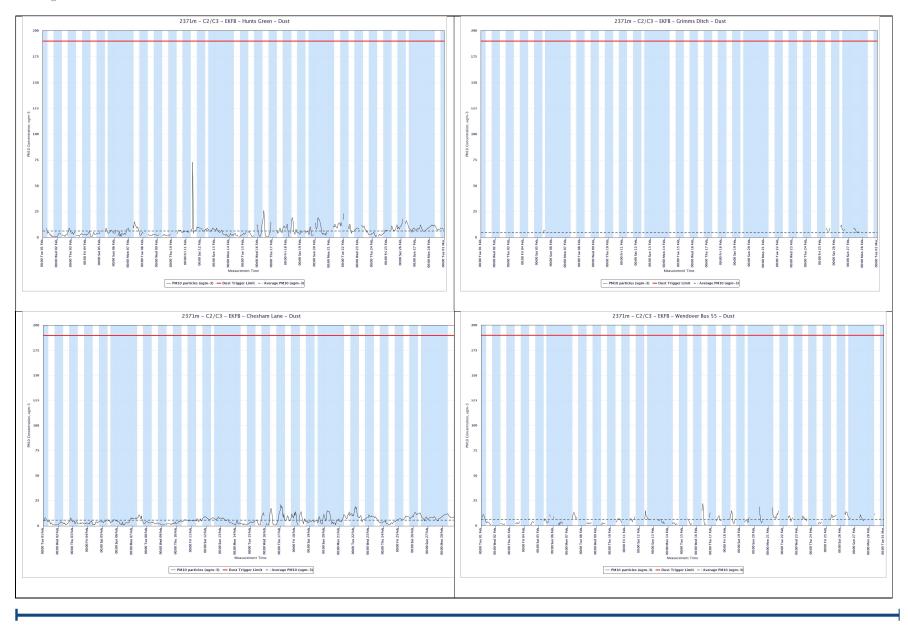
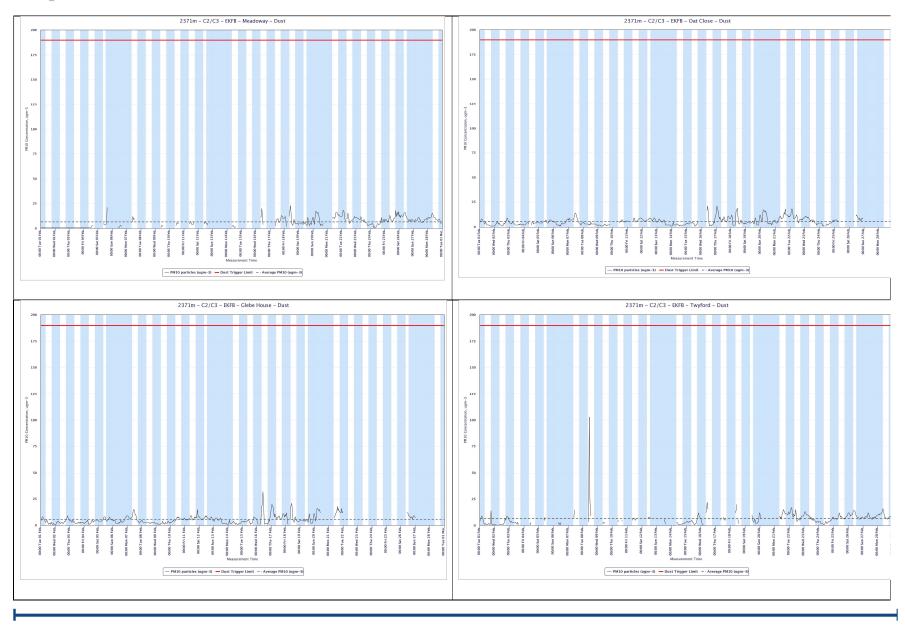
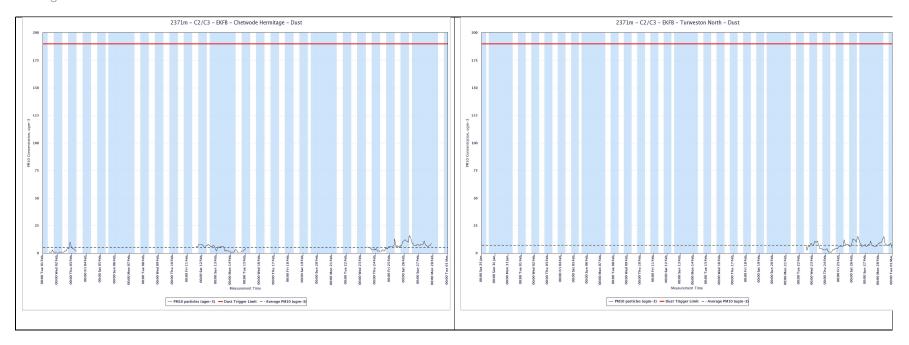
Figure 7: Continuous dust 1-hour mean indicative PM<sub>10</sub> concentration for CVV-AQMP1 for February 2022

- 1.1.6 Dust monitoring locations and results are presented in Appendix B, Table 1, together with line charts of monthly data from each dust monitor presented in Figure 8. All continuous dust monitoring is undertaken using indicative monitors. Despite being Environment Agency (MCERTS) certified, indicative monitors carry a higher level of uncertainty than reference monitors, and therefore cannot be strictly compared with Air Quality Standards for human health and the environment. The purpose of the monitoring undertaken is to ensure the effectiveness of the on-site mitigation.

- 1.1.7 The trigger level for  $PM_{10}$  concentrations of 190  $\mu$ g/m³, measured as a 1-hour mean, in accordance with the updated guidance document 'Guidance on Monitoring in the Vicinity of Demolition and Construction Sites (October 2018)' has been applied.

- 1.1.8 No (0) dust trigger alerts were recorded during the monitoring period (February 2022).
- 1.1.9 Data capture was below 90% for multiple monitors in February 2022 due to power supply issues and technical problems.
