Construction Noise and Vibration Monthly Report – February 2022

Birmingham City

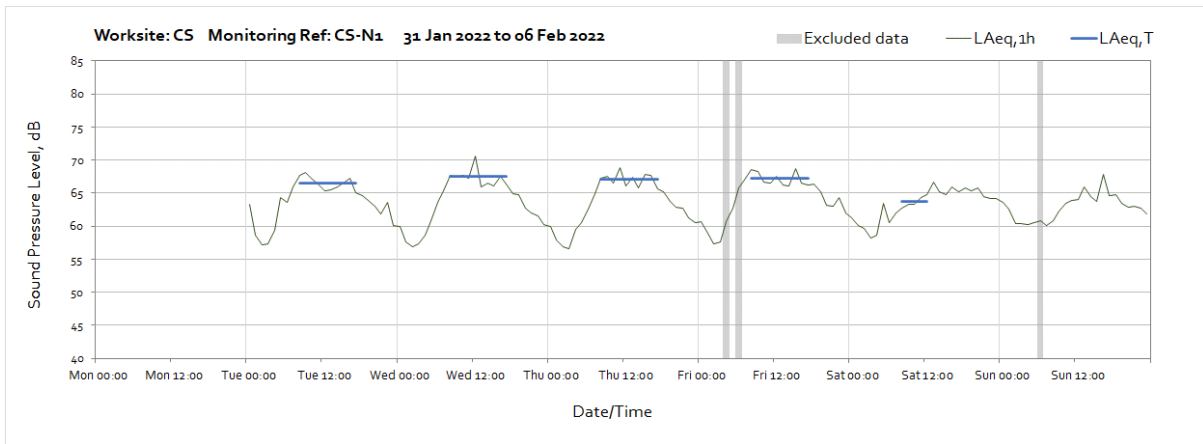
Worksite: Curzon Street (CS) – Monitoring Ref: CS-N1

The following graphs show the hourly measured ambient noise level $L_{Aeq,1h}$ and, where relevant, the averaged noise level $L_{Aeq,T}$ values, where the time period T is as specified in Table 1 of HS2 Information Paper E23. Periods with adversely weather affected noise levels are greyed out and have been excluded from the calculation of the $L_{Aeq,T}$ values in Table 3 of the main report.
