Construction Noise and Vibration Monthly Report – February 2022

London Borough of Ealing

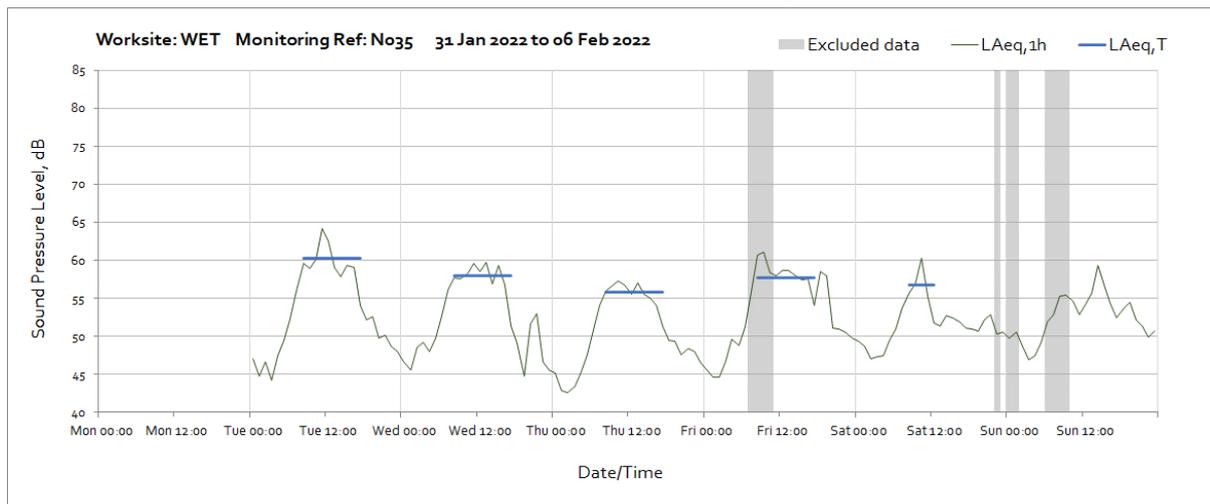
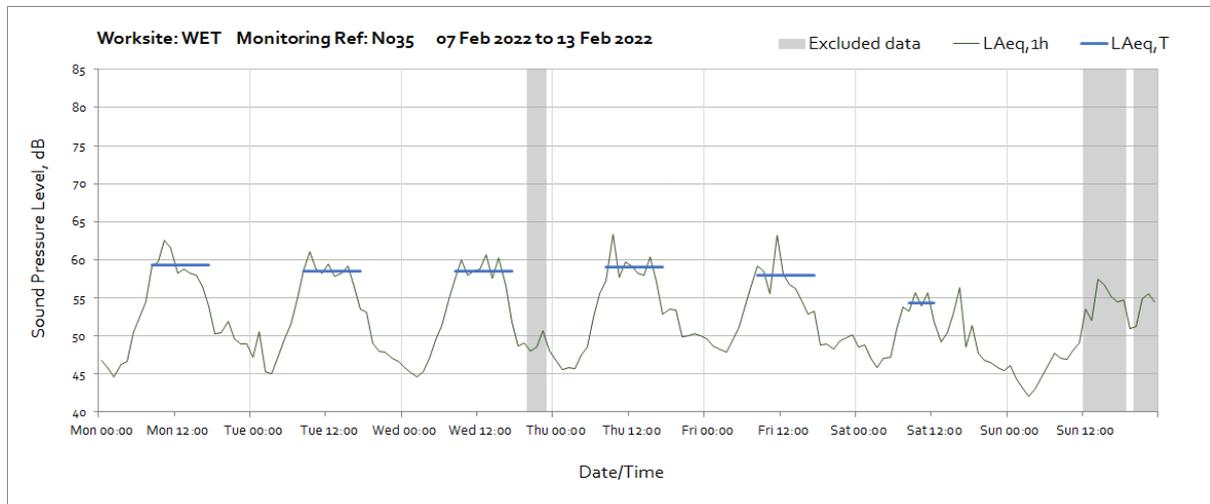
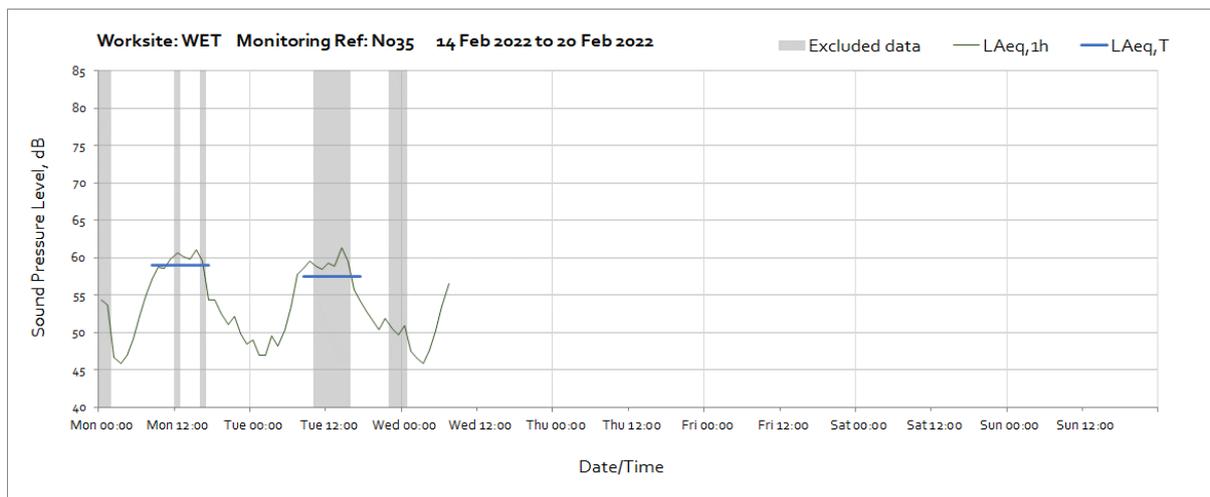
Worksite: Willesden Euro Terminal (WET) – Monitoring Ref: N035

Note: Missing data from 08:00 on Wednesday 16th February 2022 was due to loss of power at the monitoring station. The power connection will be restored after access permission from LB Ealing Highways.

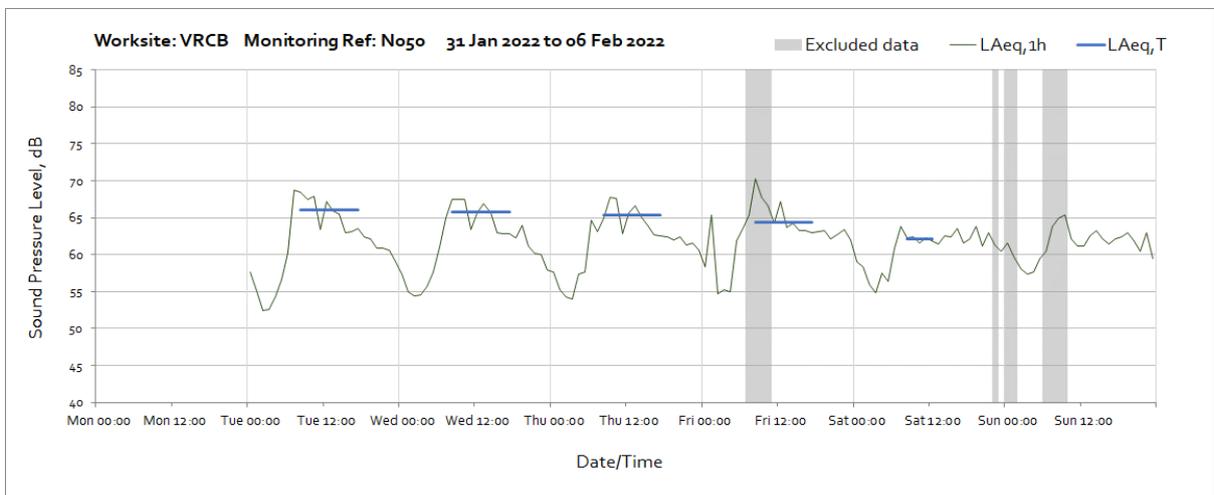
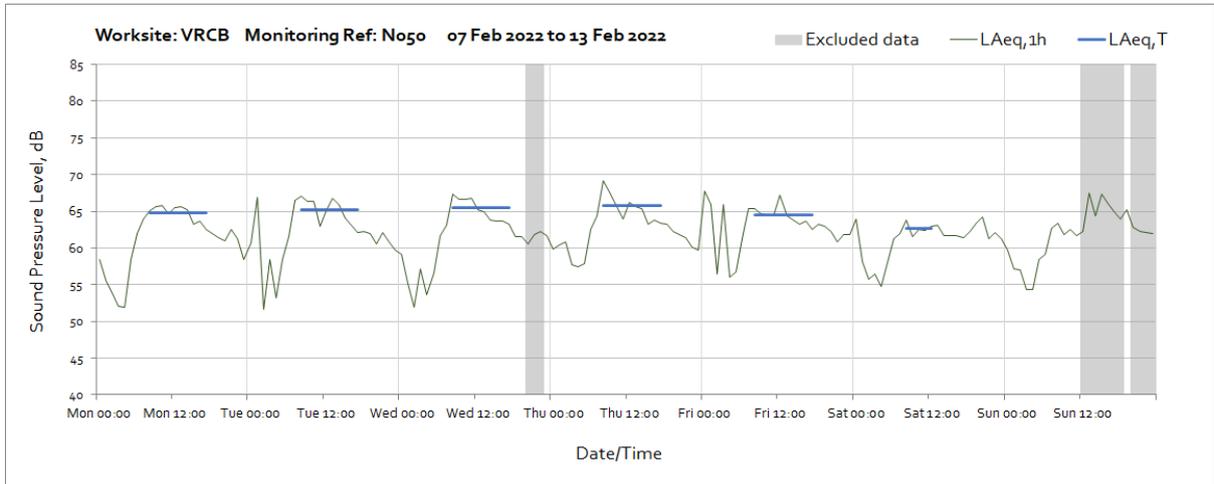
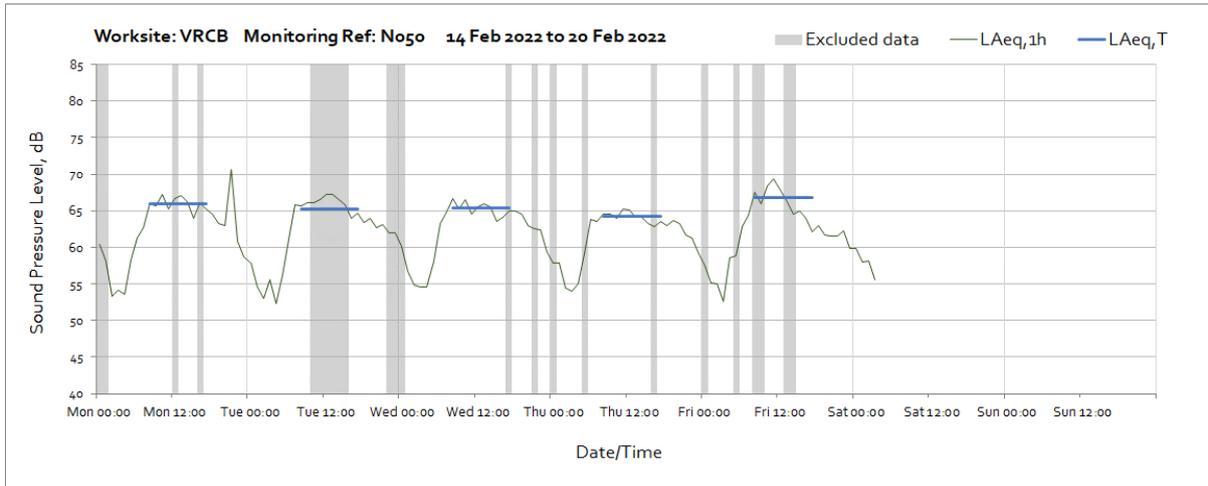
Worksite: Victoria Road Crossover Box (VRCB) – Monitoring Ref: N050

Note: Missing data from 04:00 on Saturday 19th February 2022 was due to loss of power at the monitoring station. The power connection will be restored after access permission from LB Ealing Highways.

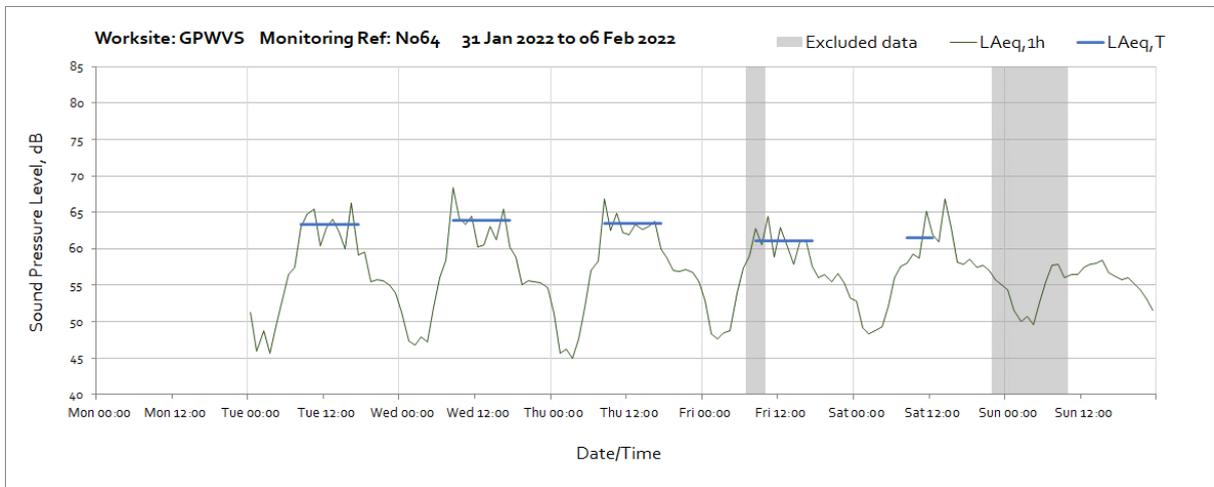
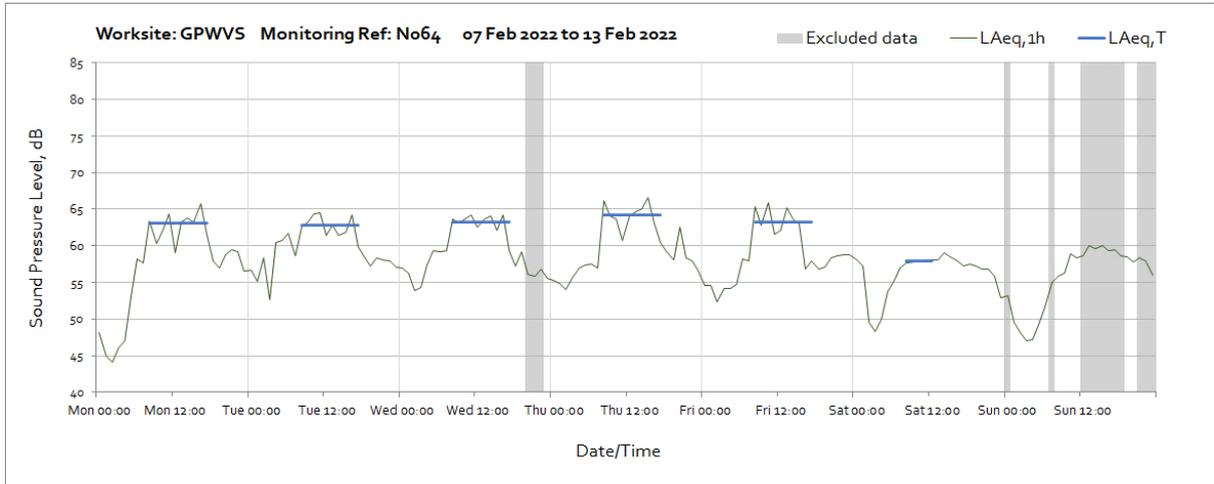
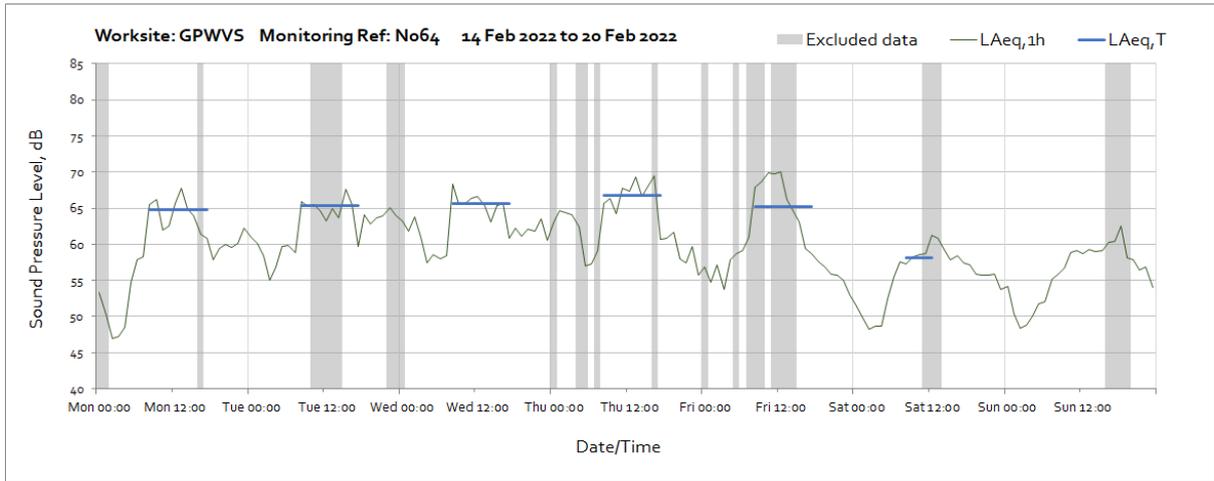
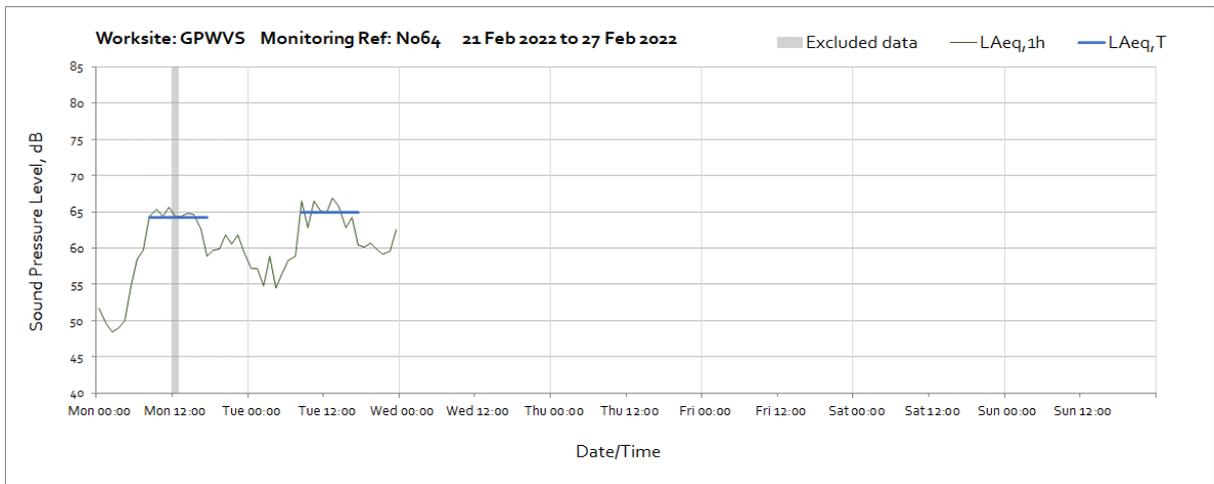
Worksite: Green Park Way Vent Shaft (GPWVS) – Monitoring Ref: N064

Note: Missing data from 00:00 on Wednesday 26th February 2022 until the end of the month was due to loss of power at the monitoring station.

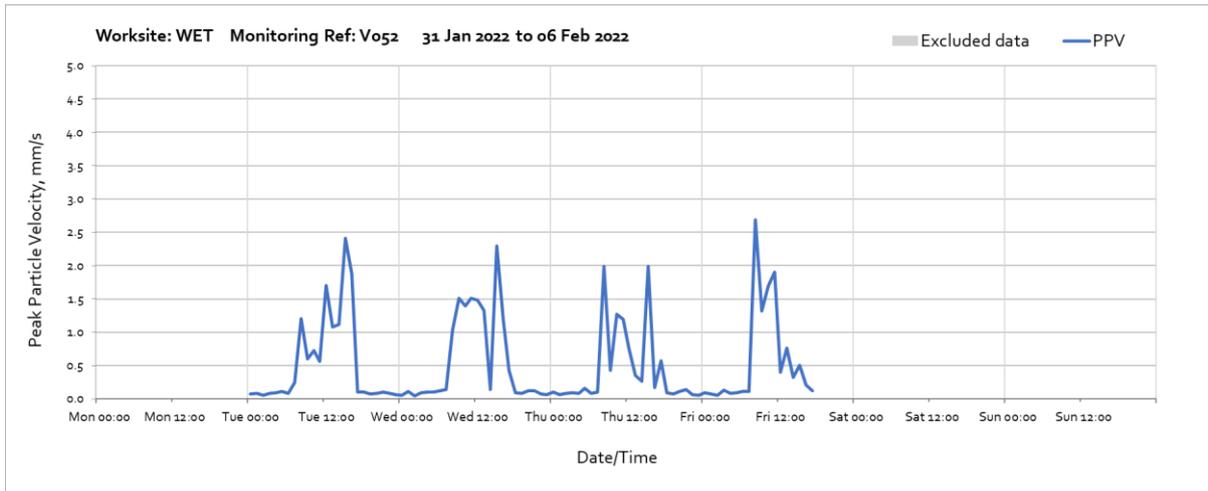
Worksite: Willesden Euro Terminal (WET) – Monitoring Ref: V052

Note: The monitor has been temporarily retrieved from site on Friday 4th February 2022.

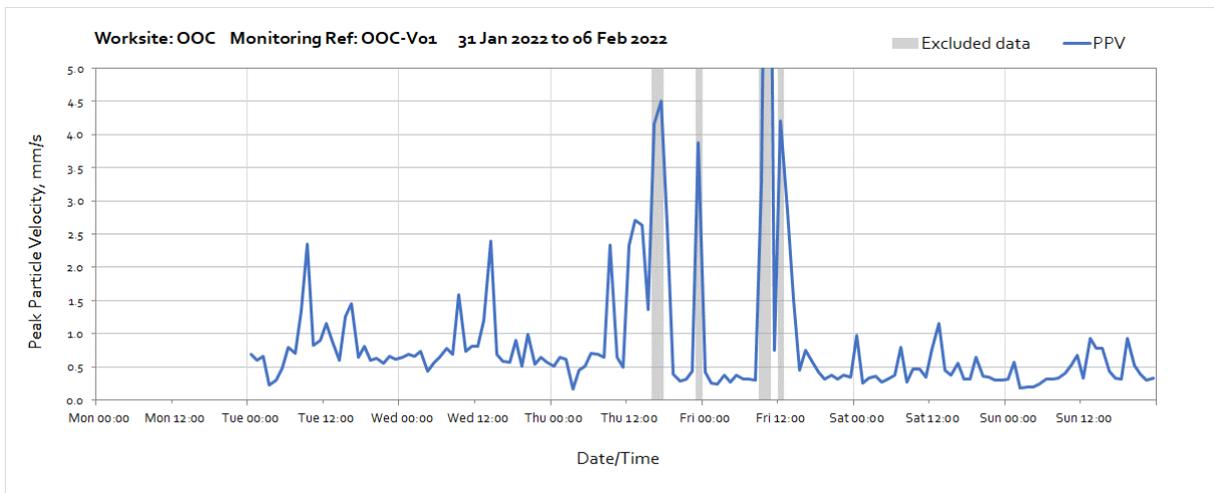
Worksite: Old Oak Common (OOC) – Monitoring Ref: OOC-V01

Note: High vibration levels across the week were due to local disturbance at the monitoring location and not representative of HS2 vibration levels at the receptor.

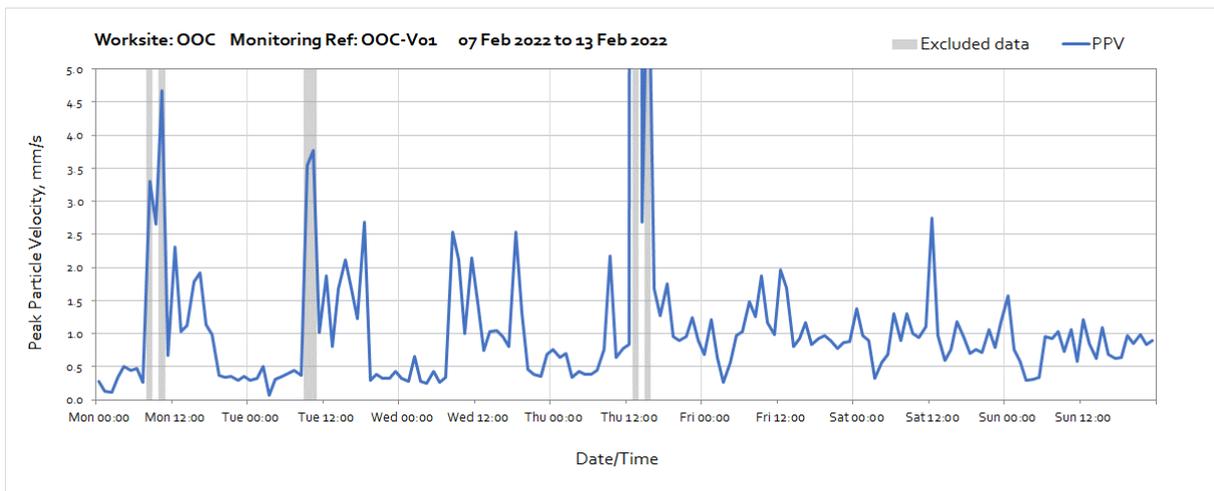
Note: High vibration levels measured across the week were due to local disturbance at the monitoring location and not representative of HS2 vibration levels at the receptor.

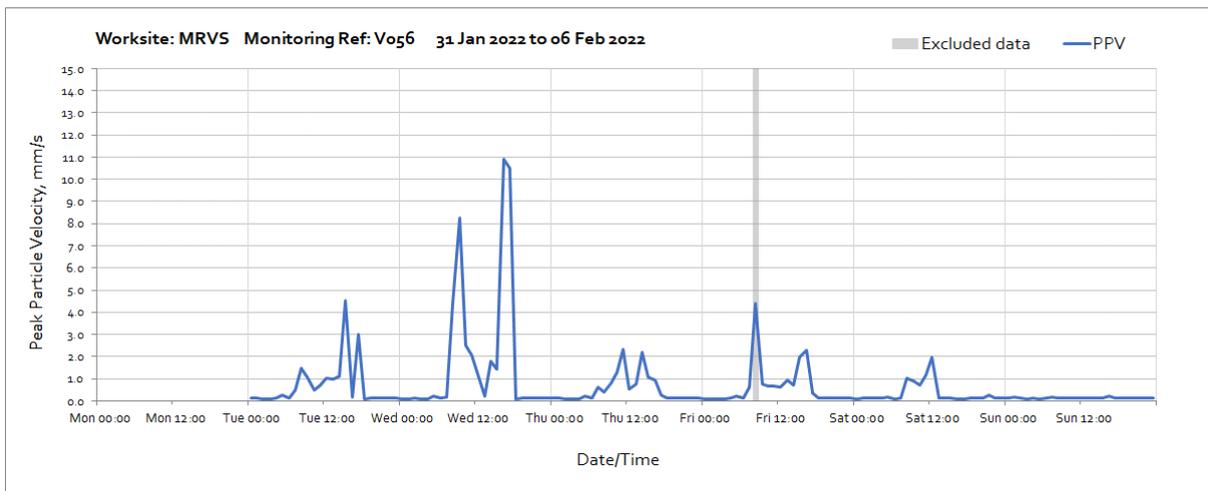
Worksite: Mandeville Road Vent Shaft (MRVS) – Monitoring Ref: V056

Note: High vibration levels measured across the week were due to piling works undertaken next to the monitoring station and therefore not representative of HS2 vibration levels at the receptor. High vibration levels measured at 08:00 on Friday 4th February 2022 were due to local disturbance at the monitoring location and not representative of HS2 vibration levels at the receptor.

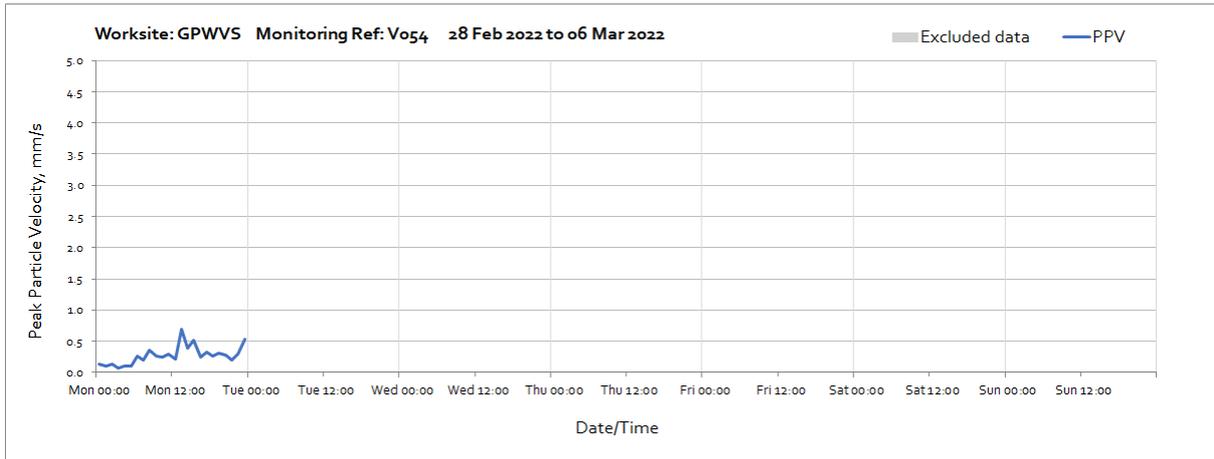
Note: High vibration levels measured at 09:00 on Monday 21st February 2022 and at 14:00 on Wednesday 23rd February 2022 were due to local disturbance at the monitoring location and not representative of HS2 vibration levels at the receptor.
