Construction Noise and Vibration Monthly Report – March 2022

Birmingham City

Non-Technical Summary

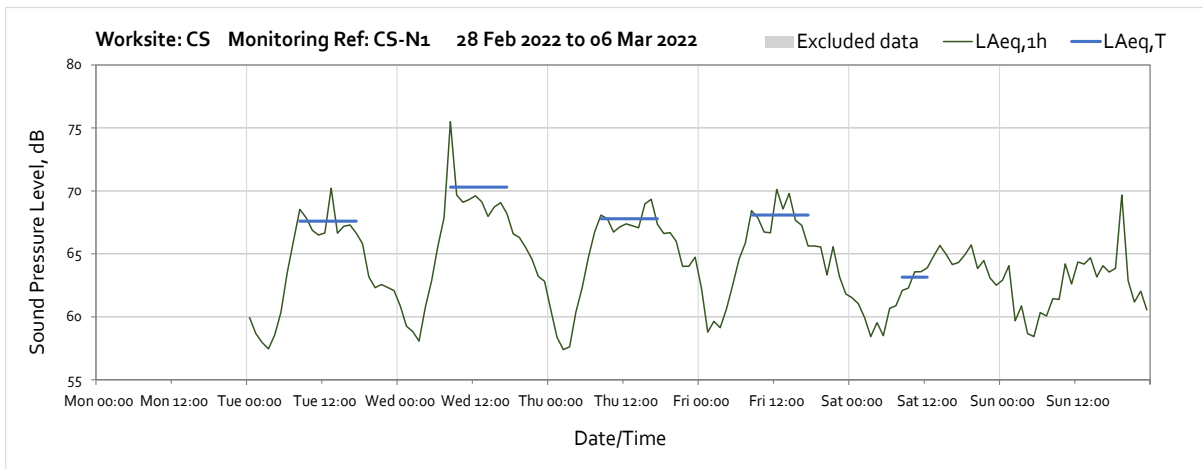
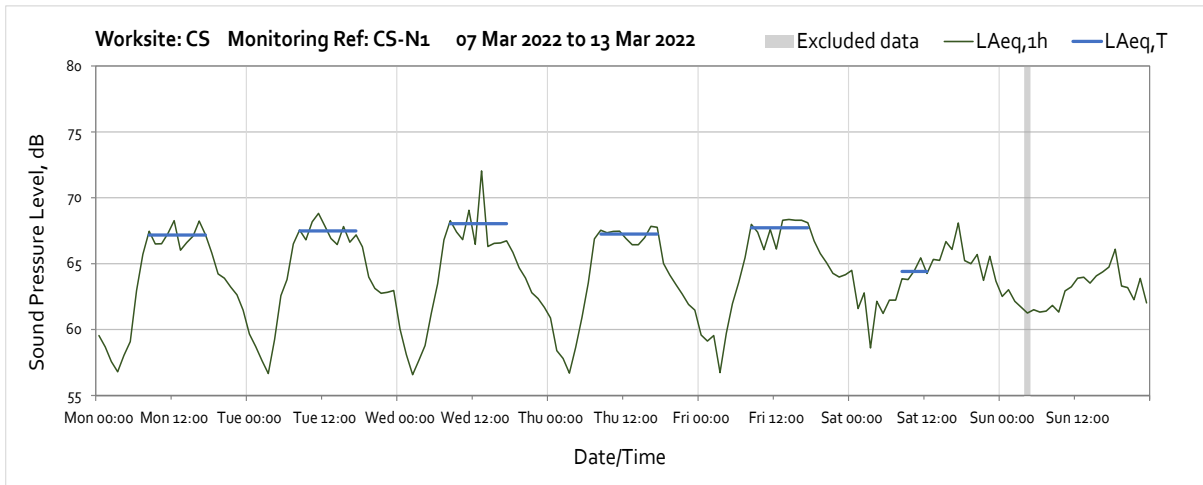
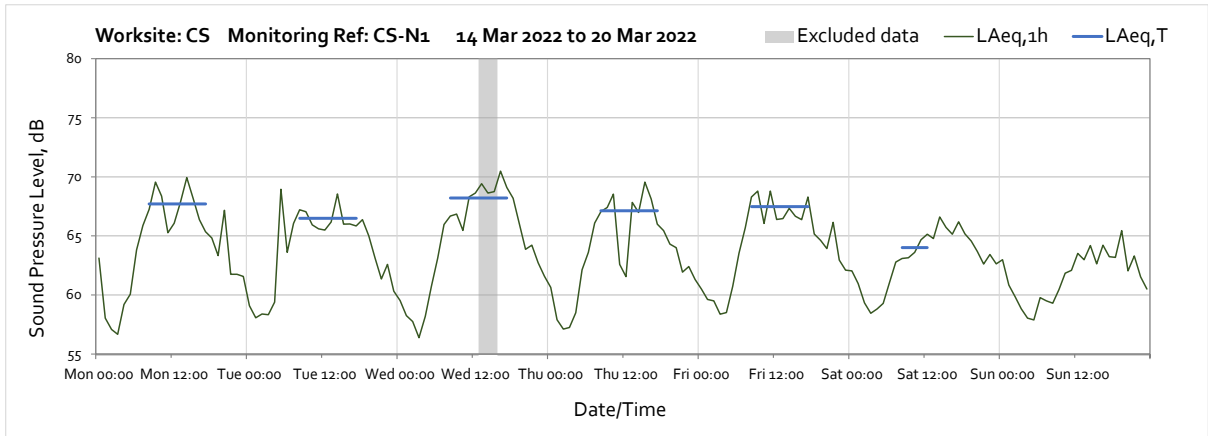
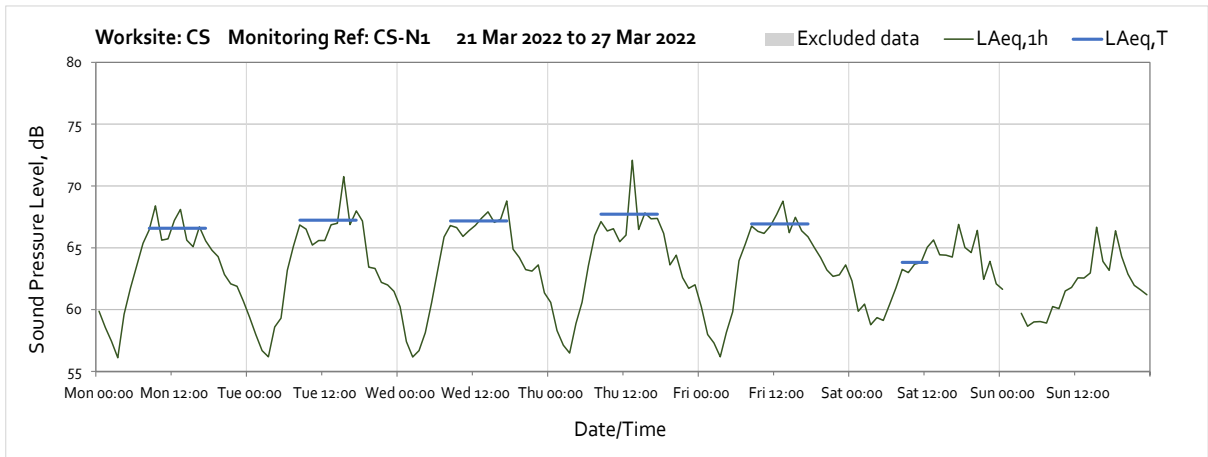
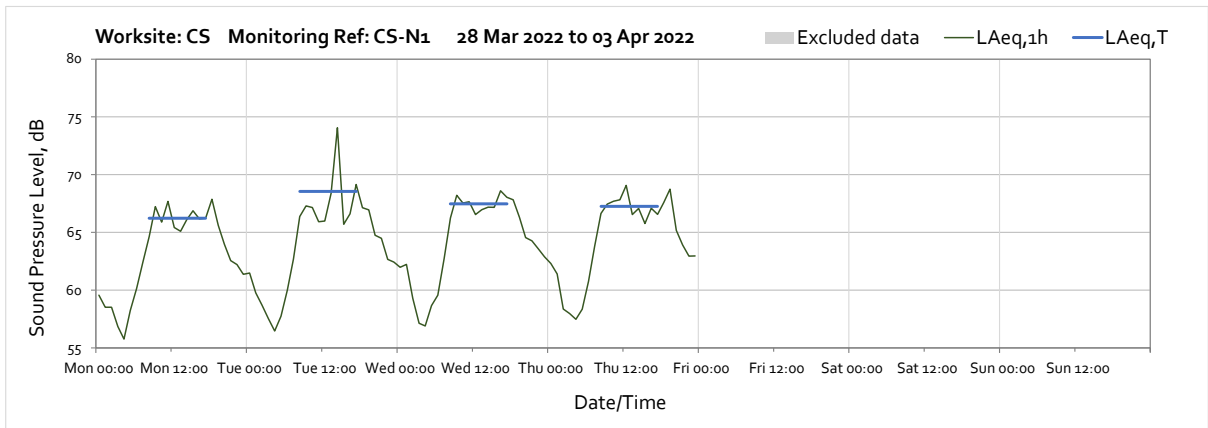
Worksite: Curzon Street (CS) – Monitoring Ref: CS-N1

The following graphs show the hourly measured ambient noise level $L_{Aeq,1h}$ and, where relevant, the averaged noise level $L_{Aeq,T}$ values, where the time period T is as specified in Table 1 of HS2 Information Paper E23. Periods with adversely weather affected noise levels are greyed out and have been excluded from the calculation of the $L_{Aeq,T}$ values in Table 3 of the main report.

Note: Missing data in between 01:00 and 02:00 on Sunday 27th March was due to the clocks going forward at the start of British Summer Time.

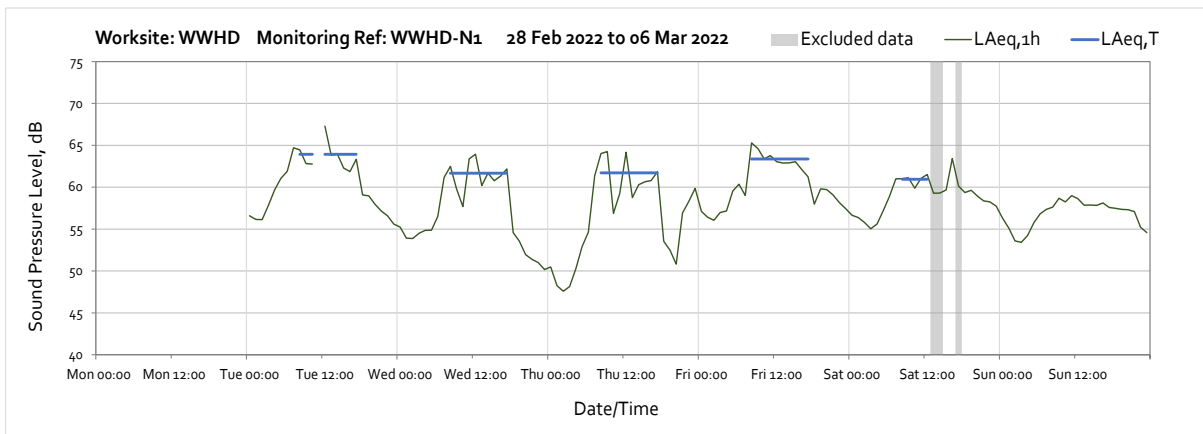
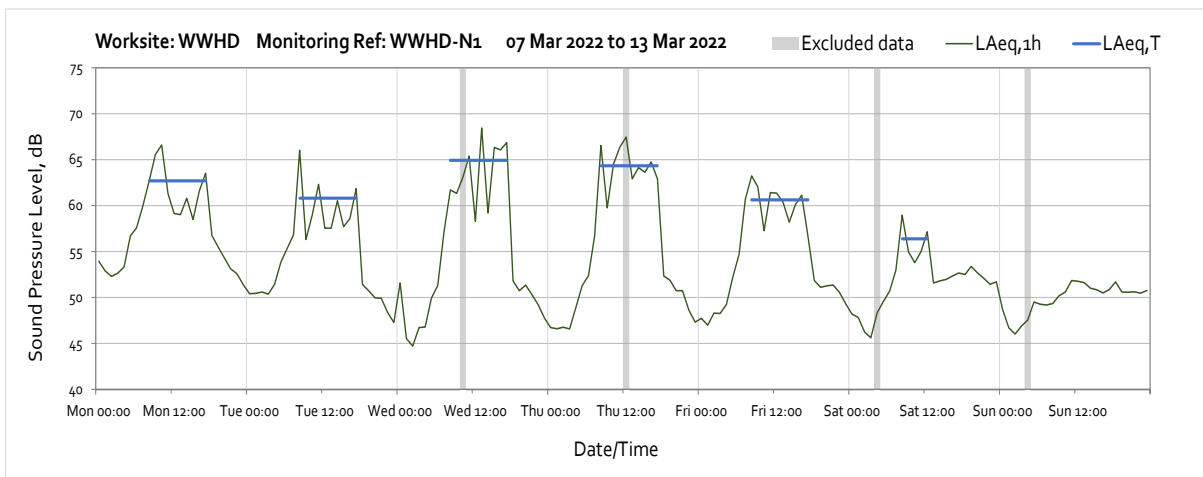
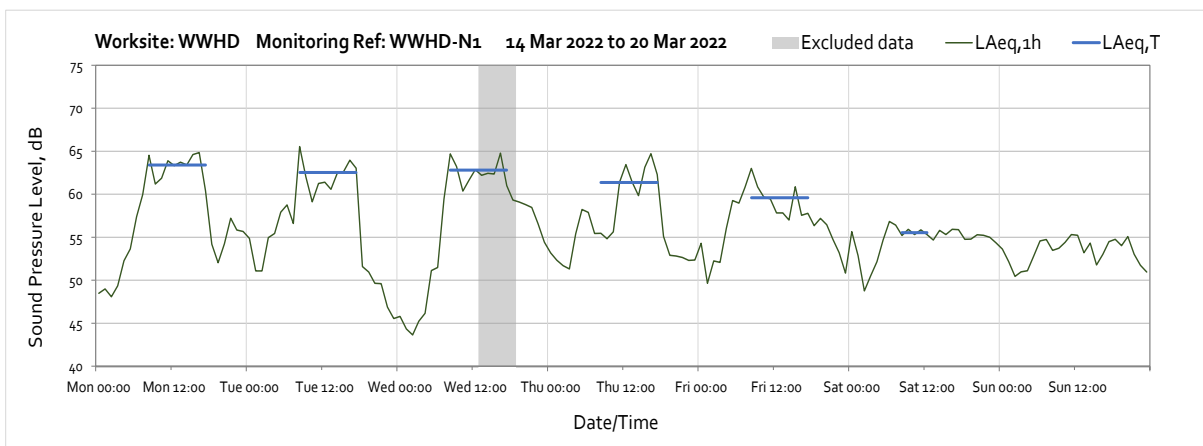
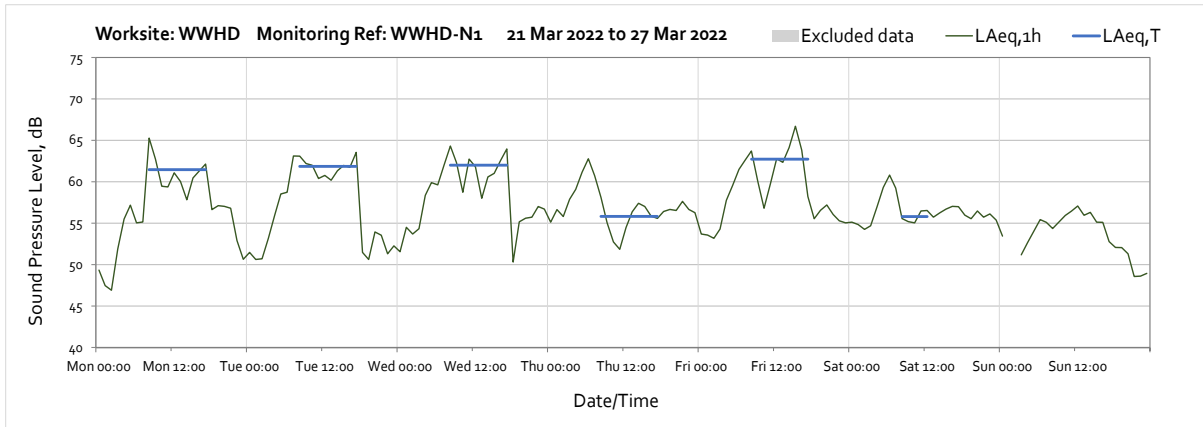
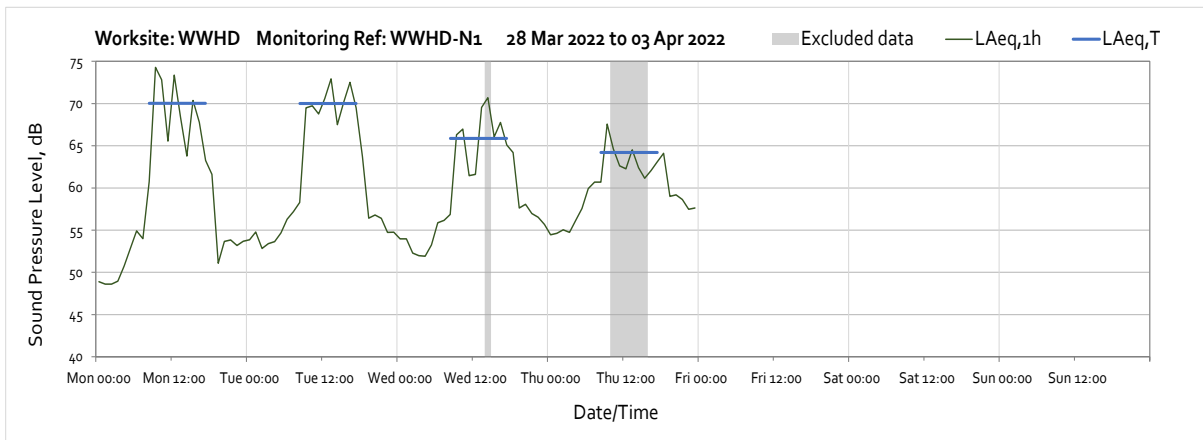
Worksite: Washwood Heath Depot (WWHD) – Monitoring Ref: WWHD-N1

Note: Missing data at 11:00 on Tuesday 1st March 2022 were due to the monitoring equipment being moved.

Note: Missing data in between 01:00 and 02:00 on Sunday 27th March was due to the clocks going forward at the start of British Summer Time.

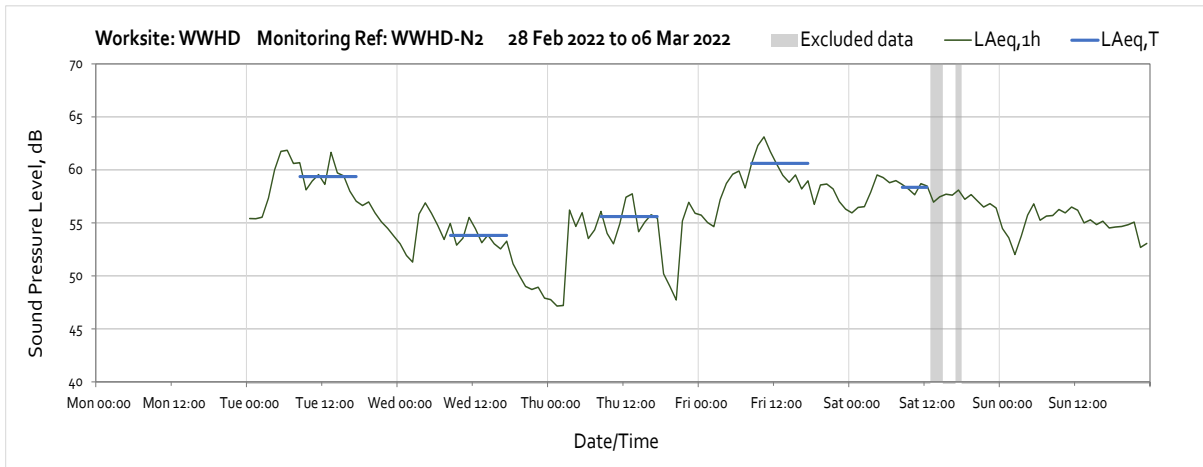
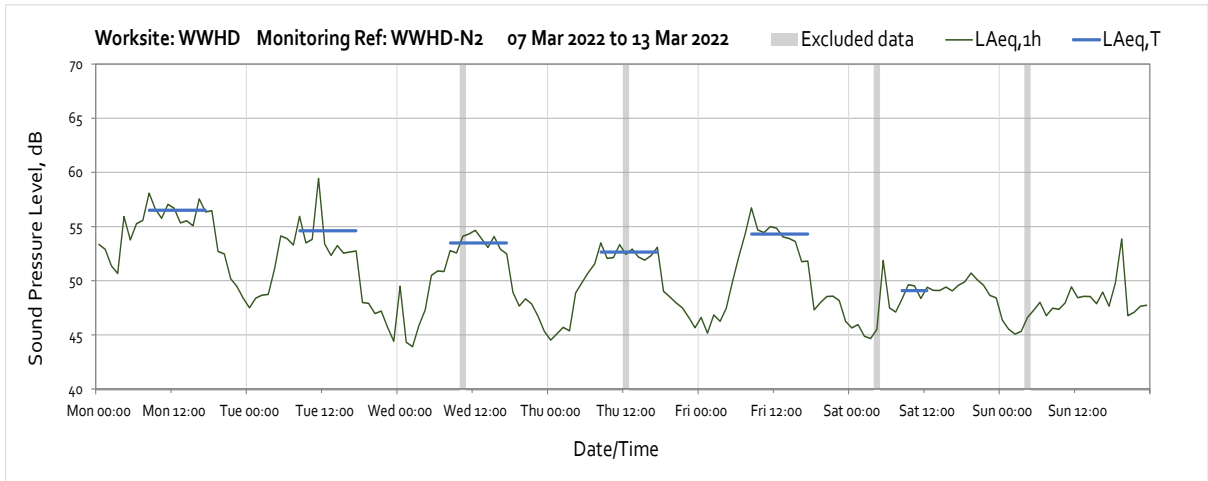
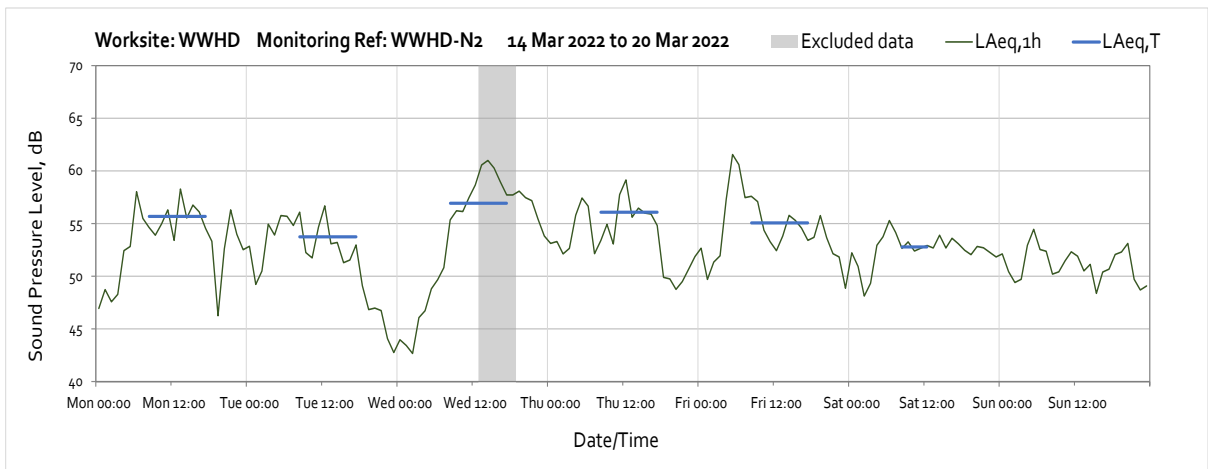
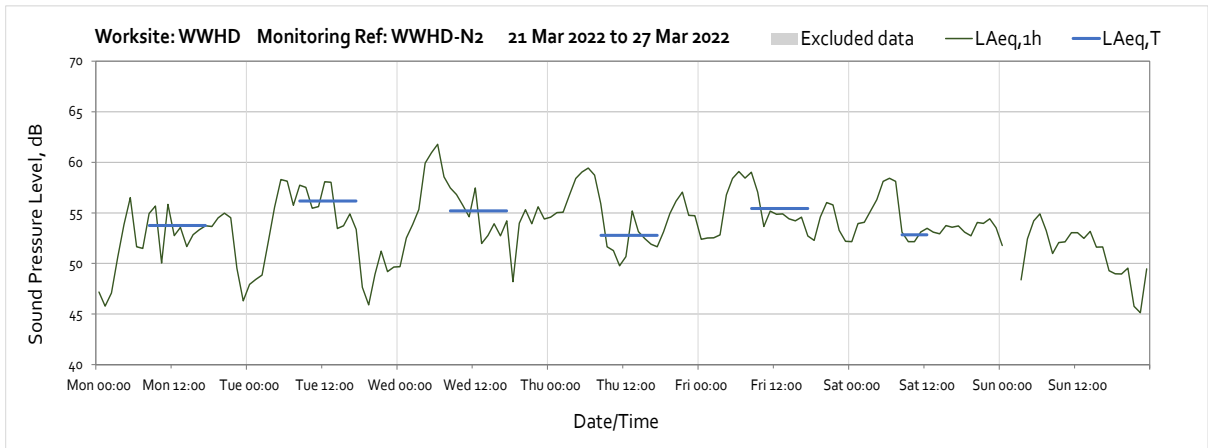
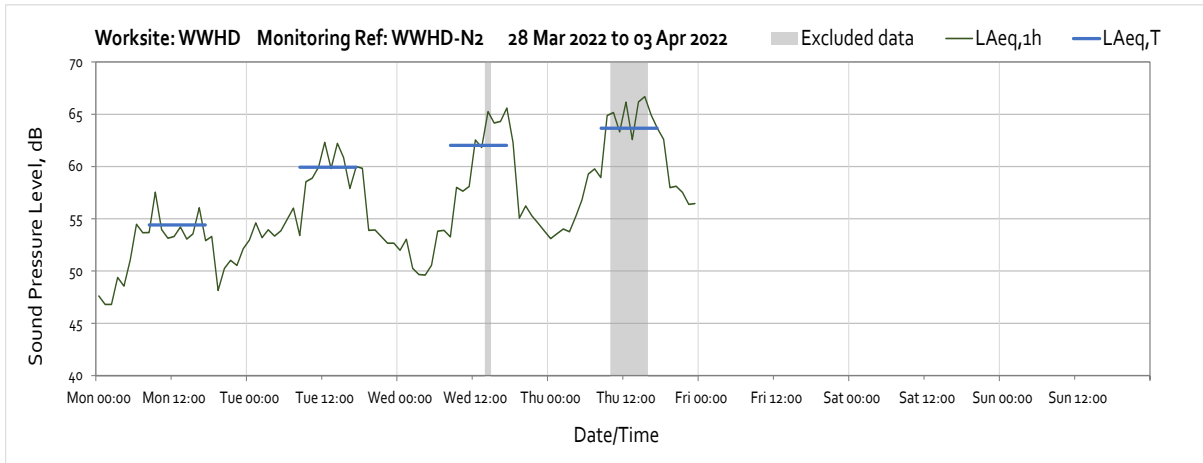
Worksite: Washwood Heath Depot (WWHD) – Monitoring Ref: WWHD-N2

Note: Missing data in between 01:00 and 02:00 on Sunday 27th March was due to the clocks going forward at the start of British Summer Time.

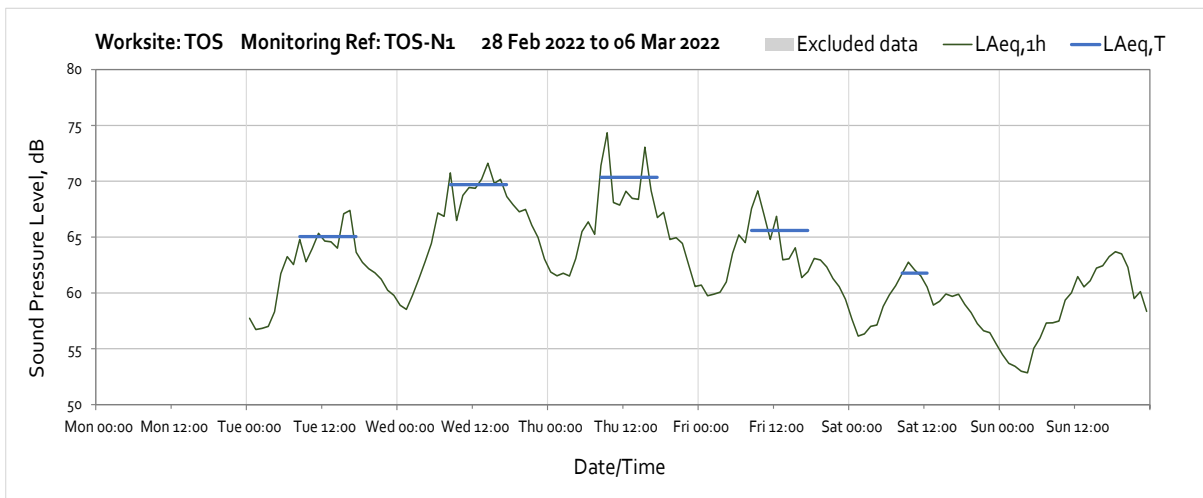
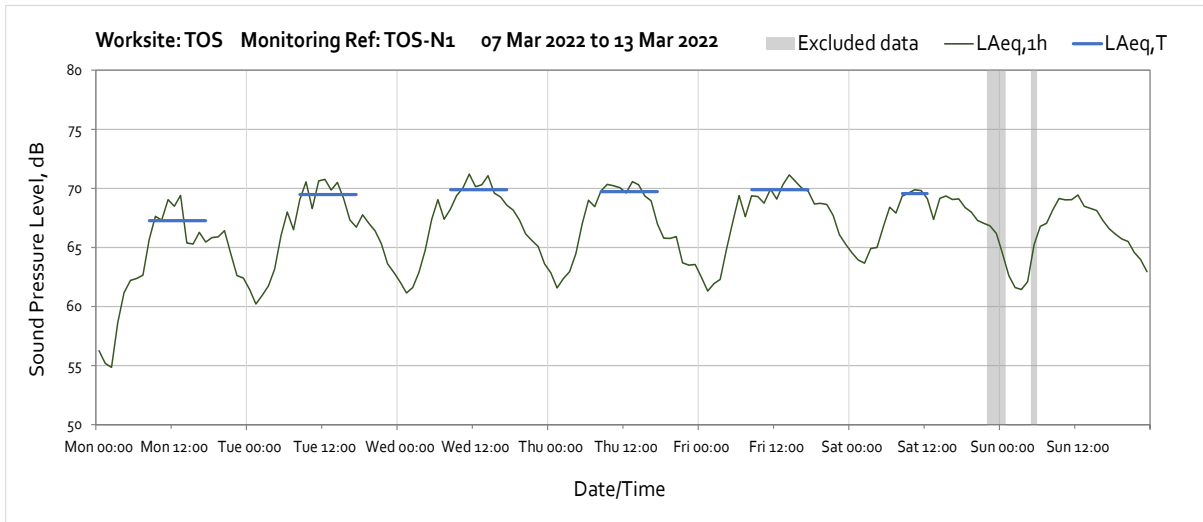
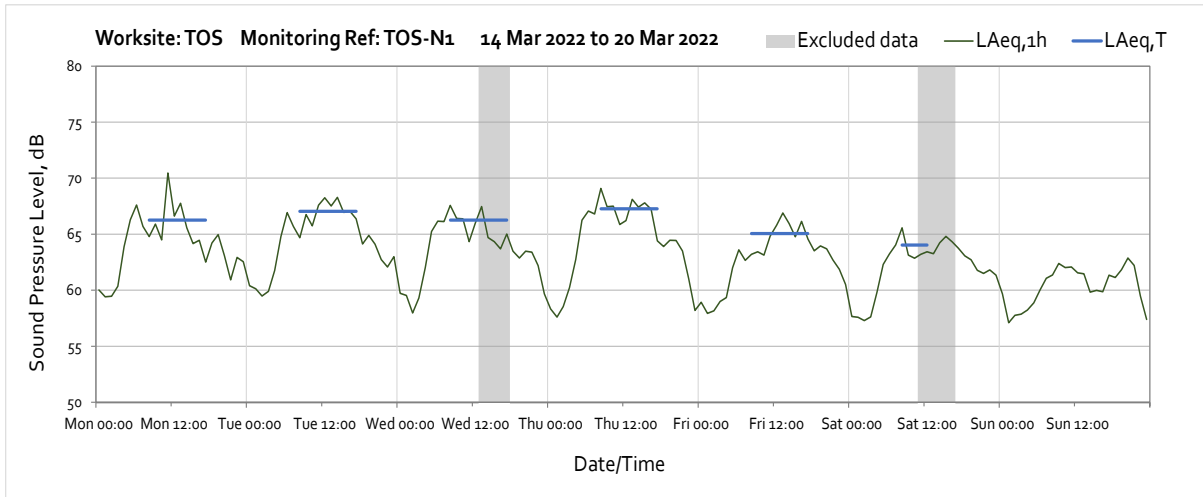
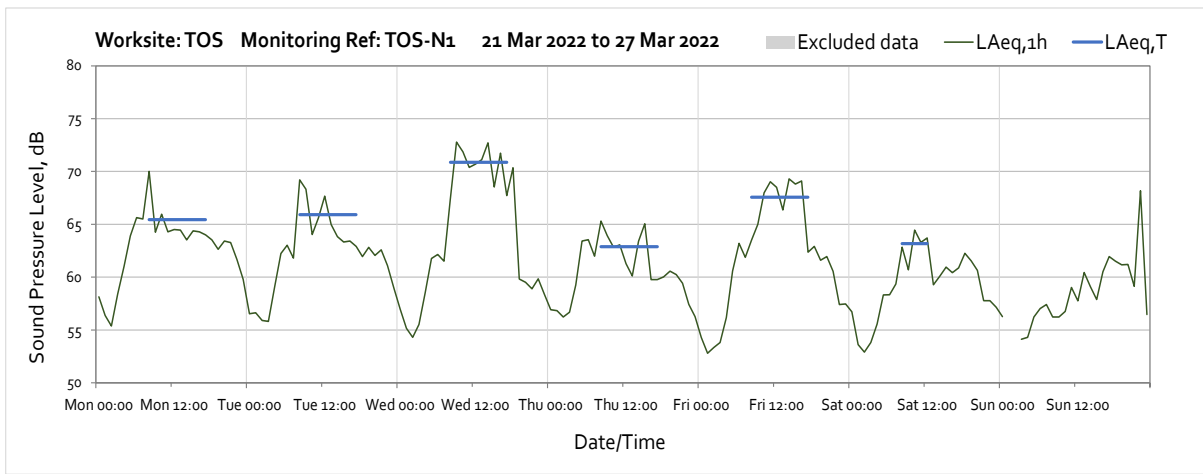
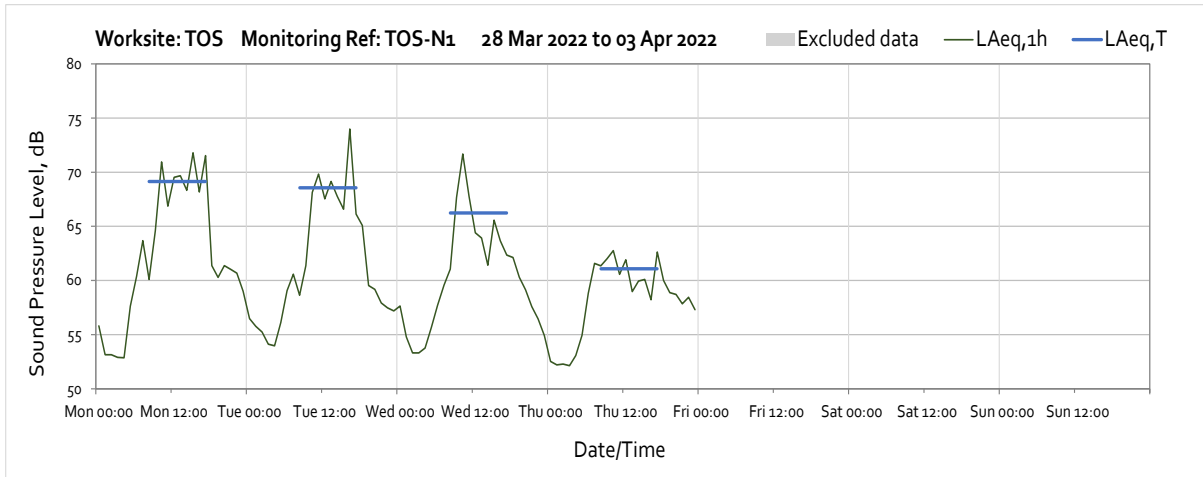
Worksite: Twisted Oak Stables (TOS) – Monitoring Ref: TOS-N1

Note: Missing data in between 01:00 and 02:00 on Sunday 27th March was due to the clocks going forward at the start of British Summer Time.

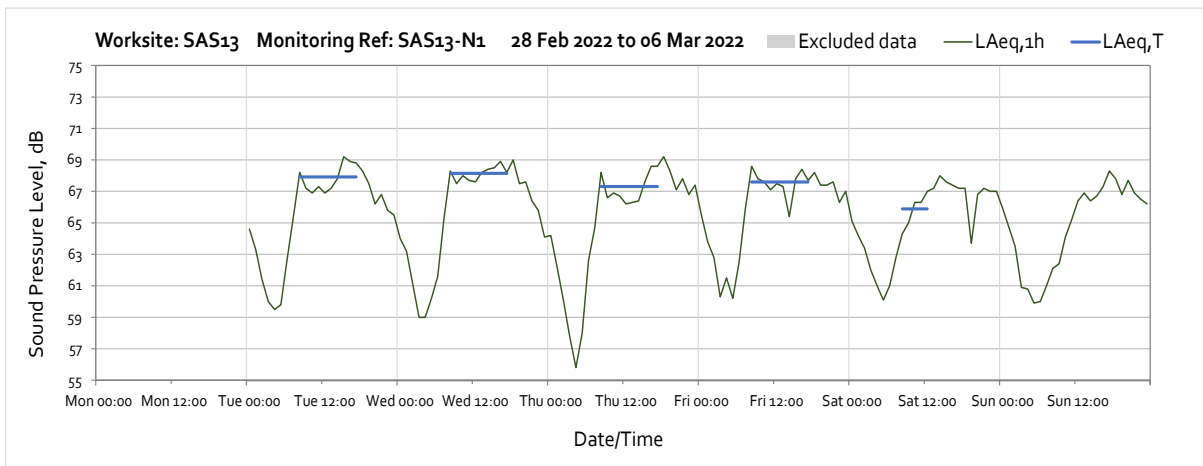
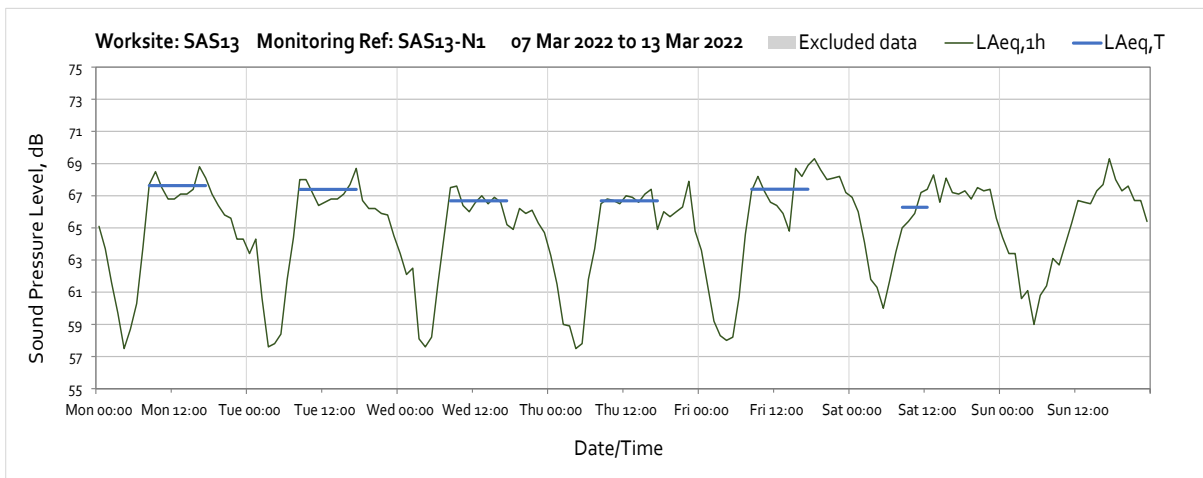
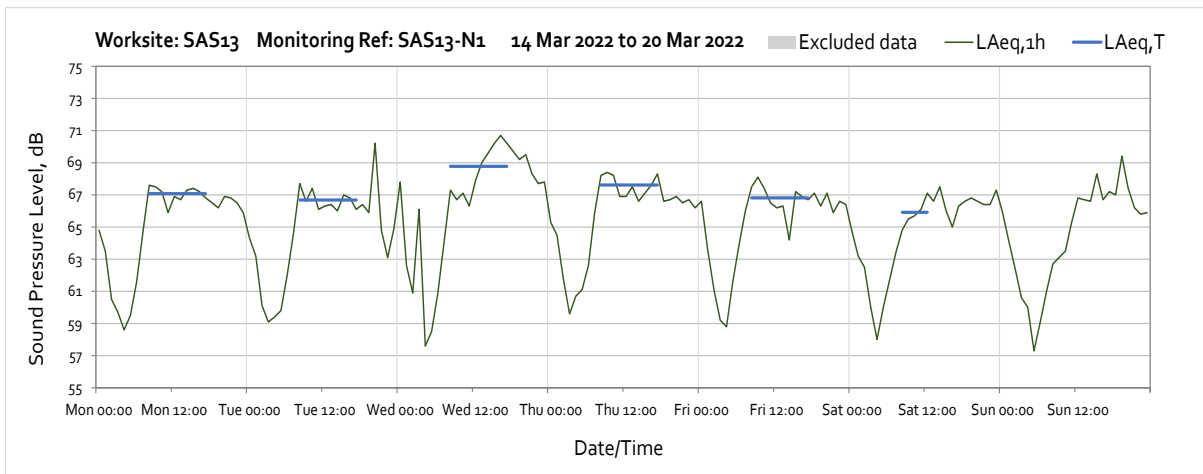
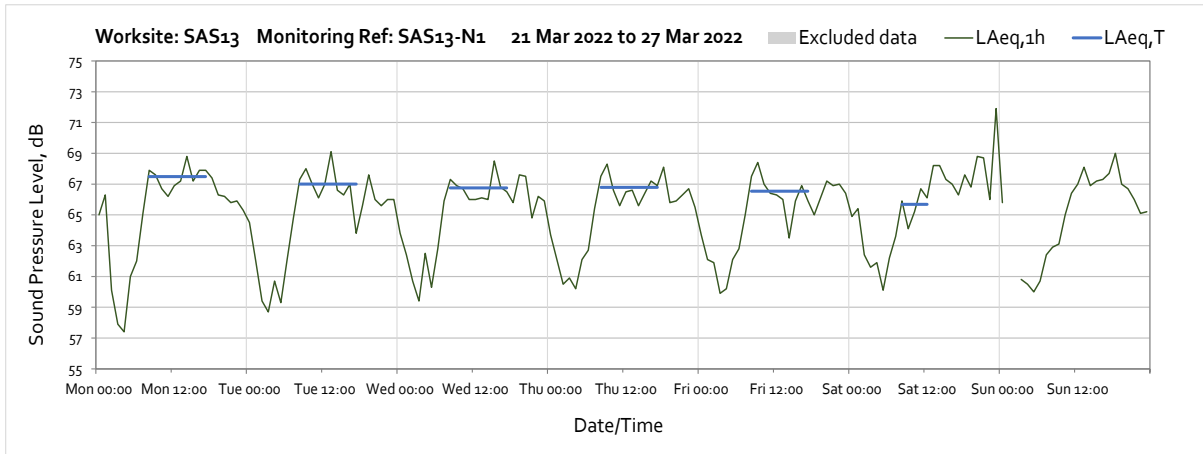
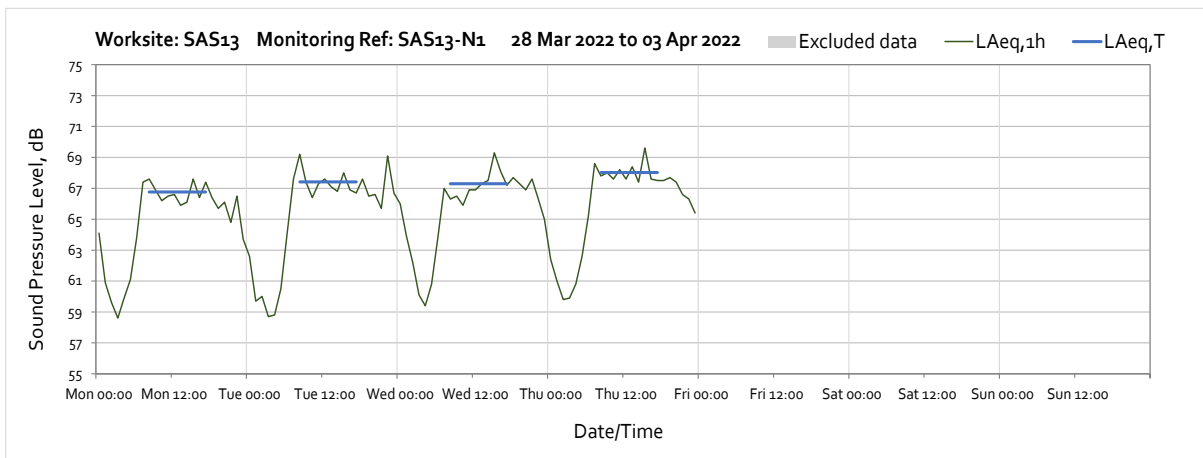
Worksite: SAS13 Bridge Replacement (SAS13) – Monitoring Ref: SAS13-N1

Note: Missing data in between 01:00 and 02:00 on Sunday 27th March was due to the clocks going forward at the start of British Summer Time.

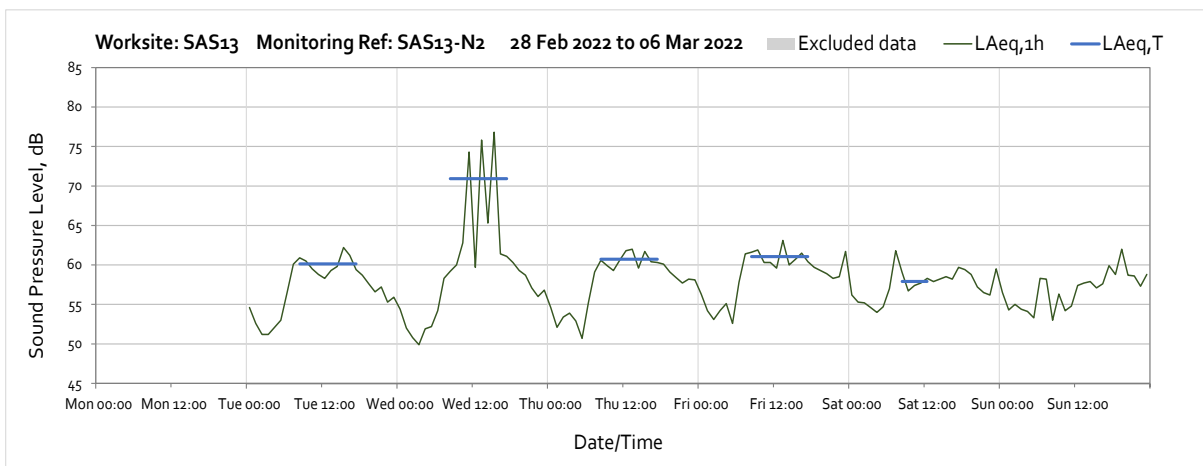
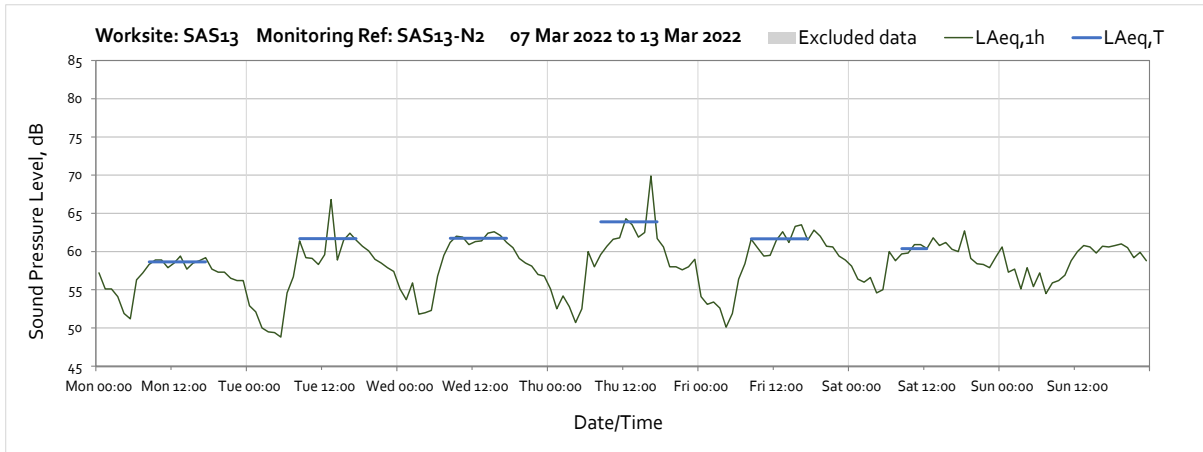
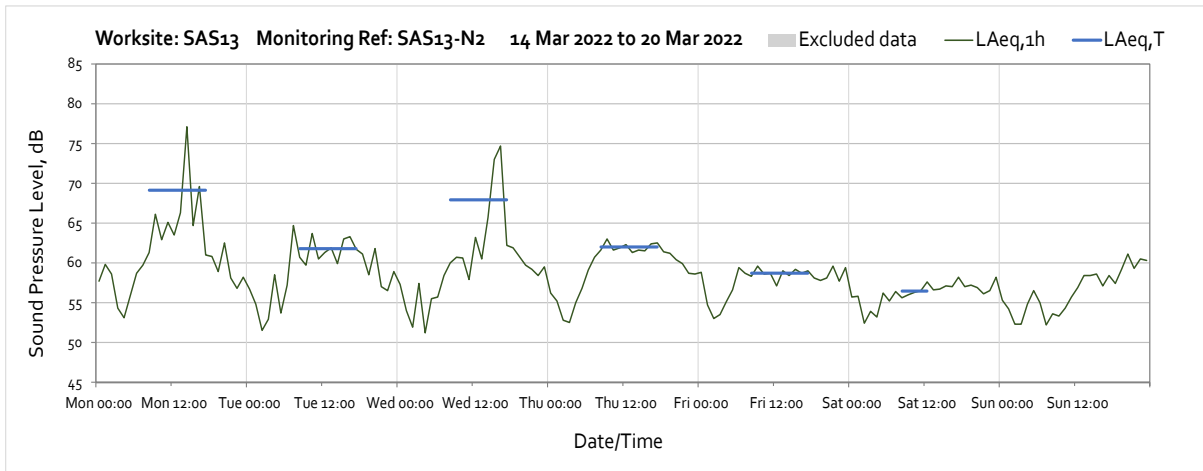
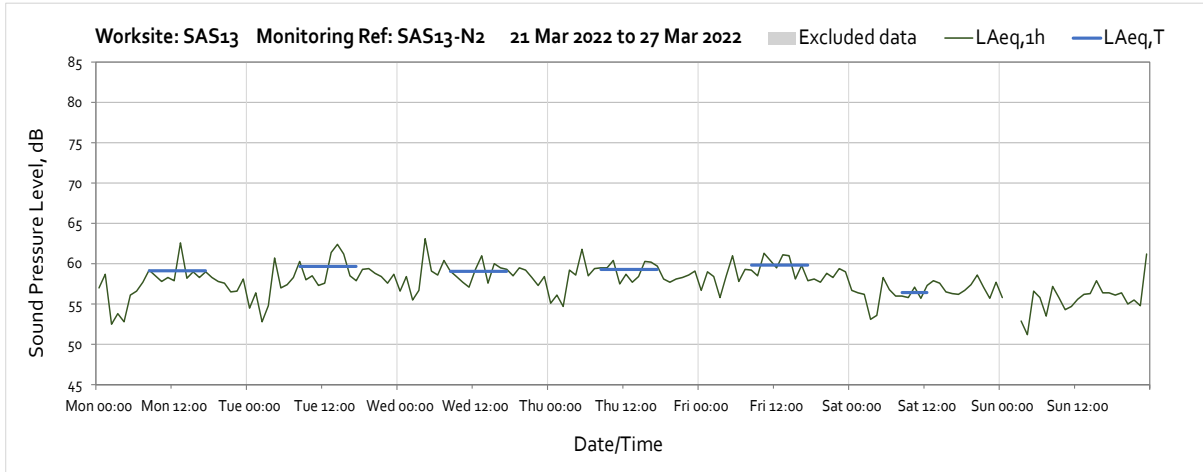
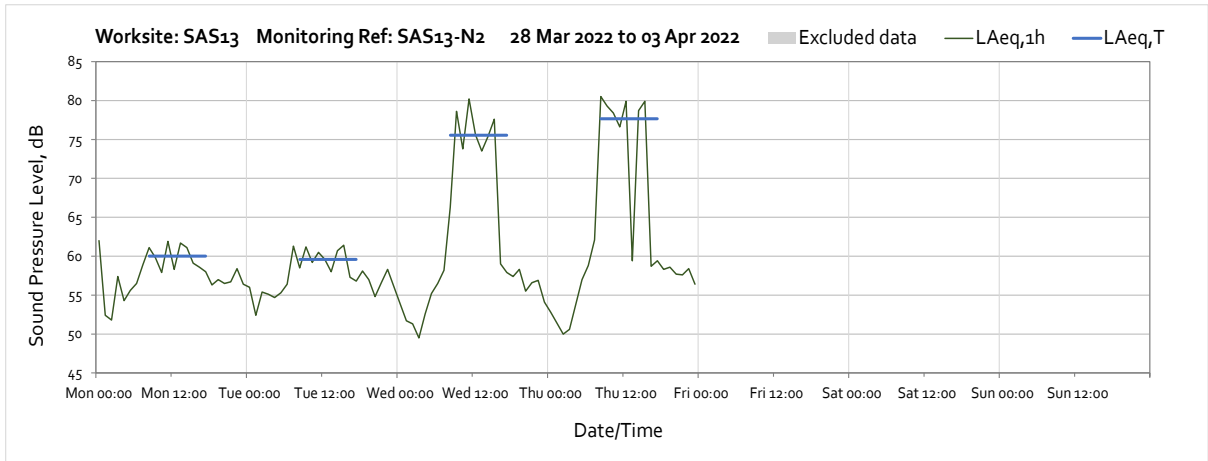
Worksite: SAS13 Bridge Replacement (SAS13) – Monitoring Ref: SAS13-N2

Note: Missing data in between 01:00 and 02:00 on Sunday 27th March was due to the clocks going forward at the start of British Summer Time.

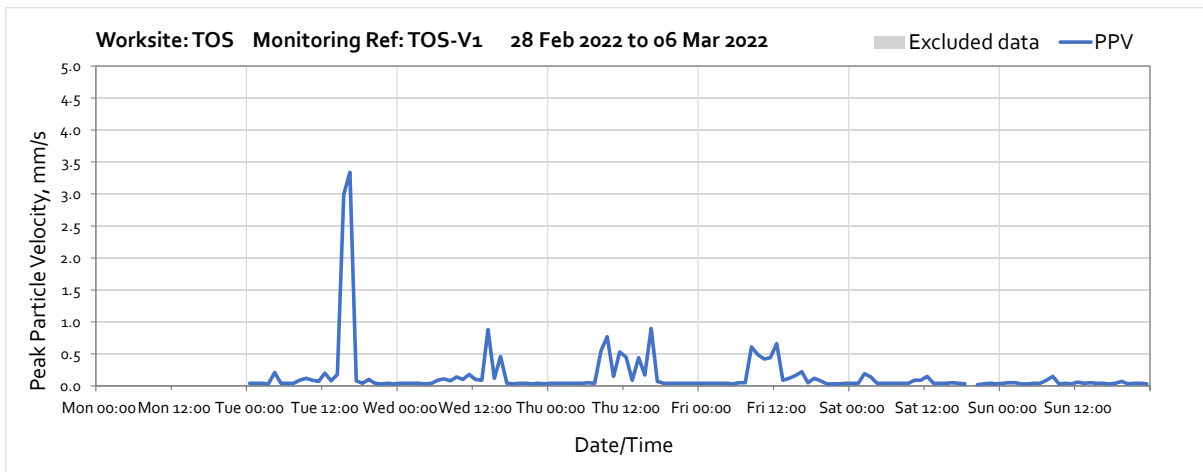
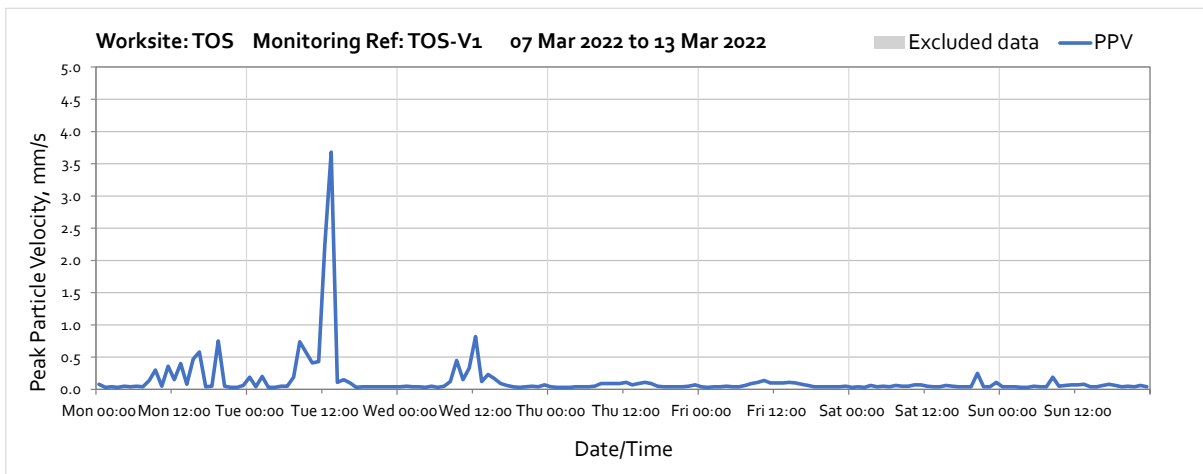
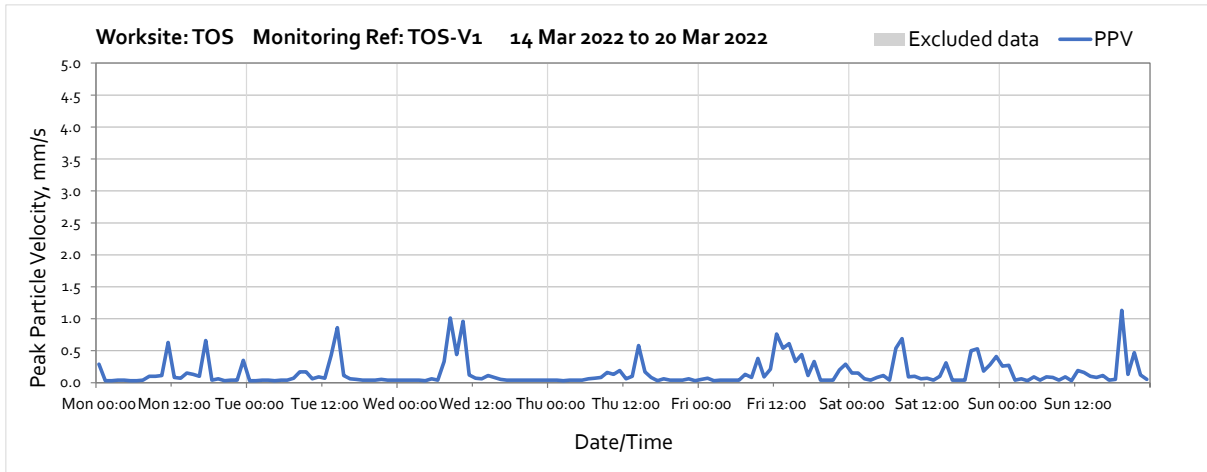
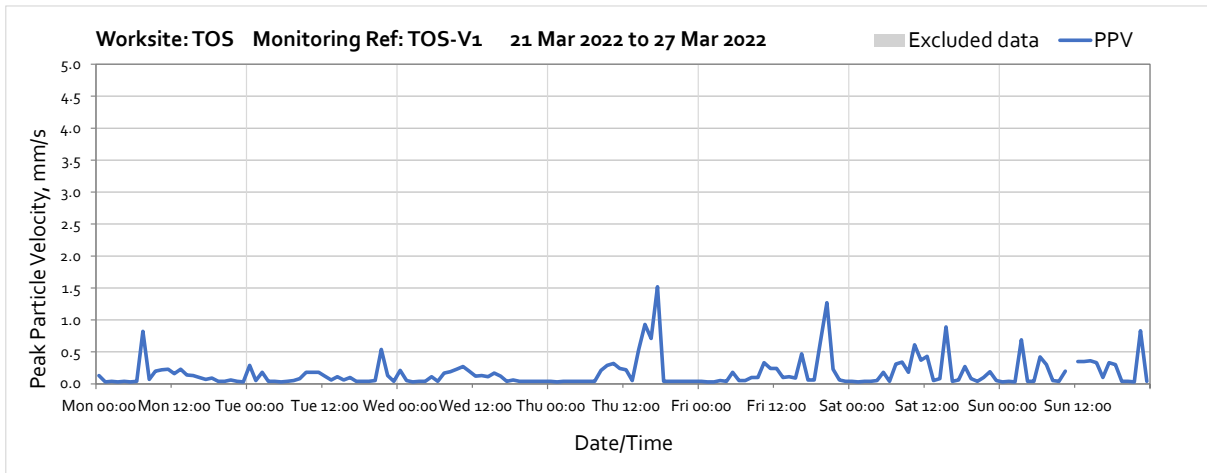
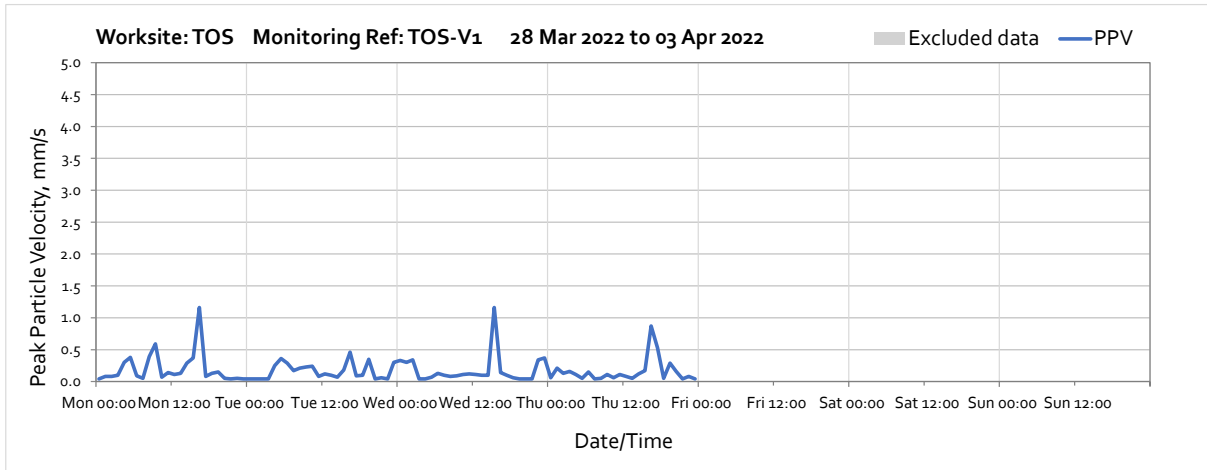
Worksite: Twisted Oak Stables (TOS) – Monitoring Ref: TOS-V1

The following graphs show the hourly measured peak particle velocity PPV recorded during the monitoring period. The graphs show the highest PPV of the three orthogonal axis x, y and z. Where high values of PPV were caused by local interference with the vibration monitor, which are not representative of HS2 construction works, these values have been greyed out in the following charts and have been excluded to calculate values in Table 4 of the main report.

Note: Missing data at 19:00 on Saturday 5th March 2022 were due to a monitoring system error is currently under investigation.

Note: Missing data at 11:00 on Sunday 27th March 2022 were due a monitoring system error and is currently under investigation.

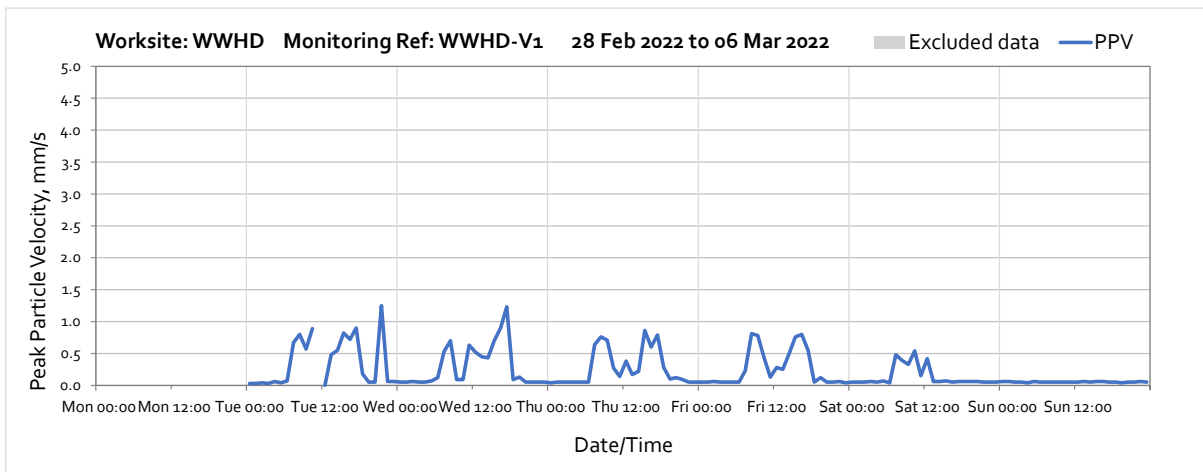
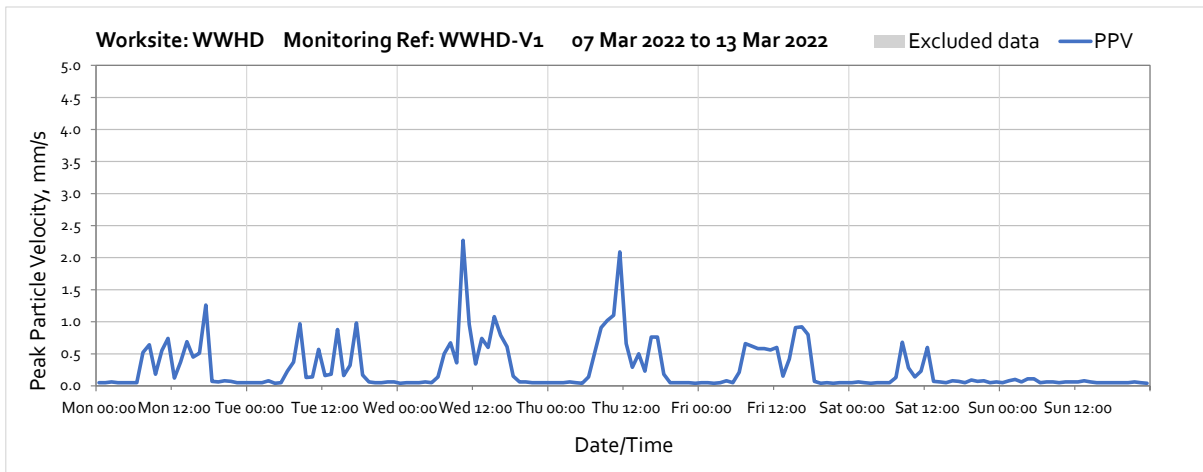
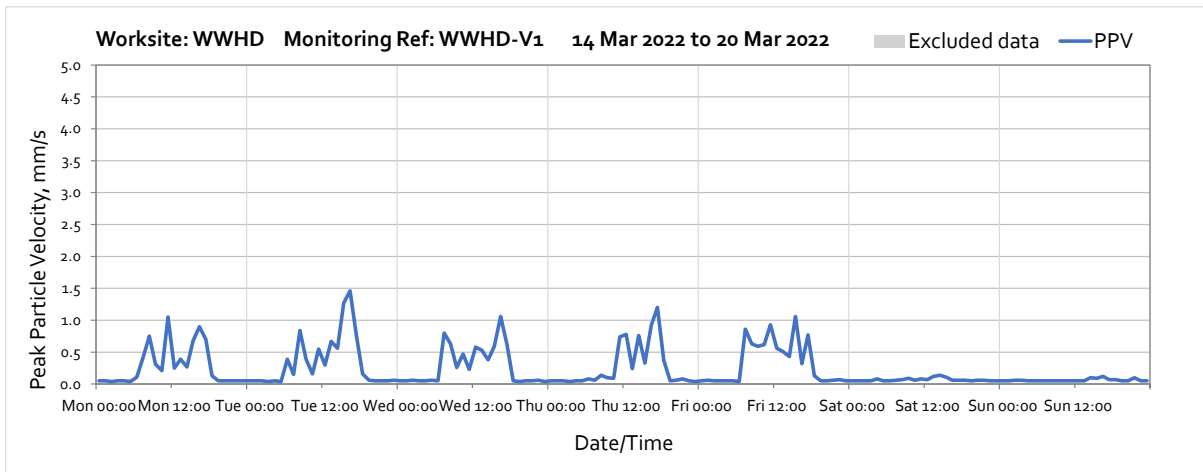
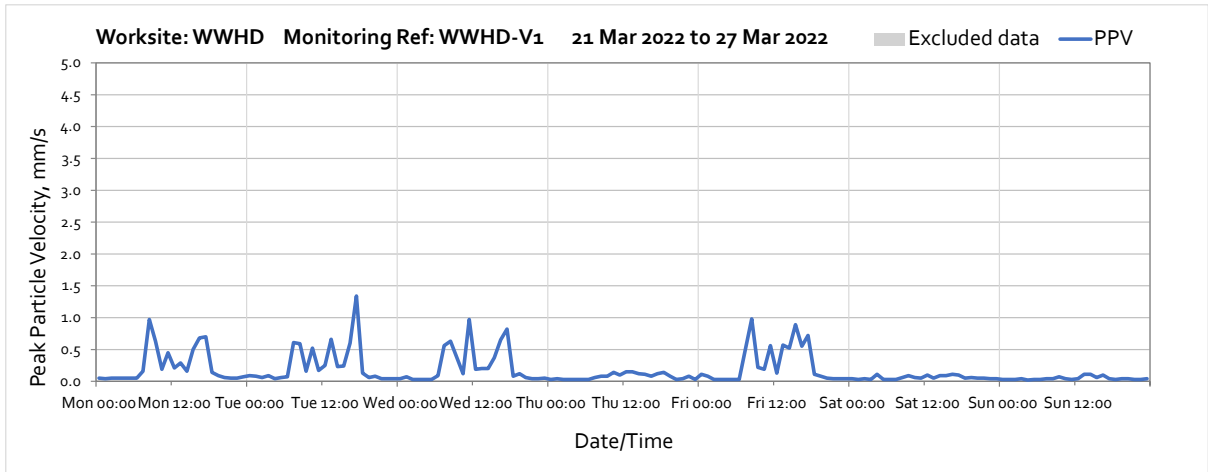
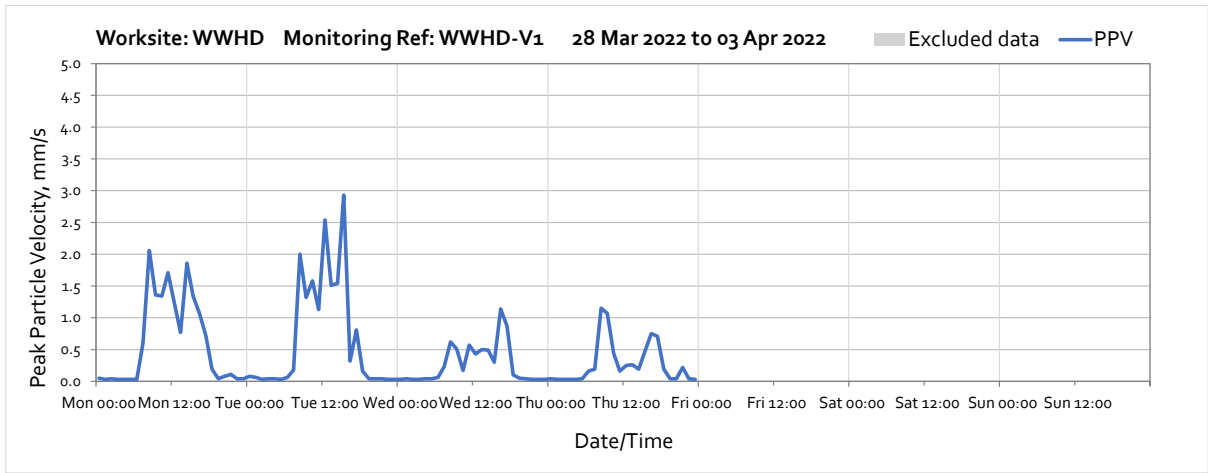
Worksite: Washwood Heath Depot (WWHD) – Monitoring Ref: WWHD-V1

Note: Missing data at 11:00 on Tuesday 1st March 2022 were due to a monitoring equipment being moved.
