Construction Noise and Vibration Monthly Report – March 2022

Birmingham City

Non-Technical Summary

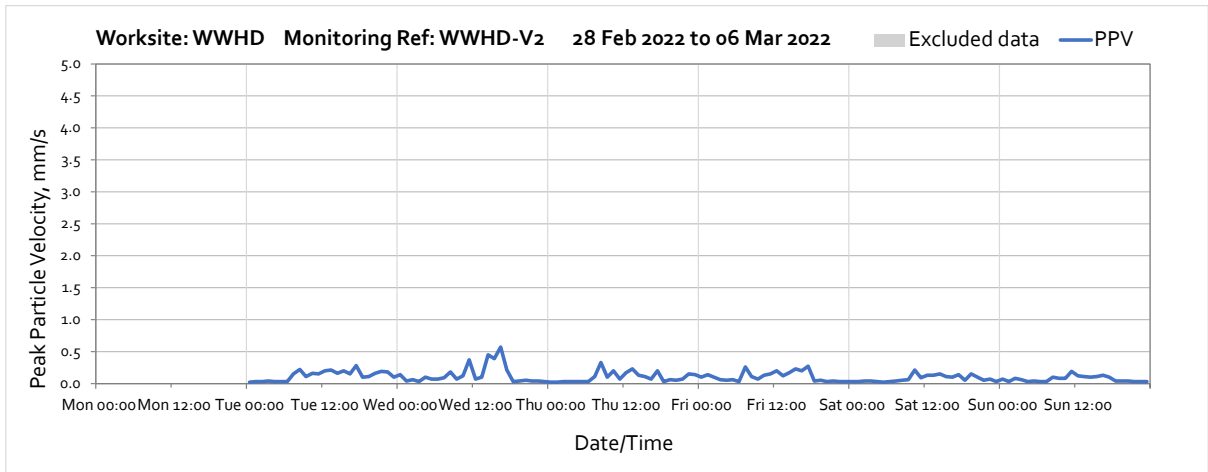
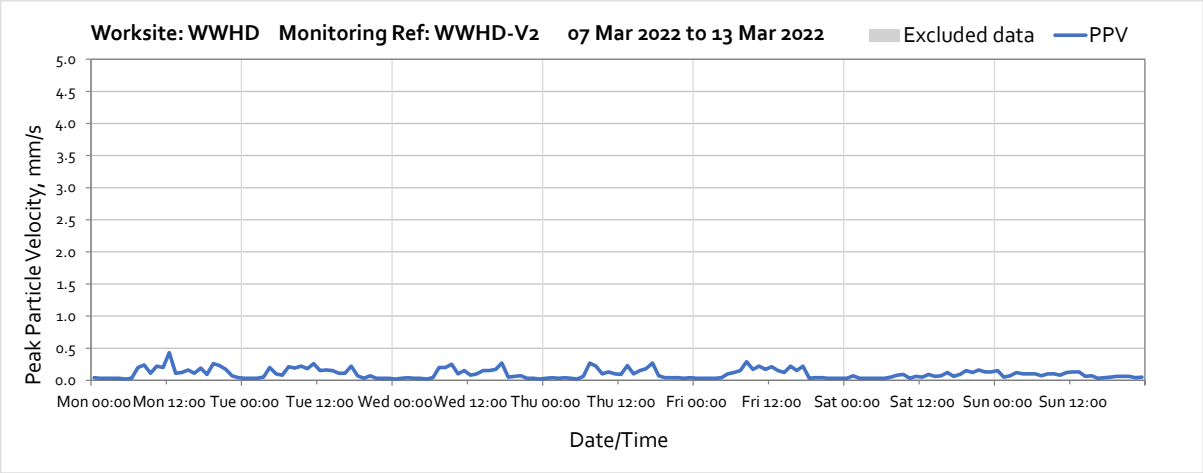
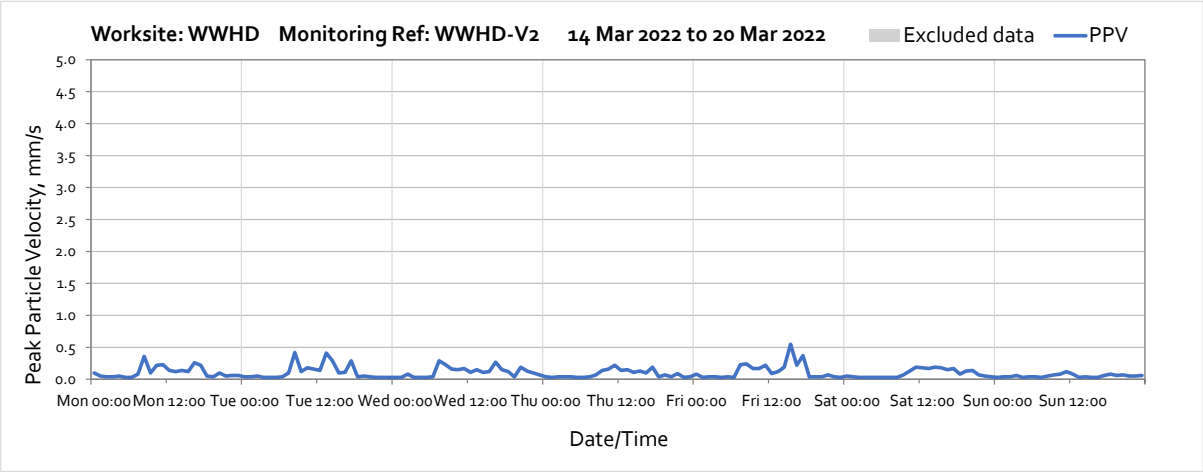
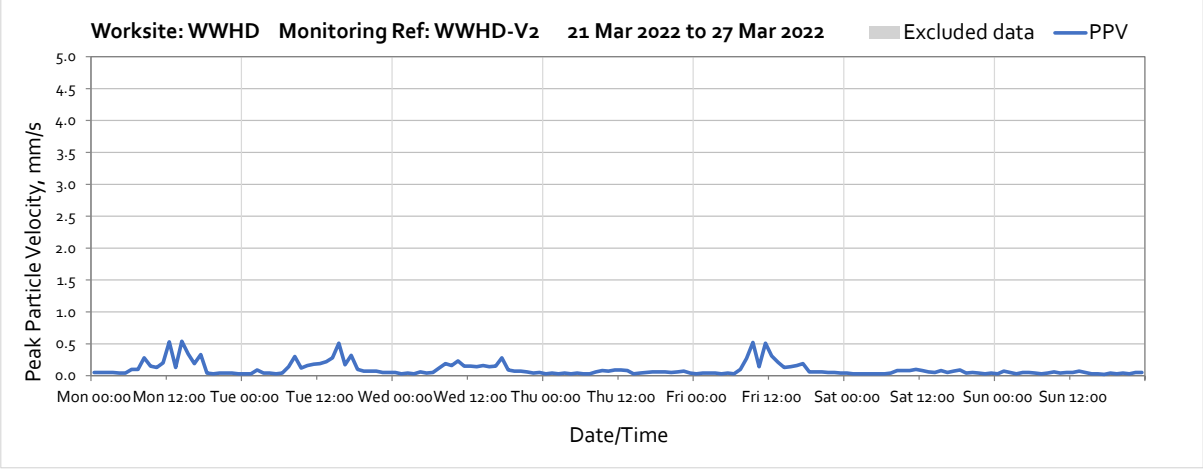
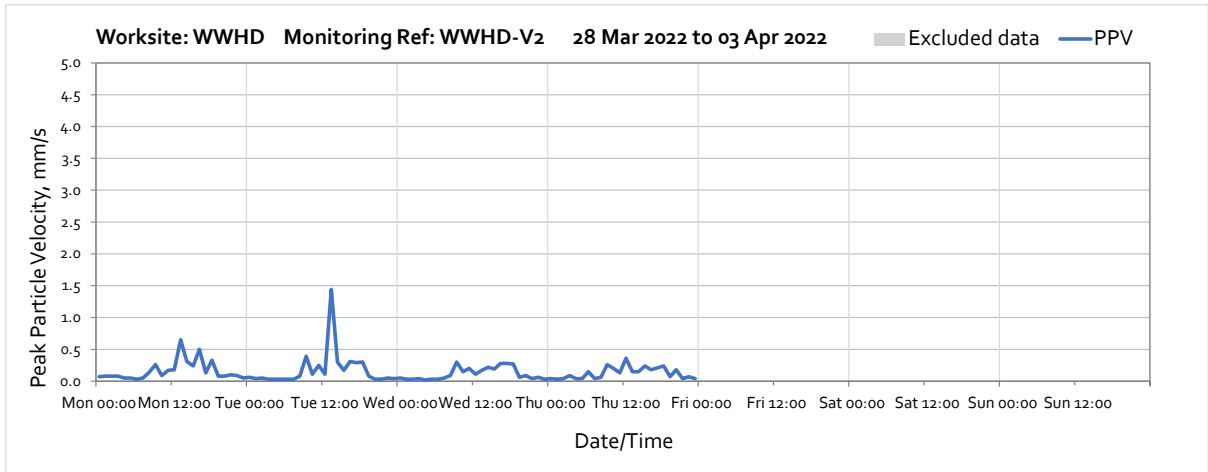
Worksite: Washwood Heath Depot (WWHD) – Monitoring Ref: WWHD-V2

The following graphs show the hourly measured peak particle velocity PPV recorded during the monitoring period. The graphs show the highest PPV of the three orthogonal axis x, y and z. Where high values of PPV were caused by local interference with the vibration monitor, which are not representative of HS2 construction works, these values have been greyed out in the following charts and have been excluded to calculate values in Table 4 of the main report.
